**Appendix L - Treorchy**

# Flood and Water Management Act 2010

## Section 19 Flood Investigation Report

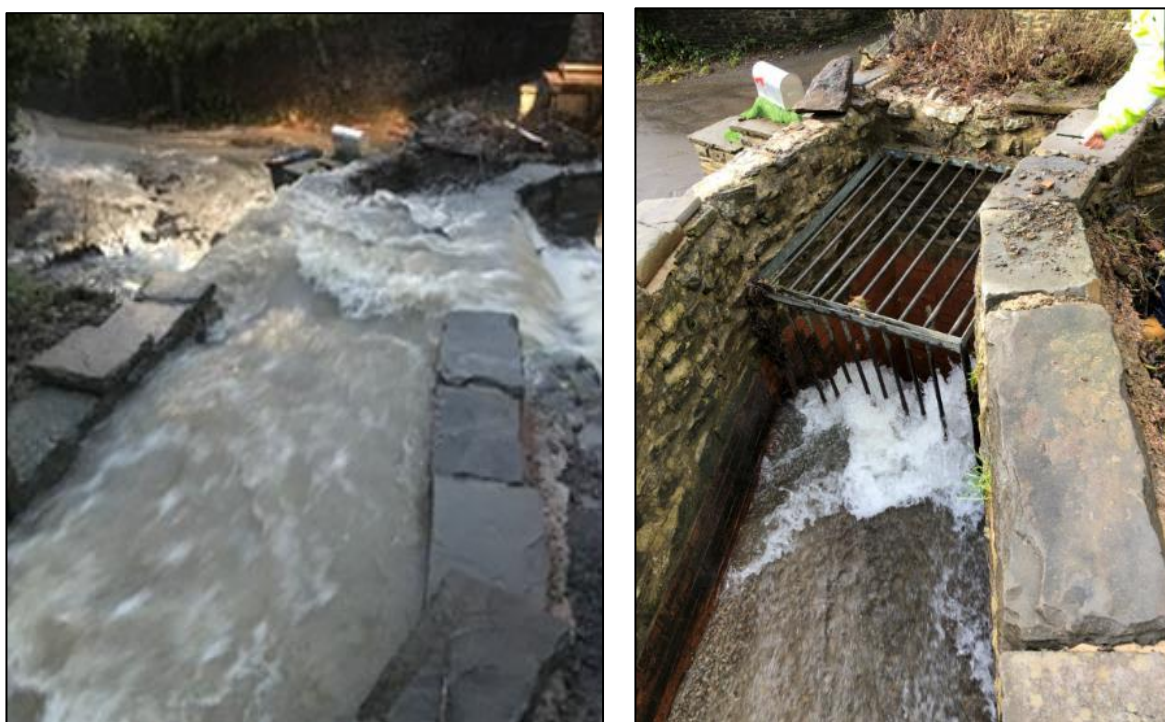
'Culvert Inlet 1' was reported by residents as the primary source of flooding to properties at Dumfries Street, Luton Street and the A4061 (Bute Street / High Street). The inlet is situated approximately 60 metres north of the 'Column Street Culvert Inlet'. The culvert was reported by residents as being "unable to manage the flow of water entering the culvert" during the early hours of the storm event and as a result surcharged. Debris consisting of large stones and silt was also noted by residents to have blocked the inlet debris screen.

Approximately 33 residential properties and 4 commercial properties along Dumfries Street, Luton Street and the A4061 (Bute Street / High Street) were internally flooded as a result of this flow path.

**Figure 5:** Evidence of 'Culvert Inlet 1' surcharging during the storm event and conveying southwards towards Column and Dumfries Streets (left) (image provided by resident), and 'Culvert Inlet 1' post storm event (right) (captured by RCT's Flood Risk Management team on 20<sup>th</sup> February 2020)

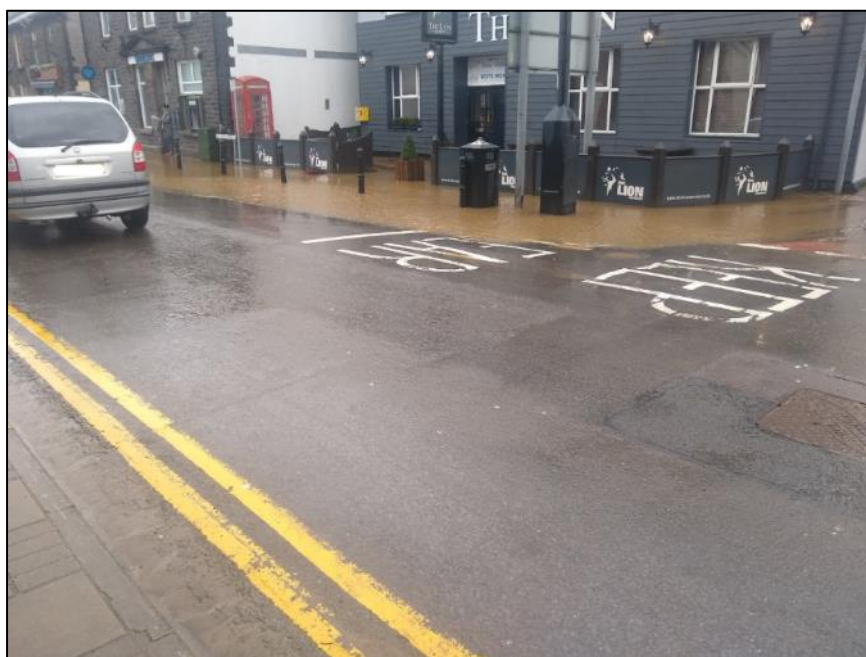
**Figure 6:** Surface water ponding along the A4061 High Street during Storm Dennis on 16<sup>th</sup> February 2020 (image provided by resident)

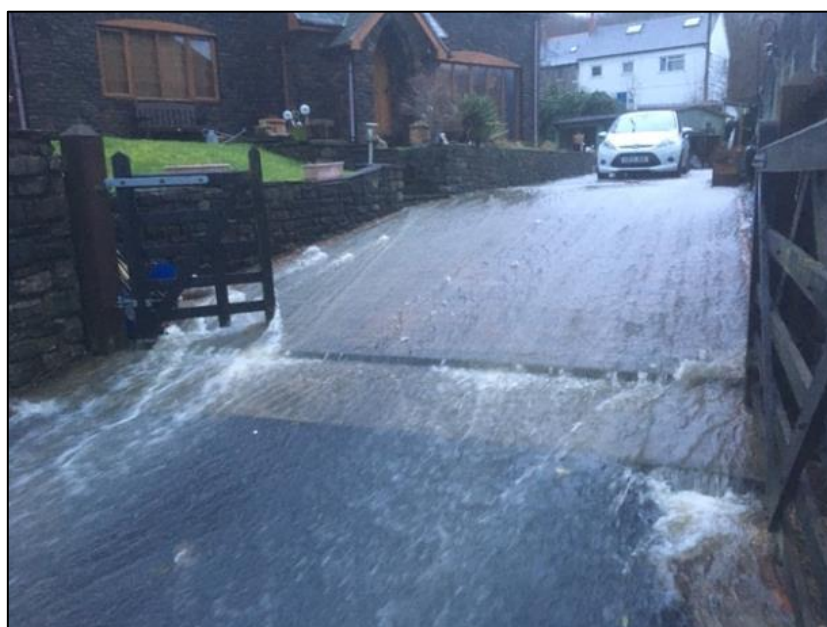
Upstream of 'Culvert Inlet 1', 'Culvert Inlet 2', located north east of Glyncoli Close, was reported to have surcharged during the storm event, causing water to travel through external private property towards Glyncoli Close and flooding 1 residential property (flow path depicted in Figure 7).

**Figure 7:** Flow path from 'Culvert Inlet 2' conveying towards Glyncoli Close

Accounts provided by residents stated that the flow of water was diverted by residents during the storm event to allow the water to convey southwards down a small lane towards 'Culvert Inlet 1'. On its path, water was partially redirected back into the downstream open watercourse, whilst the remaining flow conveyed towards the lower reaches of Treorchy, contributing to the flooding at Dumfries Street, Luton Street and the A4061 (Bute Street / High Street).

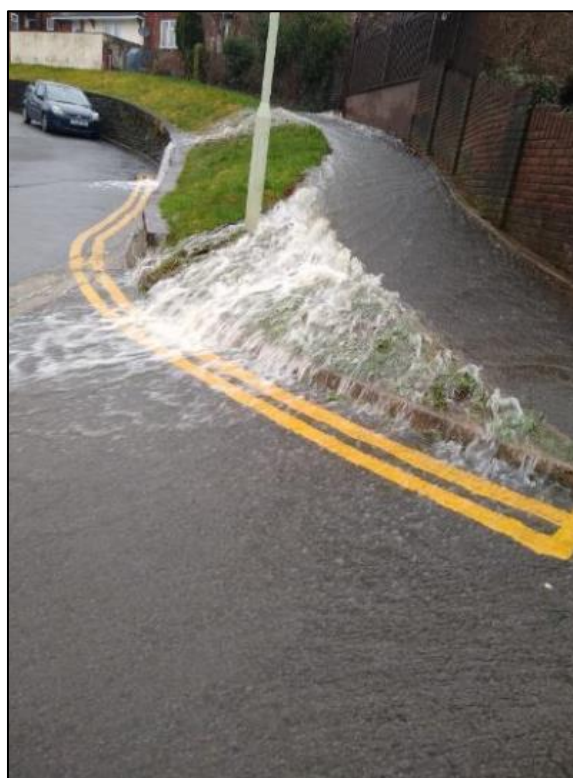
The site inspection also identified evidence of a third surcharged culvert inlet located at Heol Tyle-Du (labelled 'Culvert Inlet 3' in Figure 4). This inlet conveys flows from the Nant Tyle-du ordinary watercourse towards the 'Column Street Culvert Inlet'. 'Culvert Inlet 3' was observed as surcharging by residents during the event, resulting in water conveying down Heol Tyle Du towards Bryn Rhodfa. At a low point along Bryn Rhodfa, water overtopped the kerb line before cascading down the hillside towards the rear of properties at Heol Orchwy. Four residential properties along Heol Orchwy were confirmed as internally flooded as a result of this flow path.

Exceedance flows from 'Culvert Inlet 3' are also considered to have conveyed towards Column Street, contributing to the flow path which affected properties in the lower reaches of Treorchy.

**Figure 8:** Surcharging flows down Heol Tyle Du from 'Culvert Inlet 3' during Storm Dennis (image provided by resident)

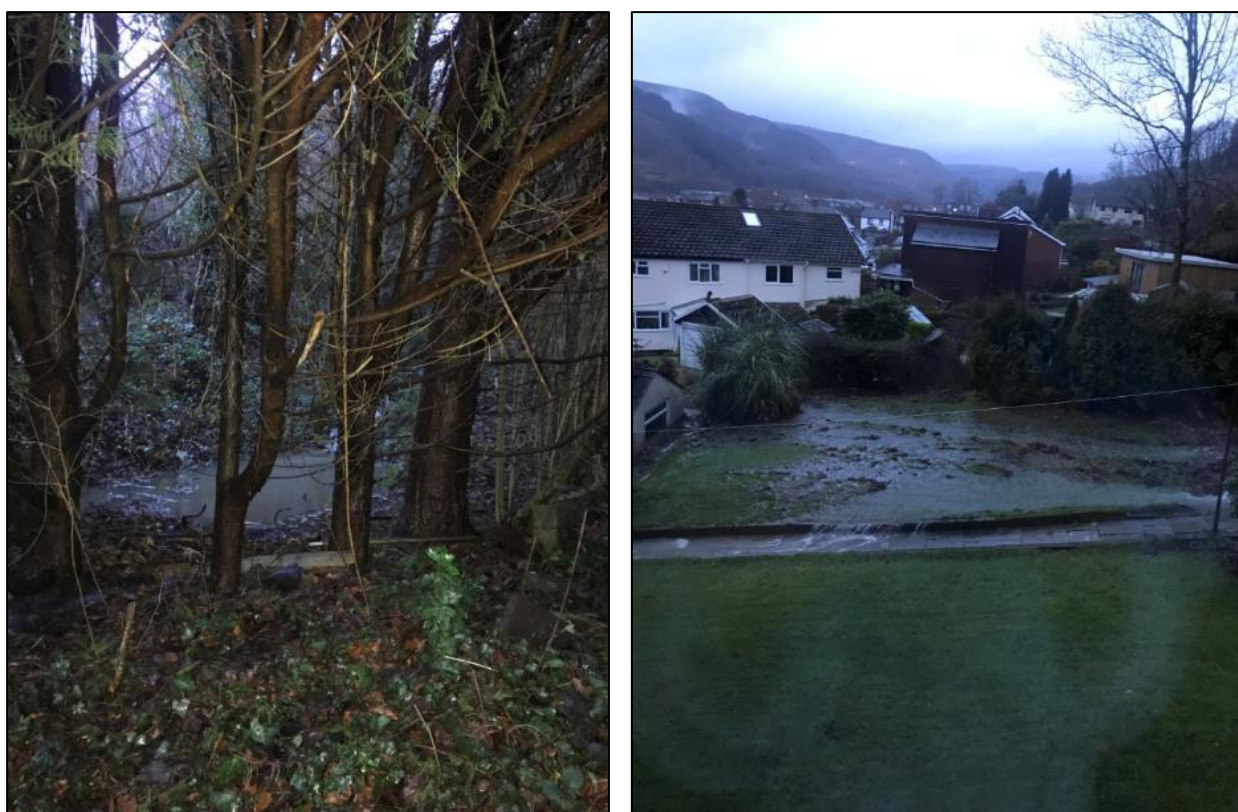
Calls were received by residents at Crosswood Street to report water emanating from a culvert inlet situated north of Crosswood Street. Upon wider inspection of the area and discussions with residents, undertaken by RCT's Flood Risk Management team on 21<sup>st</sup> February 2020, one culvert inlet, labelled 'Culvert Inlet 4' in Figure 9, showed evidence of surcharge.

One residential property at Crosswood Street was internally impacted by the flows originating from 'Culvert Inlet 4' during Storm Dennis.

**Figure 10:** Evidence of 'Culvert Inlet 4' surcharging during Storm Dennis (left) and evidence of surcharging flows travelling through the garden of a private property towards the park space downstream (right) (images provided by resident)

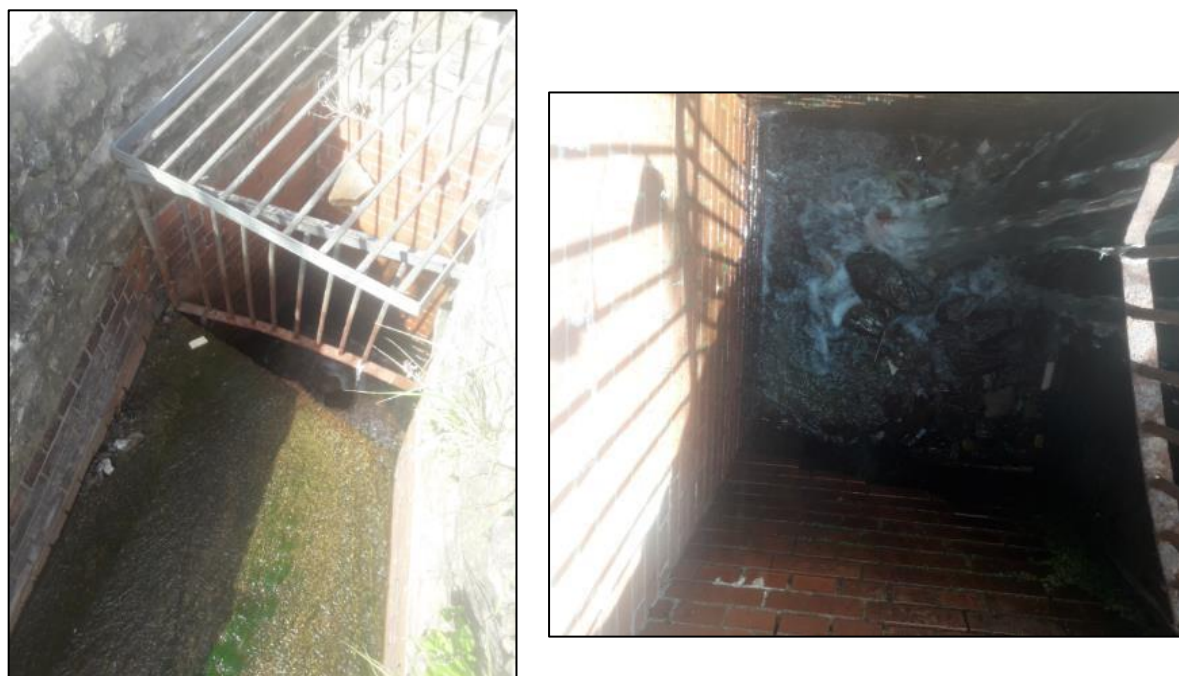
The 'Culvert 1 – Nant Tyle-du' network was surveyed to be in acceptable condition downstream of the inlet however, significant debris was noted to have accumulated within the inlet chamber during cleansing operations (Figure 12, right). The ordinary watercourse entering the culvert network is set much higher than the inlet itself,

allowing smaller debris to pass through the debris screen and build up at the start of the pipe (Figure 12, left).

**Figure 12:** Image of 'Culvert Inlet 1' captured post event during CCTV surveying operations (30/07/2020) (left) and evidence of debris accumulation within the culvert chamber (right)

The CCTV survey also noted damages caused to the inlets trash screen, indicating that the inlet suffered significant debris accumulation during the storm event. It was noted by residents and emergency responders that the culvert became blocked with debris during the storm event. It was also noted by residents that tyres were amongst the debris removed from the culvert.

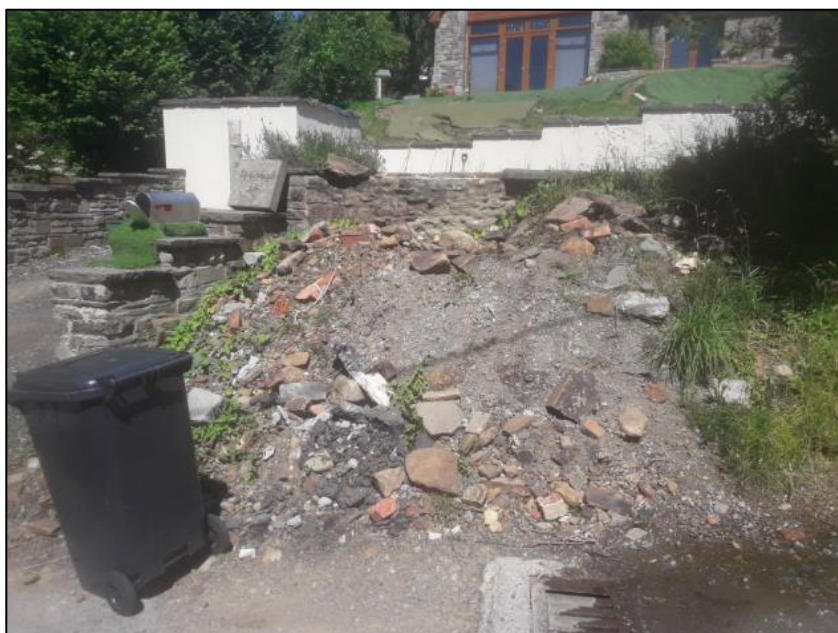
The condition of the inlet structure itself is considered to have contributed to the surcharging at 'Culvert Inlet 1' by allowing some debris to enter the network however, the volume of debris entering the network from the hillside above RCT26 is considered the primary cause of surcharge.

**Figure 13:** Evidence of debris removed from 'Culvert Inlet 1' post event (captured by Council appointed contractor during CCTV surveying operations on 30/07/2020)

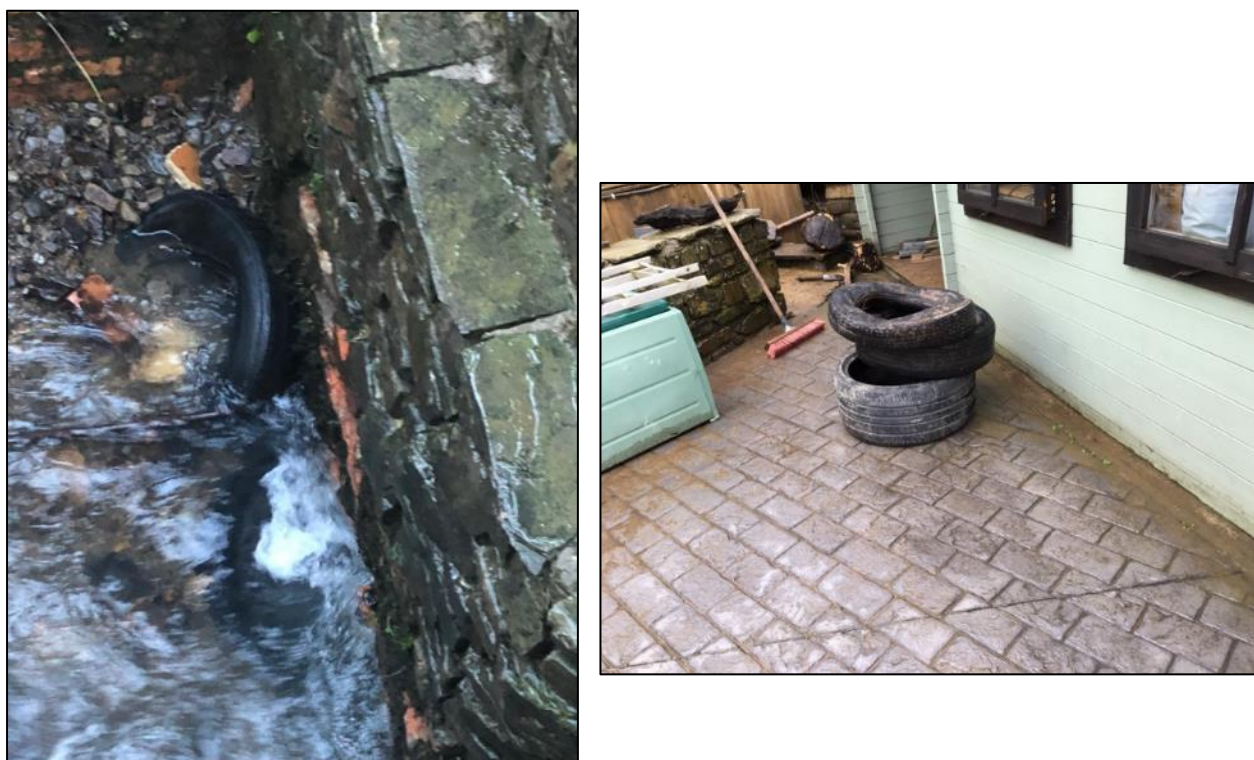
'Culvert Inlet 2' was identified by first responders as being blocked with silt and debris mobilised by the fast-flowing water entering the network during the storm event. Photographs and video footage provided by residents during post event inspections carried out by RCT's Flood Risk Management team on 17<sup>th</sup> February 2020 show evidence of tyres being manually pulled out of the culvert inlet to manage the flow of water (Figure 14). This material was reportedly washed down from the upstream ordinary watercourse section (described in Section 3.2).

**Figure 14:** Evidence of debris, inclusive of tyres, causing a blockage to 'Culvert Inlet 2' during Storm Dennis (left) and evidence of the three tyres removed from the inlet by a resident (right) (images provided by resident)

'Culvert Inlet 2 – Nant Tyle-du' network was surveyed by a Council appointed contractor in August 2020. The culvert network was found to be in poor structural condition with multiple operational defects observed. Its poor condition is considered to have contributed to the surcharging of 'Culvert Inlet 2', however, the blockage to the inlet structure has been determined as the most significant contributor to the surcharging and associated flood flow path along Glyncoli Close and downhill towards Column Street during Storm Dennis.

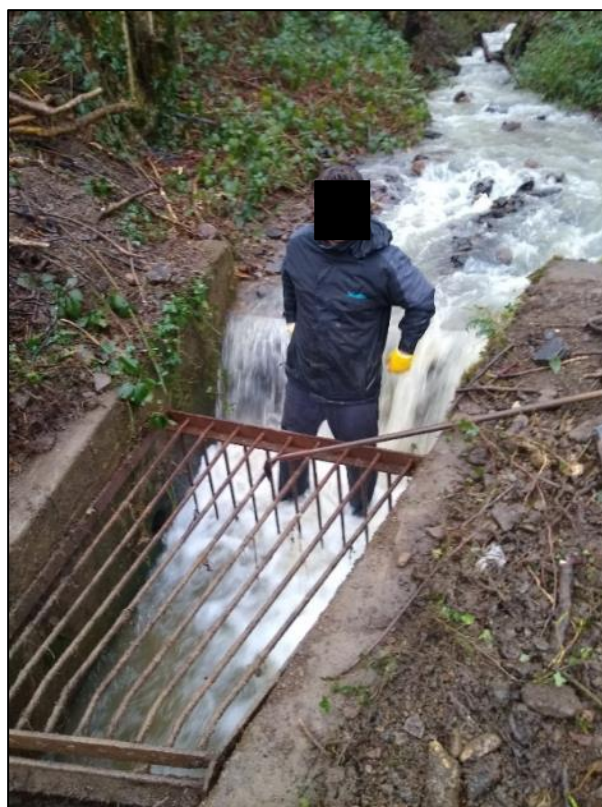
the hillsides above RCT26 during the storm event. This debris is considered to have reduced the inlet's hydraulic capacity to manage the flow of water, resulting in surcharge. The inlet was initially cleared by local residents (Figure 15) and subsequently, inspected and cleared of debris by the Highway and Streetcare Depot.

**Figure 15:** Photo of 'Culvert Inlet 3' following initial debris clearance by local residents on 16<sup>th</sup> February 2020.

Internal CCTV surveys of the culvert network recorded the culvert as being in poor structural and operation condition with several fractures and broken sections of pipe in addition to loss in cross-sectional area caused by settled deposits. As a result, approximately 2 tonnes of debris was removed from the network during cleansing operations.

The poor condition of the 'Culvert Inlet 3 – Heol Tyle-du' network is considered to have contributed to the flooding however, blockages to the inlet structure which reduced the inlet's hydraulic capacity to manage the flow of water has been determined as the most significant contributor to the observed surcharging during Storm Dennis.

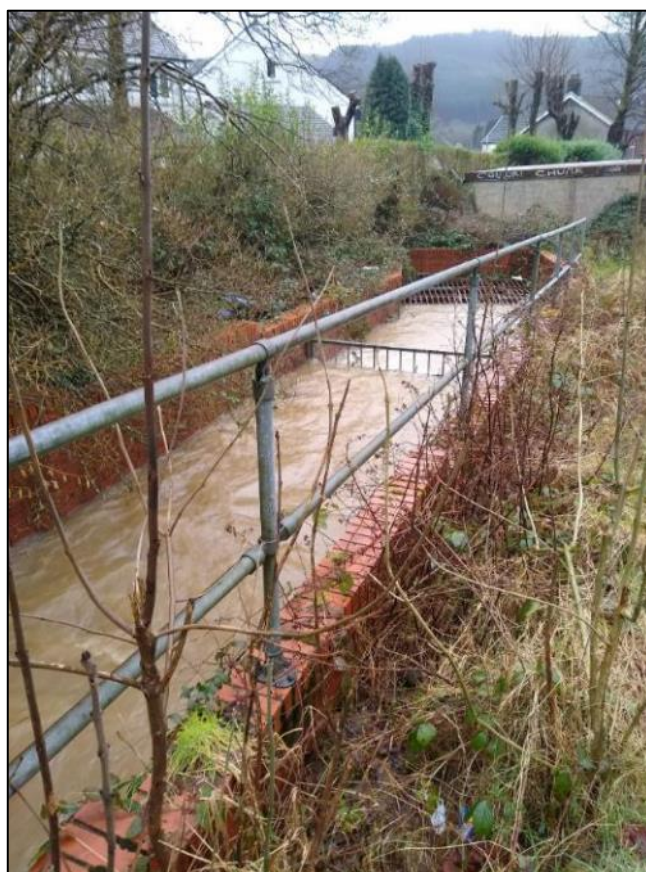
During the storm event, the ‘Column Street Culvert Inlet’ and upstream section of open watercourse was observed as being almost at full capacity (Figure 16). Partial debris accumulation behind the upper debris screen within the open channel were observed by residents however, it was noted that the culvert inlet was still able to manage the flow of water during the storm event (Figure 16).

**Figure 16:** Column Street open channel and culvert inlet showing high flows (image provided by resident. Captured at 11am on 16th February 2020)

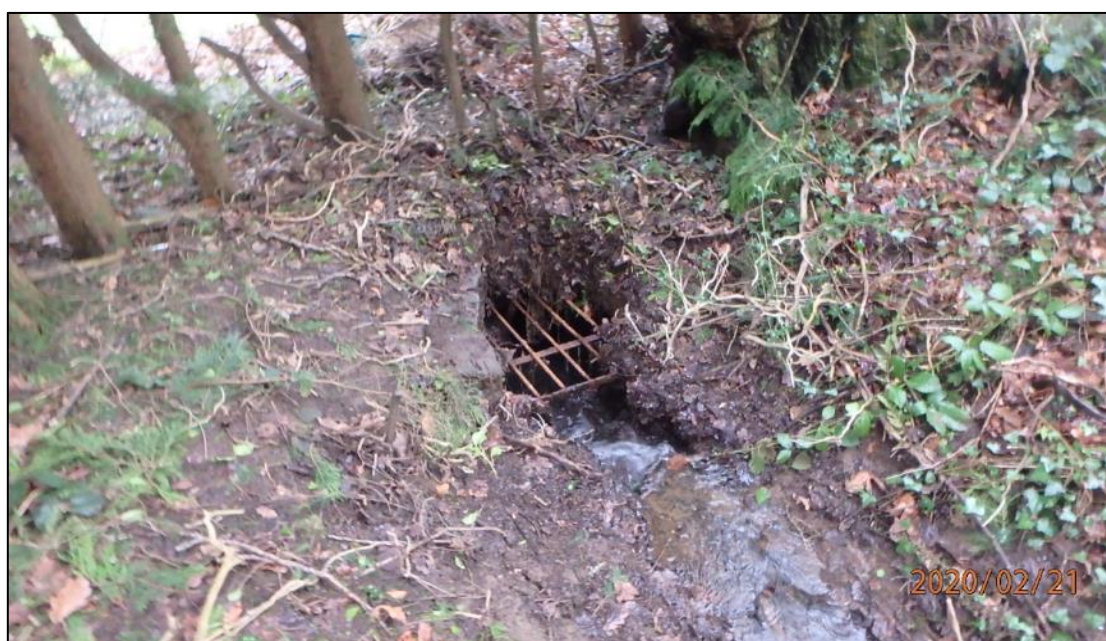
The network downstream of 'Culvert Inlet 4' was unable to be surveyed due to the inlet's poor condition restricting camera access. Furthermore, the area around the inlet structure had been washed away meaning there was no access point on the safety grid to securely carry out the CCTV survey.

**Figure 18:** Photo of 'Culvert Inlet 4' captured by RCT's Flood Risk Management team post storm event on 21<sup>st</sup> February 2020

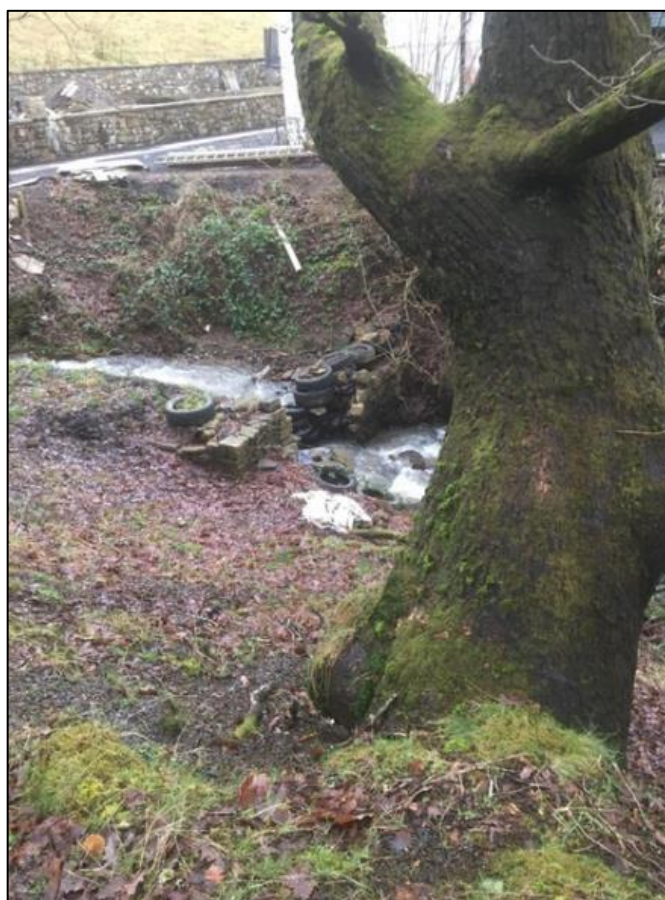
On review of the unnamed open watercourse conditions upstream of 'Culvert Inlet 2', an obstruction was identified within the channel. Evidence of the obstruction, which consisted of a man-made tyre damn across the width of the channel, is shown in Figure 20. This material is considered to have been mobilised downstream during the storm event, contributing to the surcharge of 'Culvert Inlet 2' and 'Culvert Inlet 1' by reducing both inlets' hydraulic capacities to manage the flow of the watercourse.

**Figure 20:** Image of tyre damn acting as an obstruction to the watercourse upstream of 'Culvert Inlet 2' (captured by RCT's Flood Risk Management team on 17th February 2020)

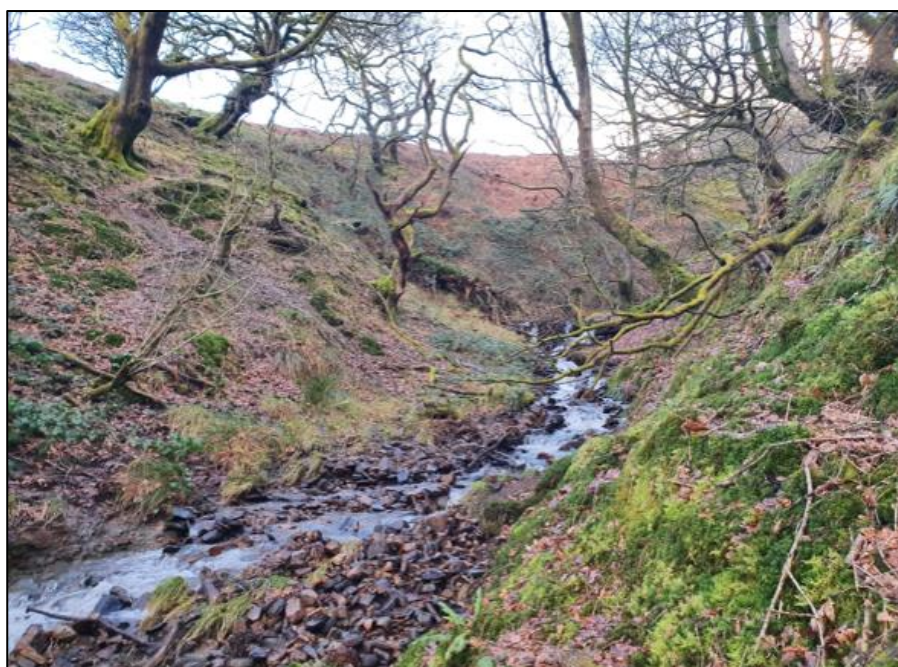
Upstream of the identified obstruction, the unnamed ordinary watercourse channel showed evidence of debris mobilisation within the upper catchment above RCT26 (Figure 21). On review of the type of debris that contributed to the blockages at 'Culvert Inlets 1 and 2', the identified stonewash material depicted in Figures 21 is considered to have been washed down the catchment towards both culvert inlets during the storm event and contributing to its surcharge.

**Figure 21:** Photo of the unnamed ordinary watercourse upstream of 'Culvert Inlet 2' within the upper catchment (captured by RCT's Flood Risk Management team on 17<sup>th</sup> February 2020)

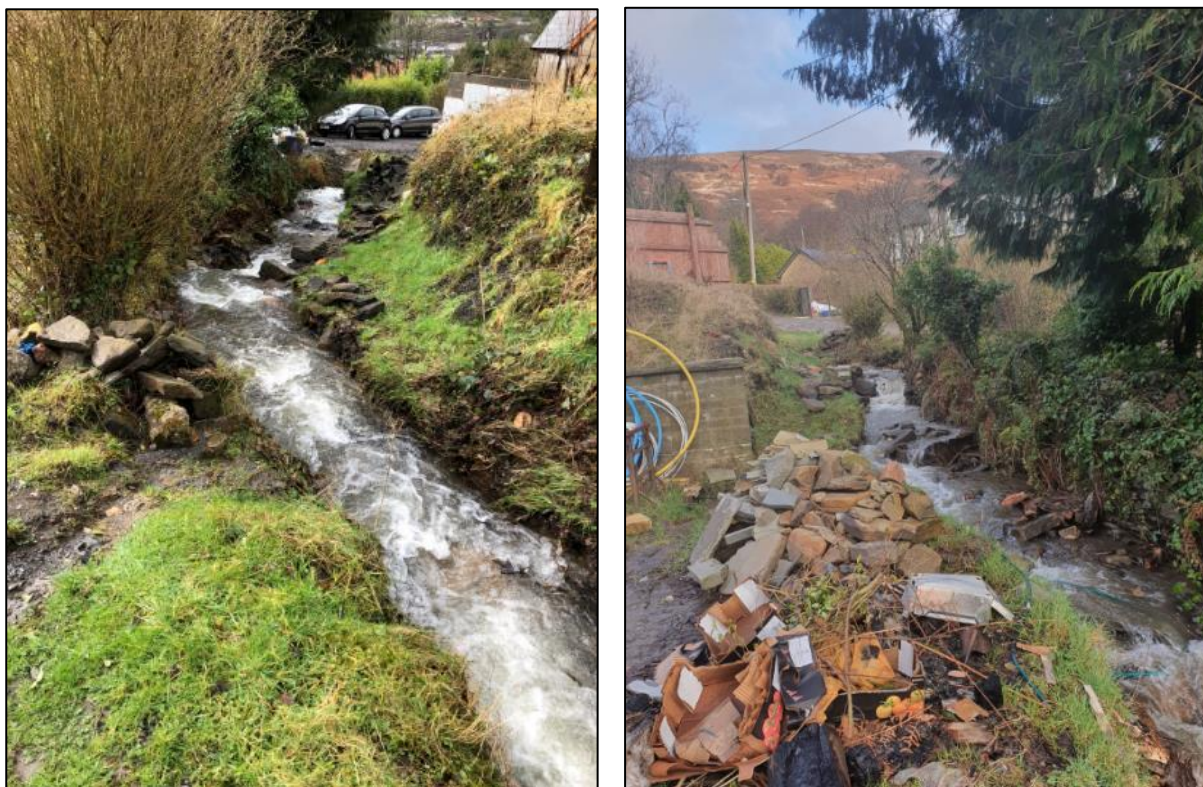
13) consisted of similar stonewash material inclusive of large stones. It is considered that this material was transported from the upper reaches of Treorchy via the unnamed watercourse and contributed to the surcharging of both 'Culvert Inlet 1 and 2'.

**Figure 22:** Unnamed open watercourse upstream of 'Culvert Inlet 1' showing evidence of large stones within the channel and surrounding embankment area (captured by RCT's Flood Risk Management team on 20<sup>th</sup> February 2020). Looking downstream towards 'Culvert Inlet 1' (left) and looking upstream towards the outfall of 'Culvert Inlet 2' (right).

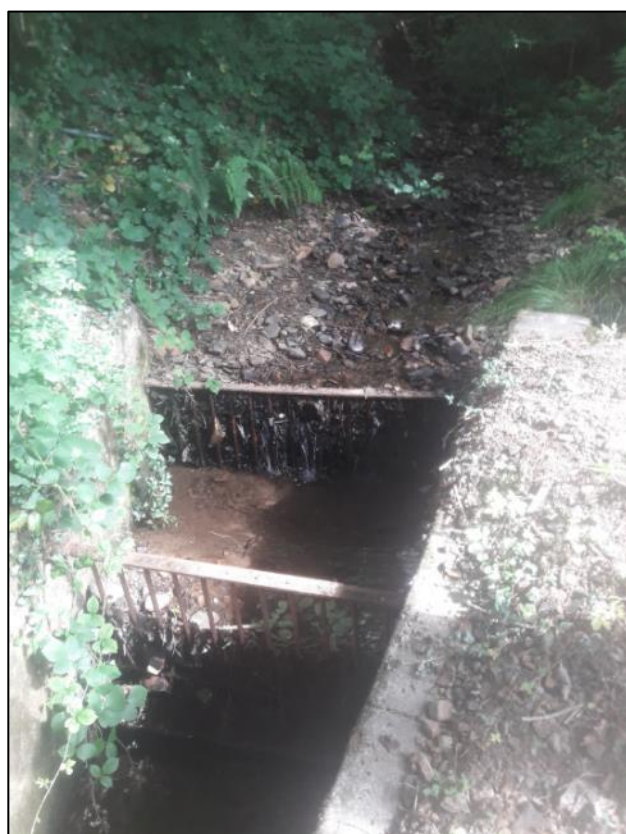
The Nant Tyle-du ordinary watercourse enters the town of Treorchy via 'Culvert Inlet 3' at Heol Tyle-du. On review of the condition of the Nant Tyle-du ordinary watercourse, significant accumulation of natural scour material was evident behind the upper debris screens upstream of 'Culvert Inlet 3' (Figure 23). Figure 23 highlights the extreme flows within the Nant Tyle-du during the storm event which were able to convey a significant volume of scour material downstream towards 'Culvert Inlet 3'.

**Figure 23:** Photo of significant debris accumulation behind the upstream debris screens above 'Culvert Inlet 3' in the Nant Tyle-du watercourse (captured by a Council appointed contractor on 03/08/2020 during CCTV survey operations)

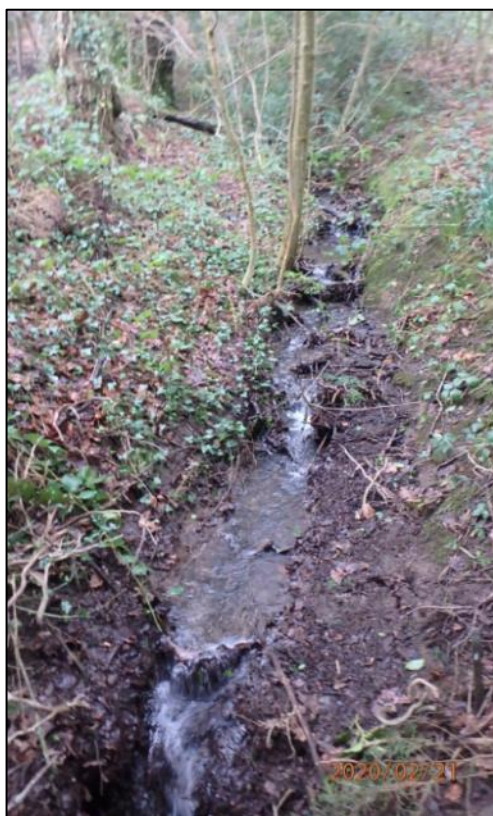
The unnamed ordinary watercourse channel was observed as largely undefined with dense vegetation restricting on-site inspections (Figure 24). The inspecting officer noted minimal evidence of scour and debris deposition within the channel, and debris was not noted at 'Culvert Inlet 4' during post event inspections, indicating that the geomorphic condition of the upstream channel had little impact on the surcharging of 'Culvert Inlet 4'.

**Figure 24:** Photo of the unnamed ordinary watercourse upstream of 'Culvert Inlet 4' (captured by RCT's Flood Risk Management team on 21<sup>st</sup> February 2020)

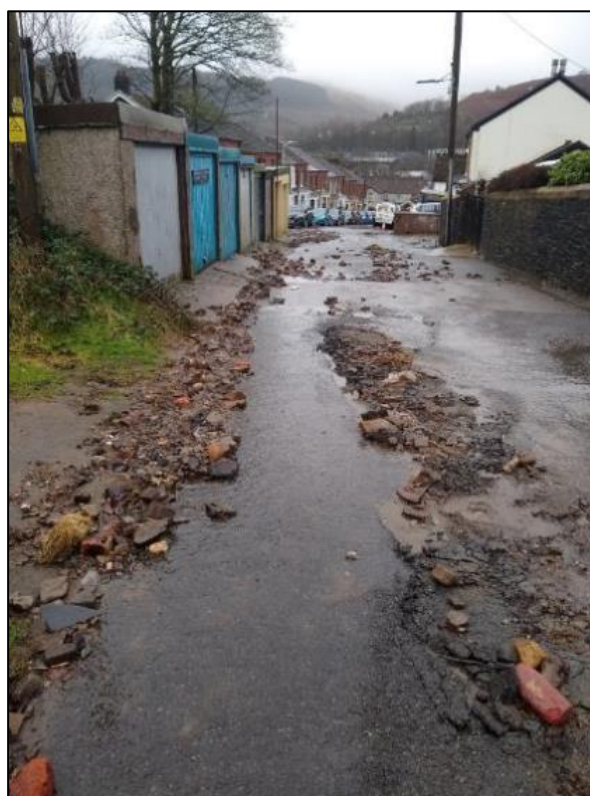
Overland flows from areas of hillside and runoff originating from surcharged culvert inlets across RCT26 resulted in deposition of mud, silt and debris across several streets which is assumed to have entered the highway drainage network via gullies. Evidence of deposited debris along Column Street is indicative of the flow path during the storm event (Figure 27).

**Figure 27:** Road damage and debris deposited along Column Street by the surcharging ordinary watercourse flows during the storm event (image provided by resident)

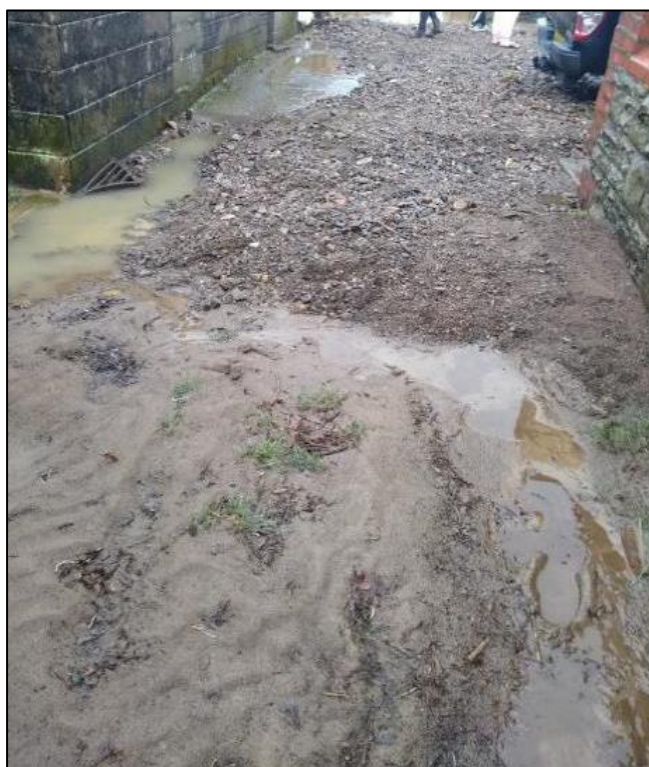
The large quantities of sediment and debris washed onto the streets is also indicative of the high sediment loading from the ordinary watercourses described in Section 3.2.

**Figure 28:** Photo of deposits of silt and debris left behind at Dumfries Street following the flooding during Storm Dennis (image provided by resident)
