**5. ADRODDIADAU YMCHWILIO I LIFOGYDD ADRAN 19**

**Atodiad L - Treorci**

# **Flood and Water Management Act 2010**

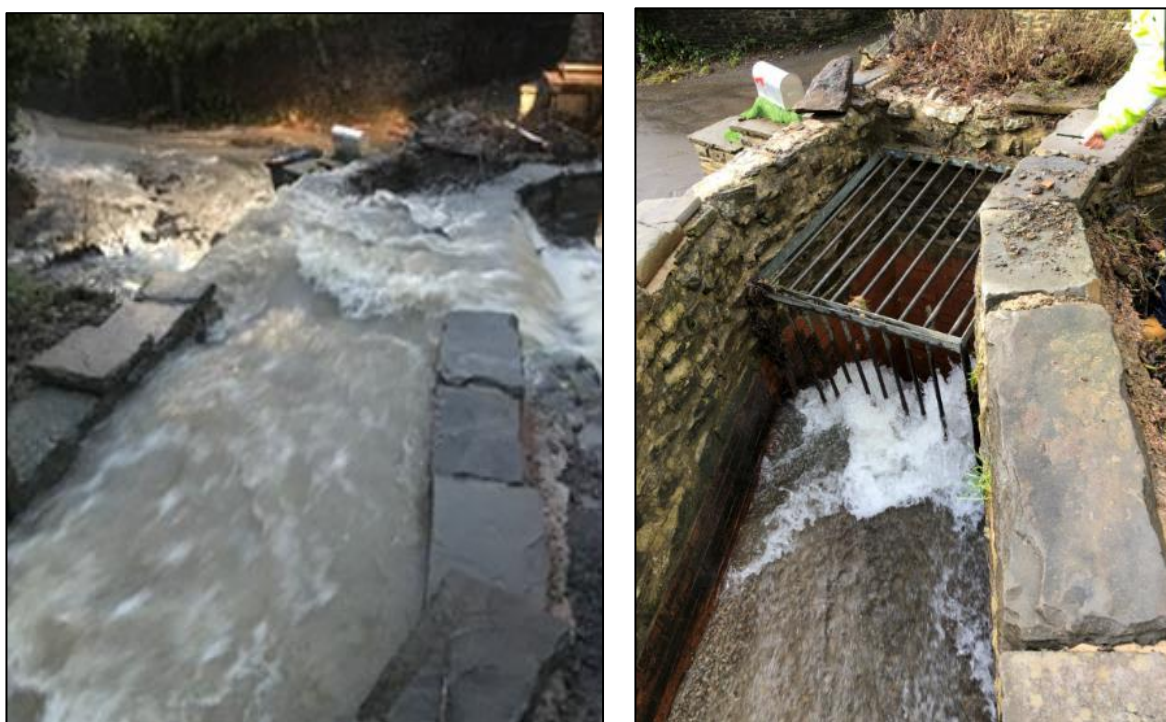
'Culvert Inlet 1' was reported by residents as the primary source of flooding to properties at Dumfries Street, Luton Street and the A4061 (Bute Street / High Street). The inlet is situated approximately 60 metres north of the 'Column Street Culvert Inlet'. The culvert was reported by residents as being "unable to manage the flow of water entering the culvert" during the early hours of the storm event and as a result surcharged. Debris consisting of large stones and silt was also noted by residents to have blocked the inlet debris screen.

**Figure 5:** Evidence of 'Culvert Inlet 1' surcharging during the storm event and conveying southwards towards Column and Dumfries Streets (left) (image provided by resident), and 'Culvert Inlet 1' post storm event (right) (captured by RCT's Flood Risk Management team on 20<sup>th</sup> February 2020)

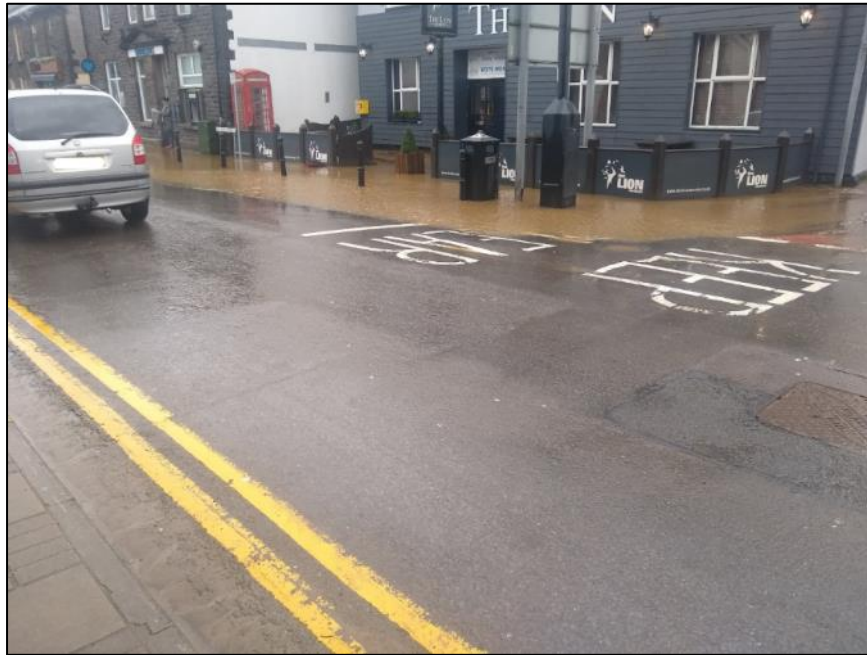
**Figure 6:** Surface water ponding along the A4061 High Street during Storm Dennis on 16<sup>th</sup> February 2020 (image provided by resident)

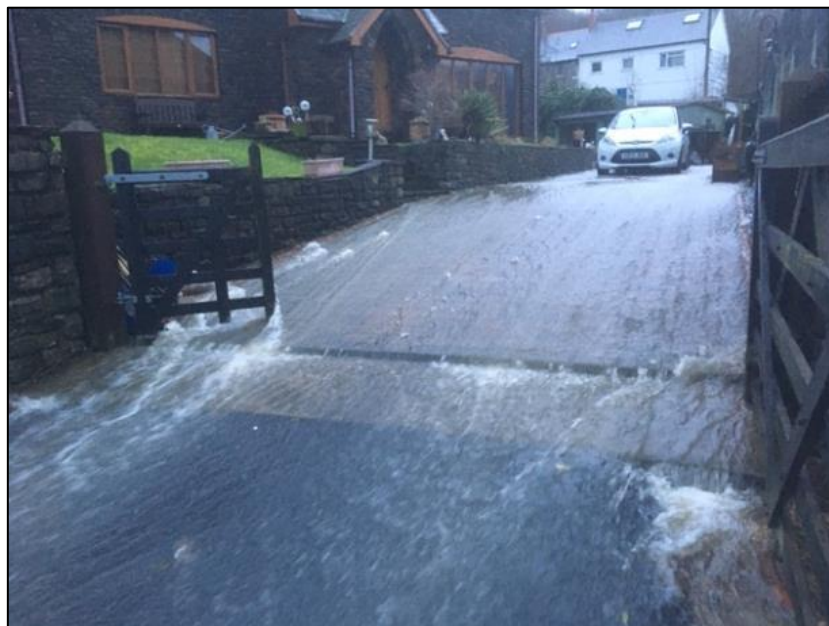
Upstream of 'Culvert Inlet 1', 'Culvert Inlet 2', located north east of Glyncoli Close, was reported to have surcharged during the storm event, causing water to travel through external private property towards Glyncoli Close and flooding 1 residential property (flow path depicted in Figure 7).

**Figure 7:** Flow path from 'Culvert Inlet 2' conveying towards Glyncoli Close

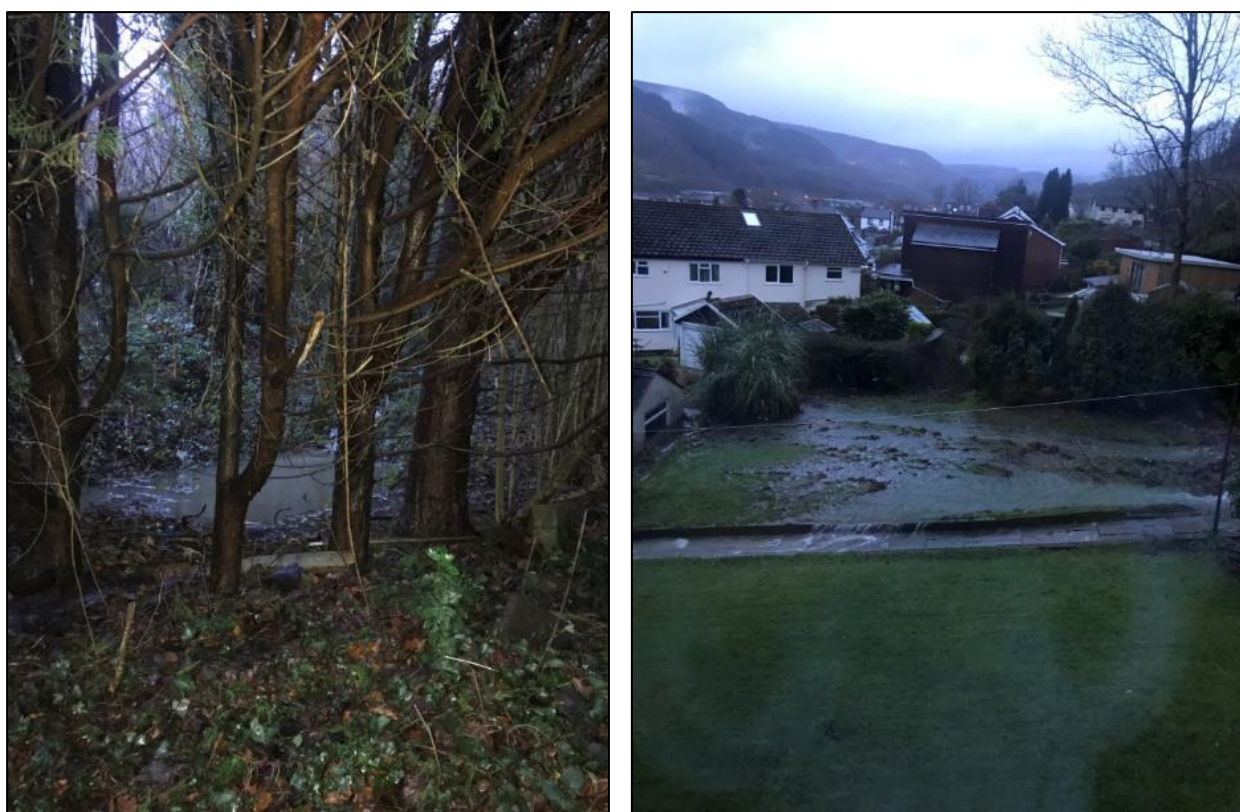
One residential property at Crosswood Street was internally impacted by the flows originating from 'Culvert Inlet 4' during Storm Dennis.

**Figure 10:** Evidence of 'Culvert Inlet 4' surcharging during Storm Dennis (left) and evidence of surcharging flows travelling through the garden of a private property towards the park space downstream (right) (images provided by resident)

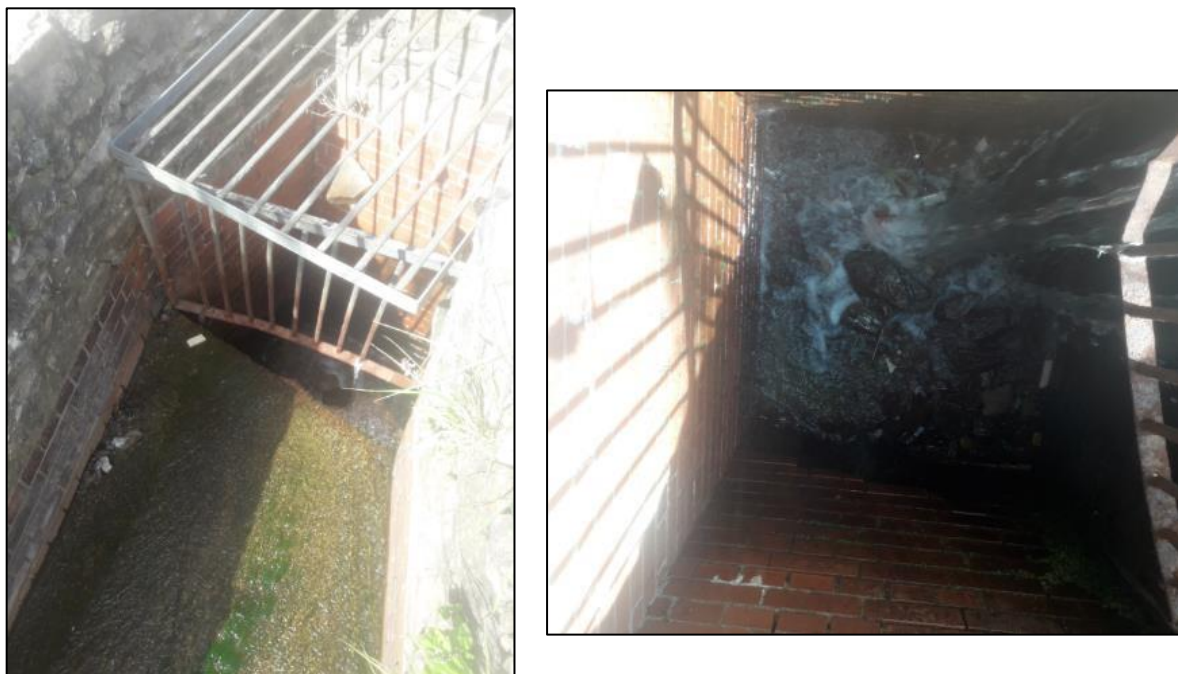
The 'Culvert 1 – Nant Tyle-du' network was surveyed to be in acceptable condition downstream of the inlet however, significant debris was noted to have accumulated within the inlet chamber during cleansing operations (Figure 12, right). The ordinary watercourse entering the culvert network is set much higher than the inlet itself,

allowing smaller debris to pass through the debris screen and build up at the start of the pipe (Figure 12, left).

**Figure 12:** Image of 'Culvert Inlet 1' captured post event during CCTV surveying operations (30/07/2020) (left) and evidence of debris accumulation within the culvert chamber (right)

The CCTV survey also noted damages caused to the inlets trash screen, indicating that the inlet suffered significant debris accumulation during the storm event. It was noted by residents and emergency responders that the culvert became blocked with debris during the storm event. It was also noted by residents that tyres were amongst the debris removed from the culvert.

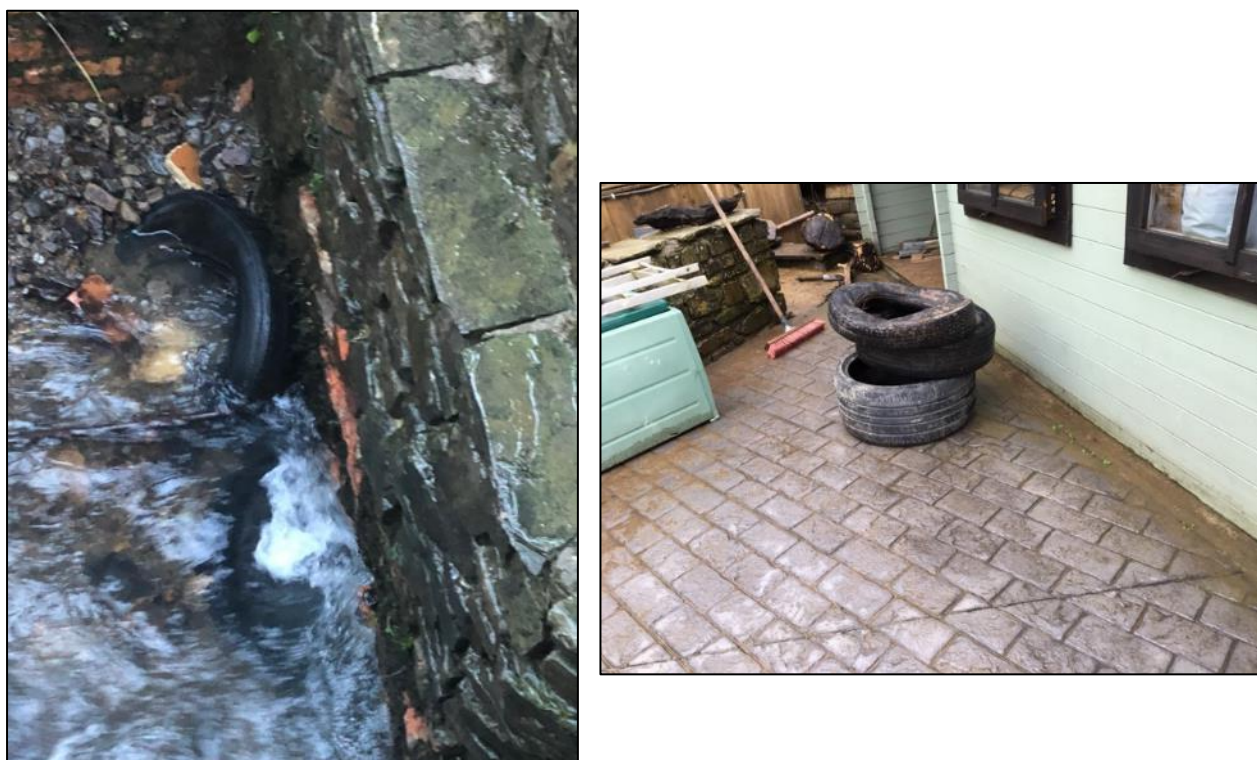
'Culvert Inlet 2' was identified by first responders as being blocked with silt and debris mobilised by the fast-flowing water entering the network during the storm event. Photographs and video footage provided by residents during post event inspections carried out by RCT's Flood Risk Management team on 17<sup>th</sup> February 2020 show evidence of tyres being manually pulled out of the culvert inlet to manage the flow of water (Figure 14). This material was reportedly washed down from the upstream ordinary watercourse section (described in Section 3.2).

**Figure 14:** Evidence of debris, inclusive of tyres, causing a blockage to 'Culvert Inlet 2' during Storm Dennis (left) and evidence of the three tyres removed from the inlet by a resident (right) (images provided by resident)

'Culvert Inlet 2 – Nant Tyle-du' network was surveyed by a Council appointed contractor in August 2020. The culvert network was found to be in poor structural condition with multiple operational defects observed. Its poor condition is considered to have contributed to the surcharging of 'Culvert Inlet 2', however, the blockage to the inlet structure has been determined as the most significant contributor to the surcharging and associated flood flow path along Glyncoli Close and downhill towards Column Street during Storm Dennis.

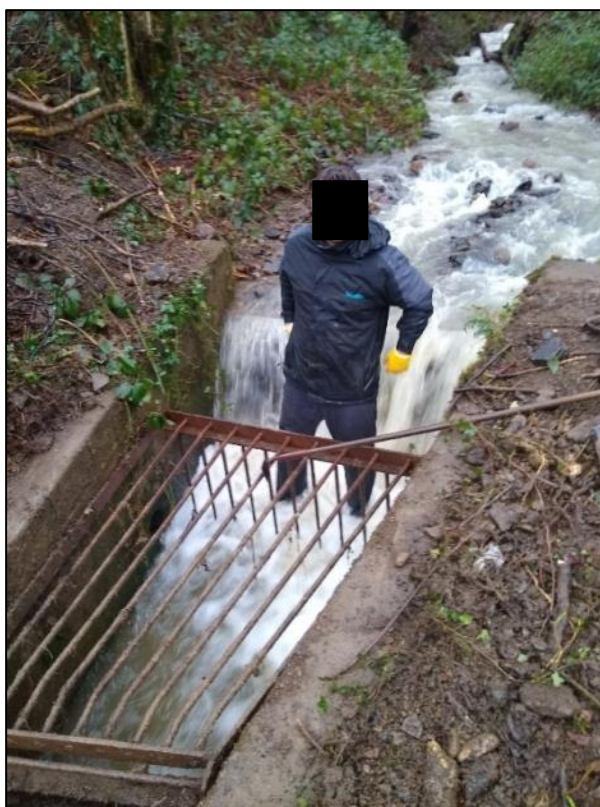
the hillsides above RCT26 during the storm event. This debris is considered to have reduced the inlet's hydraulic capacity to manage the flow of water, resulting in surcharge. The inlet was initially cleared by local residents (Figure 15) and subsequently, inspected and cleared of debris by the Highway and Streetcare Depot.

**Figure 15:** Photo of 'Culvert Inlet 3' following initial debris clearance by local residents on 16<sup>th</sup> February 2020.

Internal CCTV surveys of the culvert network recorded the culvert as being in poor structural and operation condition with several fractures and broken sections of pipe in addition to loss in cross-sectional area caused by settled deposits. As a result, approximately 2 tonnes of debris was removed from the network during cleansing operations.

The poor condition of the 'Culvert Inlet 3 – Heol Tyle-du' network is considered to have contributed to the flooding however, blockages to the inlet structure which reduced the inlet's hydraulic capacity to manage the flow of water has been determined as the most significant contributor to the observed surcharging during Storm Dennis.

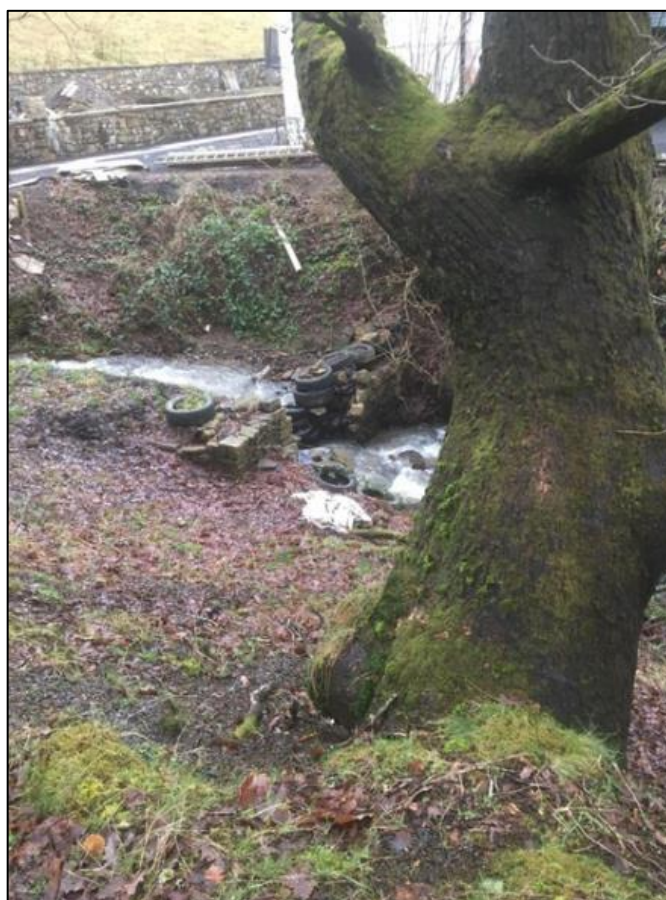
On review of the unnamed open watercourse conditions upstream of 'Culvert Inlet 2', an obstruction was identified within the channel. Evidence of the obstruction, which consisted of a man-made tyre damn across the width of the channel, is shown in Figure 20. This material is considered to have been mobilised downstream during the storm event, contributing to the surcharge of 'Culvert Inlet 2' and 'Culvert Inlet 1' by reducing both inlets' hydraulic capacities to manage the flow of the watercourse.

**Figure 20:** Image of tyre damn acting as an obstruction to the watercourse upstream of 'Culvert Inlet 2' (captured by RCT's Flood Risk Management team on 17th February 2020)

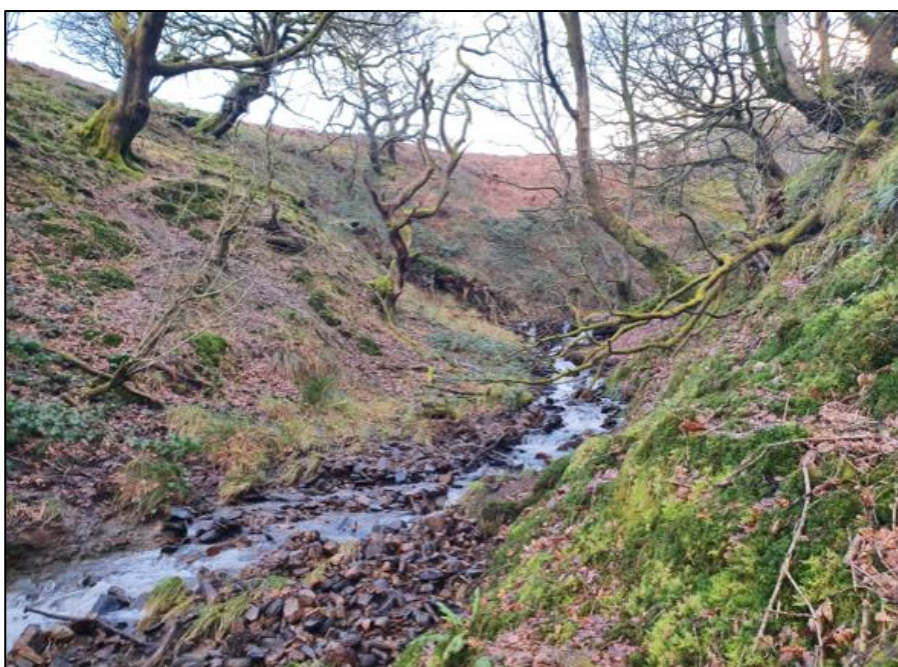
Upstream of the identified obstruction, the unnamed ordinary watercourse channel showed evidence of debris mobilisation within the upper catchment above RCT26 (Figure 21). On review of the type of debris that contributed to the blockages at 'Culvert Inlets 1 and 2', the identified stonewash material depicted in Figures 21 is considered to have been washed down the catchment towards both culvert inlets during the storm event and contributing to its surcharge.

**Figure 21:** Photo of the unnamed ordinary watercourse upstream of 'Culvert Inlet 2' within the upper catchment (captured by RCT's Flood Risk Management team on 17<sup>th</sup> February 2020)

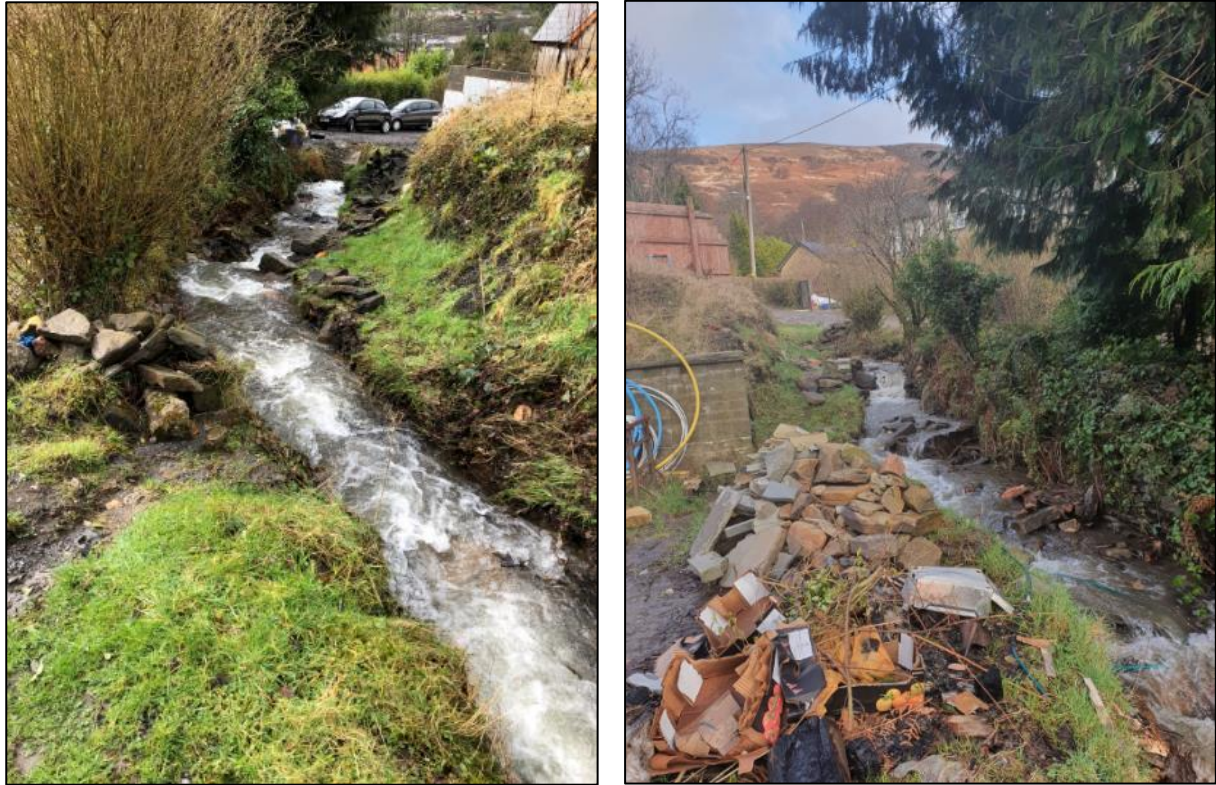
13) consisted of similar stonewash material inclusive of large stones. It is considered that this material was transported from the upper reaches of Treorchy via the unnamed watercourse and contributed to the surcharging of both 'Culvert Inlet 1 and 2'.

**Figure 22:** Unnamed open watercourse upstream of 'Culvert Inlet 1' showing evidence of large stones within the channel and surrounding embankment area (captured by RCT's Flood Risk Management team on 20<sup>th</sup> February 2020). Looking downstream towards 'Culvert Inlet 1' (left) and looking upstream towards the outfall of 'Culvert Inlet 2' (right).

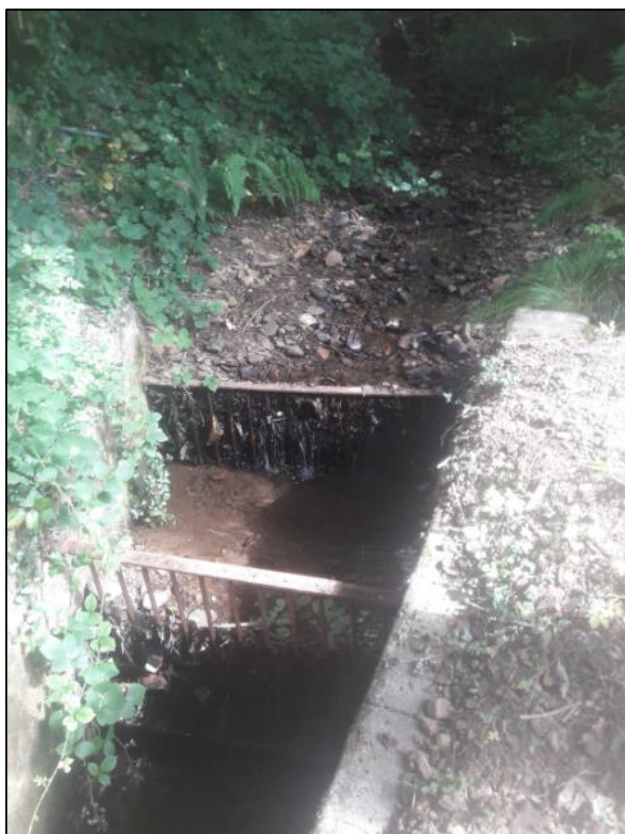
The Nant Tyle-du ordinary watercourse enters the town of Treorchy via 'Culvert Inlet 3' at Heol Tyle-du. On review of the condition of the Nant Tyle-du ordinary watercourse, significant accumulation of natural scour material was evident behind the upper debris screens upstream of 'Culvert Inlet 3' (Figure 23). Figure 23 highlights the extreme flows within the Nant Tyle-du during the storm event which were able to convey a significant volume of scour material downstream towards 'Culvert Inlet 3'.

**Figure 23:** Photo of significant debris accumulation behind the upstream debris screens above 'Culvert Inlet 3' in the Nant Tyle-du watercourse (captured by a Council appointed contractor on 03/08/2020 during CCTV survey operations)

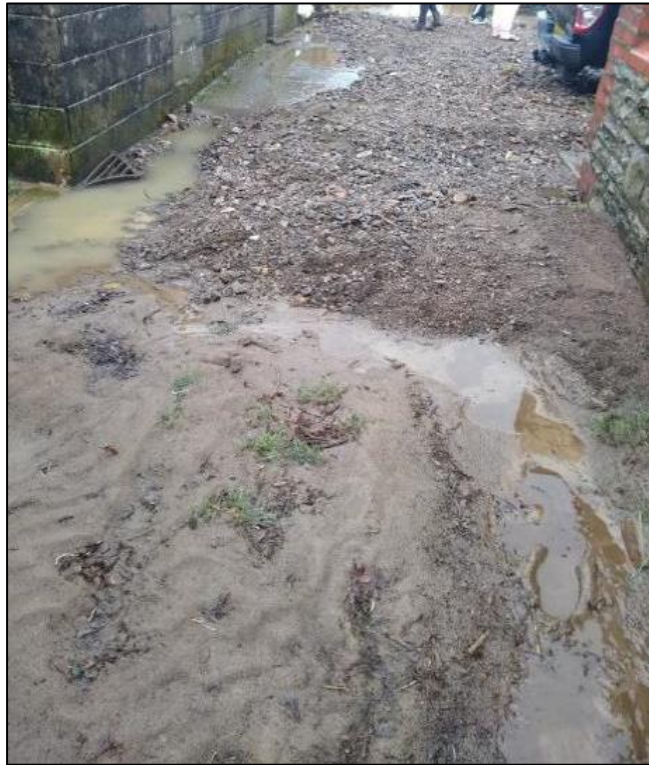
The large quantities of sediment and debris washed onto the streets is also indicative of the high sediment loading from the ordinary watercourses described in Section 3.2.

**Figure 28:** Photo of deposits of silt and debris left behind at Dumfries Street following the flooding during Storm Dennis (image provided by resident)
