Flood and Water Management Act 2010

Section 19 Flood Investigation Report

Storm Dennis – Flood Investigation Area RCT25

July 2021

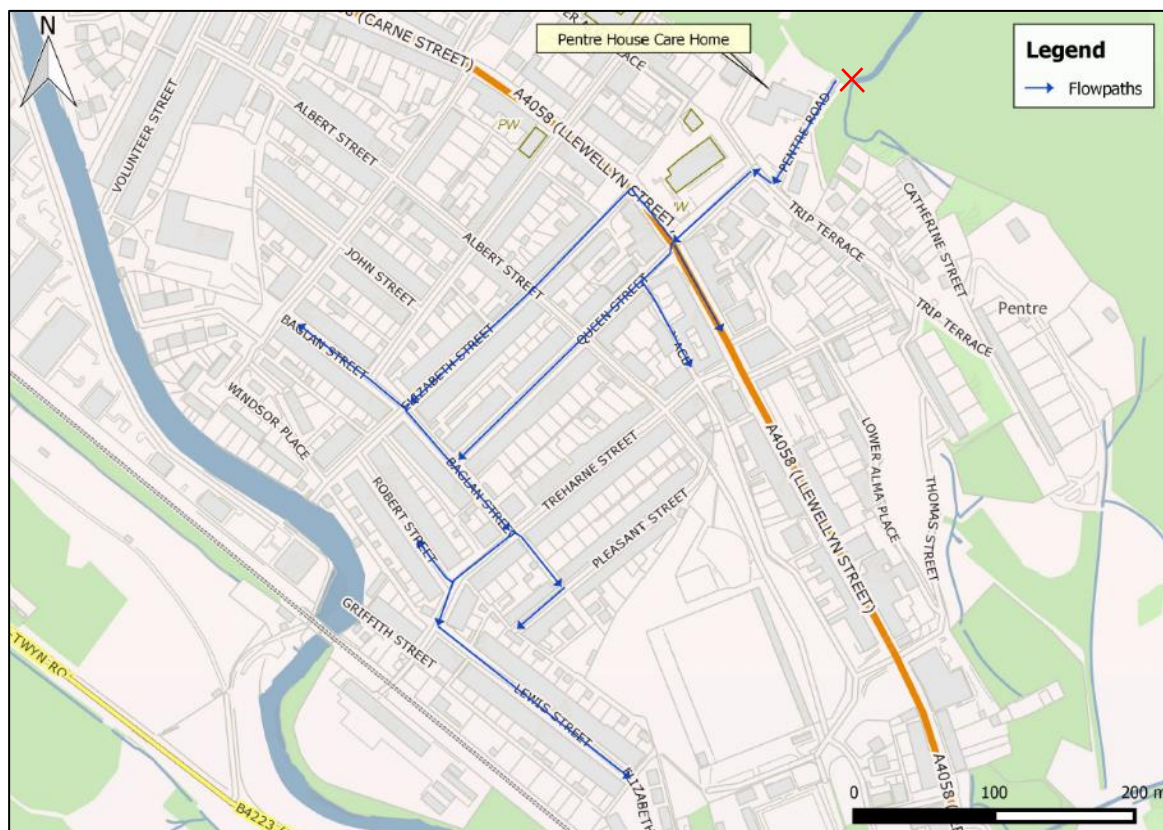
Pentre Road and onto Elizabeth Street and Queen Street (Figure 3), impacting the majority of properties downstream at the base of the valley, particularly properties at Baglan and Lewis Street.

Figure 3: Source and observed flow path of the flood event on the 16th February (Storm Dennis)

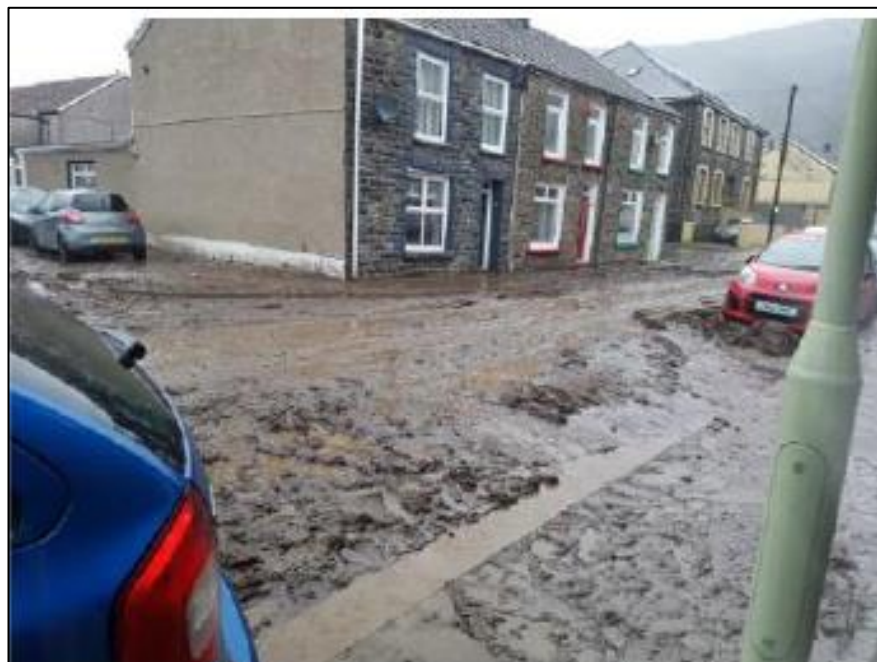
Anecdotal evidence collected during the August 2020 site visit provided evidence of flooding within properties up to 1.3m in depth. Post event photos reveal the severe and long-lasting damage caused by the flooding, with deposits on the streets of Pentre reported to have been transported from the upper catchment and made apparent once the flood water had drained away (Figure 4 and 5). Significant cleansing from a Council

Figure 4: Photo depicts significant deposits post Storm Dennis at Lewis Street captured by FRM officers on 17th February 2020

specialist contractor and the respective Council Highways and Streetcare Depot was carried out to clear both the streets and surface water networks following the storm event.

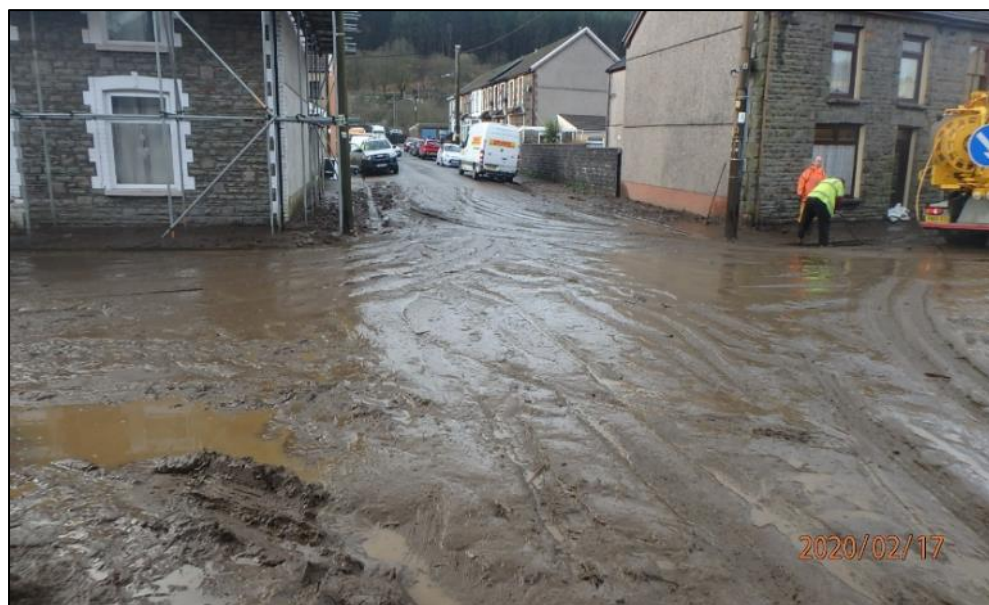
Figure 5: Photo depicts significant deposits post Storm Dennis at Baglan Street captured by FRM officers on 17th February 2020

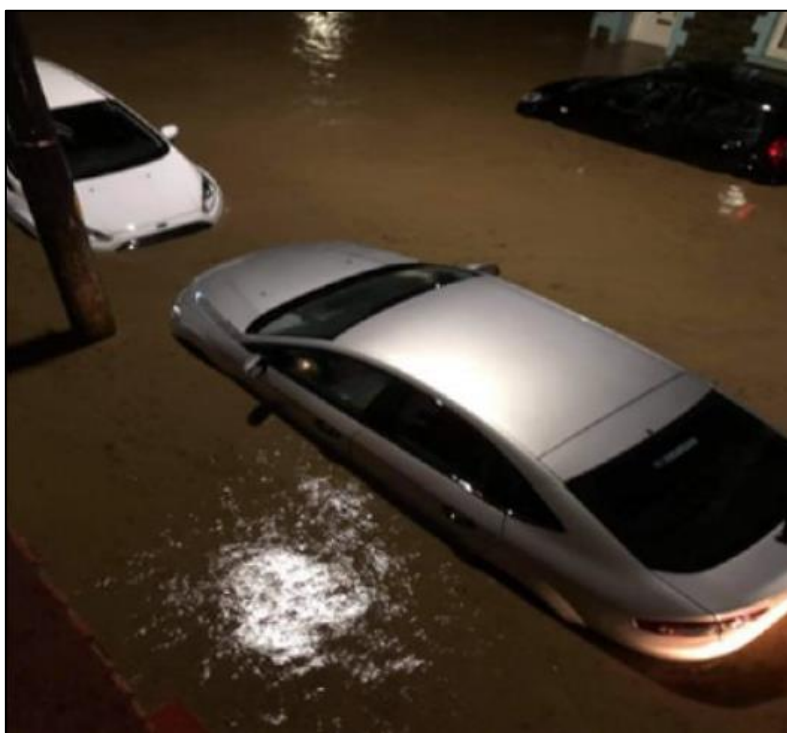
Figure 6: Photo showing severe flooding at Lewis Street, Pentre on 16th February 2020 (image provided by resident)

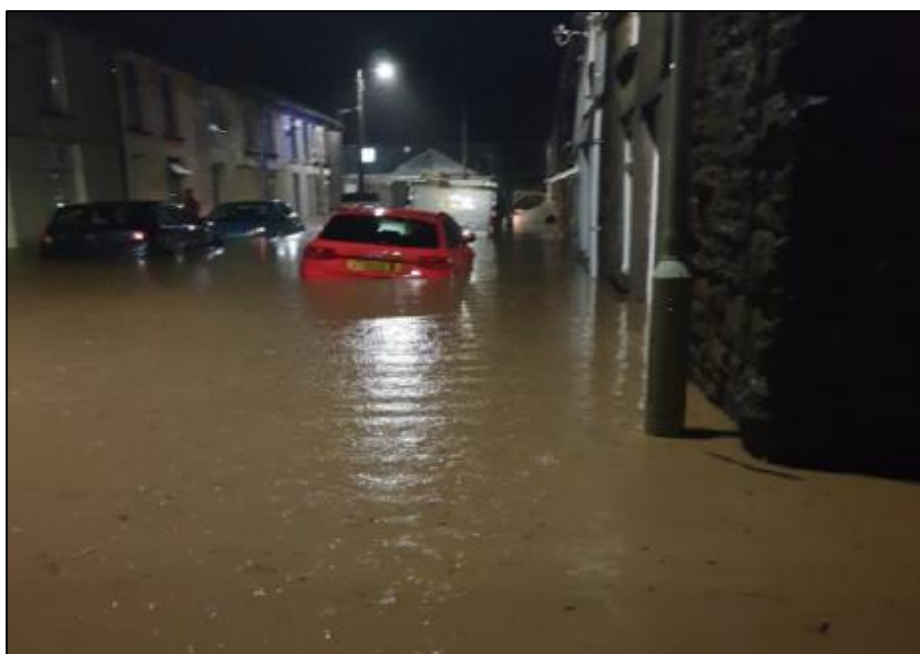
Figure 7: Photo showing severe flooding to the south of Pleasant Street, Pentre on 16th February 2020 (image provided by resident)

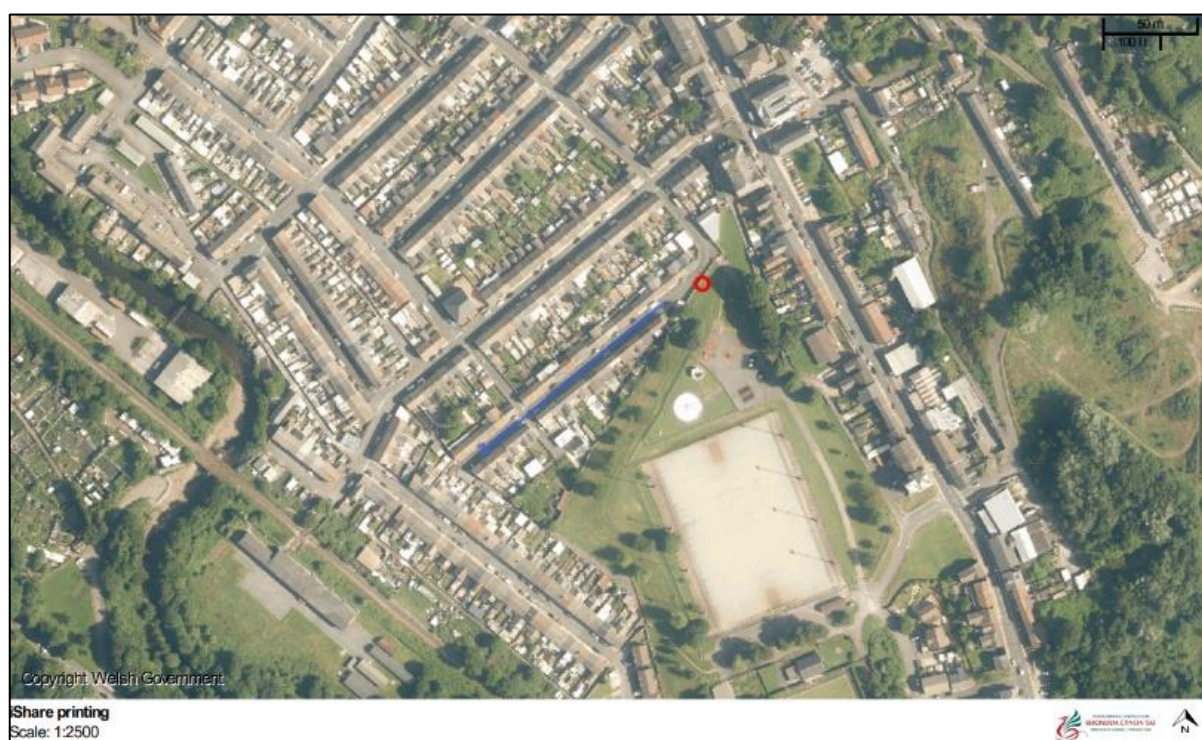
Several properties at Pleasant Street reported repeat internal flooding to residential properties on Thursday 20th February, only four days following the initial flood event during Storm Dennis. Post analysis surveys and questionnaire feedback noted the source of flooding to have originated from a manhole situated within Pleasant Street Park, due to blockages of the Pentre Road culvert network within the park (location shown in Figure 8).

Figure 8: Location plan illustrating the location and flow path of flood water from the manhole within Pleasant Street Park

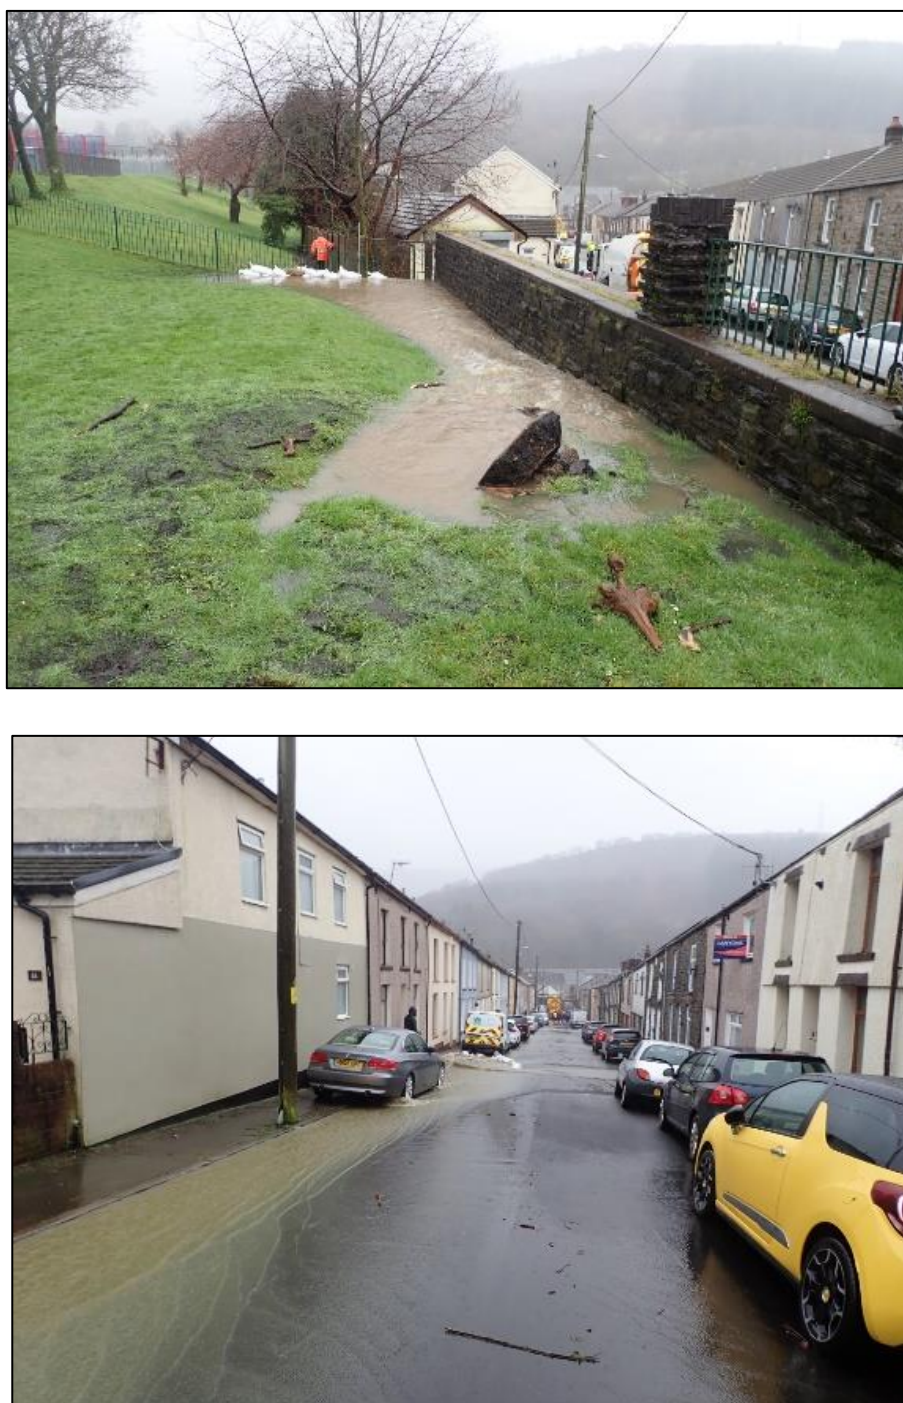
Figure 9: Surcharging manhole within Pleasant Street Park (top) and flow path down Pleasant Street (bottom) taken by RCT's FRM team on 20th February 2020

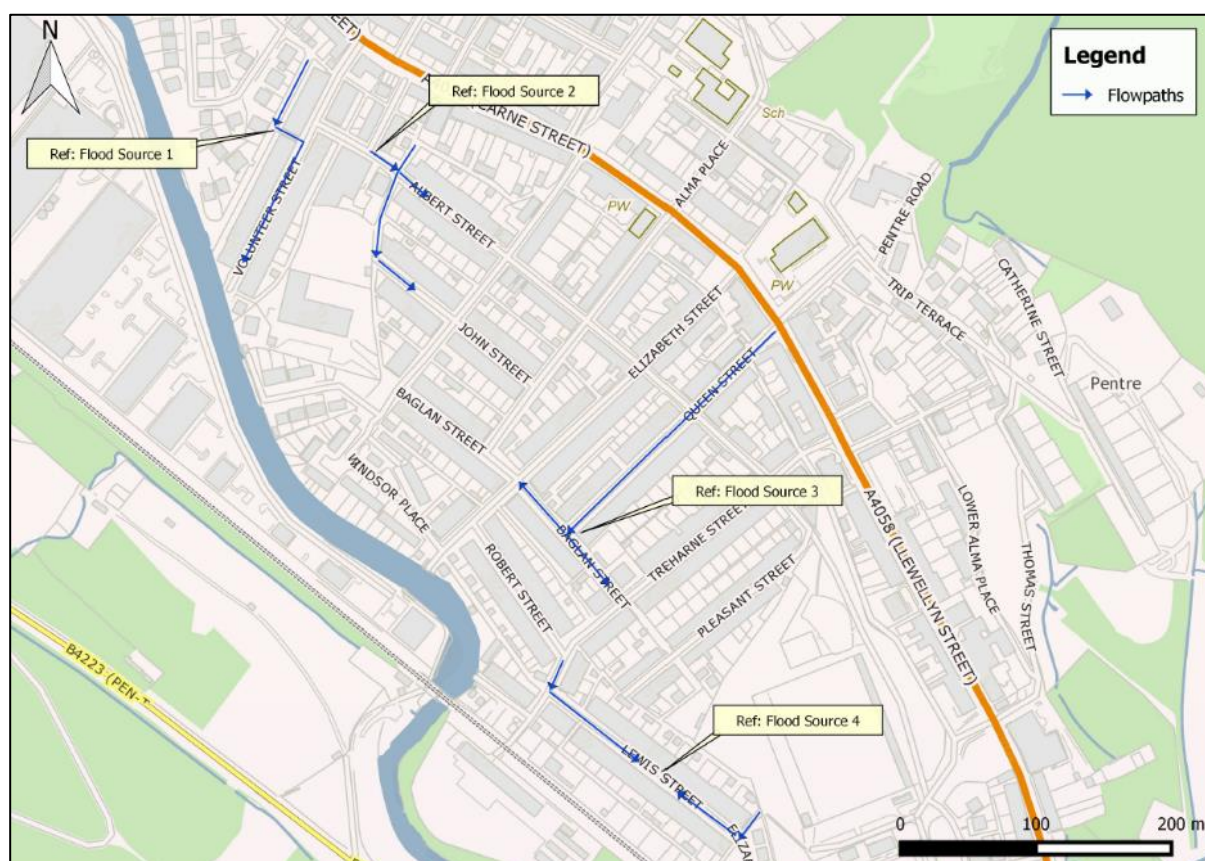
Figure 10: Main sources of flooding on the 17th June 2020 based on anecdotal evidence

Large volumes of water were observed flowing down a lane to the west of Volunteer Street then onto Volunteer Street (Flood Source 1 shown in Figure 10). Surface water travelled along gullies on both sides of Volunteer Street, where a number of properties were impacted internally and/or externally by the flood water. Two manholes were also reported to have surcharged within two residential properties on Volunteer Street, resulting in both properties near the Volunteer Street lane flooding internally.

High volumes of surface water were noted to have accumulated outside the 'Pentre Legion' at the junction of Price Street and Albert Street (Flood Source 2 shown in Figure 10). Several manholes surcharged along Albert Street contributing to the flooding. The water passed along Albert Street in an easterly direction towards John Street, causing internal flooding to one property, with water entering from the rear of the property. Several properties on Price Street and Albert Street were also internally flooded from ponding surface water that was unable to drain away.

Intense rainfall caused surface water runoff to travel down the village's steep roads and accumulate at the bottom of the streets, including Queen Street, Elizabeth Street and Treharne Street (Flood Source 3 shown in Figure 10). The ponding of water led

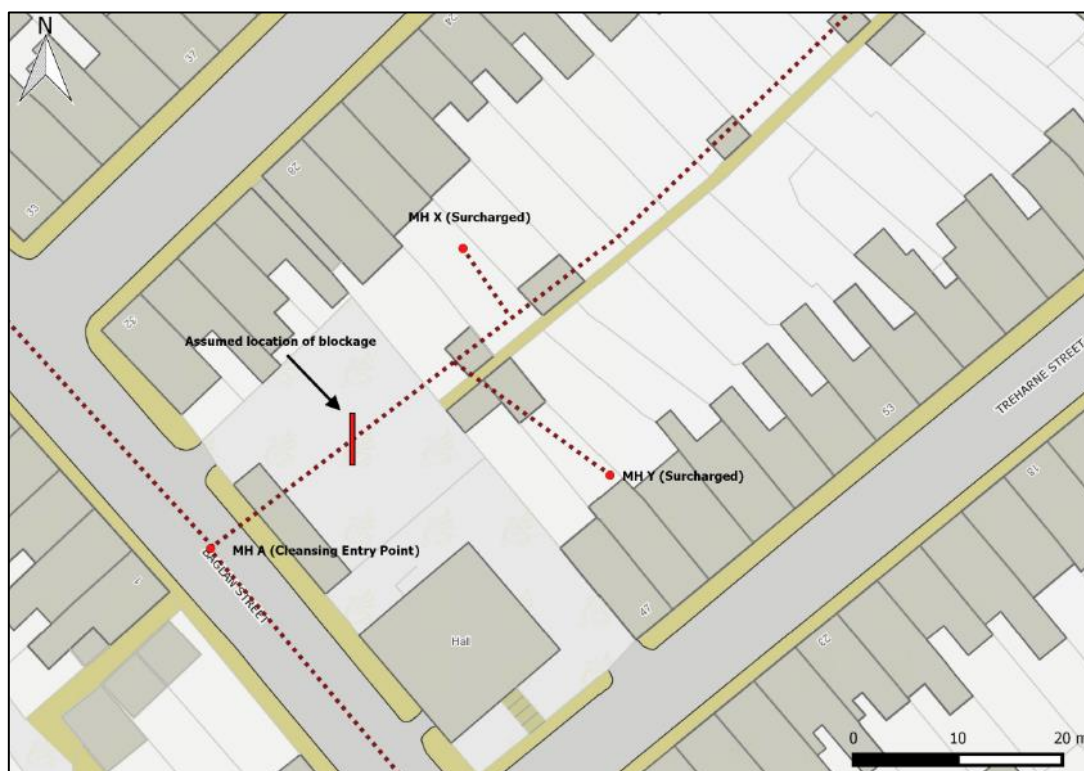
Post event analysis carried out by RCT's Flood Risk Management team identified the primary source of flooding during this event to be two surcharging manholes, caused by an assumed blockage in the combined network as shown in Figure 11. DCWW identified the cause of blockage was linked to misuse of the public sewer.

Figure 11: Location of surcharging manholes causing internal flooding to three properties during the 5th August 2020 flooding event

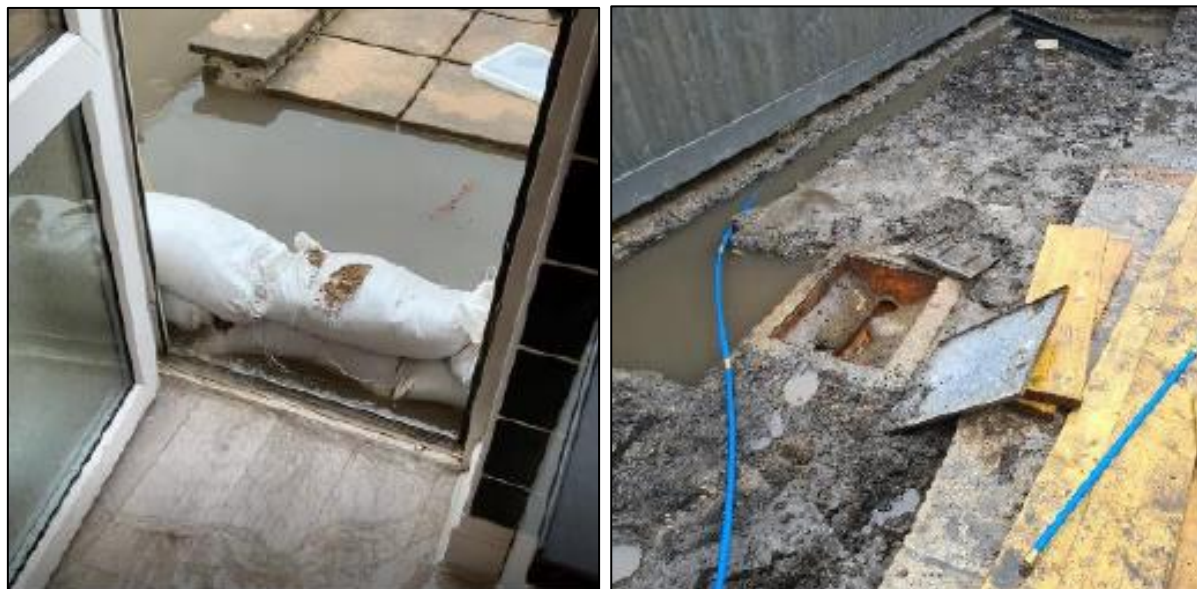
The surcharging manholes proceeded to fill the rear gardens of the affected properties within Queen Street and Treharne Street before entering the properties via the back doors, resulting in three residential properties experiencing internal damage to their property.

Figure 12: Water entering the Queen Street property via the back door (left) and location of surcharging manhole at Treharne Street, causing internal flooding to three properties (right)

During the August 2020 flood event, it was confirmed that a blockage within DCWW's combined sewer network was the cause of flooding to three residential properties. The blockage was subsequently removed by a Council appointed contractor.

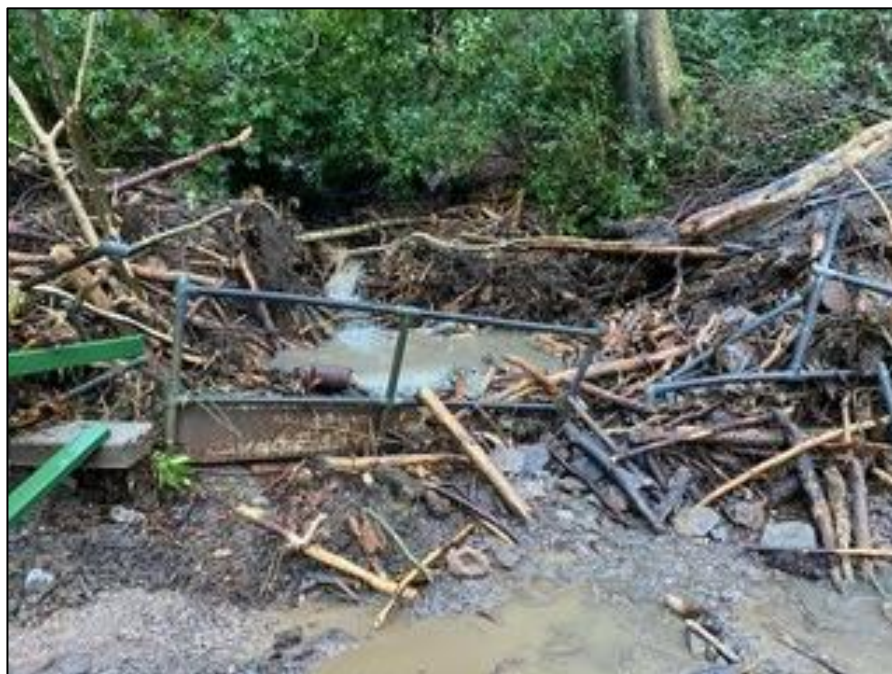
have been blocked by woody debris washed off the mountain side, which severely reduced the hydraulic capacity of the inlet. Upon a review of the hydraulic performance of the inlet without blockage, it was identified as having a standard of protection of 1 in 1000 year. This confirms that the inlet had sufficient capacity to deal with the storm event, but its capacity was significantly reduced due to blockages which ultimately was the primary cause of flooding at Pentre during Storm Dennis. These blockages at the inlet severely reduced the inlet's capacity to manage the flow of water.

Following the first flood event of 2020 that occurred on 16th February (Storm Dennis), the four culvert inlets were inspected by RCT's Flood Risk Management team. The results of which identified that only Pentre Road inlet was found to have been overcome with debris, reportedly having been washed down from the upper catchment, as shown below in Figures 14 - 17.

Figure 14: Photo of Pentre Road culvert inlet captured by RCT's Highways and Streetcare Depot immediately after the storm event (16/02/2020)

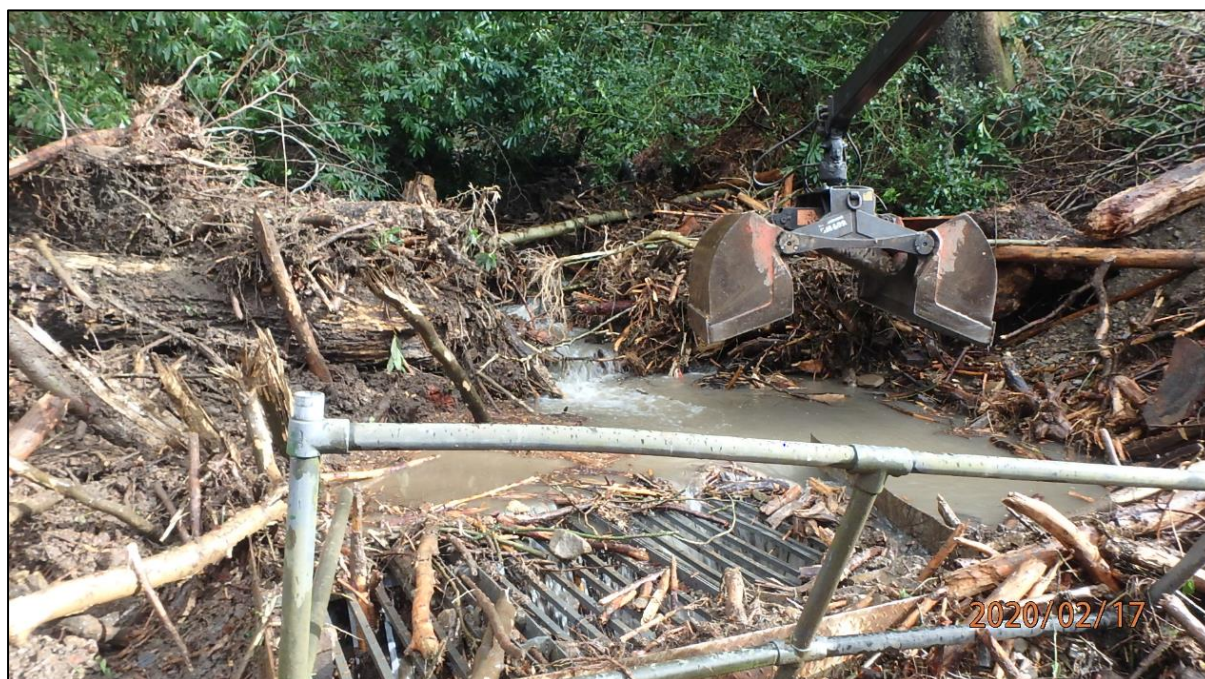
Figure 15: Photo of Pentre Road culvert inlet during works to remove deposited material post Storm Dennis (17/02/2020)

Emergency works commenced post flood event to remove the debris from around the inlet and repair the blocked culvert. An operative from RCT's Highways and Streetcare Depot described the material at the inlet as "trees and logs". A photograph captured by a resident shows evidence of woody debris being transported away from the Pentre Road culvert following initial clearance works (Figure 18). Extensive cleansing of the Pentre Road culvert inlet was carried out during 17th – 21st February.

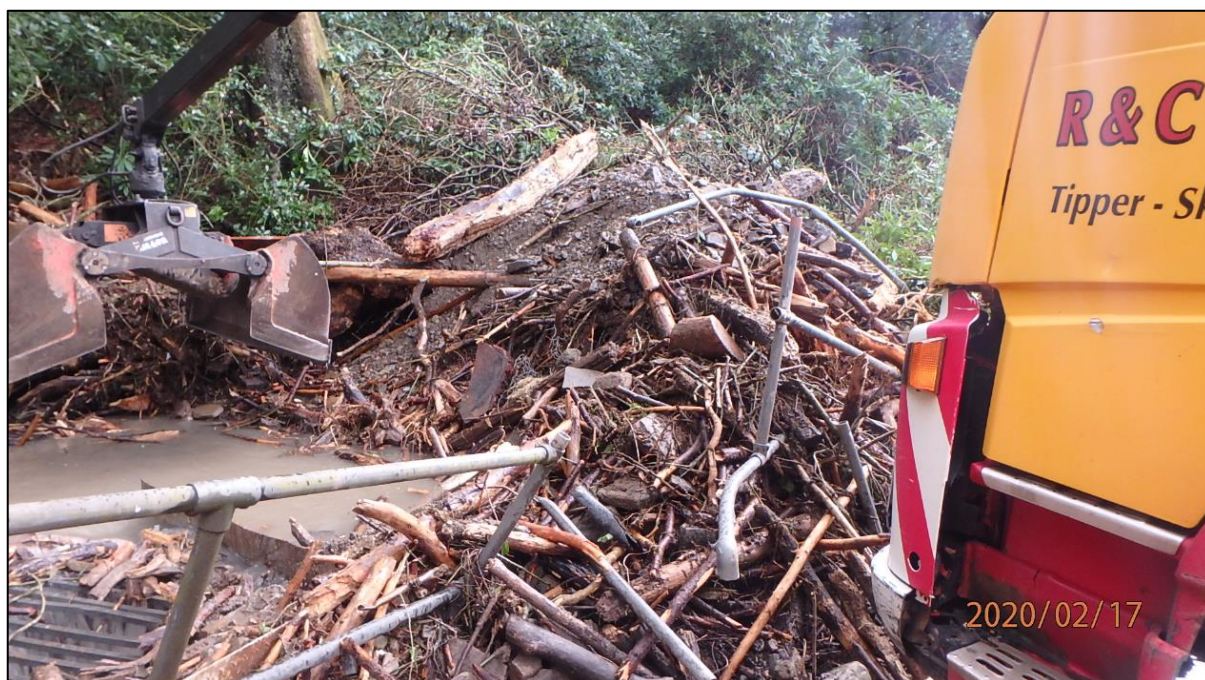
Figure 16: Photo looking across the Pentre Road culvert inlet, showing significant material collected during Storm Dennis (17/02/2020)

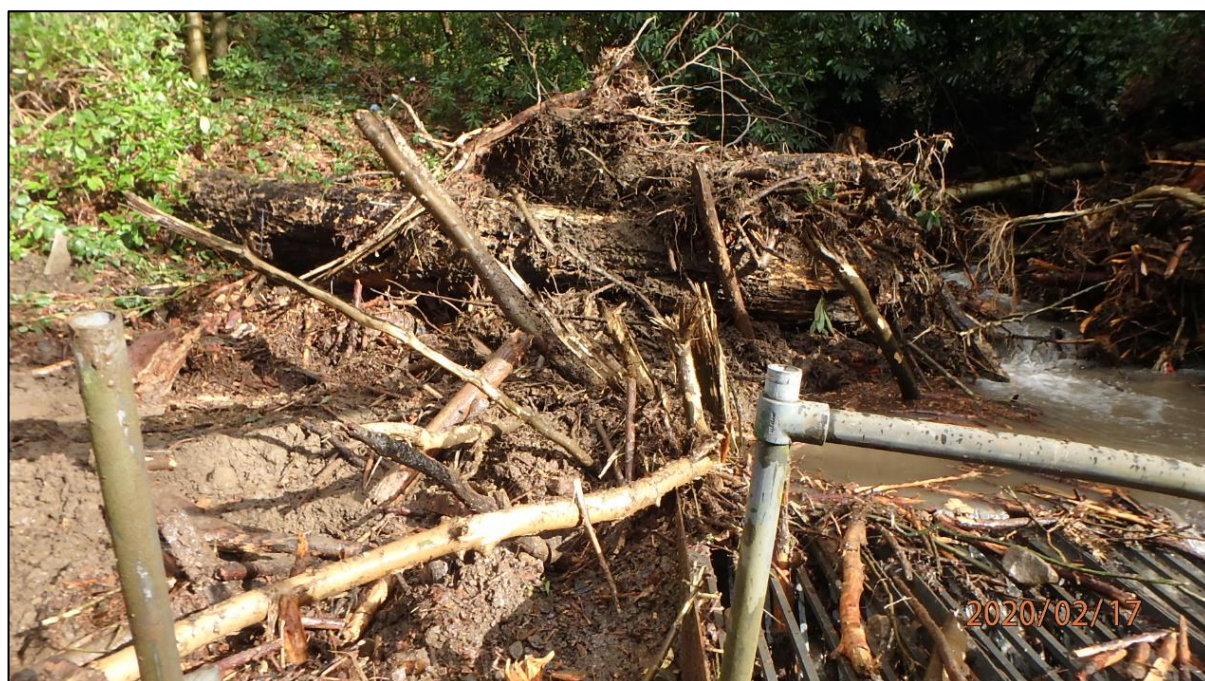
Figure 17: Photo of Pentre Road culvert inlet showing significant woody debris deposition (17/02/2020)

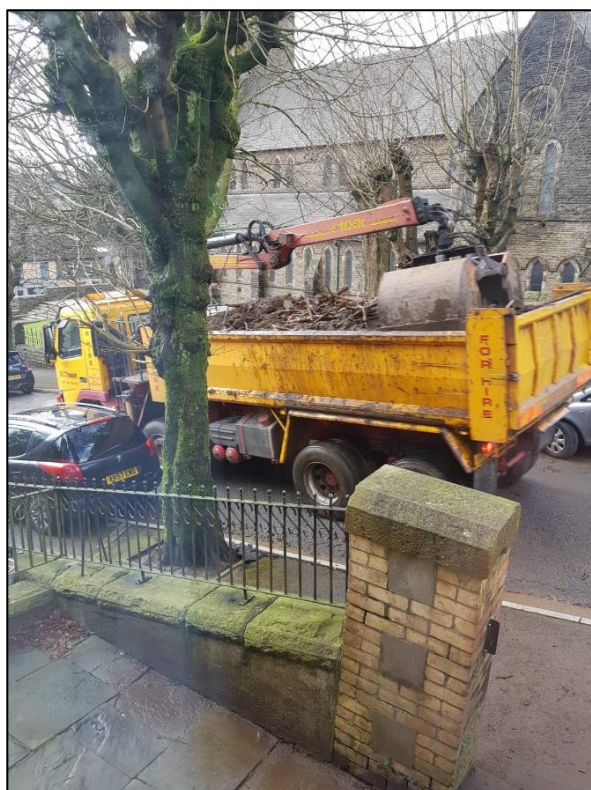
Figure 18: Photo showing woody debris being transported away from the Pentre Road culvert inlet during emergency clearance works (17/02/2020) (image provided by resident)

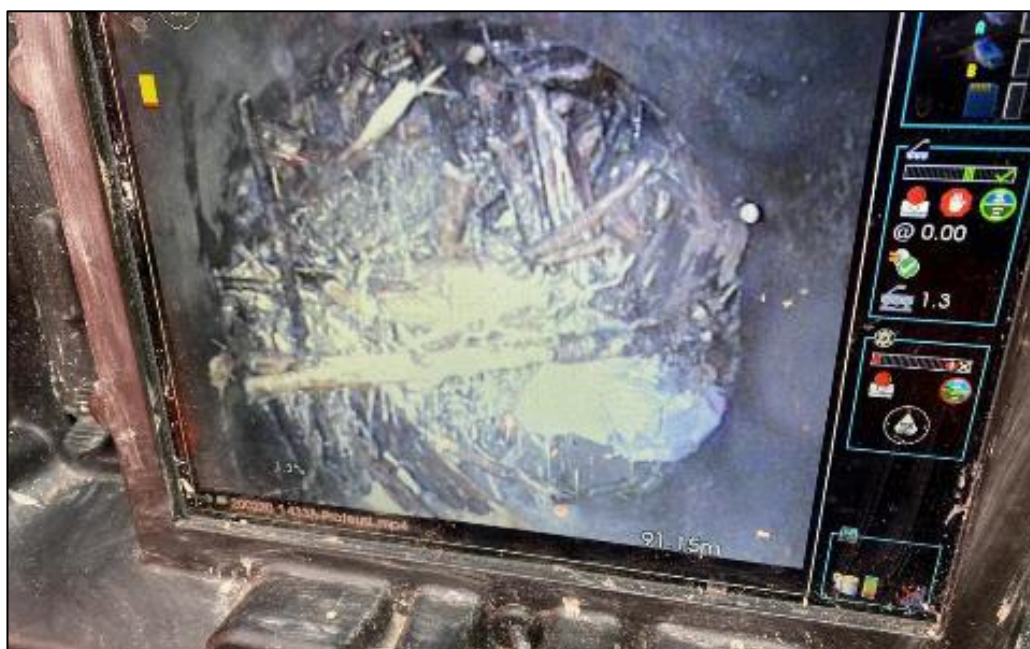
During the repeat flooding event which occurred on the 20th February 2020 impacting several properties at Pleasant Street, residents identified the source of flooding to have originated from a manhole within Pleasant Street park which had surcharged (Figure 9), resulting in water flowing out of the park towards Pleasant Street. A full-bore blockage within the Pentre Road culvert network was identified as the cause of the surcharging manhole, shown in Figure 19 below.

Figure 19: Photo showing full-bore blockage of the Pentre Road network downstream of Pleasant Street Park manhole

The image provides powerful evidence of how the mobilisation of woody debris from Pentre's upper catchment during Storm Dennis made its way into the culvert network, resulting in damages to the carrier line and a reduction in the culvert's ability to manage the flow of water. This resulted in water backing up the system and causing the manhole to surcharge. Significant resources, including the fire brigade, were rapidly deployed by RCT to remove the blockage and stop the properties from flooding in the days following the event.

In response to the debris identified within the inlet and downstream manhole, RCTCBC on the 28th February undertook extensive surveys to ascertain both the operational condition of the culvert network, and its structural integrity. The CCTV survey identified significant defects and blockages throughout the network, as well as settled deposits and stonewash reducing the networks capacity in several sections. The result was a significant operation to clear the internal culvert barrel of debris utilising specialised contractors that utilised; High Pressure Water Jetting, Vacuumation and Manual 'Hand Balling'; exercises to clear the debris from within the culvert network. This exercise lasted several months.

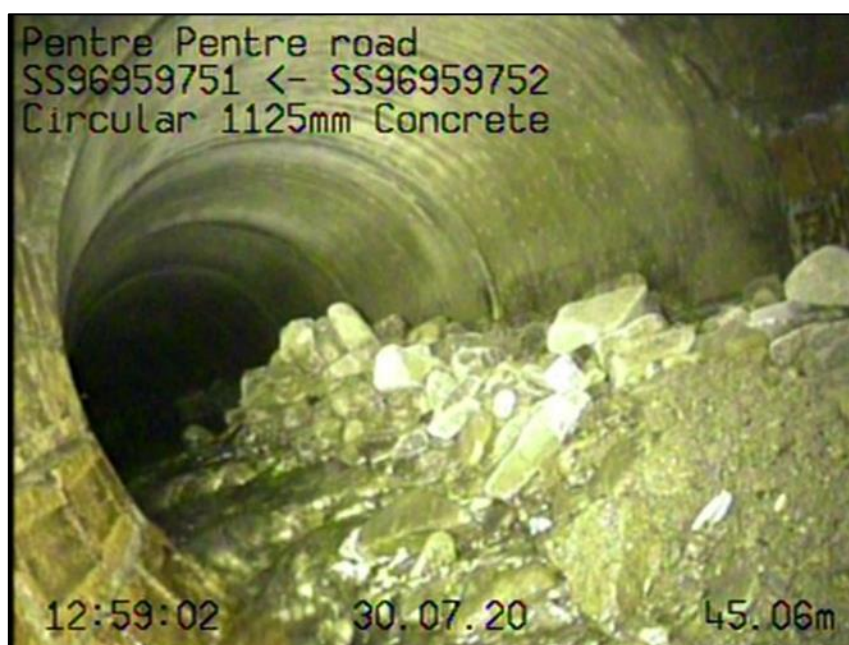
Following the flood event that occurred during the June thunderstorms, the Pentre Road culvert inlet was surveyed again on the 27th June 2020. The survey identified heavy siltation and debris that had re-accumulated in the line after previous cleansing, particularly towards the lower reaches of Pentre where between 20-60% of the network's cross-sectional areas had been lost due to settled debris and stonewash (illustrated in Figure 20). CCTV surveys of the other three networks in Pentre also confirm siltation in lower sections of the network (albeit less severe than the Pentre Road network) where the culvert gradient becomes less steep, resulting in reductions in the hydraulic capacity of the network. A total length of 3.2 km of culverted Ordinary Watercourse was surveyed, mapped and reviewed.

Figure 20: CCTV survey footage showing stone deposits between nodes SS96959751 and SS96959752 of the Pentre Road culvert network

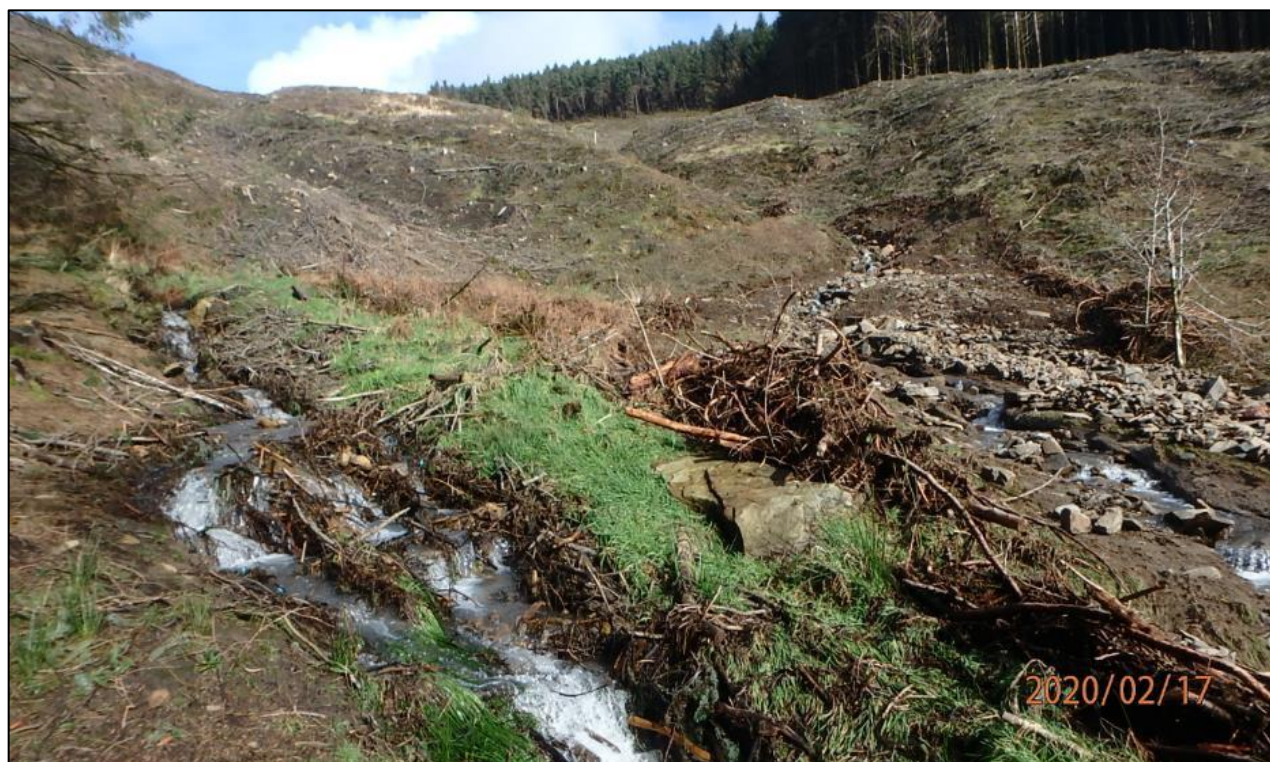
The walkover found significant amounts of woody debris across the upper catchment; an area where recent tree felling activities were carried out by NRW (Figure 22). This woody debris was similar to the debris found at the Pentre Road culvert inlet.

Figure 22: Photo of the felled area in the upper catchment of Pentre (17/02/2020) showing woody debris within the watercourses

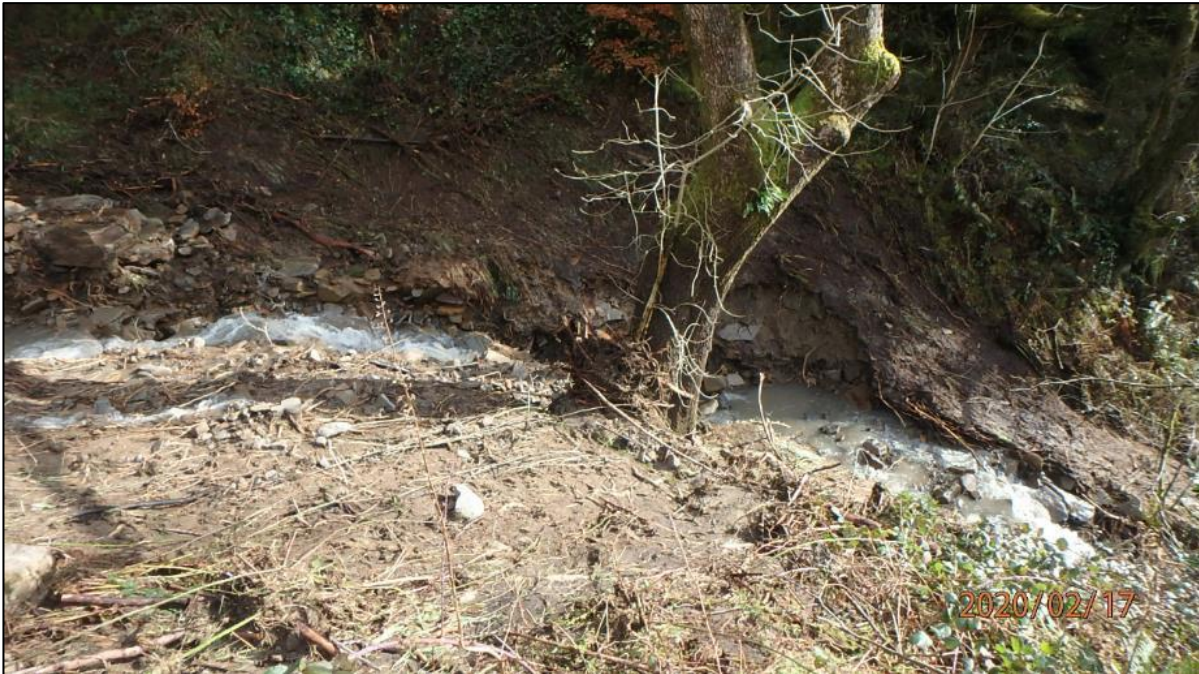
Minor scouring of the embankments of the Nant y Pentre watercourse was evident in sections (Figure 23), however this was expected given the significant flow and volume of water that followed the intense rainfall. Despite this, it is not believed that this scouring significantly contributed to the amount of debris that caused the blockage to the Pentre Road culvert inlet.

Figure 23: Photo of minor scour to the embankments of the Nant y Pentre watercourse in the upper catchment of Pentre (17/02/2020)

The watercourse was found to be in an “unstable condition” based on the amount of erosion observed. JBA conclude that “although the majority of sediment sources observed in the Nant y Pentre catchment were natural (i.e. bank erosion and landslides), it is likely they have been exacerbated by anthropogenic pressures, including land management practices”.

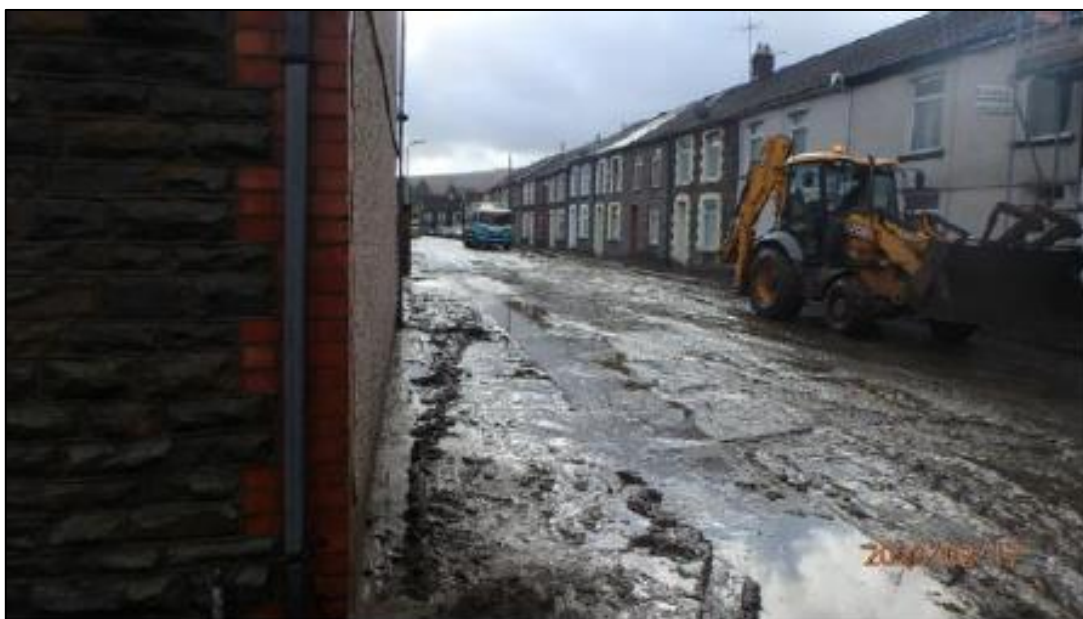
Following Storm Dennis, Pentre was left with widespread deposits of silt, sand and mud across the village which was reported to have been washed off the mountain and carried by the surcharging water through the village during the event. Figure 24 shows the deposits of mud left behind in Pentre once the flood water had drained away.

Figure 24: Photo shows the deposits of mud left behind in Pentre from the flooding during Storm Dennis (17/02/2020)

Widespread deposits on the streets are assumed to have entered the highway drainage system, leading to blockages and reduction in the hydraulic capacity of the surface water network. Evidence received following the repeat flood events in 2020 strongly suggest that there were issues relating to the function of the drainage system in Pentre, due to blockages and/or damage to the network caused by the initial flood event during Storm Dennis. A number of reports also documented manholes surcharging at various locations across the village during all flood events which suggest that the surface water network was also operating at a reduced capacity.

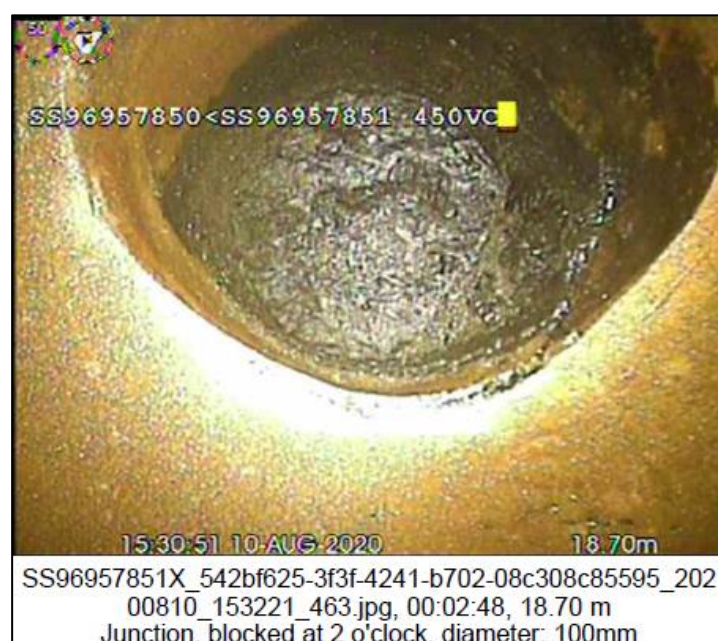
the survey had to be abandoned due to two large obstacles blocking the pipe (between manholes SS96957851 and SS96959750, shown in Figure 26).

Figure 26: CCTV footage showing blockage on Lewis Street highway drainage network

The evidence suggests that the poor condition of the highway drainage network following the initial flooding event during Storm Dennis which caused damage and serious capacity and backflow issues throughout the village, is likely to have been a contributing factor which led to repeat internal flooding to several properties and ongoing surface water flooding to the highway during the flood events of 2020 as the damage was being repaired.

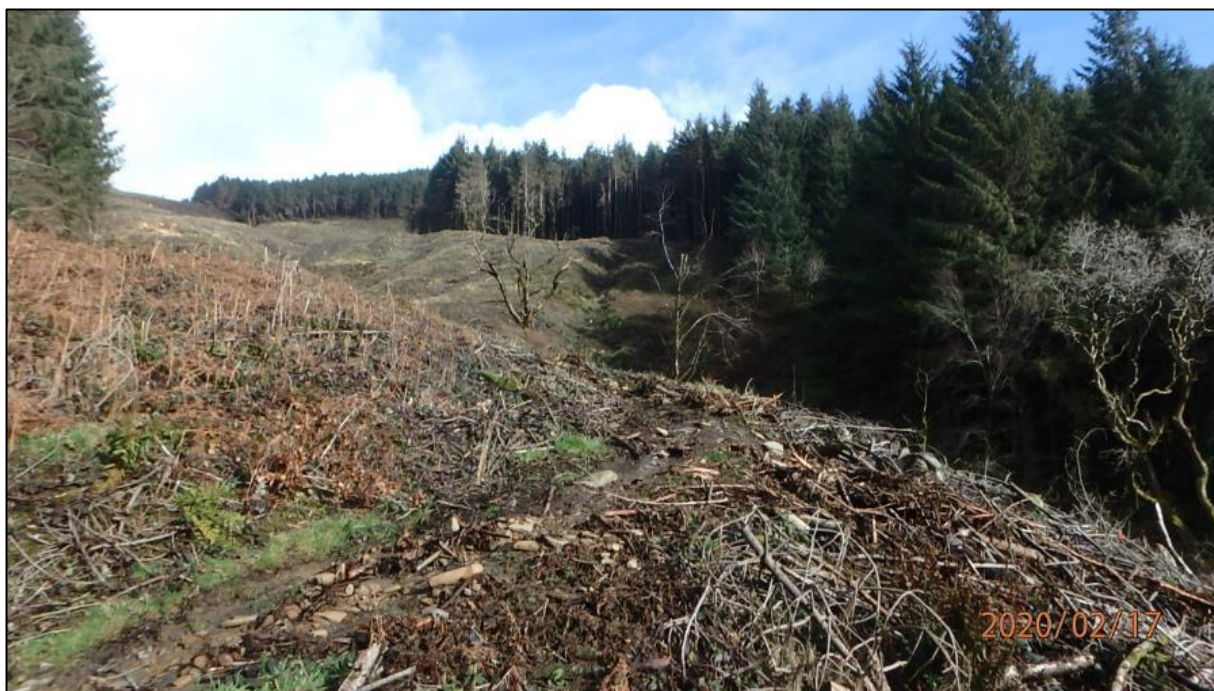
Figure 29: Photo taken by RCT's Flood Risk Management Team on 17/02/2020 showing evidence of woody debris accumulation in the upper catchment of Pentre

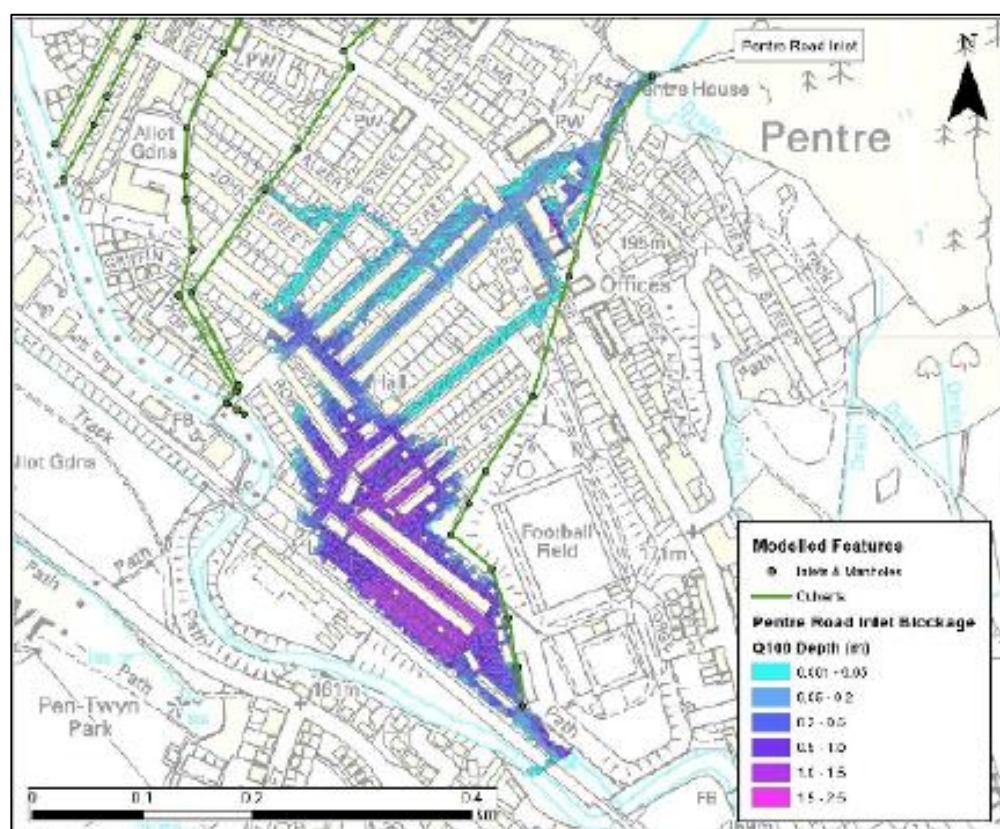
The results of the sensitivity analysis identified no flooding during scenario 1 outlining the capacity of the culvert inlet with no blockage present can accommodate the catchment flows. Scenario 2 however, identified significant flooding as depicted within Figure 31. On review of the impacts of Storm Dennis there is a close correlation with both the flow paths observed and the properties affected during Storm Dennis. This provides verification that the flooding mechanisms observed in Pentre on the 16th February 2020 were related to a blockage of the Pentre Road inlet caused by debris, the majority of which appears to have been as a result of the felling in the upper reaches of Pentre.

Figure 31: Pentre Road inlet blockage model results, Q100 flood event depths (Scenario 2)

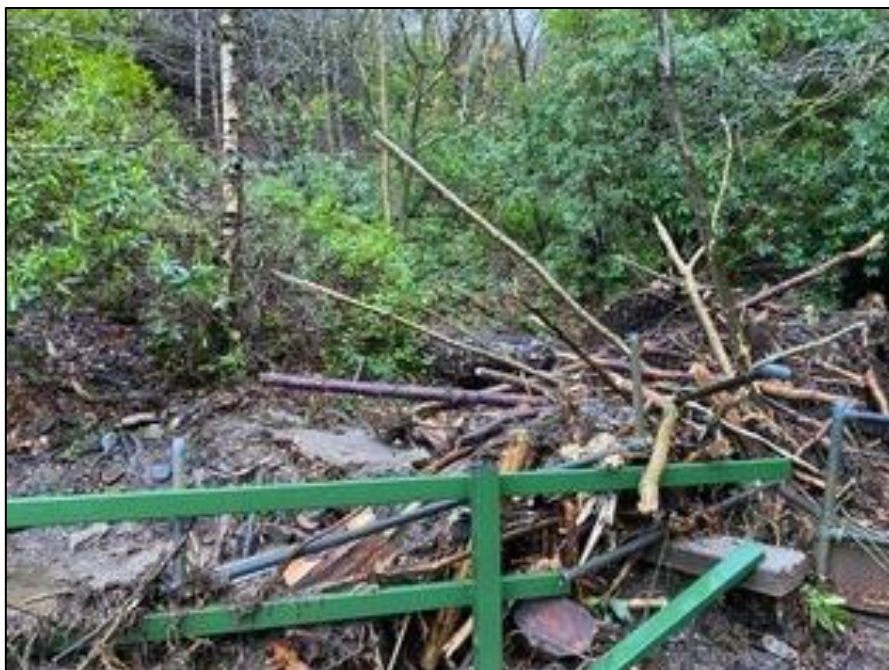
Photo provided by RCT's Highways and Streetcare Depot showing woody debris and damages to the Pentre Road Inlet on 16th February 2020.

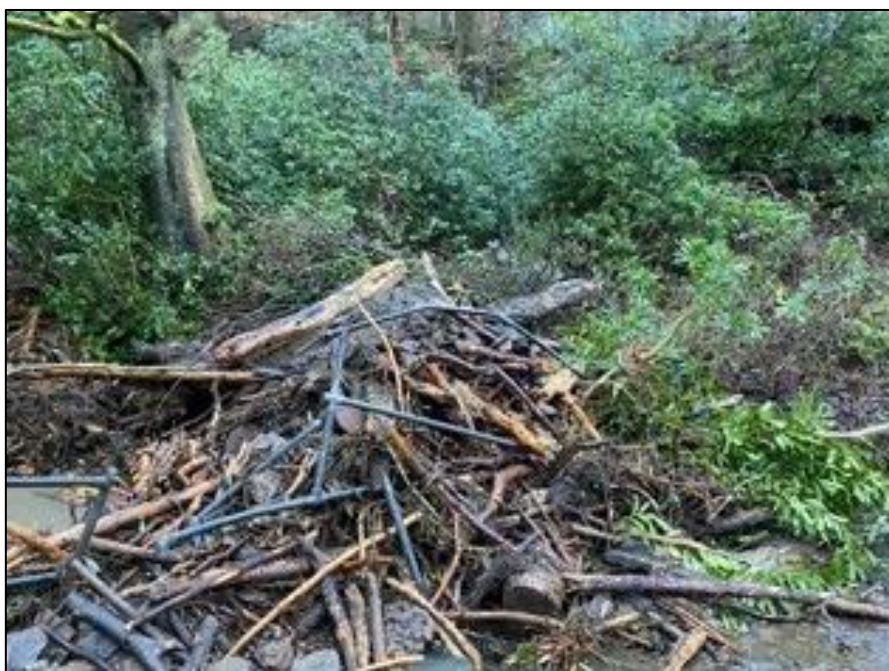
Photo provided by RCT's Highways and Streetcare Depot showing woody debris and damages to the Pentre Road Inlet on 16th February 2020.
