Flood and Water Management Act 2010

Section 19 Flood Investigation Report

Storm Dennis – Flood Investigation Area RCT25

July 2021

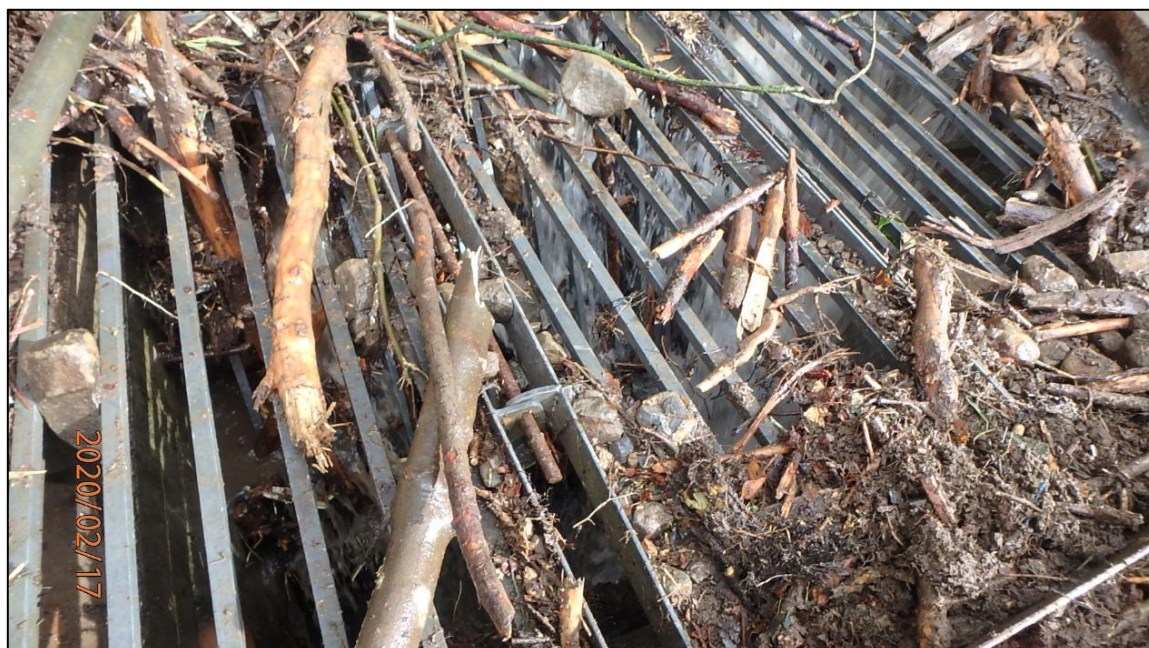
Photo provided by RCT's Flood Risk Management team showing woody debris in the Nant y Pentre channel and at the culvert inlet on 17th February 2020.

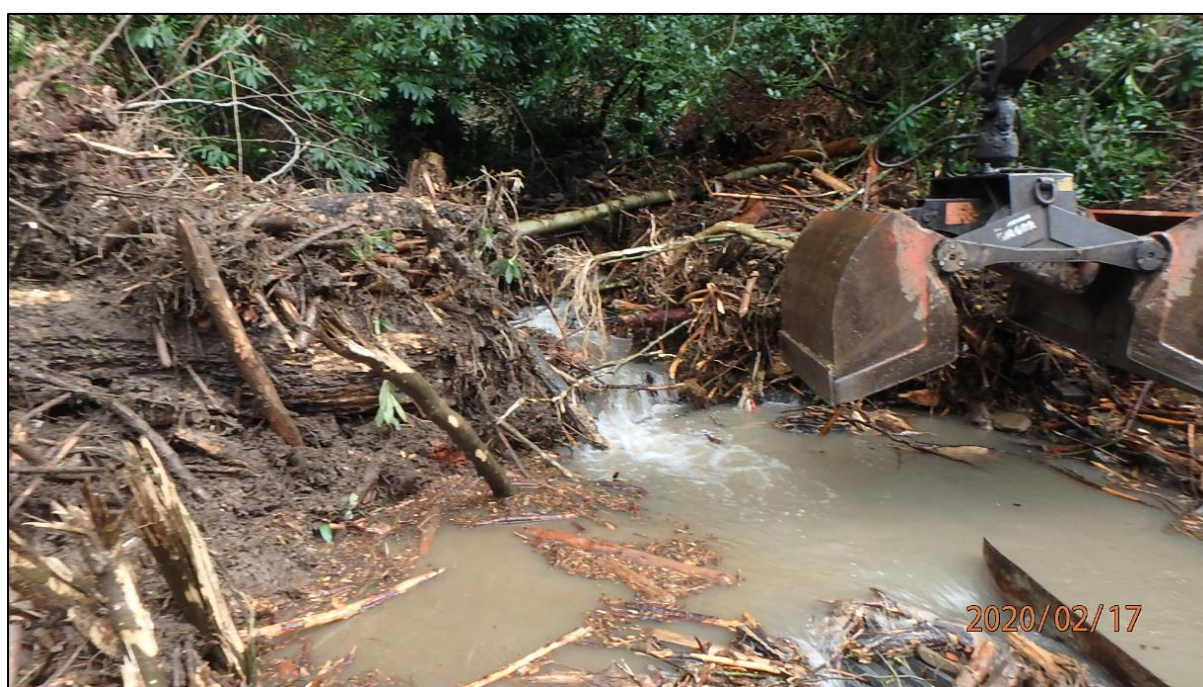
Photo provided by RCT's Flood Risk Management team showing woody debris on the debris screen of the Pentre Road culvert inlet on the 17th February 2020.

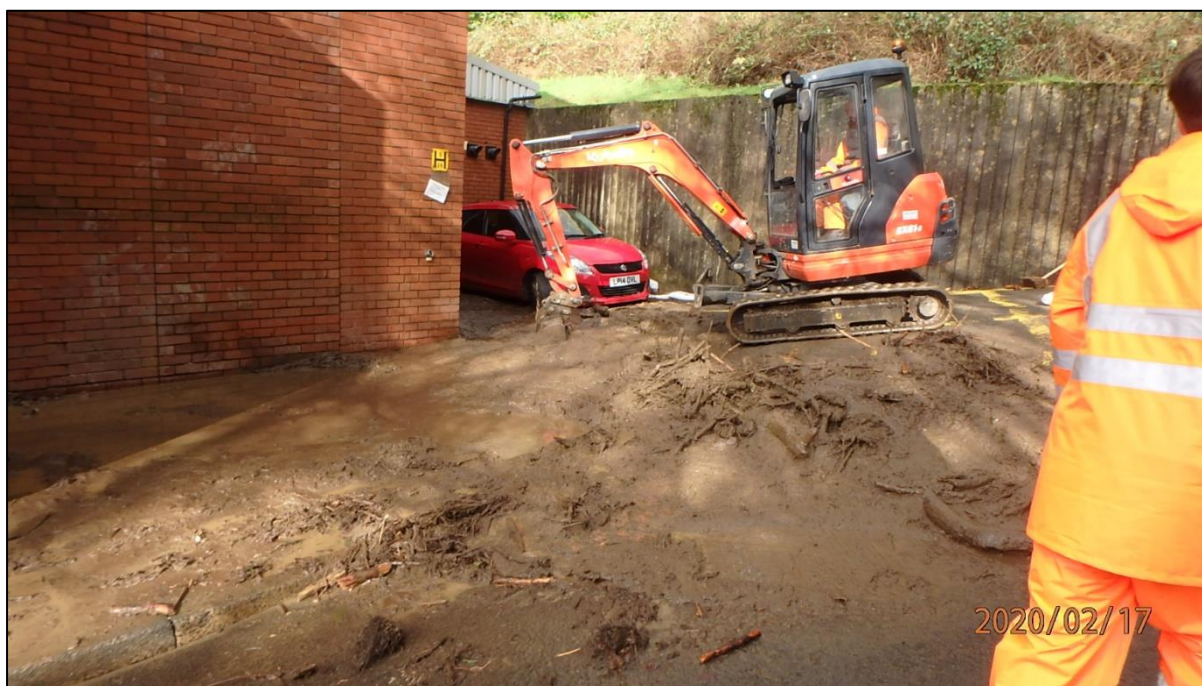
Photo provided by RCT's Flood Risk Management team showing woody debris and mud being cleared to the rear Pentre Road Care Home on the 17th February 2020 (situated directly downstream of the Pentre Road culvert inlet).

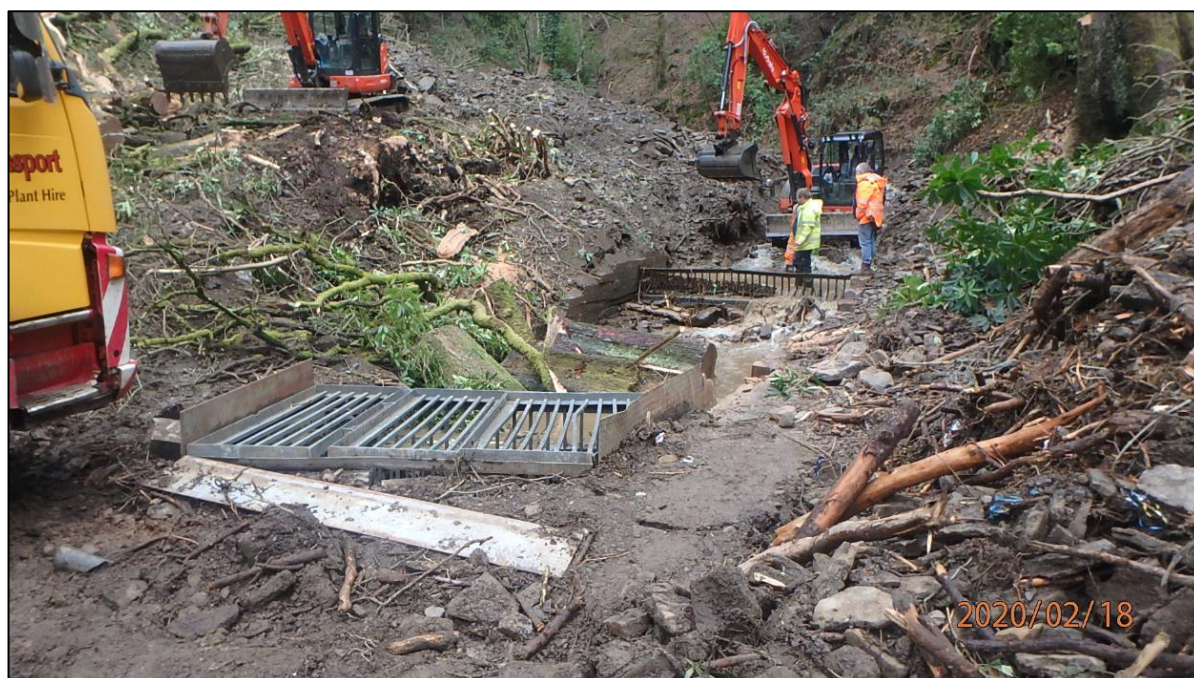
Photo provided by RCT's Flood Risk Management team of the Pentre Road culvert inlet and channel following emergency clearing works on 18th February 2020.

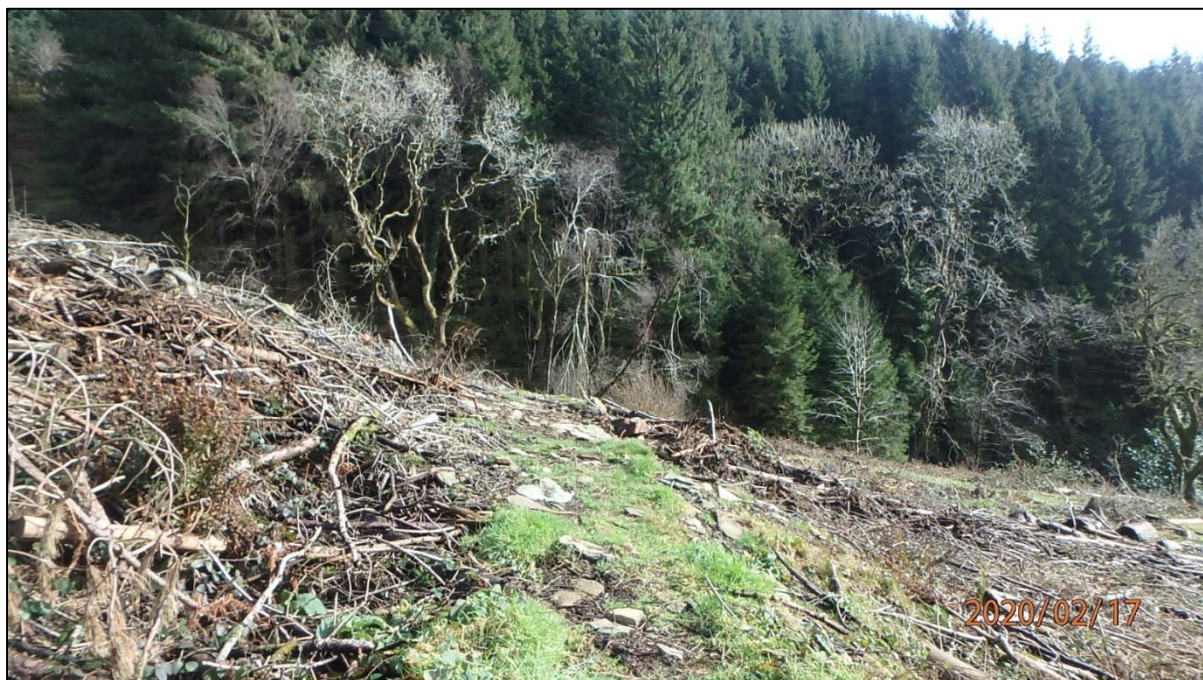
Photo provided by RCT's Flood Risk Management team on 17th February 2020 of woody debris in the felled area of Pentre's upper catchment.

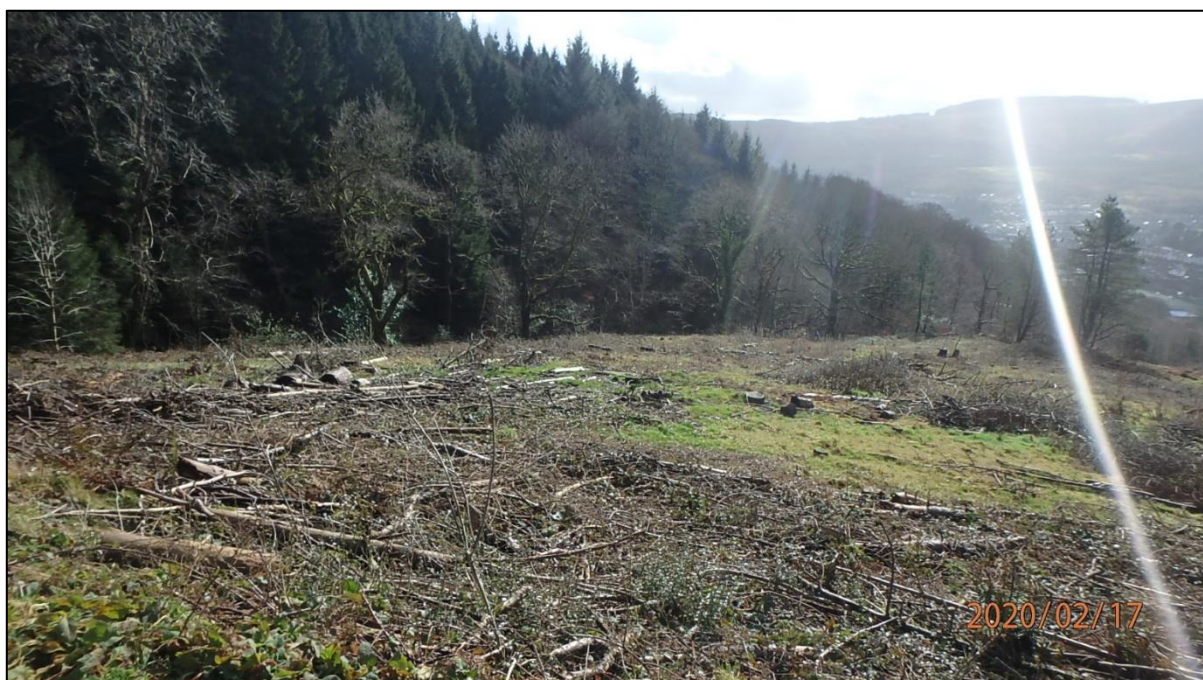
Photo provided by RCT's Flood Risk Management team on 17th February 2020 of woody debris in the felled area of Pentre's upper catchment looking downstream towards the village.

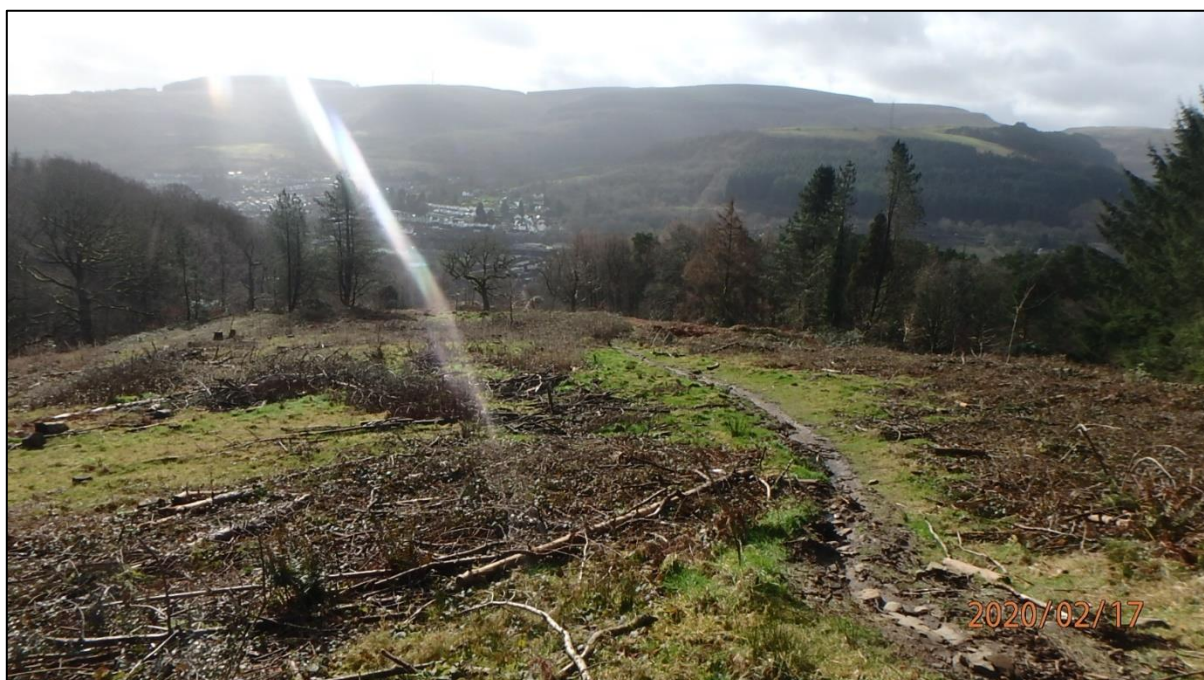
Photo provided by RCT's Flood Risk Management team on 17th February 2020 of woody debris in the felled area of Pentre's upper catchment looking downstream towards the village.

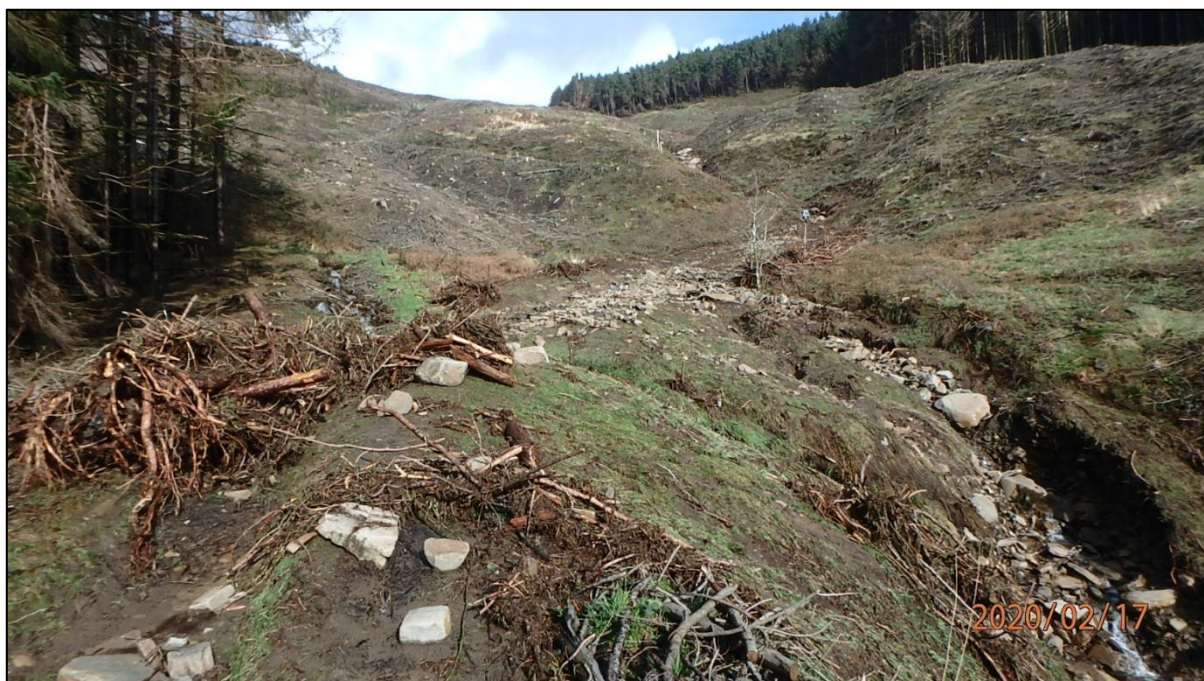
Photo provided by RCT's Flood Risk Management team on 17th February 2020 of woody debris in the felled area of Pentre's upper catchment looking upstream.

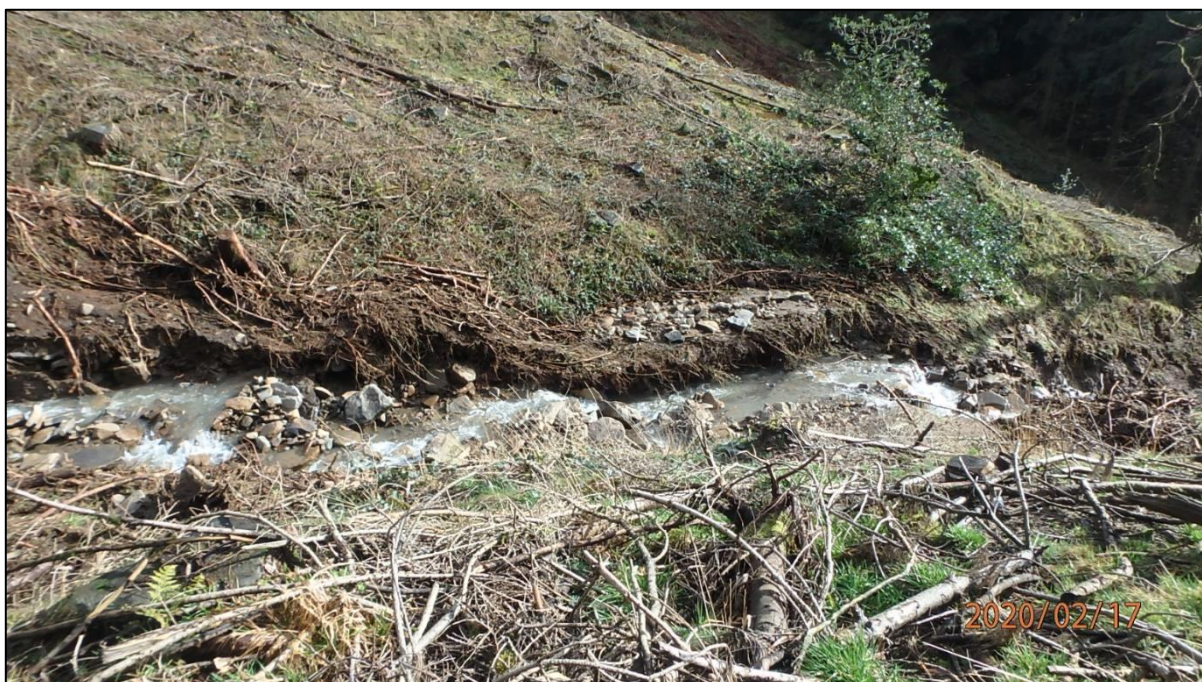
Photo provided by RCT's Flood Risk Management team on 17th February 2020 of woody debris in the felled area of Pentre's upper catchment and adjacent to the watercourse.
