**Flood and Water Management Act  
2010**

**Section 19 Flood Investigation  
Report**

**Storm Dennis –  
Flood Investigation Area RCT10**

**September 2021**

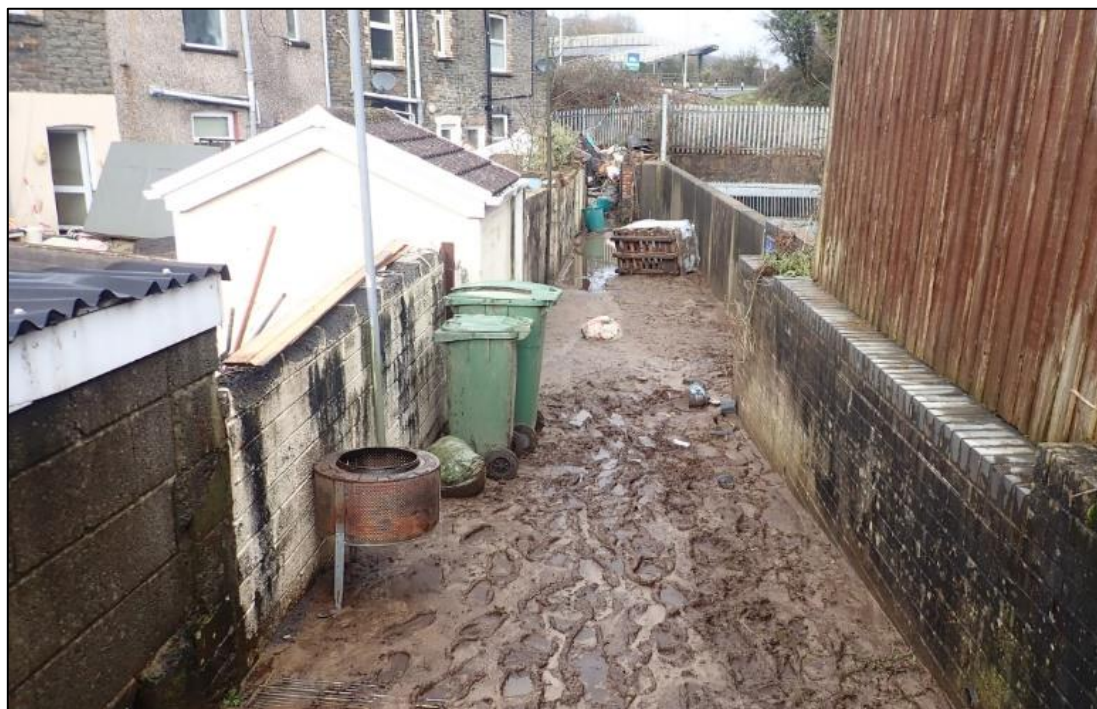
During the early hours of Sunday 16<sup>th</sup> February, the Nant Cae Dudwg ordinary watercourse overtopped the flood wall at the inlet, causing water to accumulate within the lane behind properties at Cilfynydd Road. The result of which saw riverine debris including silt and mud being deposited in the lane area. This resulted in blockages to the surface water drainage gullies in the lane, reducing the capacity of the drainage network to manage the excess water (Figure 5).

**Figure 5:** View of the lane between the Nant Cae Dudwg inlet and the rear gardens of properties on Cilfynydd Road captured by FRM officers on 17<sup>th</sup> February 2020.

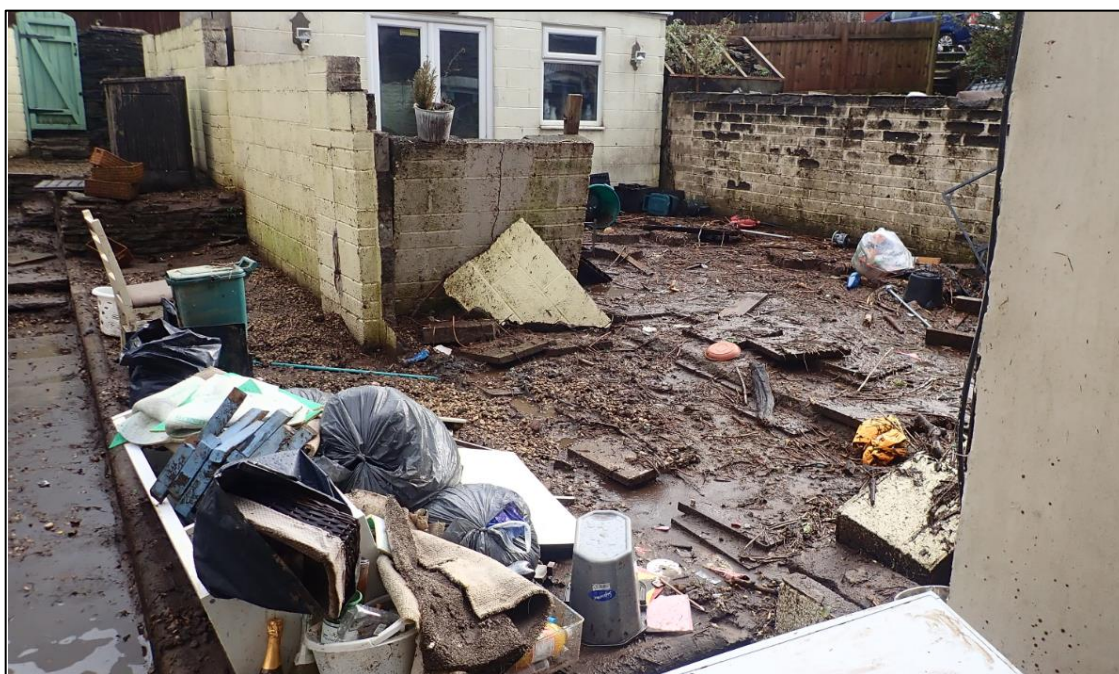
Post event inspections found evidence of collapsed concrete boundary walls, exemplifying the force of the water emanating from the watercourse and flowing through the gardens during the event. The images below reveal the severe and long-lasting damages caused by the flood event to properties at Cilfynydd Road (Figure 6).

**Figure 6:** Damages left after the event to the rear of a property at Cilfynydd Road captured by FRM officers on 17<sup>th</sup> February 2020

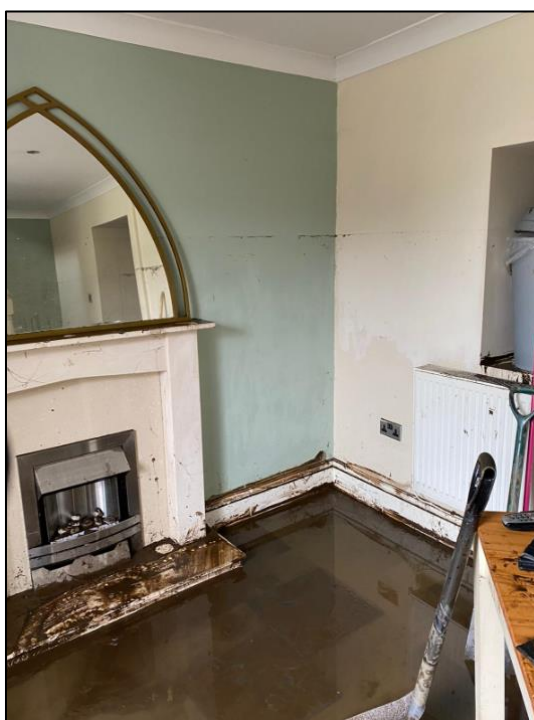
**Figure 7:** Water depth marks in a property at Cilfynydd Road following Storm Dennis (image provided by resident)

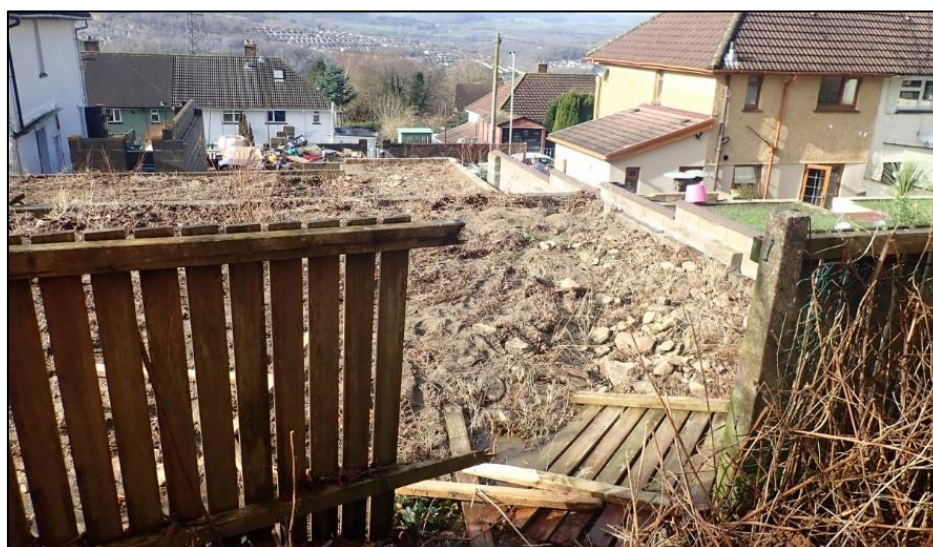
**Figure 9:** Damages to rear garden of a property at Heol Mynydd following the storm event (captured by FRM officers on 17<sup>th</sup> February 2020)

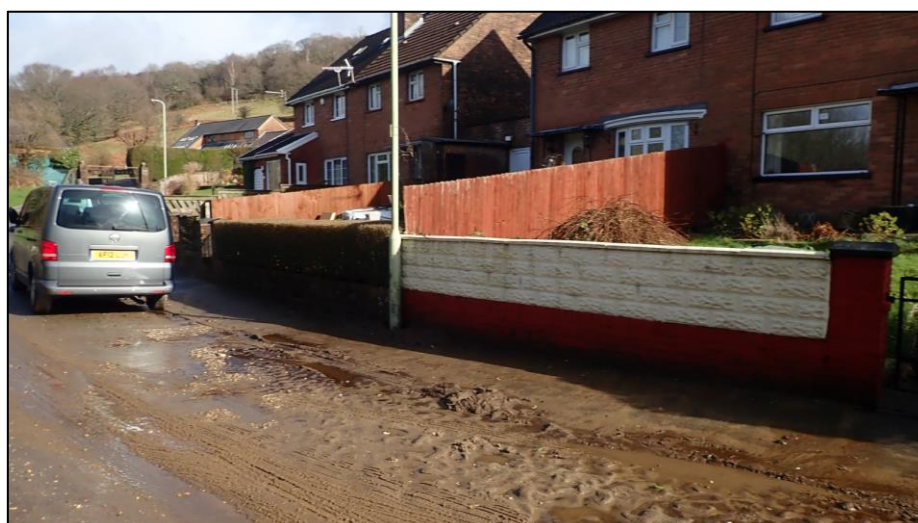
**Figure 10:** Road damages and debris deposited along Heol Cronfa following the storm event (captured by FRM officers on 17<sup>th</sup> February 2020)

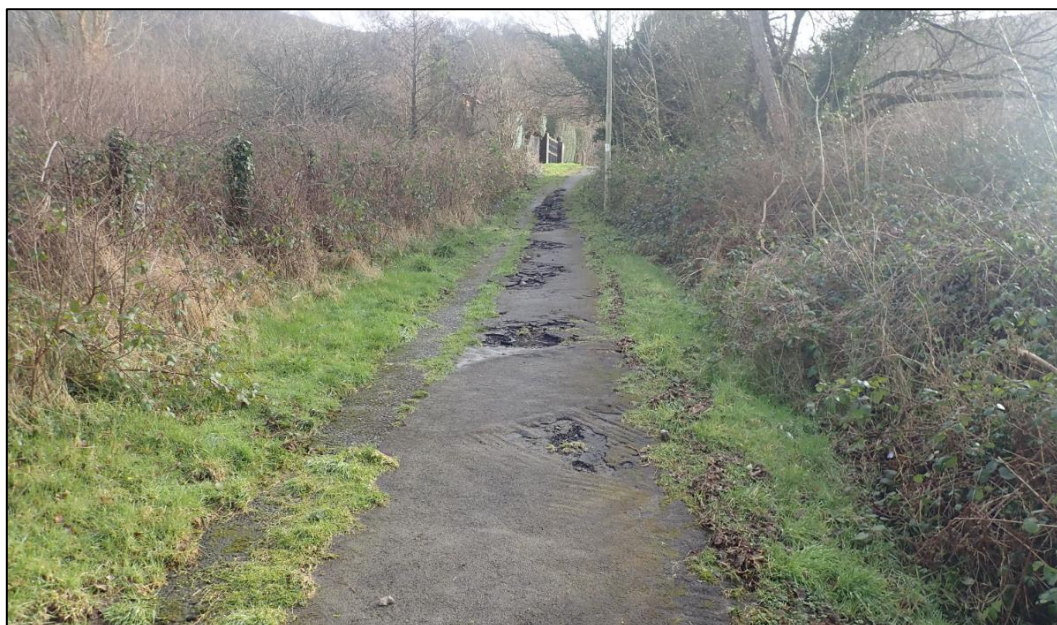
Water was observed coming out from the field before conveying onto the path towards Brynderwen. The path was badly damaged, assumed to be caused by the force of water flowing towards Brynderwen (Figure 11). Damages to the path were identified higher up than the gate, indicating that significant flows were also travelling from the overtopped watercourse at Heol Mynydd (Figure 12). The water entered the road, carrying debris in its flow which caused highway and private drainage infrastructure to block and surface water to pool. Properties on the western side of Brynderwen are situated slightly lower than the road, which resulted in internal flooding to three residential properties and external flooding to the front of several others.

**Figure 11:** Evidence of damages to the top of the path looking up towards Heol Nant (captured by FRM officers on 17<sup>th</sup> February 2020)

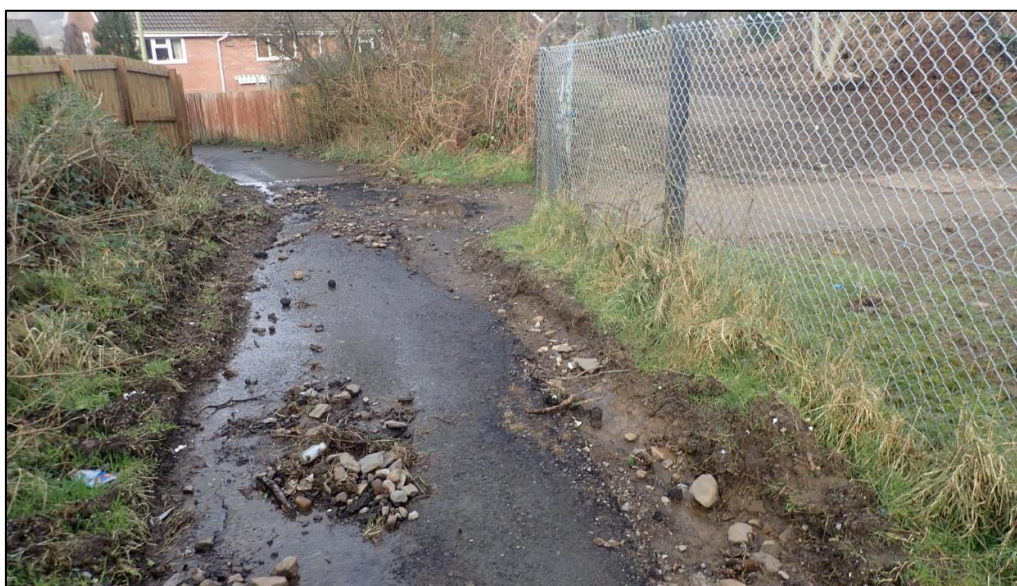
**Figure 12:** Evidence of deposited debris and damages to the bottom of the path looking down towards Brynderwen. Overland flows were observed flowing through land to the right behind the fencing (captured by FRM officers on 17<sup>th</sup> February 2020).

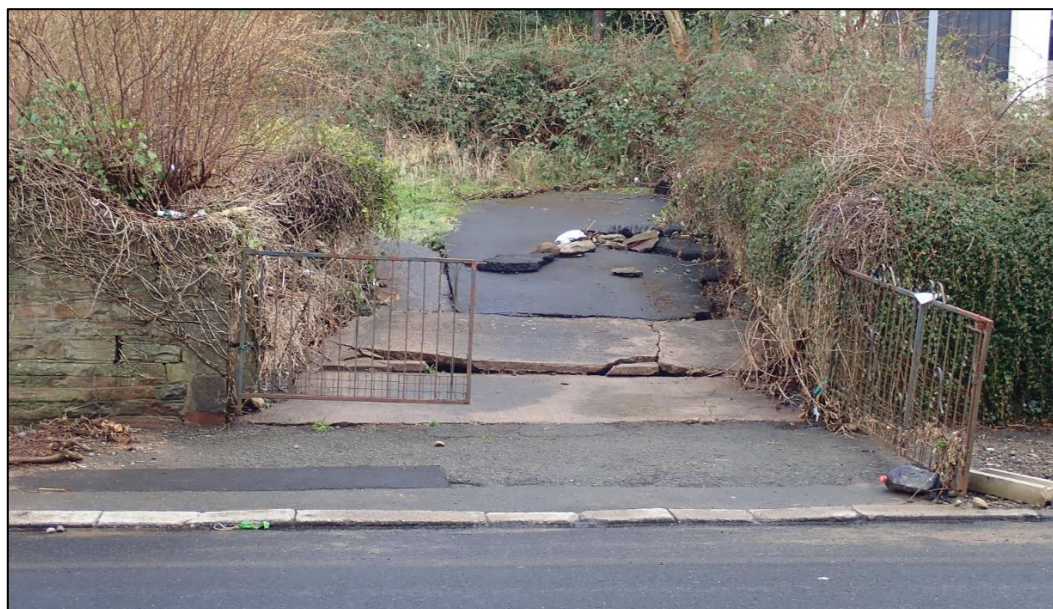
The evidence suggests the inlet became blocked with debris during the storm event which caused water to overflow from the culvert inlet and flow down the driveway of a residential property opposite the Royal Oak Inn, and onto Pontshonnorton Road. Post event inspections also identified a section of the tarmac driveway to have suffered from subterranean hydraulic pressure, i.e., the driveway appears to indicate that water from the culvert network erupted, through the tarmac and contributed to the flooding along Pontshonnorton Road (Figure 14).

**Figure 14:** Damages to the driveway situated below the Ely Brook culvert inlet showing evidence of subterranean hydraulic pressure (captured by FRM officers on 17<sup>th</sup> February 2020)

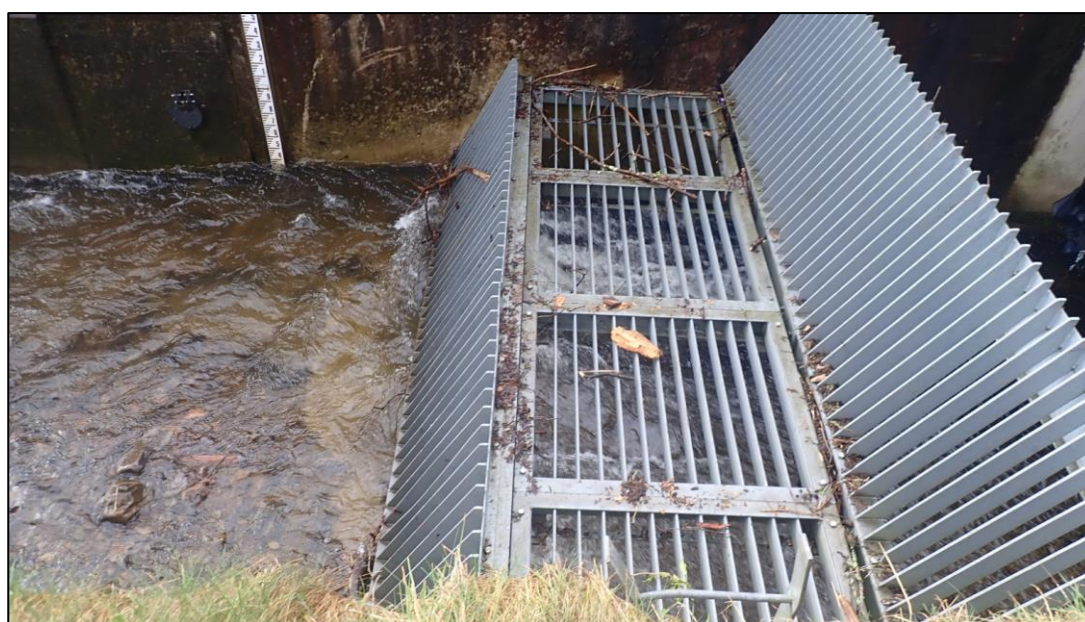
The culvert inlet was inspected by RCT's Highway Authority prior to the storm event on the 13<sup>th</sup> February 2020 and was found to be in good condition with no significant blockages or debris present (Figure 16).

**Figure 16:** Photo of 'Culvert Inlet 1' (Nant Cae Dudwg culvert inlet) captured by RCT's Flood Risk Management team prior to Storm Dennis on 13<sup>th</sup> February 2020

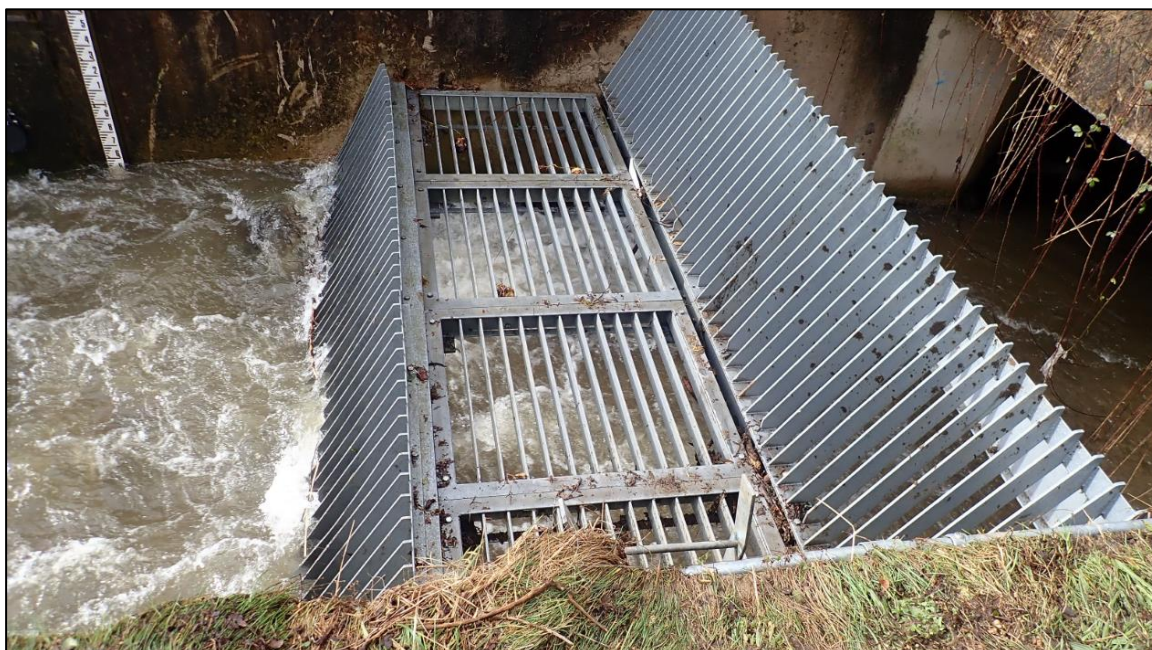
Following reports that 'Culvert Inlet 1' which conveys the Nant Cae Dudwg ordinary watercourse beneath Cilfynydd Road was the source of flooding to eight residential properties at Cilfynydd Road, post event inspections were carried out. According to emergency responders, the culvert inlet debris screen was partially blocked with woody debris, suggesting some debris was likely deposited during Storm Dennis however, there was little evidence to suggest that the inlet surcharged due to blockage during the event.

The culvert inlet was cleared of debris on 17<sup>th</sup> February 2020 by the Council's Depot once the watercourse level had subsided and safe working conditions were available. Notably, the debris screen shows no evidence of damage caused by the flood event (Figure 17). Trash screens further upstream of the inlet had significant stonewash and debris trapped behind which would suggest that the largest debris did not reach the

**Figure 17:** Nant Cae Dudwg culvert inlet (captured by FRM officers on 17<sup>th</sup> February 2020)

Although some settled coarse deposits was identified downstream of the inlet, the condition of both the inlet and culvert network is not considered to be the primary cause of flooding to properties at Cilfynydd Road. The water level within the Nant Cae Dudwg was high enough that debris likely travelled over the debris screen, avoiding any significant blockages, therefore the cause of flooding to Cilfynydd Road is considered to be related to the watercourse becoming overwhelmed during the storm event.

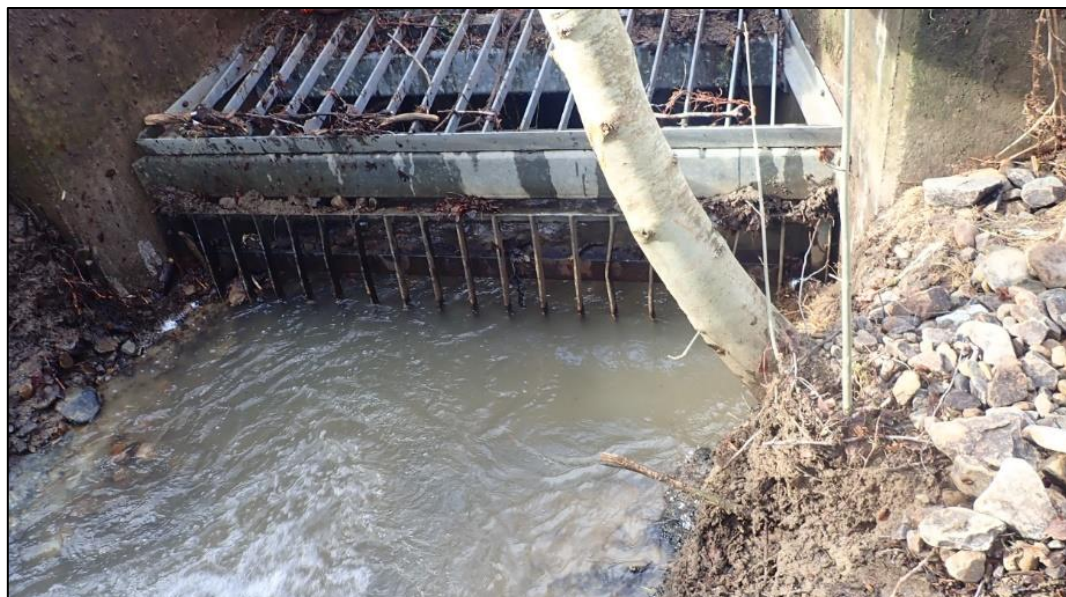
**Figure 18:** Culvert inlet to the rear of Heol Mynydd which surcharged during Storm Dennis due to blockages at the inlet (captured by FRM officers on 17<sup>th</sup> February 2020 following clearance works)

The culvert network was found to be in acceptable operational and structural condition following internal CCTV surveys. It is considered that blockages to the debris screen itself was the primary cause of flooding to Heol Mynydd and not the condition of the culvert network.

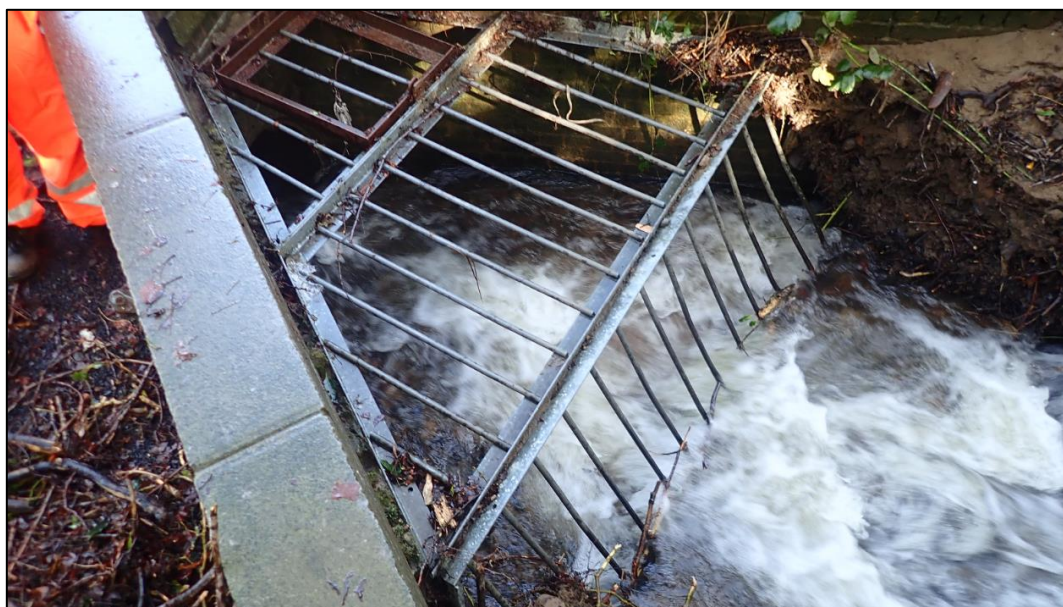
**Figure 19:** Ely Brook culvert inlet to the rear of Pontshonnorton Road which surcharged during Storm Dennis due to blockages at the inlet (captured by FRM officers on 17<sup>th</sup> February 2020 following clearance works)

Internal surveys of the Ely Brook network have highlighted several sections of the culvert drainage system that are in poor condition following the flood event. The culvert section immediately downstream of the inlet known to surcharge is in the poorest condition, both structurally and operationally according to CCTV survey data.

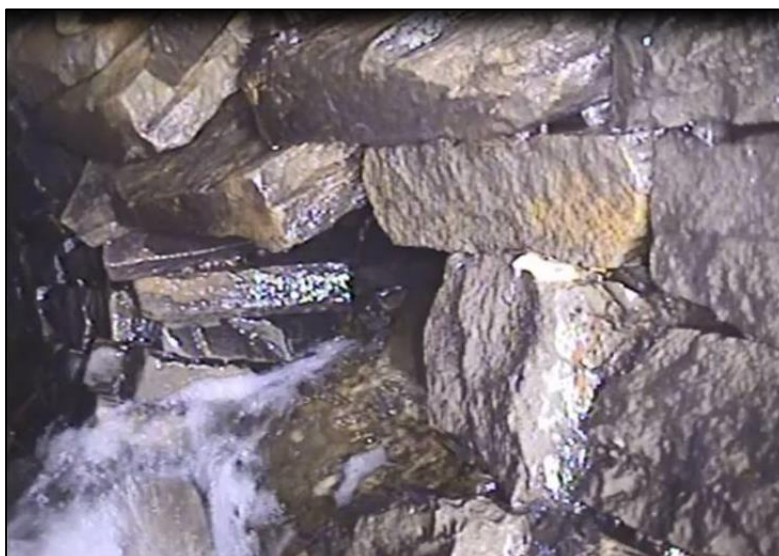
A Grade 5 structural defect was identified approximately 23 meters downstream of the inlet (Figure 20), located on the driveway below the Ely Brook culvert inlet, and has been determined as a secondary source of flooding to properties along Pontshonnorton Road, Norton Court and Evans Square, whereby water breached the culvert system below the tarmac driveway due to hydraulic pressure, contributing to the flooding at Pontshonnorton Road.

The poor condition of the culvert network is considered to have contributed to the flooding, however, the blockage to the inlet structure has been determined as the most significant contributor to flood flow path C (Figure 3) during Storm Dennis.

**Figure 20:** Hole in culvert 22.9 meters downstream of the Ely Brook inlet opposite Royal Oak Inn

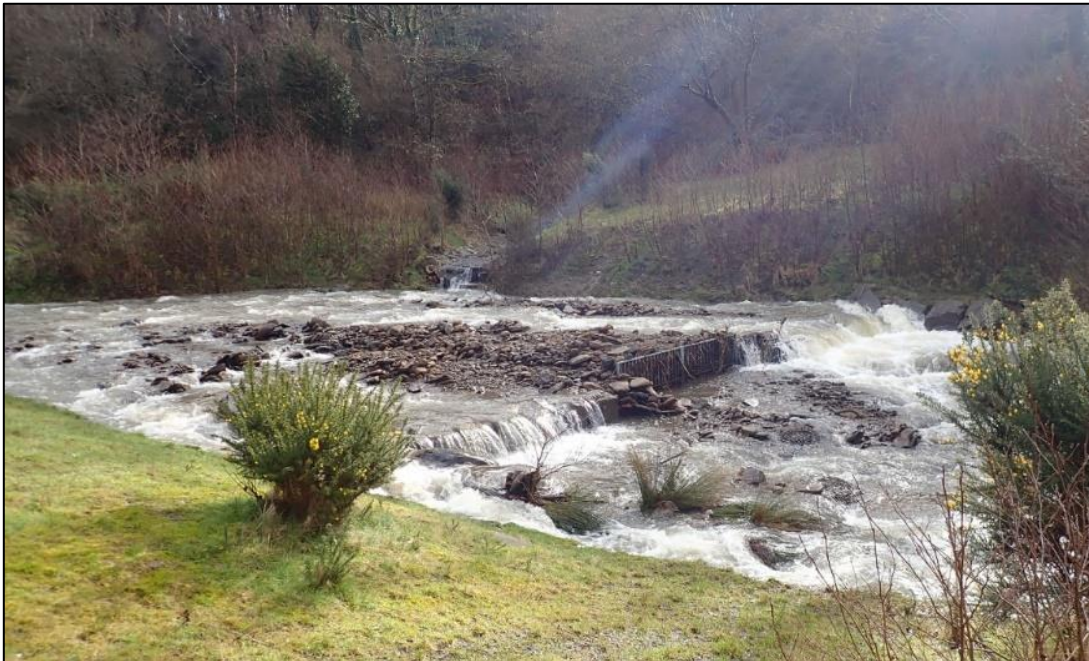
**Figure 22:** Initial upstream debris screen in the Nant Cae Dudwg watercourse (captured by RCT's Flood Risk Management team on 17<sup>th</sup> February 2020)

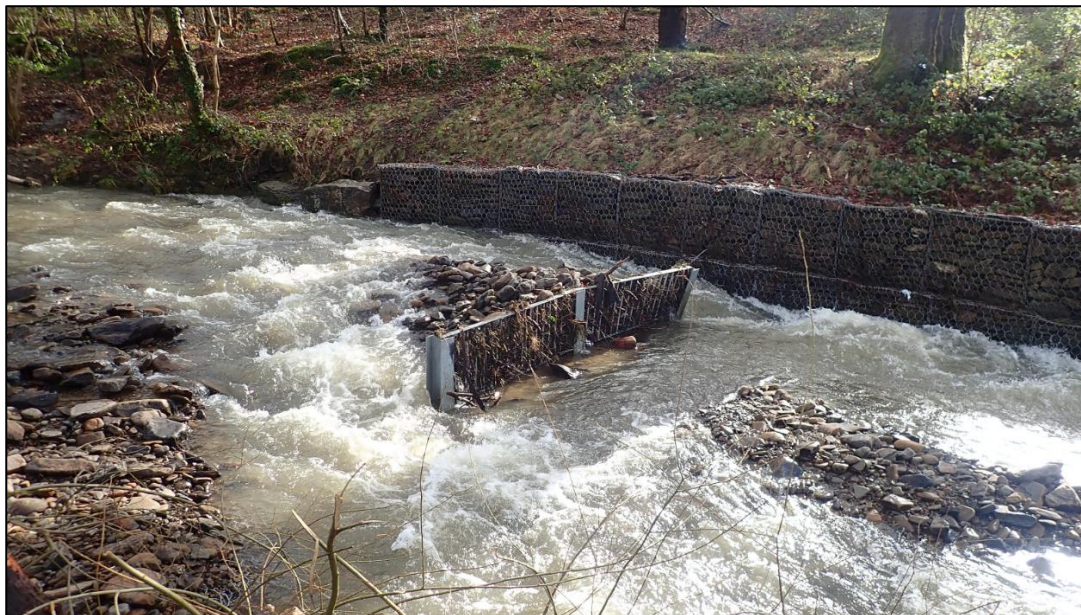
**Figure 23:** Second upstream debris screen in the Nant Cae Dudwg watercourse (captured by RCT's Flood Risk Management team on 17<sup>th</sup> February 2020)

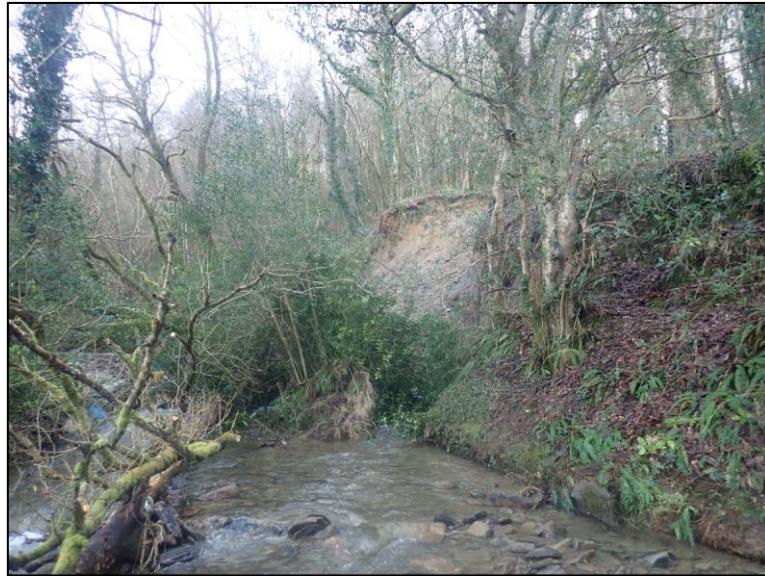
Evidence of embankment scour and localised landslips were identified along sections of the Nant Cae Dudwg watercourse (Figures 26 and 27). It is considered that this scoured material contributed to the volume of debris deposited along the watercourses' upper debris screens.

**Figure 26:** Photo of localised landslip on the embankment of the Nant Cae Dudwg watercourse (image captured by RCT's Flood Risk Management team on 02/03/2020)

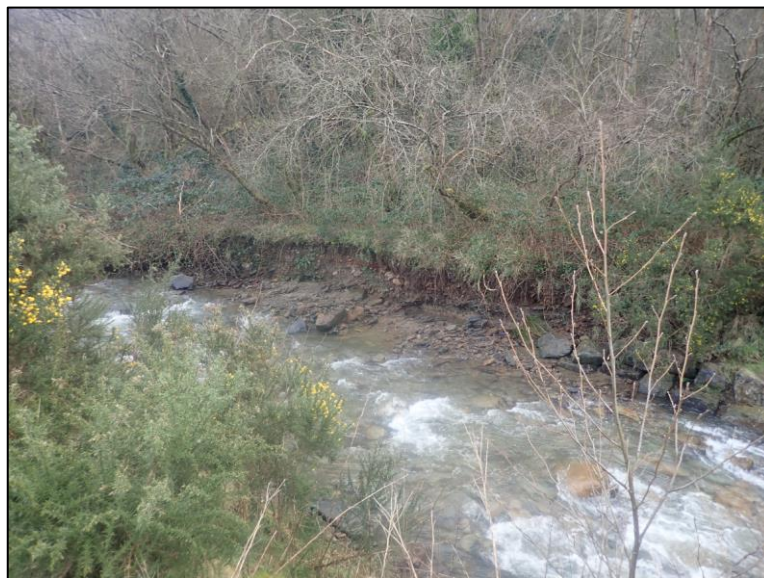
**Figure 27:** Photo of embankment scour to the Nant Cae Dudwg watercourse (image captured by RCT's Flood Risk Management team on 02/03/2020)

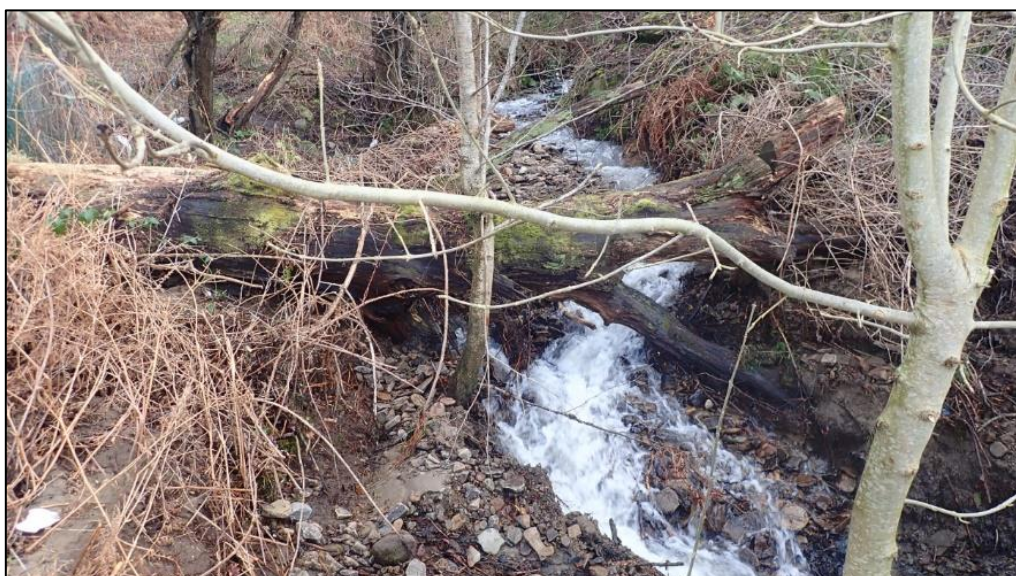
Post event inspections undertaken by RCT's FRM officers also identified a collapsed tree within the watercourse (Figure 29), just upstream of the culvert inlet. It is not believed that the collapsed tree contributed to the flooding at Cilfynydd, however it does provide evidence of the powerful flows within the watercourse during the storm event which caused embankment scouring as well as mobilisation of debris, contributing to the inlet blockage downstream. Emergency clearance works were undertaken by the Council's Depot to remove the tree from the watercourse.

**Figure 29:** Tree collapse in the unnamed ordinary watercourse to the rear of Heol Mynydd (captured by FRM officers on 17<sup>th</sup> February 2020)

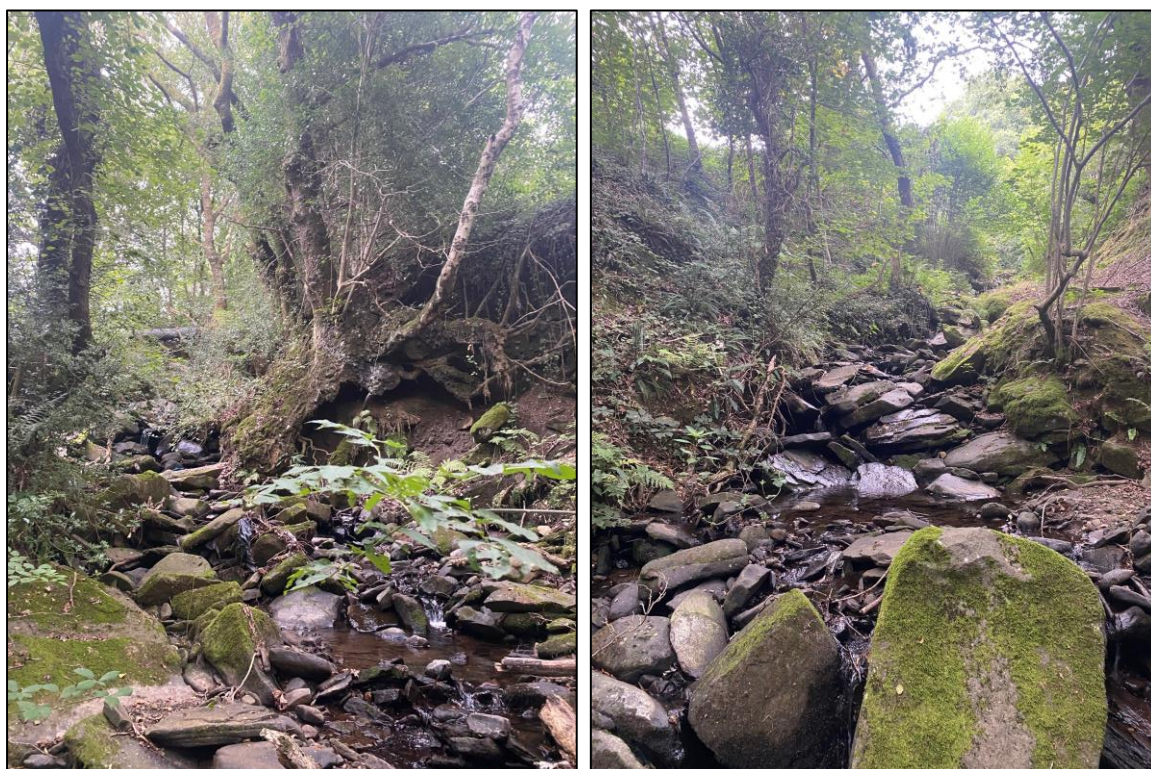
Post event inspections of the Ely Brook watercourse identified large stonewash within the channel, as well as the undercutting of large trees caused by bank erosion in the upper catchment (depicted in Figures 30). The inspection also noted that the watercourse is very steep in its upper reaches, indicating that fast flowing water generating large debris mobilisation and sedimentation is likely in this part of the catchment during storm events.

**Figure 30:** Photo of stone deposition, bank erosion and undercutting of trees within the Ely Brook ordinary watercourse in the upper catchment (captured by RCT's Flood Risk Management team post Storm Dennis)

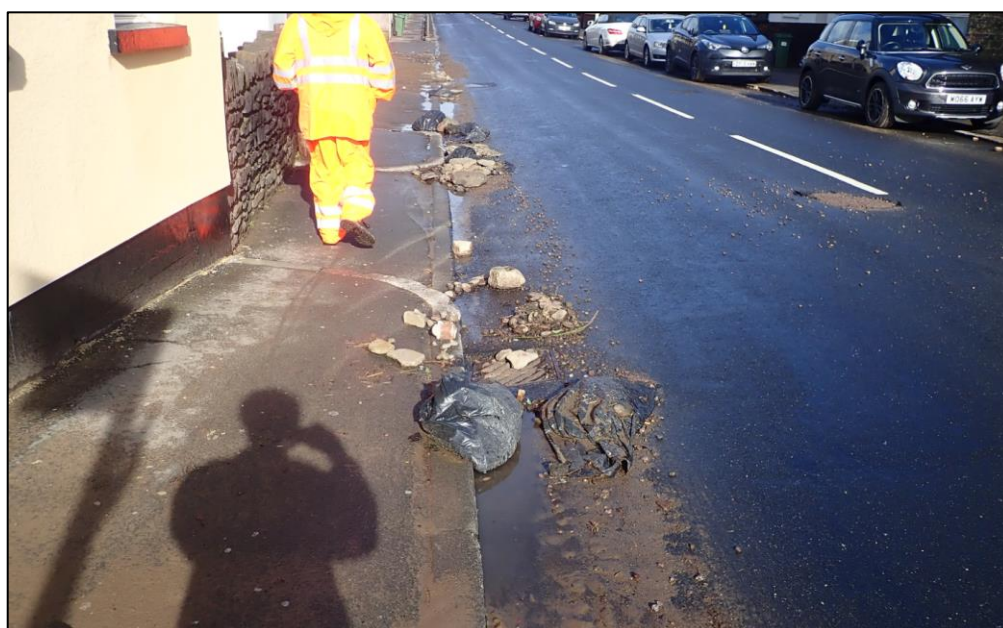
Overland flows from private land and runoff originating from the surcharged inlet to the rear of Heol Mynydd caused water to travel towards Heol Nant and Heol Cronfa, and onwards toward Brynderwen via a small pathway. Deposited mud, silt and debris was evident across these streets, along with several reports of blocked highway drainage gullies, illustrating the flow path of water during the event. Likewise, water sourced by the Ely Brook watercourse travelled north along Pontshonnorton Road, depositing debris on its course, causing blockages to the highway drainage infrastructure (Figure 31).

**Figure 31:** Debris left after the storm event at Pontshonnorton Road (captured by FRM officers on 17th February 2020)

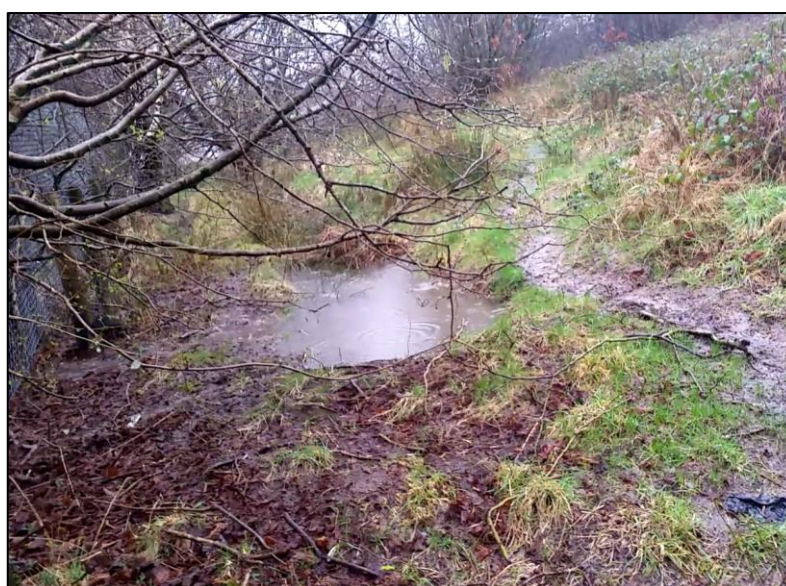
Surface water flooding from an area of land behind Brynderwen was observed by residents as a secondary source of flooding to properties at Brynderwen during Storm Dennis. Upon an inspection of the land by RCT's Flood Risk Management team a small land drainage channel was identified, within privately owned land.

**Figure 32:** Photo of the drainage ditch overtopping (image captured by resident on 16/02/2020)
