# Flood and Water Management Act 2010

## Section 19 Flood Investigation Report

### Storm Dennis – Flood Investigation Area RCT27

November 2021

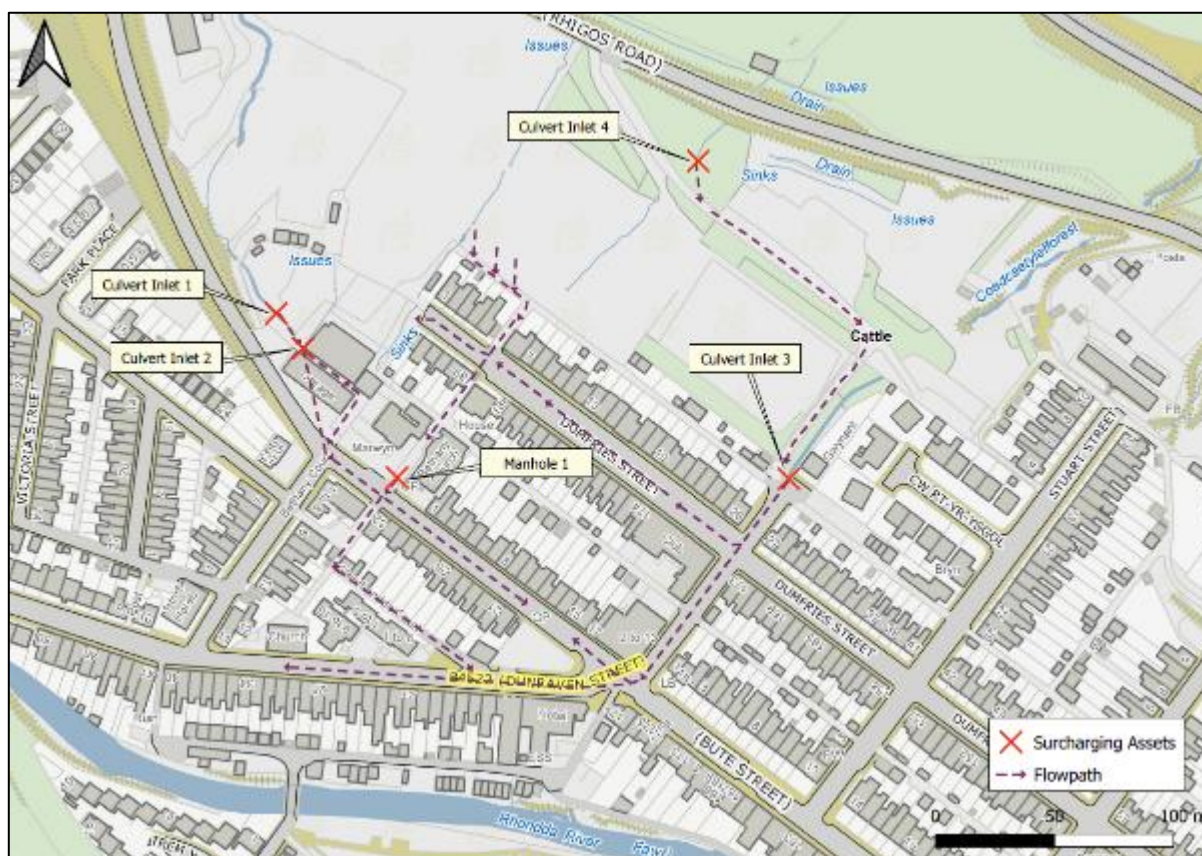
**Figure 4:** Observed flow paths within 'Treherbert West' sub-catchment during Storm Dennis (16<sup>th</sup> February 2020)

Several calls were received from residents at Abertonllwyd Street and Dunraven Street on the 16<sup>th</sup> February 2020 to report water ingress into multiple residential properties. Upon a site inspection undertaken by RCT's Flood Risk Management team on the 18<sup>th</sup> February 2020, a culvert inlet adjacent to New Park Garage on Abertonllwyd Street (labelled 'Culvert Inlet 1' in Figure 4) was identified as half-submerged (Figure 5), indicating that the inlet was operating at a limited capacity post storm event.

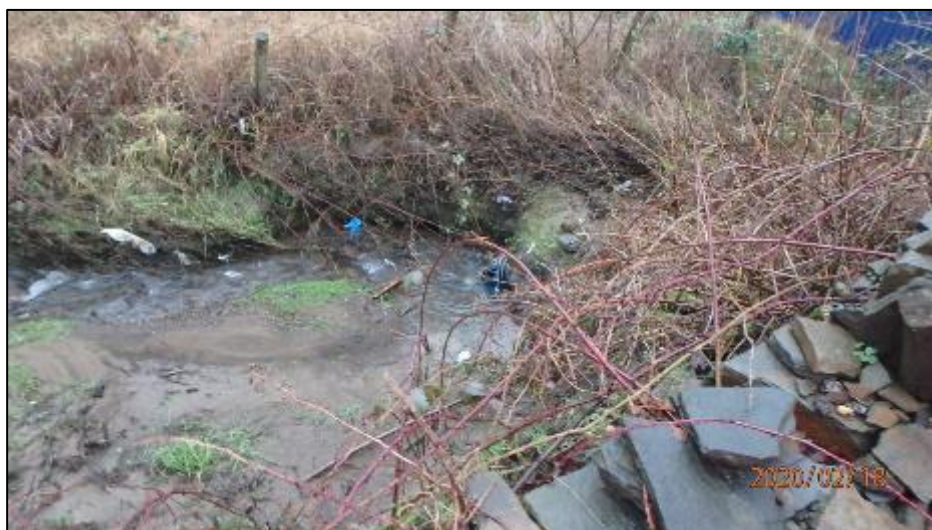
**Figure 5:** Evidence of submerged 'Culvert Inlet 1' which surcharged during Storm Dennis (captured by RCT's Flood Risk Management team on 18<sup>th</sup> February 2021)

The poor condition of both culvert inlets is considered to have contributed to the surcharging of both inlets.

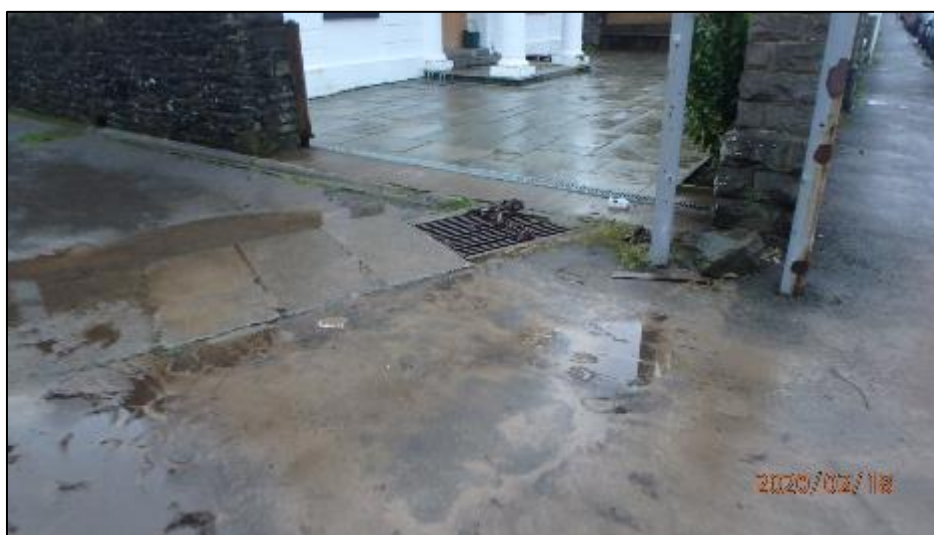
A manhole located downstream of the surcharged inlets (labelled 'Manhole 1' in Figure 4) also showed evidence of surcharge. Exceedance flows from the ordinary watercourse manhole reportedly contributed additional overland flow towards Abertonllwyd Street. Water also conveyed down the path to the rear of Abertonllwyd Street towards Glenrhondda Court and onto Dunraven Street, as depicted in Figure 4.

**Figure 6:** 'Manhole 1' located at Abertonllwyd Street surcharged during Storm Dennis (captured by RCT's Flood Risk Management team on 18<sup>th</sup> February 2021)

The poor condition of the culvert network downstream of 'Manhole 1' is considered to have contributed to its surcharging during Storm Dennis. The debris identified within the network is also indicative of the high flow rates which enabled the erosion and transportation of a significant volume of debris from the upper catchment and subsequent deposition within the culvert network during the storm event.

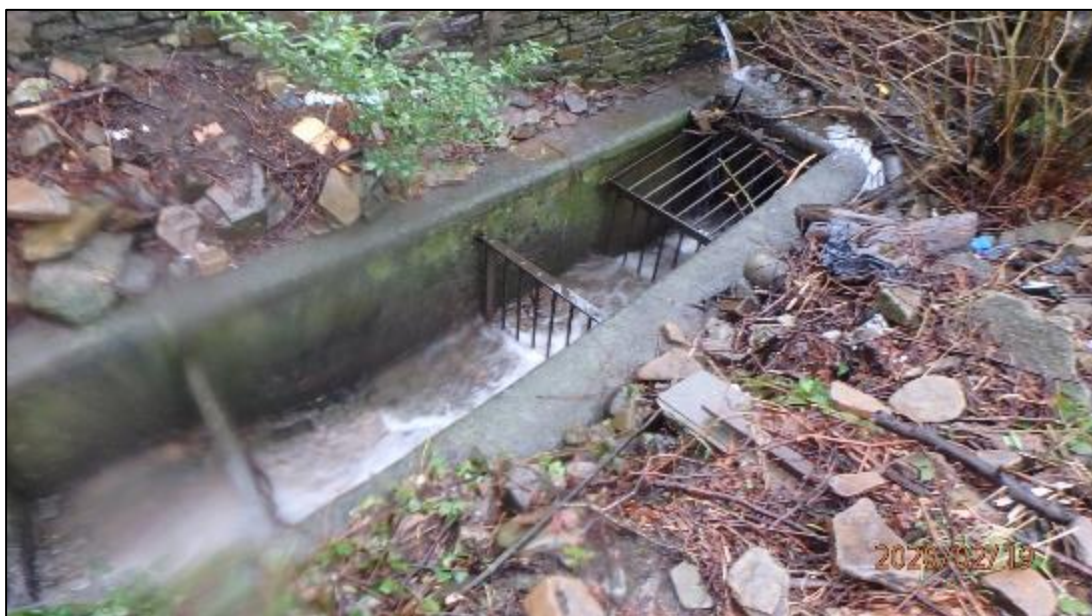
The site inspection also identified evidence of a third surcharged culvert inlet located near Dumfries Street (labelled 'Culvert Inlet 3' in Figure 4). This culvert inlet conveys flows from the Nant Coedcaetylleforest ordinary watercourse. Evidence of cleared debris was identified (Figure 7) post event, indicating that the culvert inlet became blocked during Storm Dennis, resulting in surcharge.

**Figure 7:** 'Culvert Inlet 3' to the rear of Dumfries Street which surcharged during Storm Dennis (captured by RCT's Flood Risk Management team on 19<sup>th</sup> February 2021)

Following reports that 'Culvert Inlet 3', which conveys the Nant Coedcaetyllefforest ordinary watercourse beneath Dumfries Street, was a contributing source of flooding to properties at Dumfries and Dunraven Streets, post event inspections were carried out. These inspections found evidence of debris surrounding the inlet structure, indicating that the inlet had surcharged due to blockage during the event (see Figure 7).

It is assumed that the watercourse at Area 3 exceeded its usual capacity, resulting in out-of-bank flows mobilising debris from the surrounding bank area which caused the blockage at 'Culvert Inlet 3' (Figure 4), resulting in surcharge.

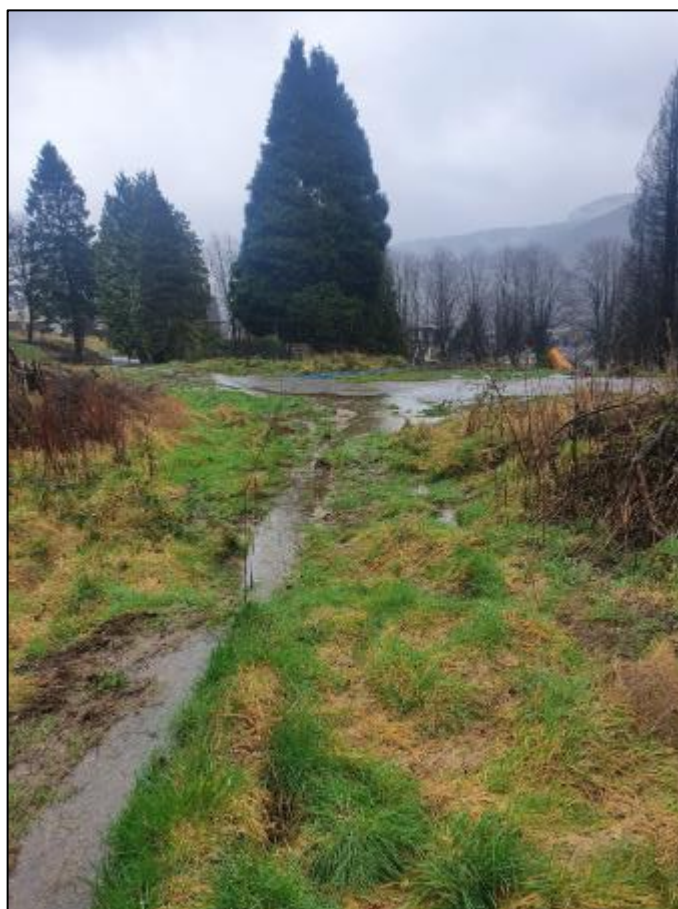
Furthermore, a culvert on private land to the rear of Dumfries Street was identified as fully submerged during RCT's site inspection (Figure 8), which resulted in overland flows travelling along the track road and contributing additional surface water flows towards Dunraven Street during the storm event.

**Figure 8:** Overland runoff originating from 'Culvert Inlet 4' flowing along the track road to the rear of Dumfries Street (image captured by RCT's Flood Risk Management team post event on 18<sup>th</sup> February 2020)

Exceedance flows from the surcharged inlet travelled down Dumfries Street and onwards to Dunraven Street, exacerbating the flooding in this area.

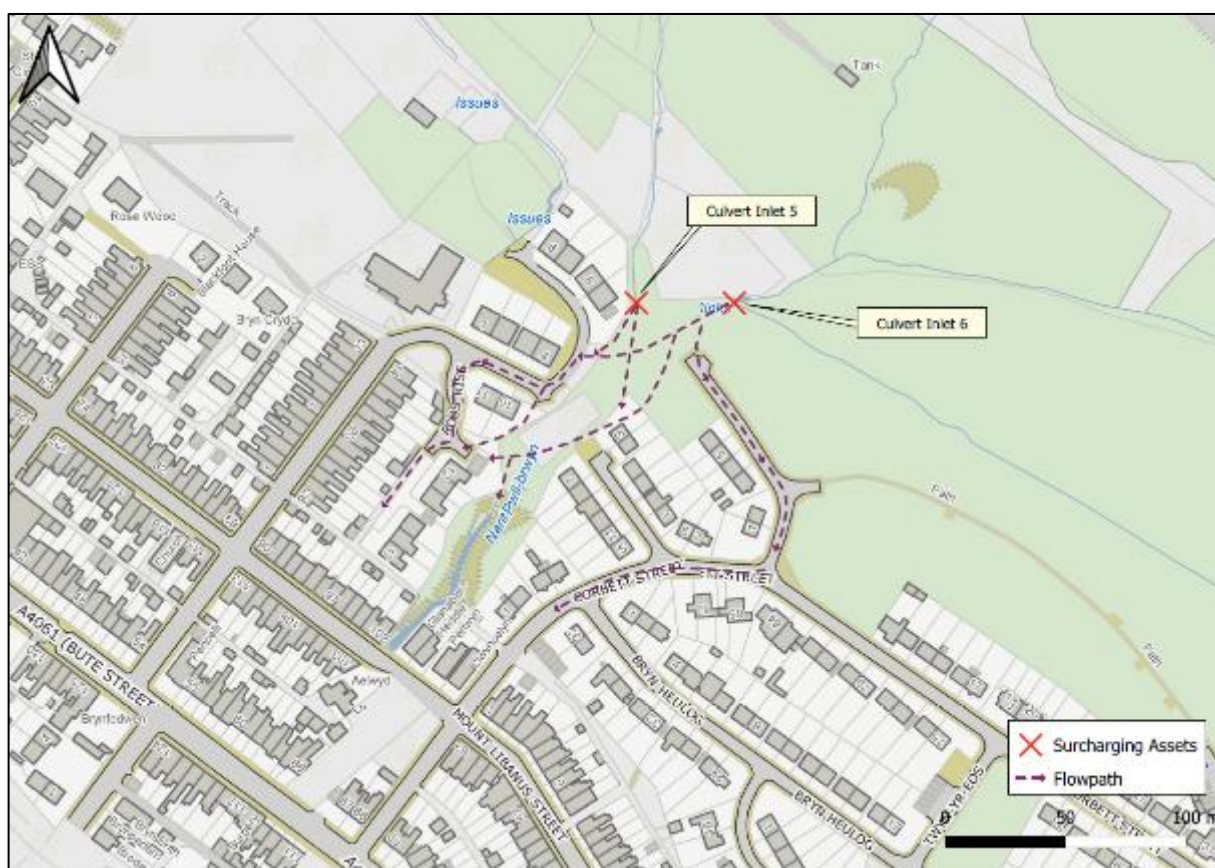
**Figure 9:** Observed flow paths within 'Treherbert East' sub-catchment during Storm Dennis (16<sup>th</sup> February 2020)

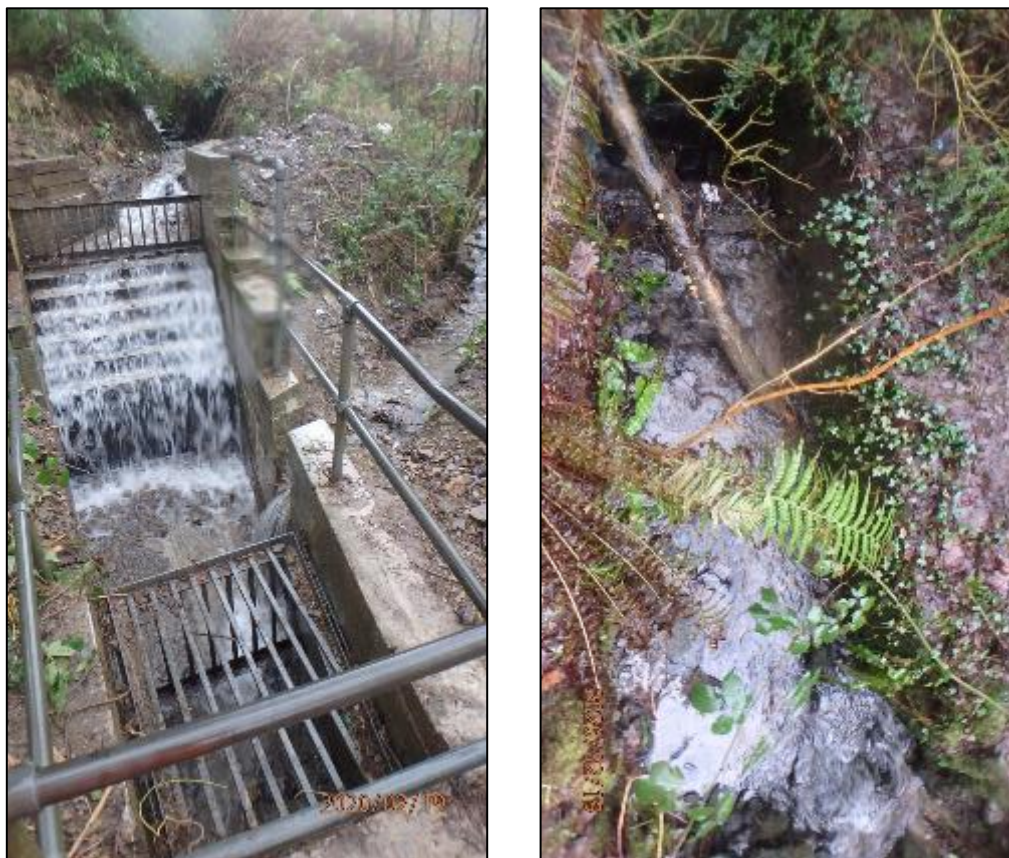
February 2020, two culvert inlets, labelled 'Culvert Inlet 5' and 'Culvert Inlet 6' in Figure 9, located to the north of Ross Rise and Tyn-y-coedcae, showed evidence of surcharge (Figure 10).

**Figure 10:** 'Culvert Inlet 5' (left) and 'Culvert Inlet 6' (right) located to the rear of Tyn-y-coedcae which surcharged during Storm Dennis (captured by RCT's Flood Risk Management team on 19<sup>th</sup> February 2020)

'Culvert Inlet 5' was identified as being in very poor condition, with the surrounding area showing evidence of surcharge according to on site officers. The CCTV survey identified the network downstream of the inlet to be in acceptable condition, however

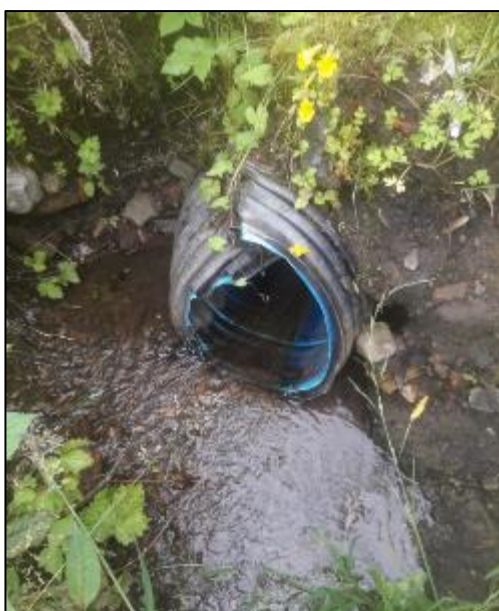
The culvert network length between 'Culvert Inlet 1' and 'Culvert Inlet 2', situated behind New Park Garage, consists of a 450mm plastic pipe which was noted as deformed during CCTV survey operations (Figure 12). Upon site inspections of the inlet during storm event conditions, water is observed to bypass 'Culvert Inlet 1' and flow over the top of the pipework towards 'Culvert Inlet 2'. This flow path is assumed to have occurred during Storm Dennis.

**Figure 12:** 'Culvert Inlet 1' captured during CCTV survey operations on 30/06/2020

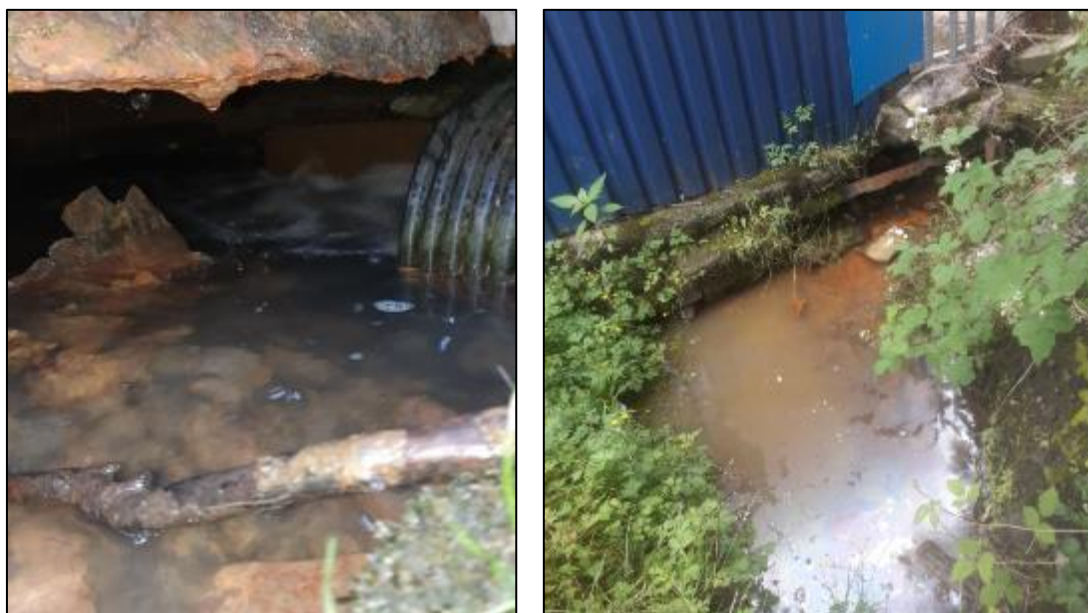
'Culvert Inlet 2' primarily consists of an outfall pipe which discharges underneath New Park Garage (Figure 13). The inlet also receives flow from an ordinary watercourse which runs adjacent to the garage. As depicted in Figure 13, the outfall pipe is relatively level with the surface, resulting in standing water surrounding the inlet.

**Figure 13:** Outfall pipe entering 'Culvert Inlet 2' (left) and standing water surrounding 'Culvert Inlet 2' (right) (captured during CCTV survey operations on 30/06/2020)

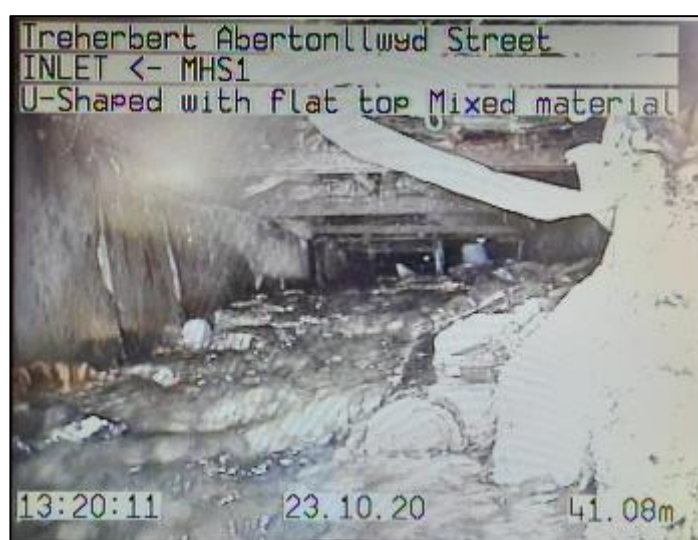
A second Council appointed contractor undertook a further survey of the culvert network on 21<sup>st</sup> October 2020. The survey had to be abandoned again approximately 27 meters downstream of 'Culvert Inlet 2' due to a high volume of settled debris reducing the networks cross-sectional area by 70% (depicted in Figure 14). This debris is considered to have reduced the culvert's hydraulic capacity to manage the flow of water entering the network, contributing to the surcharging at 'Culvert Inlet 2'.

**Figure 14:** Internal view of 'Abertonllwyd Street Culvert Network 1' looking up towards 'Culvert Inlet 2' (CCTV survey footage captured 23/10/2020)

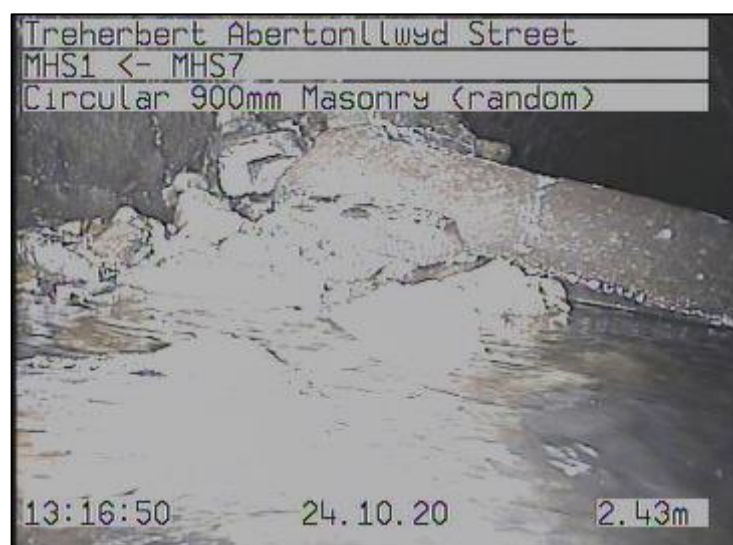
Surcharging at 'Manhole 1' was also identified as a secondary source of flooding to properties at Abertonllwyd and Dunraven Streets during Storm Dennis. Both CCTV survey operations were also abandoned downstream of 'Manhole 1' due to settled deposits and large debris identified within the network (depicted in Figure 15). The culvert network downstream of 'Manhole 1' was also graded as being in very poor structural condition.

**Figure 15:** Internal view of 'Abertonllwyd Street Culvert Network 1' downstream of 'Manhole 1' (CCTV survey footage captured 24/10/2020)

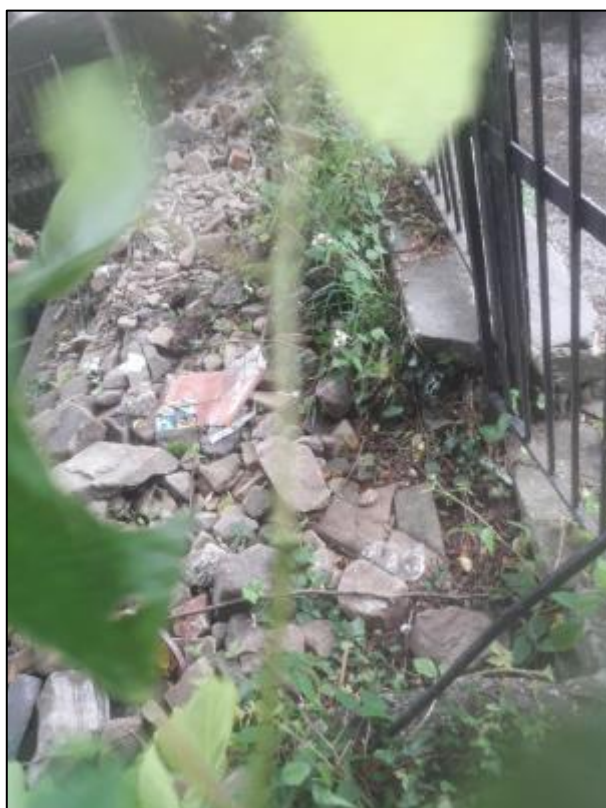
The 'Dumfries Street Culvert Network' was also surveyed to be in poor condition, with significant operational and structural defects identified throughout the network. The volume of settled deposits led to operators abandoning the CCTV survey operations on two occasions. As a result, approximately 5 tonnes of debris was removed from the network (shown in Figure 16).

**Figure 16:** Debris removed from the 'Dumfries Street Culvert Network' during cleansing operations (image captured on 29/06/2020)

Similarly to the Abertonllwyd Street culvert networks, the debris identified within the Dumfries Street network highlights the strength of the ordinary watercourse flows that would have been travelling down the hillsides above RCT27 and entering the culvert networks during the storm event. Its poor condition is considered to have contributed to the surcharging of 'Culvert Inlet 3', however, the blockage to the inlet structure has been determined as the most significant contributor to the flood flow path along Dumfries and Dunraven Streets during Storm Dennis.

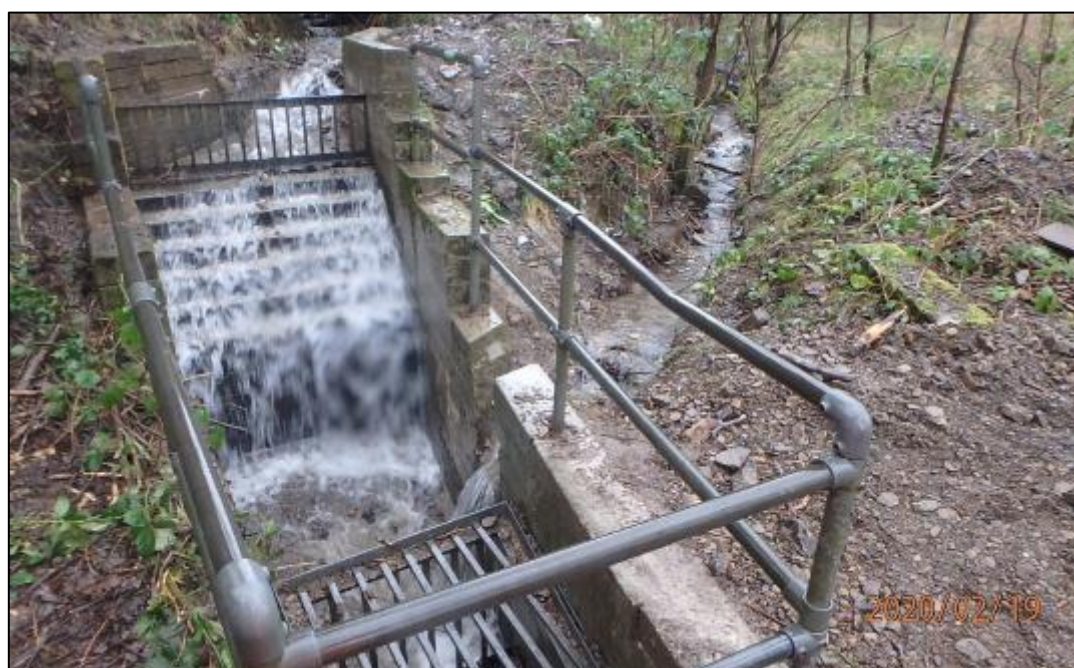
The 'Culvert Inlet 6' structure was identified by first responders as being blocked with debris and was subsequently cleansed. Figure 18 captured post event by FRM officers depicts the inlet following clearance works.

**Figure 18:** Photo of 'Culvert Inlet 6' captured by RCT's Flood Risk Management team following debris clearance post Storm Dennis (19/02/2020)

The 'Tyn-y-coedcae Culvert Network' downstream of 'Culvert Inlet 6' was surveyed to be in acceptable structural and operational condition, indicating that the blockage to the inlet structure caused by debris was the primary cause of surcharge.

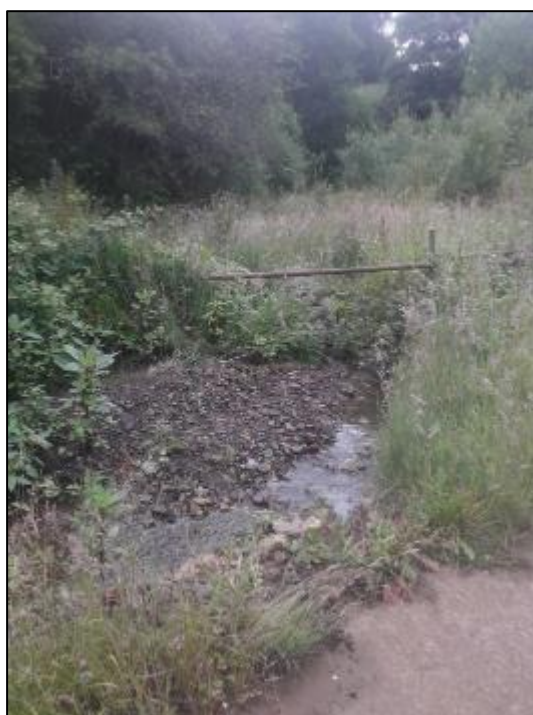
According to on-site officers, several sections of open watercourse upstream of the 'Abertonllwyd Street Culvert Network 1' (Figure 11) had significant build-up of debris within the channels, indicating significant mobilisation of debris occurred during the storm event (depicted in Figure 20). The conveyance of sediment, silt and stone downstream is considered to have contributed to the surcharging of 'Culvert Inlet 1' and 'Culvert Inlet 2' during Storm Dennis. This debris is also considered to have entered the culvert network, contributing to the surcharge of 'Manhole 1' during the event.

**Figure 20:** Image of debris accumulation within the unnamed ordinary watercourse channel upstream of 'Culvert Inlet 1' (Figure 4) (captured during CCTV operations on 30/06/2020)

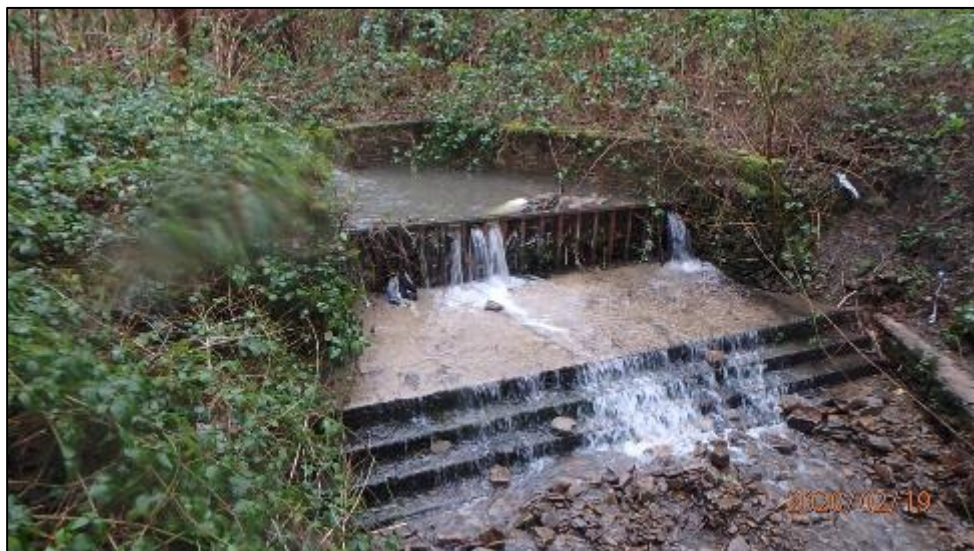
The upstream sections of the Nant Coedcaetylefforest ordinary watercourse (Area 1, Figure 21) showed evidence of debris deposition within the man-made channel, along with significant accumulation of material across the upper debris screens and headwall structure. Figure 22 and 23 depicts the material, which consists of coarse stone, silt and woody debris, within the upper channel. This material is assumed to have been mobilised from the upper reaches above the A4061 (Rhigos Road) and carried downstream by the high flows during Storm Dennis.

**Figure 22:** Photo of debris deposition behind the upper debris screen of the Nant Coedcaetylleforest ordinary watercourse (captured by RCT's Flood Risk Management team on 19/02/2020)

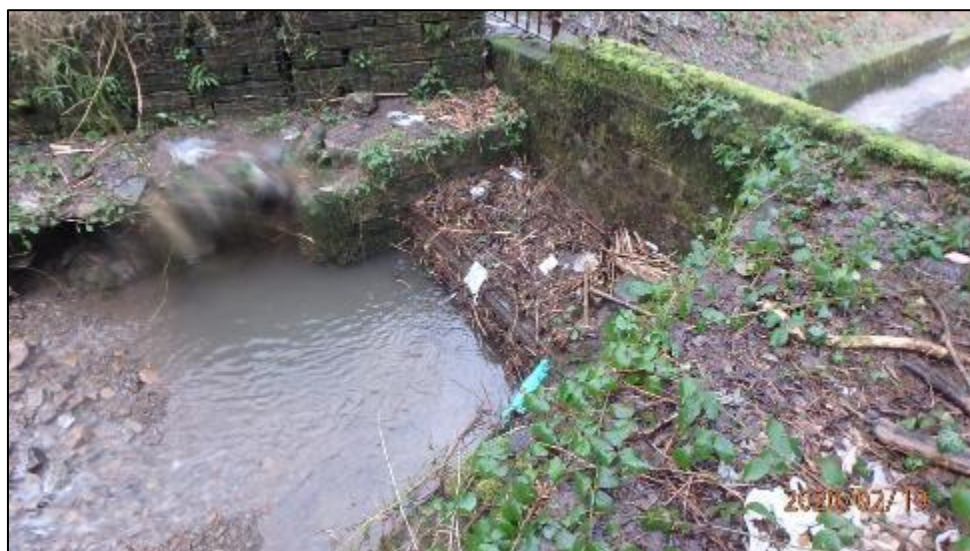
**Figure 23:** Photo of debris accumulation in the upper reaches of the Nant Coedcaetylleforest ordinary watercourse (below the A4061) (captured by RCT's Flood Risk Management team on 19/02/2020)

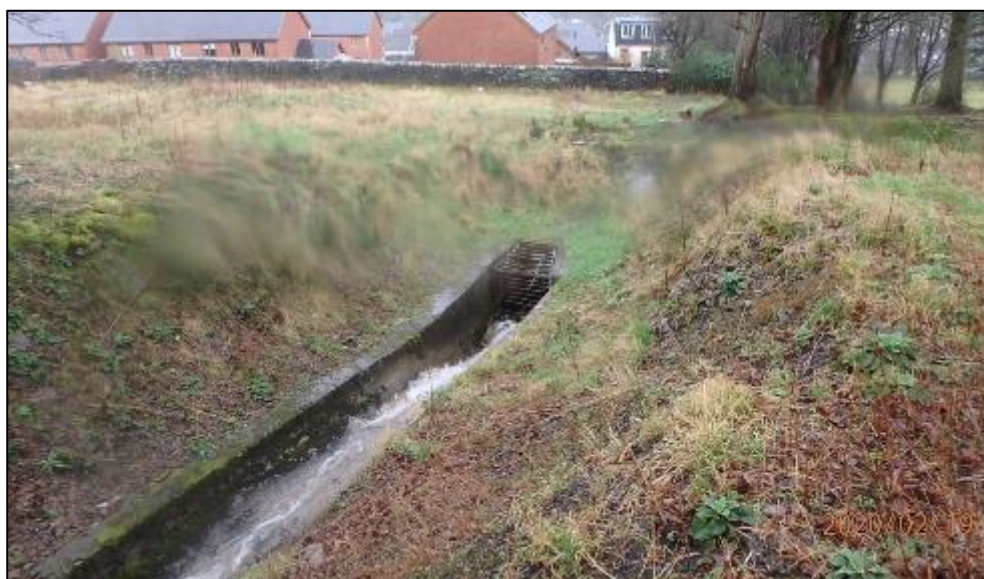
Below the headwall structure, the channel and culvert inlet (Area 2, Figure 21) did not show evidence of debris conveyance or blockage to the inlet, as shown in Figure 24. It is considered that the upstream debris screens at Area 1 succeeded in minimising the volume of debris travelling downstream.

**Figure 24:** Culvert inlet at Area 2 which conveys the Nant Coedcaetylleforest ordinary watercourse towards Area 3 (captured by RCT's Flood Risk Management team on 19/02/2020)
