**Section 19 Flood Investigation
Report**

**Storm Dennis –
Flood Investigation Area RCT12**

January 2022

Client	Director Frontline Services
Project	Flood and Water Management Act 2010, Section 19 Flood Investigation Report
Document Title	Storm Dennis – Flood Investigation Area RCT 12
Document Ref	FRM – S19 – 012
Project No	N/A

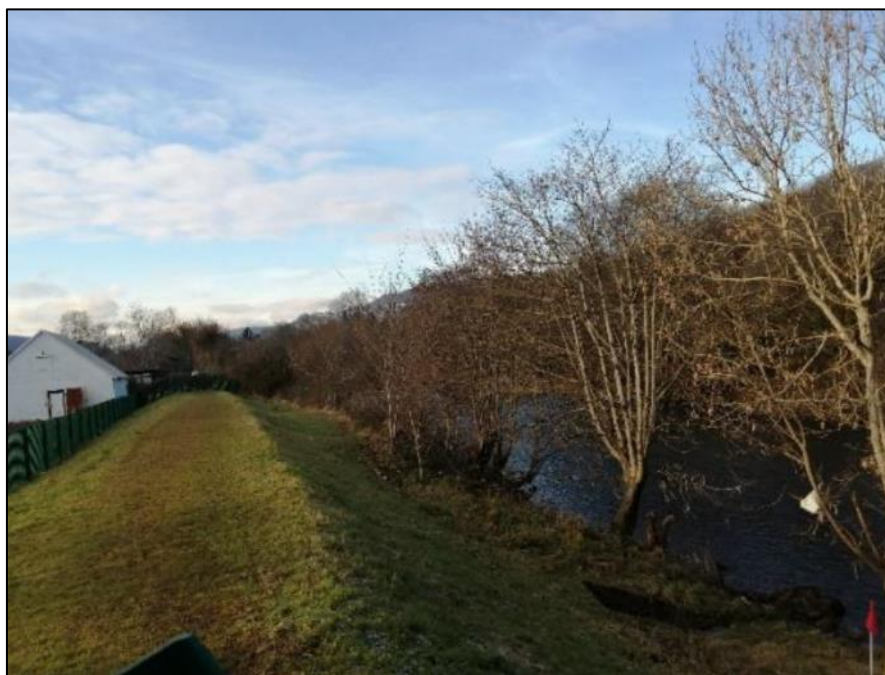
Figure 3: A view of the River Taf and southern riverbank, looking north-east (Redstart's Flood Investigation Report)

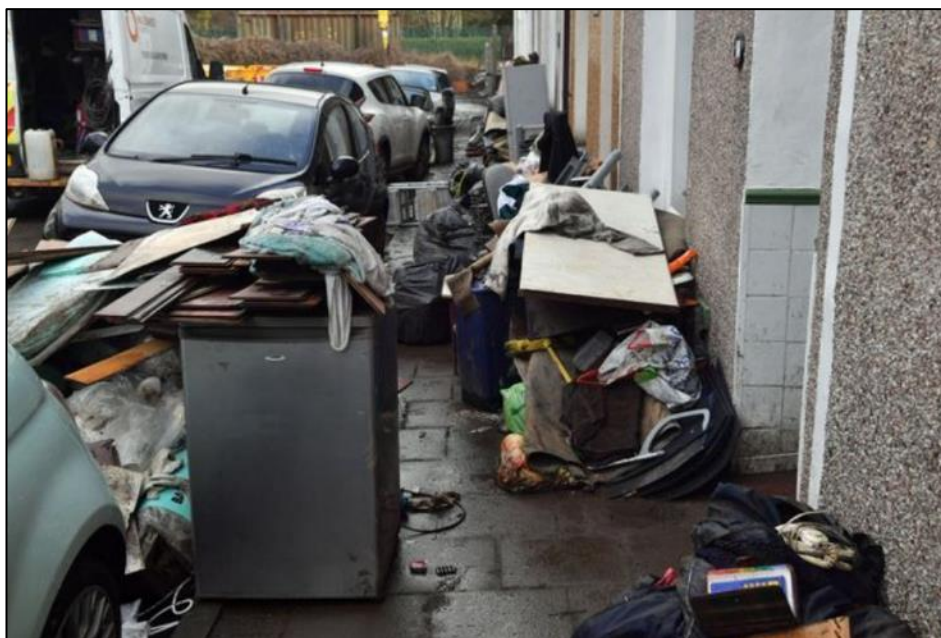
Significant flood depths of over 1.5 metres were reported by residents at Egypt, Niagara and Nile Streets, where at least 42 residential and 6 non-residential properties were internally impacted by the River Taf. Figure 4 depicts the damages caused to property at Treforest following the flood event.

Figure 4: Image capturing the damage to property and belongings at RCT12 following Storm Dennis
(Image: WalesOnline/Rob Browne)

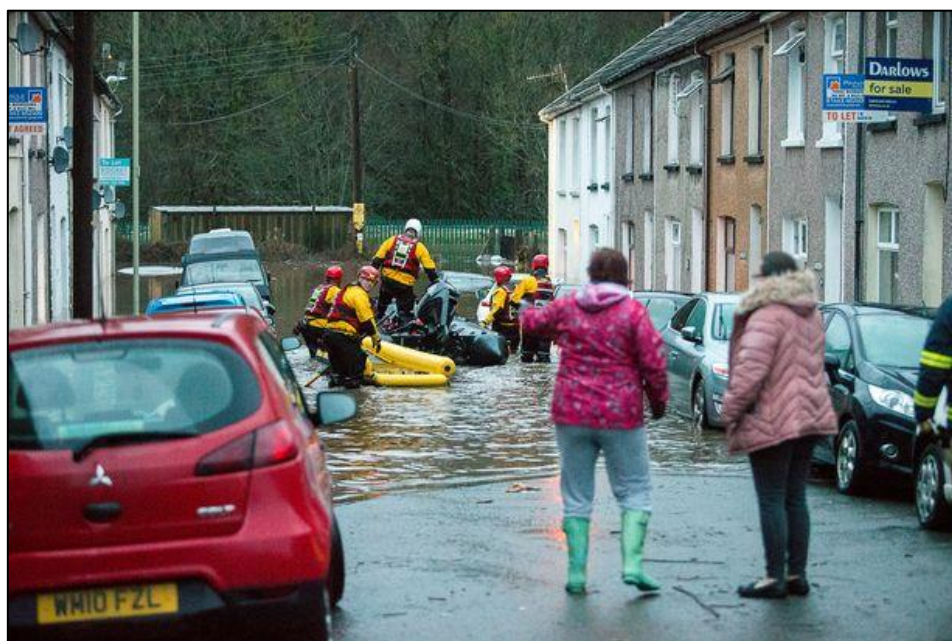
Emergency rescue efforts by the Fire Service were in operation following the overtopping of the River Taf on the 16th February 2020 to evacuate residents from their homes (Figure 5).

Figure 5: Image capturing South Wales Fire and Rescue Service undertaking evacuations within Egypt Street on 16th February 2020, (Image: Huw Evans Picture Agency Ltd)

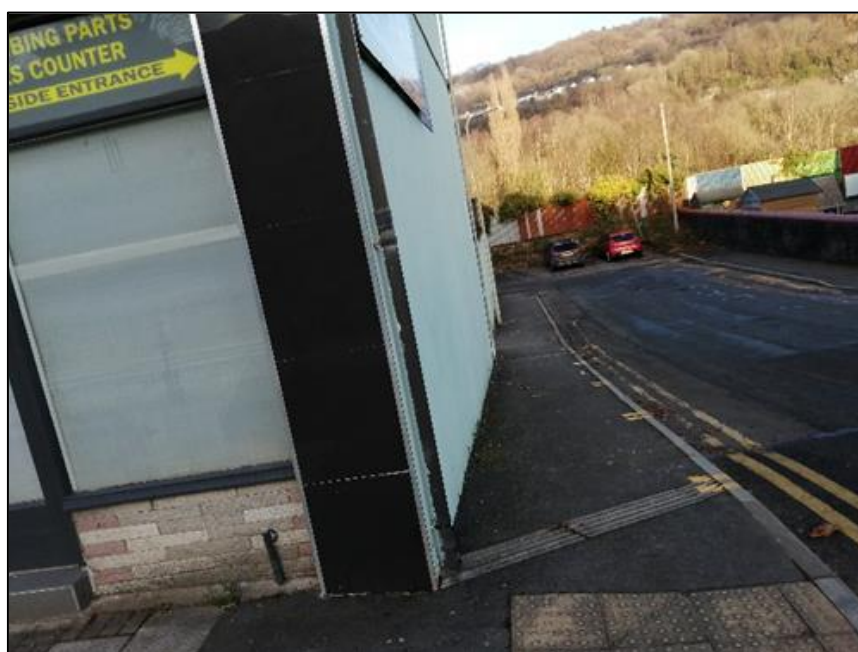
Surface water was also identified as a primary source of flooding at an end of terrace property on Broadway (B4595), whereby pluvial flows from the highway network accumulated on the access road west of Parc Lewis Primary School (Nile Road), depicted in Figure 6, due to local topography.

Figure 6: A view of Nile Road from Broadway. (Redstart's Flood Investigation Report)

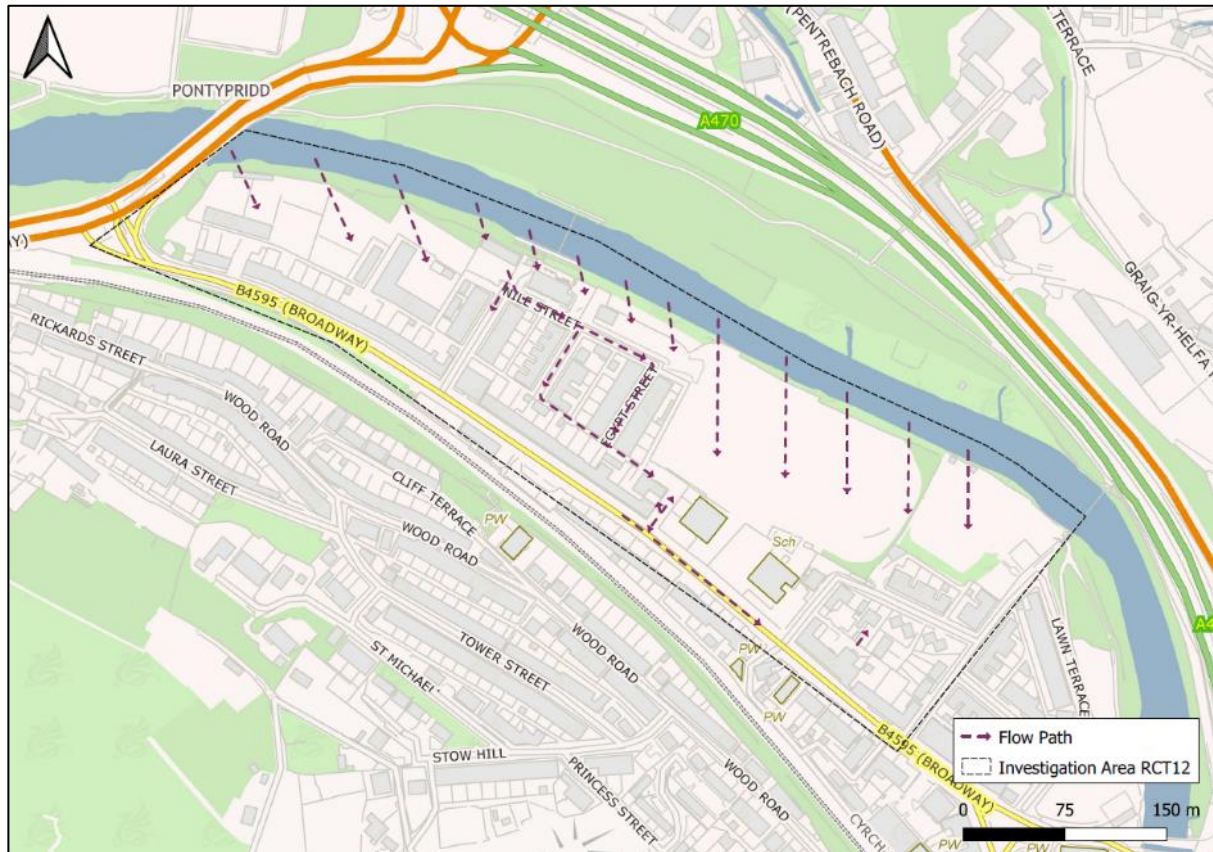
During the early hours of Sunday 16th February, RCT received several calls from residents at Treforest reporting the overtopping of the River Taf which was causing water ingress into properties. The primary flow paths observed during the event saw fluvial flood water convey beyond the western riverbank of the River Taf (Figure 3) and onto Nile Street, following local topography. Flood water subsequently flowed onto Egypt Street and Niagara Street before subsiding at the rear of Broadway (B4595) (illustrated in Figure 7).

The observed flow pathways that resulted in the internal flooding of properties within the investigation area are illustrated in Figure 7.

Figure 7: Observed flow paths that caused internal flooding within RCT12 during Storm Dennis

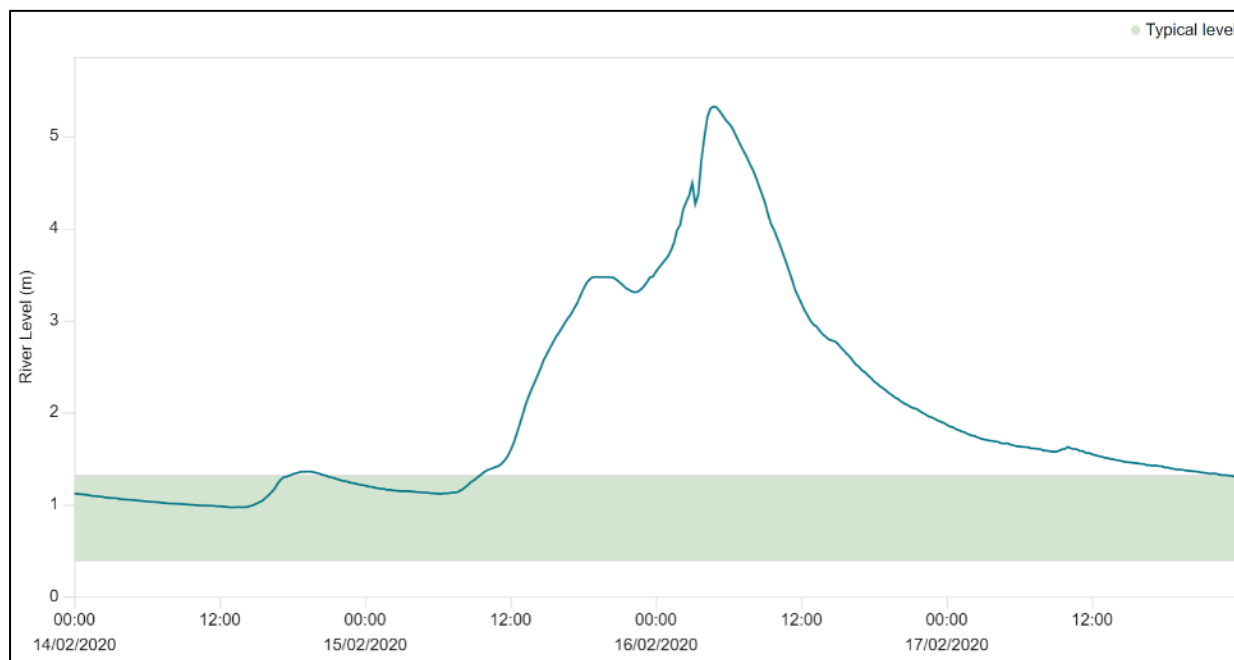
The green bar displayed on the hydrograph shows the typical level of the River Taf at the Pontypridd station, ranging between 0.4 and 1.3 metres. The river level was above this green line for over 48 hours, highlighting the severity of the storm event and its unprecedented nature. At its peak, the River Taf at Pontypridd was almost four meters higher than its average level.

Figure 8: The River Taf levels at Pontypridd station between the 14th and 17th February 2020 (Natural Resources Wales)

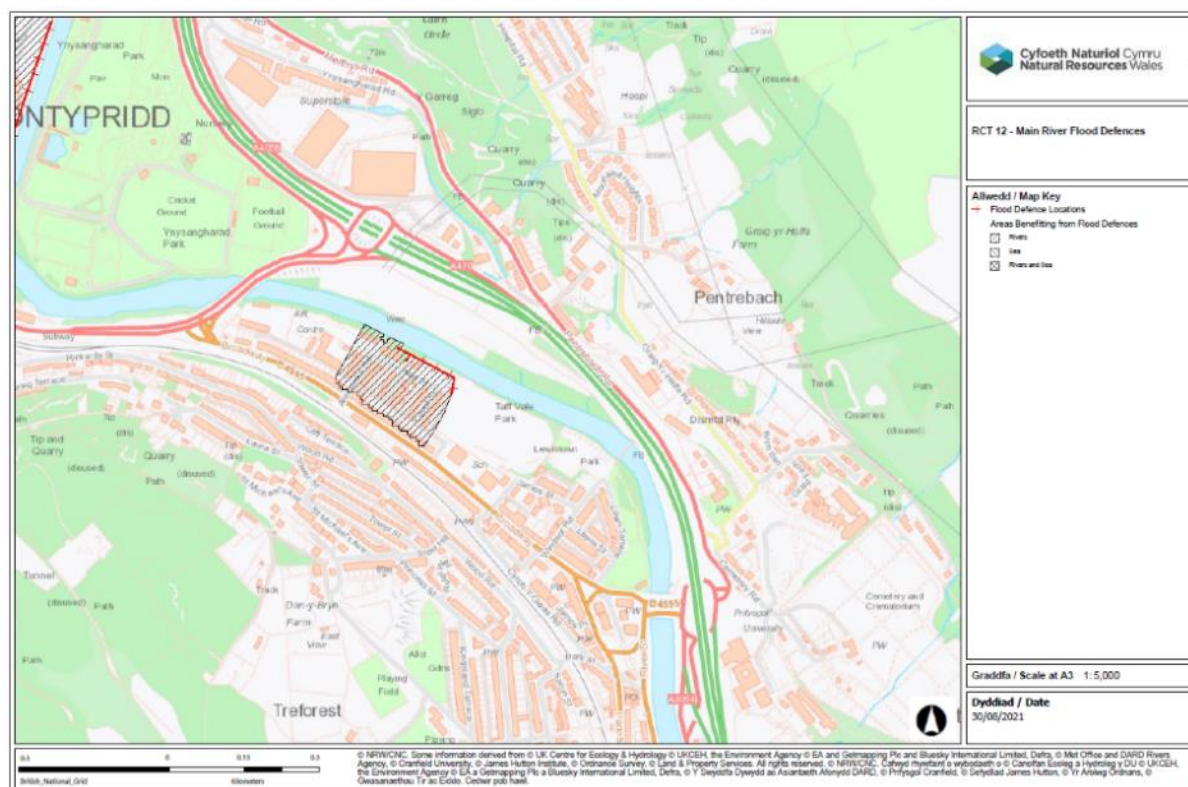
As illustrated in Figure 11 (demarcated by a bold red line), there are approximately 150 metres of formally designated flood defence infrastructure along the western bank of the River Taf at RCT12. This infrastructure is operated and maintained by NRW.

According to NRW, this infrastructure provides a standard of protection up to 1 in 75 annual probability flood event (Q75) to several properties within the investigation area (black hatched area in Figure 11), including properties at Alexandra Road, Nile Street, Egypt Street and Niagara Street.

Figure 11: Natural Resources Wales’ map for Main River Flood Defences and areas benefiting at RCT12. Contains Natural Resources Wales information © Natural Resources Wales and database right. All rights reserved

The current indicative design standard of protection for flood defences on a main river is 1 in 100 annual probability (Q100) flood event plus, for new defences, an allowance for climate change. This is stated within the Welsh Government’s National Strategy for Flood and Coastal Erosion Risk Management which encourages main river flood alleviation schemes to provide a Standard of Protection (SOP) up to Q100⁵. It is thereby inferred that the current SOP of flood defence infrastructure at RCT12 is below current indicative standards.

Whilst the flood defences identified at RCT12 are below the current indicative standard, the unprecedented rise of river levels in the Taf during Storm Dennis resulted in the overtopping of assets up to Q100 SOP. NRW’s ‘Flood Incidence Response Review’⁴ does in fact outline that no flood defences failed in the lower Taf region and that the flooding was the result of river flows exceeding the construction design standard.

R1B	<p>NRW to investigate the standard of protection provided by flood defences at RCT12 and “consider improvements to NRW flood alleviation schemes and structures on a prioritised basis”. Aligns with recommendation ‘Action FD3’ within NRW’s Flood Incident Management Review.</p>
					R1C	<p>NRW to review its flood warning service provision, especially for extreme events. This will form part of NRW’s Flood Warning Service Review Implementation Programme and aligns with the recommendations set out in their ‘Flood Incidence Management Review’.</p>
2	Surface water drainage network across RCT12	Rhondda Cynon Taf CBC Highway Authority	Surface Water	Highway Authority and Lead Local Flood Authority	R2A	<p>The Highways Authority to jet and cleanse the highway drainage network and action repairs accordingly.</p>

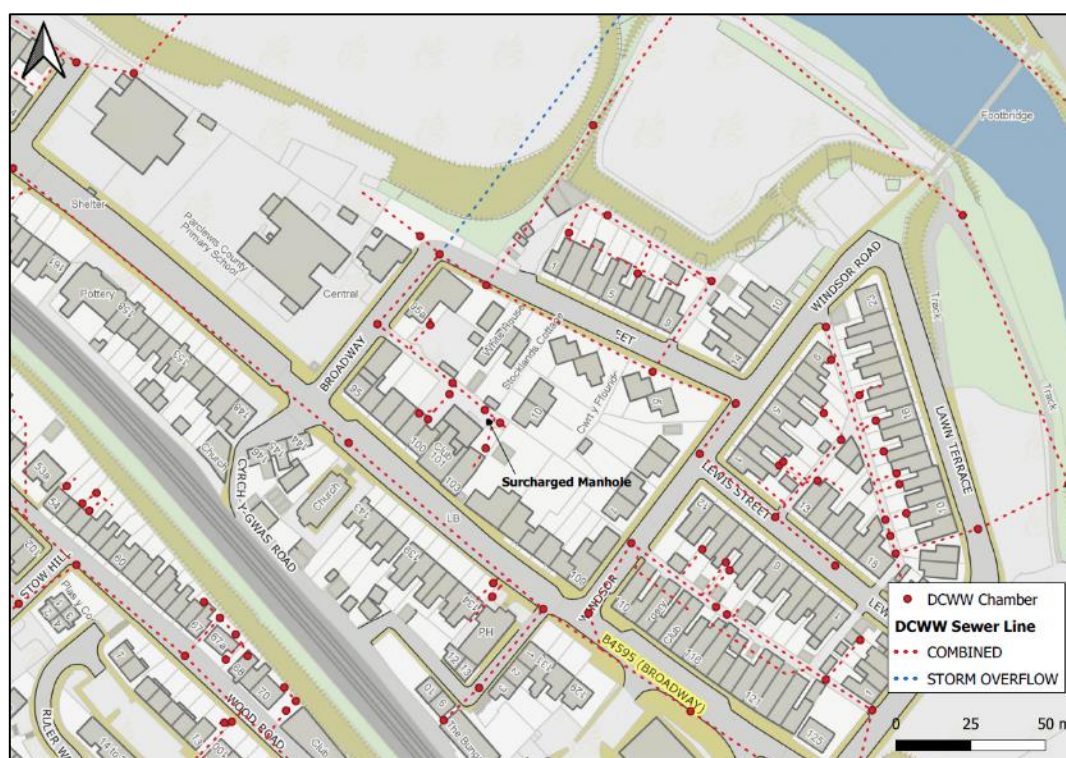
In addition to the highway drainage infrastructure within RCT12, the overtopping of the River Taf and the intensity of rainfall during Storm Dennis is considered to have overwhelmed parts of DCWW's combined drainage infrastructure during the storm event. This is evidenced by the surcharging of a DCWW combined sewer manhole on James Street (illustrated in Figure 12), resulting in the internal flooding of a nearby residential property which is also situated at a localised low point.

Figure 12: Location of surcharging manhole on DCWW's Combined Sewer network

Furthermore, reports from properties on Niagara Street during the flood event also refer to being impacted by sewage. Surcharging from the combined sewer network in this area may have occurred during the storm event, however, this cannot be confirmed due to the dominant impact of fluvial flooding sourced by the River Taf during the event. The unprecedented height of main river levels within the River Taf may have also impacted the ability of DCWW's infrastructure to manage the discharge of water during the storm event.

As outlined in 'FRM – Storm Dennis – Overview Report'², DCWW sewers have a current design standard of Q30, as per the 'Sewers for Adoption 7th Edition'⁶ guidance document. Given that the design standard was markedly exceeded during Storm Dennis, the maintenance condition of DCWW apparatus is not considered to have significantly impacted the flooding experienced.

R2B	The LLFA and Highway Authority to evaluate surface water management options to alleviate pluvial flooding at locations across the investigation area.
3	DCWW combined sewer and associated manhole	DCWW	Sewer	DCWW	R3A	DCWW to evaluate the standard of service and the condition of the combined sewer network servicing RCT12.

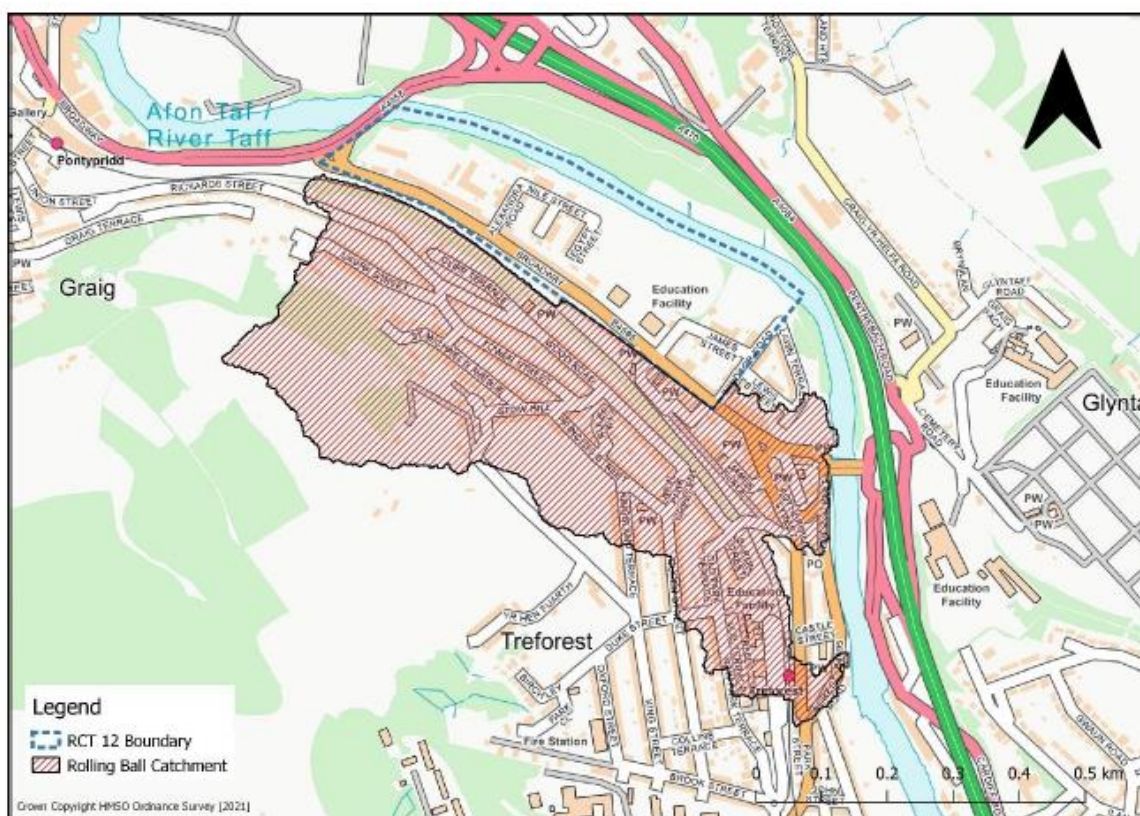
Figure 13: Topographic Watershed above RCT12

Figure 13 shows that surface water runoff originating from the hillsides to the south and southwest of Treforest are separated from the investigation area by the railway embankment running alongside Broadway. This suggests that whilst overland flows may have contributed to the pluvial flooding that occurred at Broadway, it is considered that surface water flooding within RCT12 was predominantly localised and not a consequence of the dominant valley gradient.
