Section 19 Flood Investigation Report

Storm Dennis –
Flood Investigation Area RCT14

January 2022

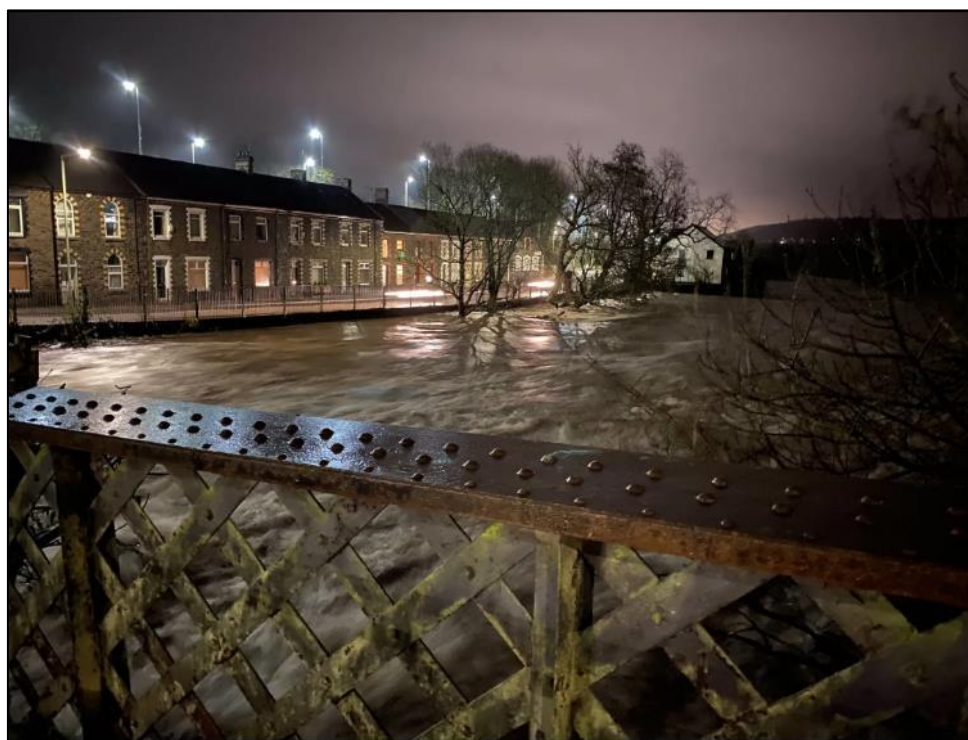
The primary source of internal flooding within the sub-catchment was the overtopping of the River Taf during the early hours of Sunday 16th February. Figure 4 depicts the swollen River Taf flowing rapidly through Treforest prior to its overtopping.

Figure 4: A downstream view of the River Taf at Castle Inn Bridge, Cardiff Road prior to its overtopping during Storm Dennis (Image: Storm Dennis, pontypriddtowncouncil.gov.uk)

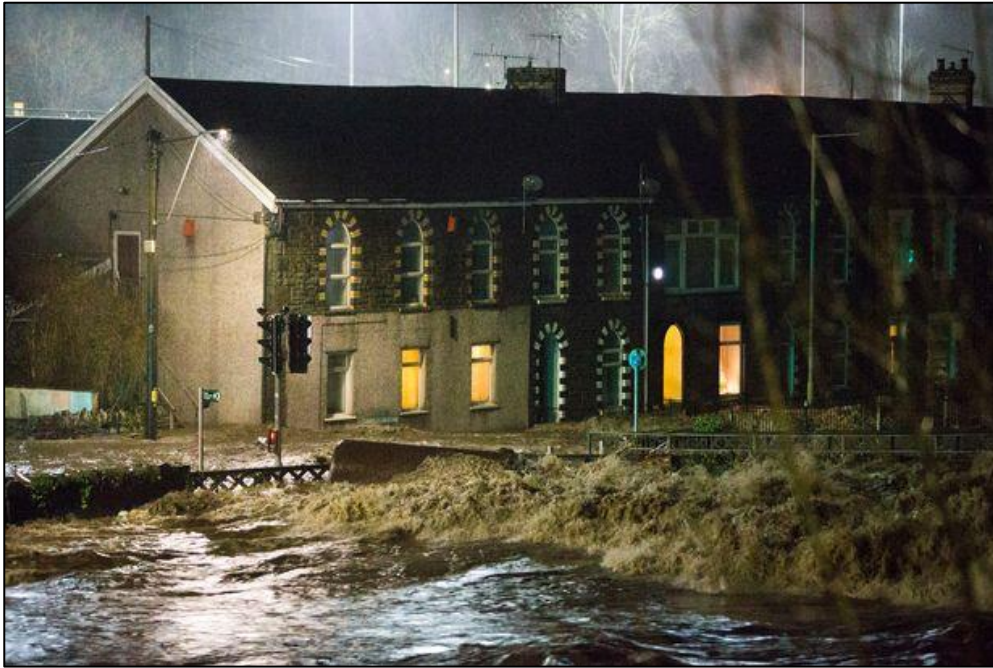
The primary flow pathway was the conveyance of fluvial flood water over the main river’s eastern embankment and onto the A4054 (Cardiff Road) at multiple locations near the Castle Inn Bridge footbridge. Figure 5 illustrates the rapid onset of flooding from the River Taf at Cardiff Road once it had overtopped.

Figure 5: Photo of the rapid onset of flooding from the River Taf at Cardiff Road during Storm Dennis
(Image: Wales Online)

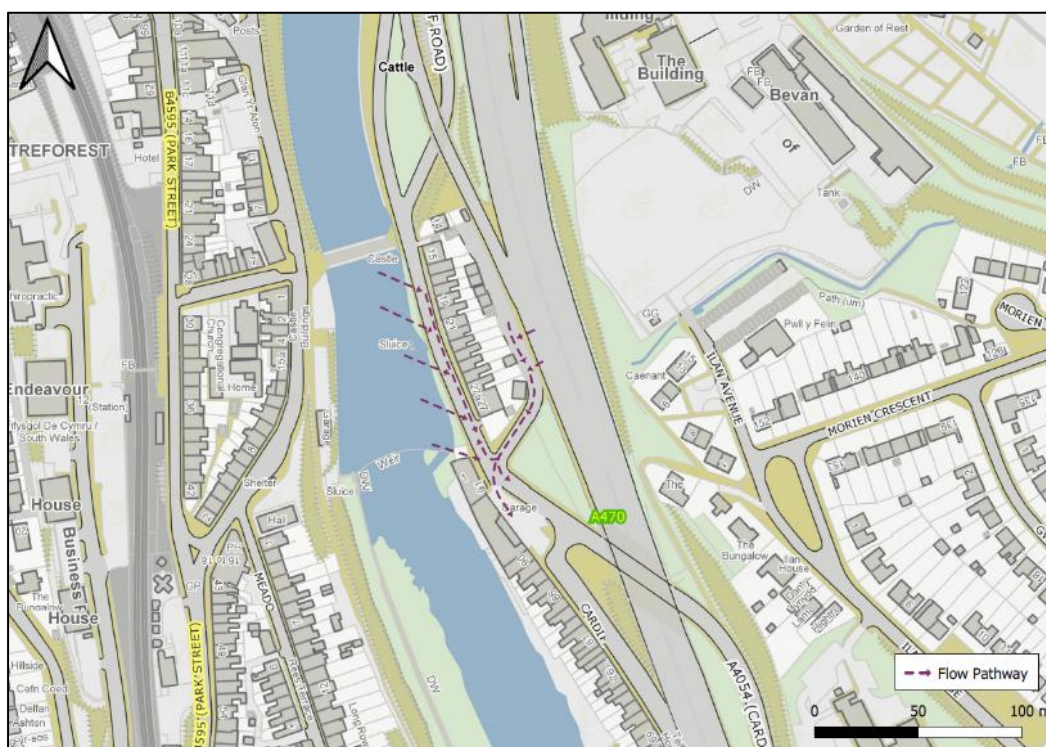
A total of 17 residential and 2 non-residential properties were internally flooded within Glyn-taf Rhydyfelin North during Storm Dennis. All flooded properties were located adjacent to the River Taf along Cardiff Road, highlighting the significant impact of the main river overtopping and the subsequent flooding that occurred in the area.

Figure 6: Flow Pathways that caused internal flooding within Glyn-taf Rhydyfelin North sub-catchment

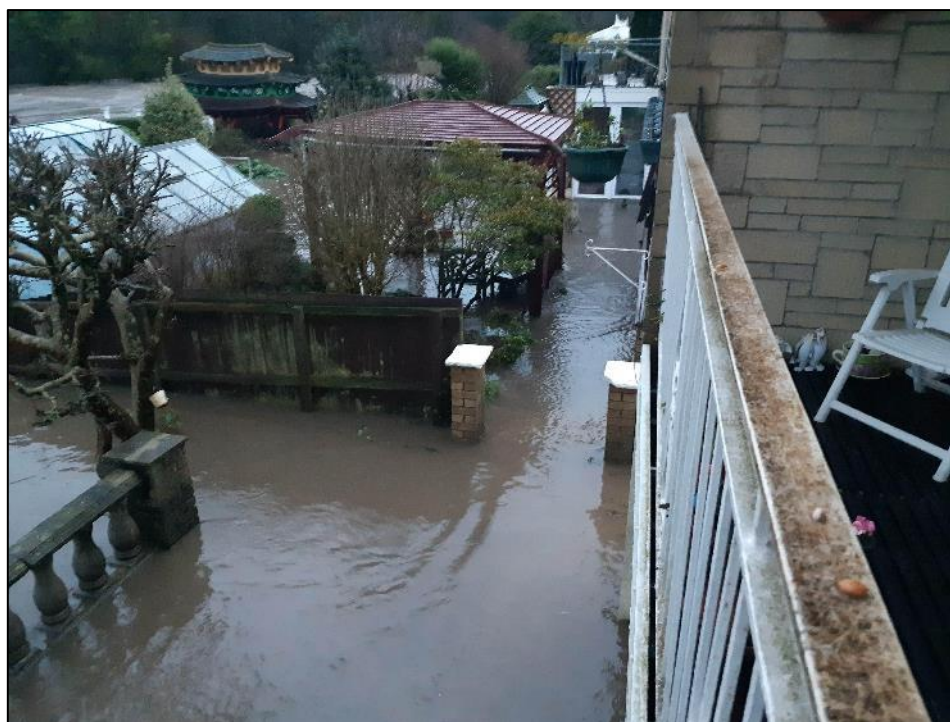
Alike Glyn-taf Rhydyfelin North, the primary source of flooding within the sub-catchment was the overtopping of the River Taf. The primary flow pathway saw flood water convey beyond the eastern riverbank onto De Barri Street and into the rear of properties on Nant Y Dall Avenue, with flood water reaching approximately 1.8 metres in some areas (Figure 7).

Figure 7: Image showing main river flooding to the south of Nant-y-Dall Avenue during Storm Dennis (image provided by resident)

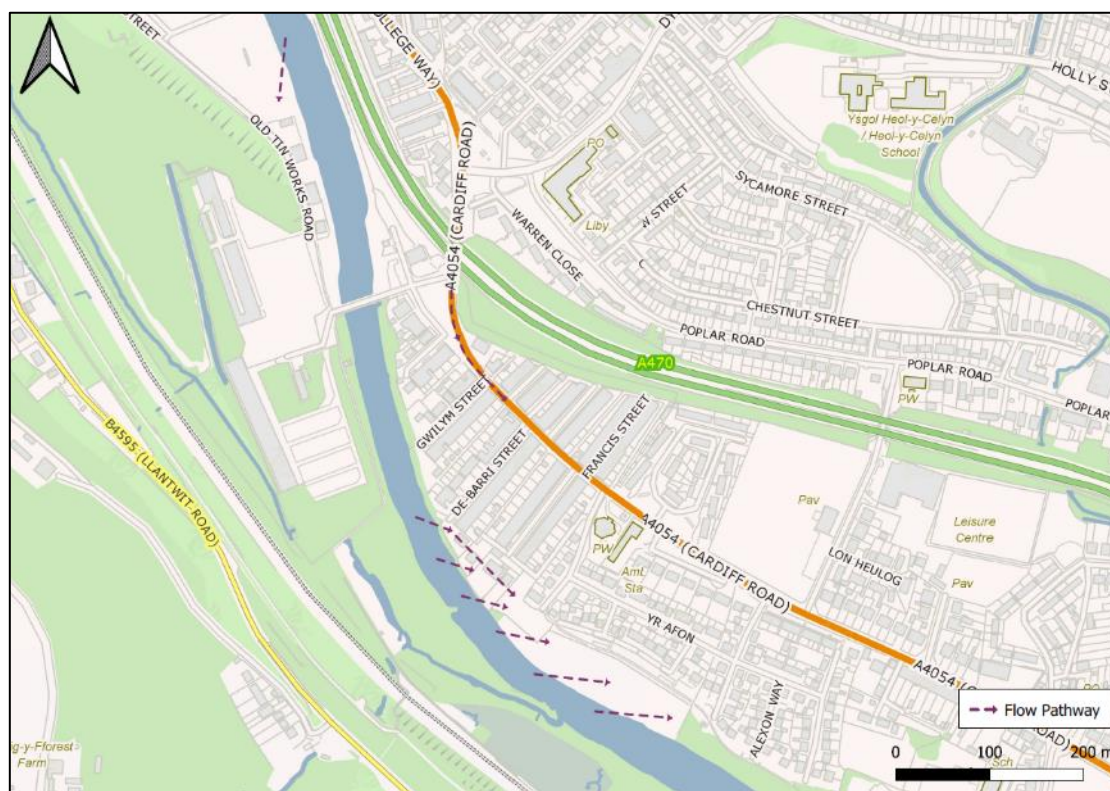
Of the six properties within Glyn-taf Rhydyfelin South that were internally flooded, four were as a result of the River Taf overtopping its banks. The remaining two residential properties that reported internal flooding, one on Owen Street and one on Alexon Way, were flooded by surface water. The pathways of observed flooding within 'Glyn-taf Rhydyfelin South' sub-catchment have been depicted in Figure 8 below.

Owen Street is approximately 130 metres away from the River Taf and, whilst it is possible that fluvial flood water conveyed along the rear of De-Barri Street and into Owen Street, this is unlikely due to the lack of evidence and limited reports of flooding along the conveyance route. Surface water is believed to have accumulated on both Owen Street and Cardiff Road, resulting in the internal flooding of an end-of-terrace property on Owen Street.

The localised accumulation of surface water is believed to have been responsible for the internal flooding of a residential property on Alexon Way. Resident reports during the storm event suggest that the River Taf did overtop its banks south of Ymyl yr Afon (Figure 8); however, evidence suggests that fluvial flows did not convey a large enough distance to internally flood any nearby properties.

Figure 8: Flow pathways that caused flooding within Glyn-taf Rhydyfelin South

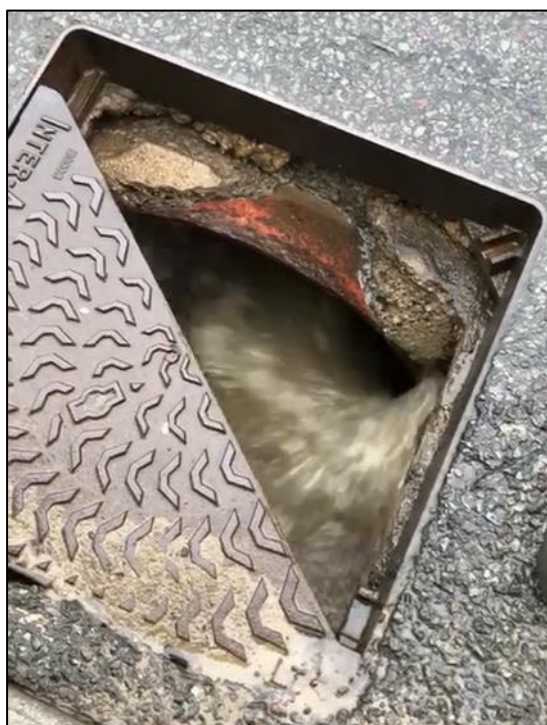
Site inspections undertaken by RCT's Flood Risk Management team during Storm Jorge (February 28th to March 1st) identified a manhole adjacent to the affected properties on Cardiff Road (labelled 'Manhole 1' in Figure 9) surcharging. This resulted in repeat surface water flooding to the external extents of several properties at Cardiff Road.

The surcharging of 'Manhole 1' approximately two weeks after Storm Dennis has been attributed to the raised river levels within the River Taf which prevented water from outfalling from the culverted network and into the River Taf. Figure 10, taken during RCT's site inspection following the receding of flood water, shows 'Manhole 1' surcharging within the chamber.

Figure 10: Photo of 'Manhole 1' surcharging during Storm Jorge (captured by RCT's Flood Risk Management team on 28th February 2020)

Following the observations made at 'Manhole 1' during Storm Jorje, it is considered that the downstream culvert network may have contributed to surface water flooding on Cardiff Road during Storm Dennis; however, the overtopping of the River Taf has been determined as the primary cause of flooding to properties at Cardiff Road in the northern sub-catchment during Storm Dennis.

R3B	The LLFA and LDA to investigate the standard of protection and the condition of the culvert structure and network as a whole.
					R3C	The LLFA to jet and cleanse the ordinary watercourse culvert network.

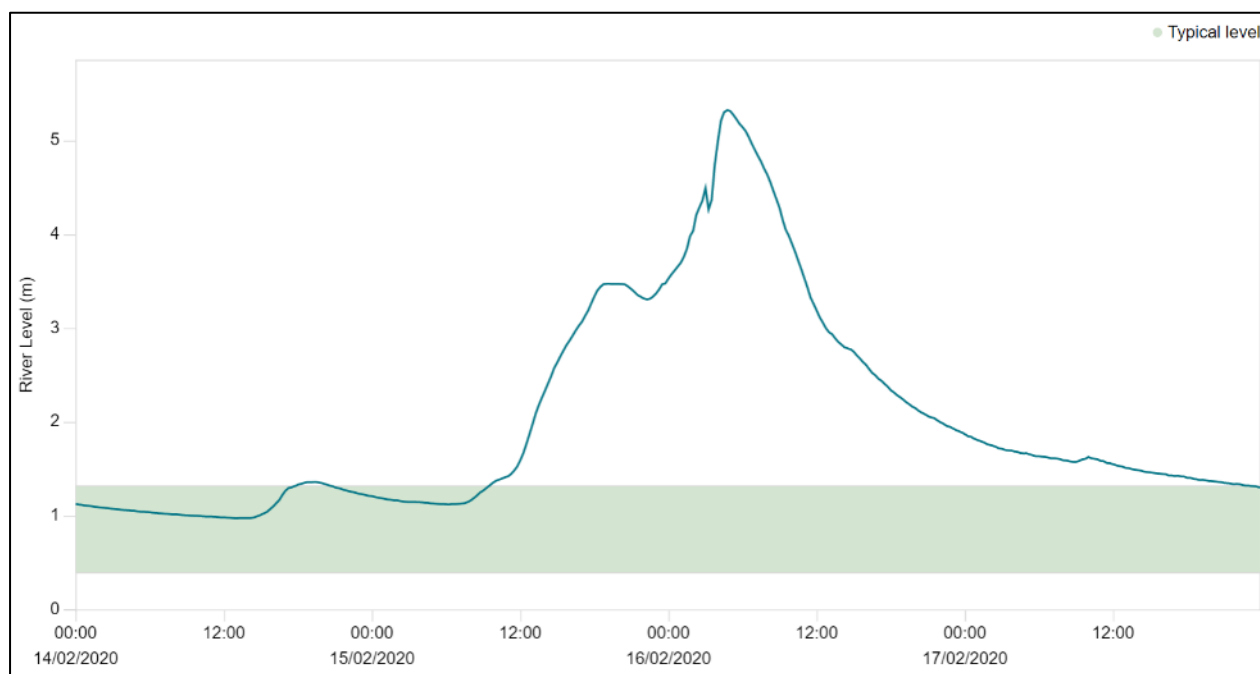
The hydrograph in Figure 12 illustrates the significant rise in the River Taf's levels in response to rainfall between the 14 – 17th February 2020. River level data was captured at NRW's Pontypridd river level gauge, located approximately 750m north-west of the northern boundary of the investigation area.

NRW issued a 'Flood Alert' (indicating possible flooding) for the entirety of the River Taf at approximately 13:30 on the 15th of February; at which point the main river was over 2 metres in depth and continuing to rise at Pontypridd station. At approximately midnight on the 16th February the River Taf began to rise again, reaching a peak river level of 5.32 metres at 04:45 on the 16th of February; the highest level recorded for the River Taf at Pontypridd since 1970.

Figure 12: The River Taf levels at Pontypridd station between the 14th and 17th February 2020 (Natural Resources Wales)

The green bar displayed on the hydrograph shows the typical level of the River Taf at the Pontypridd station, ranging between 0.4 and 1.3 metres. The river level was above this green line for over 48 hours, highlighting the severity of the storm event and its unprecedented nature. At its peak, the River Taf at Pontypridd was almost four meters higher than its average level.

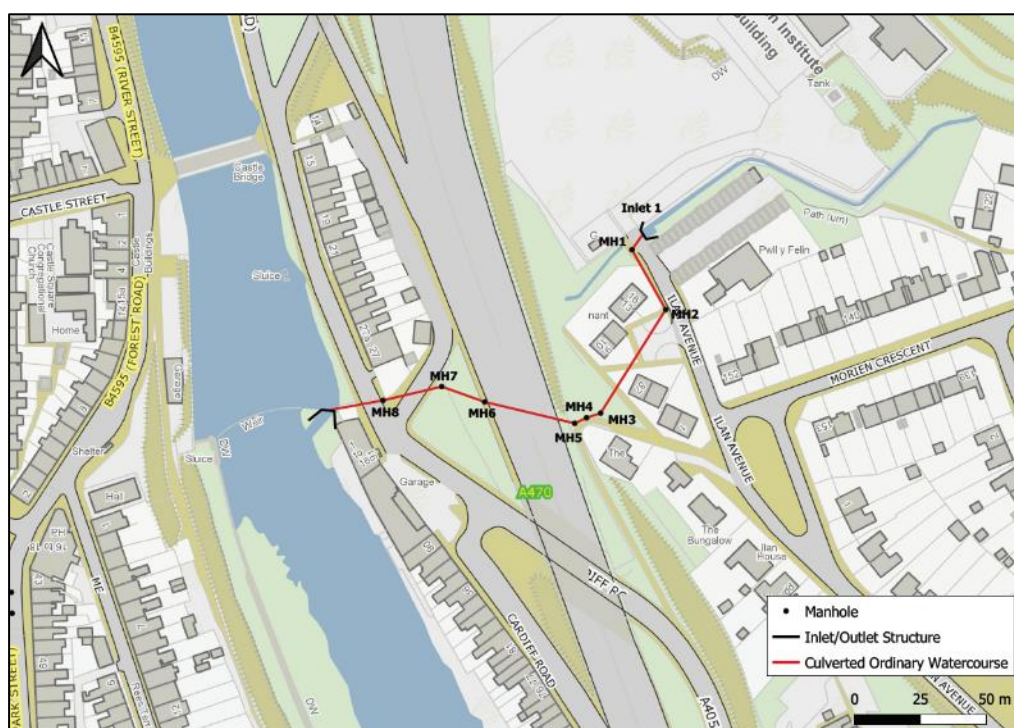
Figure 18: Ilan Avenue culverted ordinary watercourse network with annotated Manhole labels

Whilst the overtopping of the River Taf has been determined as the primary cause of flooding to the majority of properties within RCT14, the capacity of the ‘Ilan Avenue’ culvert network (illustrated in Figure 18) has also been assessed to ascertain its current standard of protection following the observed surcharging of a manhole at Cardiff Road following Storm Dennis (Figure 10).

The assessment infers that the upstream section of the network, at the culvert inlet adjacent to Ilan Avenue, has adequate hydraulic capacity to accommodate storm events up to Q200 in free-flowing conditions. This is significantly reduced to Q2 in blockage conditions however, no blockage to the upstream inlets was observed during Storm Dennis.

The capacity of the Ilan Avenue downstream network (which conveys flows beneath the A470 and Cardiff Road) was assessed as having a SOP below current design standards for new culverts as defined by CIRIA C789. This is further reduced to Q2 in blockage conditions.
