Section 19 Flood Investigation Report

Storm Dennis –
Flood Investigation Area RCT01
(Hirwaun)

January 2022

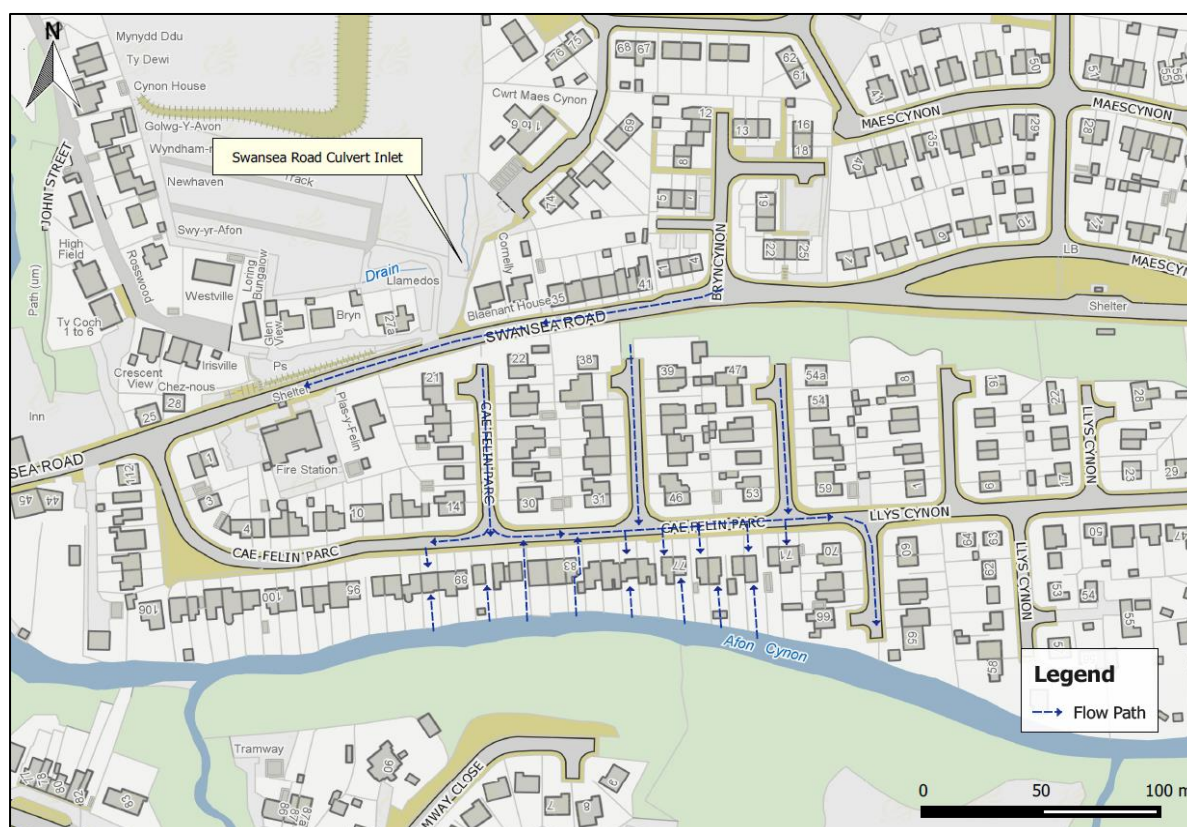
The associated flow paths observed during Storm Dennis at Cae Felin Parc and Swansea Road are illustrated in Figure 3.

Figure 3: Observed flow paths at Cae Felin Parc and Swansea Road in Hirwaun during Storm Dennis

Reports of a suspected surcharged culvert inlet located at Swansea Road (labelled 'Swansea Road Culvert Inlet' in Figure 3) were also received by some residents, however following further engagement with RCT's Highways and Streetcare Depot and the Hirwaun Fire Station, it was confirmed that the inlet did not surcharge during Storm Dennis.

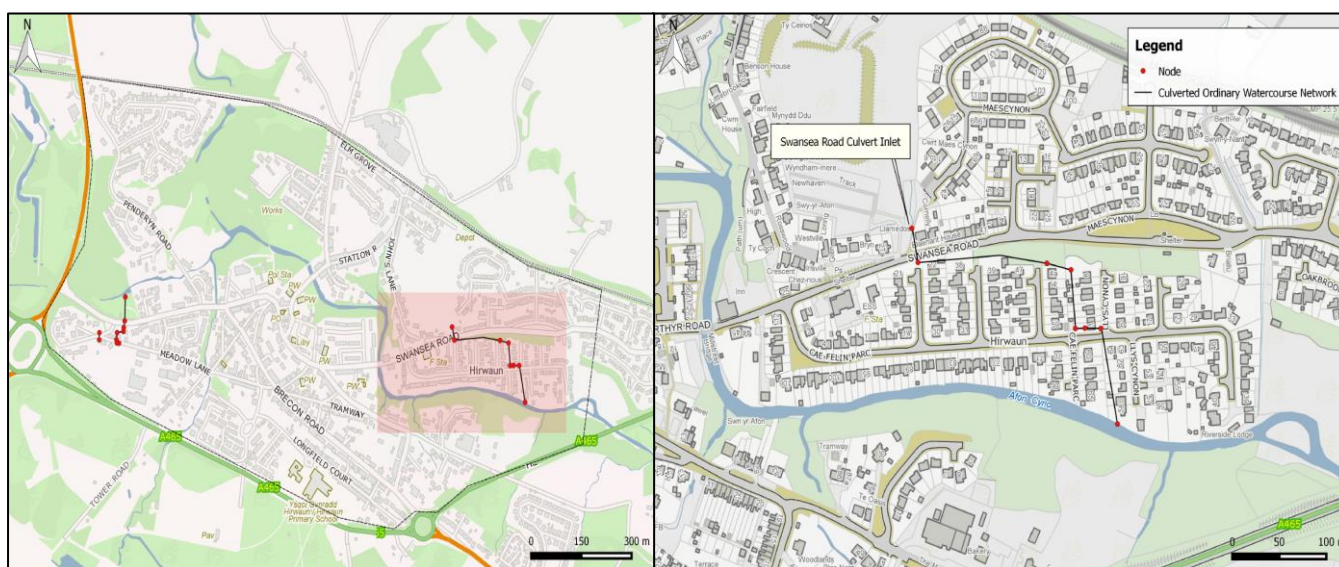
Figure 6: Swansea Road culverted watercourse network in investigation area RCT01

The condition of the Swansea Road culvert network was surveyed to be in poor condition, with multiple sections graded as 4-5 due to settled debris, fractures and

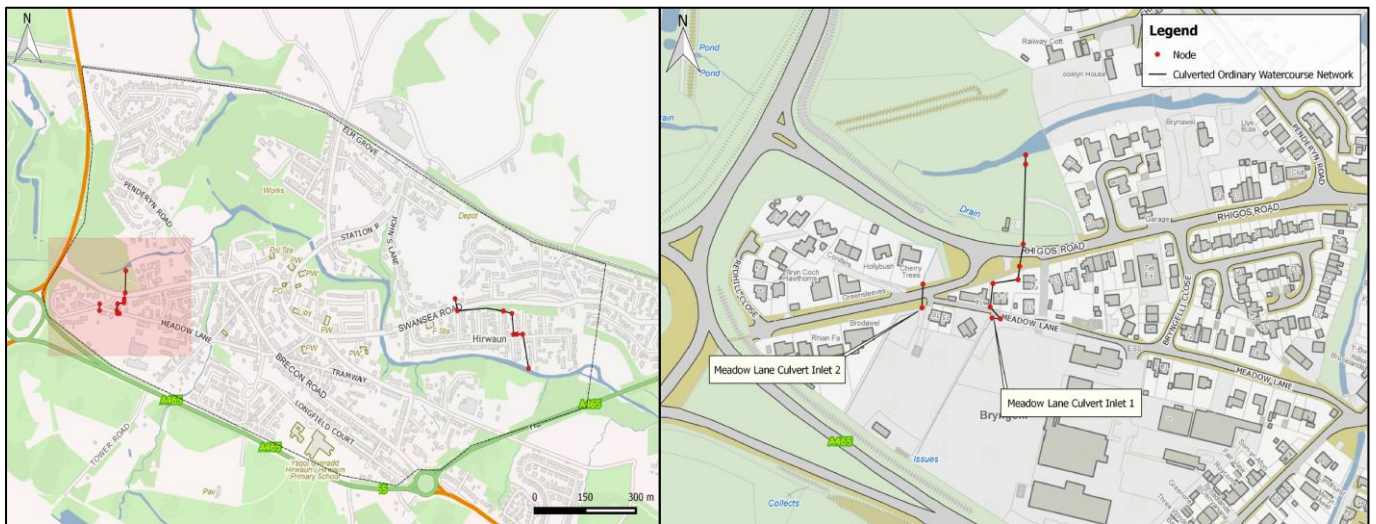
The Meadow Lane culvert networks and inlets under review are illustrated in Figure 8. Both culvert networks were surveyed to be in poor condition, with silt accumulation and obstacles reducing the networks' cross-sectional area. Despite its poor condition, 'Meadow Lane culvert inlet 1 and 2' was not identified as a source of flooding during Storm Dennis. Residents affected by flooding in this area confirmed that no flooding was observed from either inlet.

Figure 8: Meadow Lane culverted watercourse network in investigation area RCT01

In response to the settled debris identified within the culvert networks, several jetting and cleansing operations were undertaken by a Council appointed contractor to clear the debris from within the culvert networks. An estimated 205 tonnes of material was removed from the Swansea Road and Meadow Lane culvert networks during cleansing exercises.

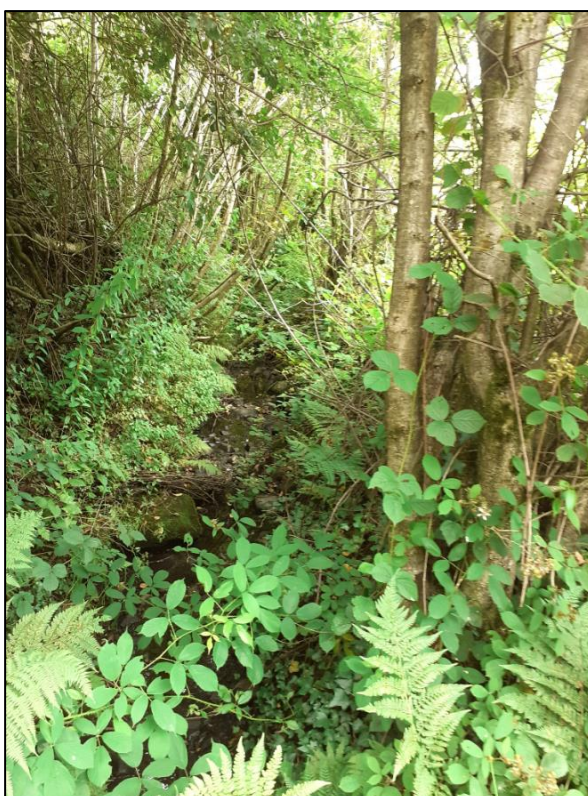
The hillside and associated watercourses were inspected to assess their condition for any evidence of scour or land movement of the hillside which would indicate potential overland flows had occurred. The assessment found no significant erosion of the channels, however both watercourses were mostly undefined and overgrown with dense vegetation which impacted the on-site assessment (Figure 11).

Figure 11: Undefined and overgrown ordinary watercourse channel above Meadow Lane Culvert Inlet 2 (image captured by RCT's Flood Risk Management team following Storm Dennis)

The intensity of rain falling on the already saturated catchment of Hirwaun during Storm Dennis is considered to have overwhelmed the unnamed watercourse below the A465 causing water to spill out of bank and flow overland towards the properties below.

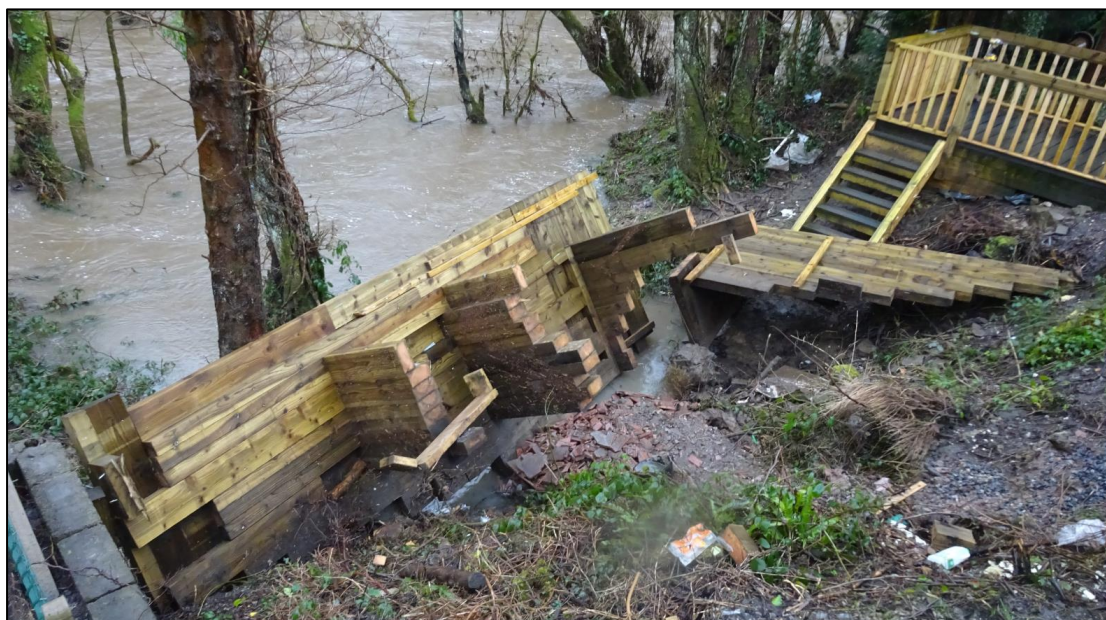
Elsewhere within the investigation area, and in addition to the flood damage at Cae Felin Parc, the River Cynon also impacted the rear of properties further upstream at Richmond Drive, to the north of investigation area RCT01, causing significant erosion of the banks in some locations. Figure 14 depicts an image of property damage caused by significant erosion of the riverbanks.

Figure 14: Damage to property caused by the River Cynon to the rear of Richmond Drive, Hirwaun on the 16th February 2020 (image captured by resident)
