Section 19 Flood Investigation Report

Storm Dennis –
Flood Investigation Area RCT16
(Upper Boat & Nantgarw)

January 2022

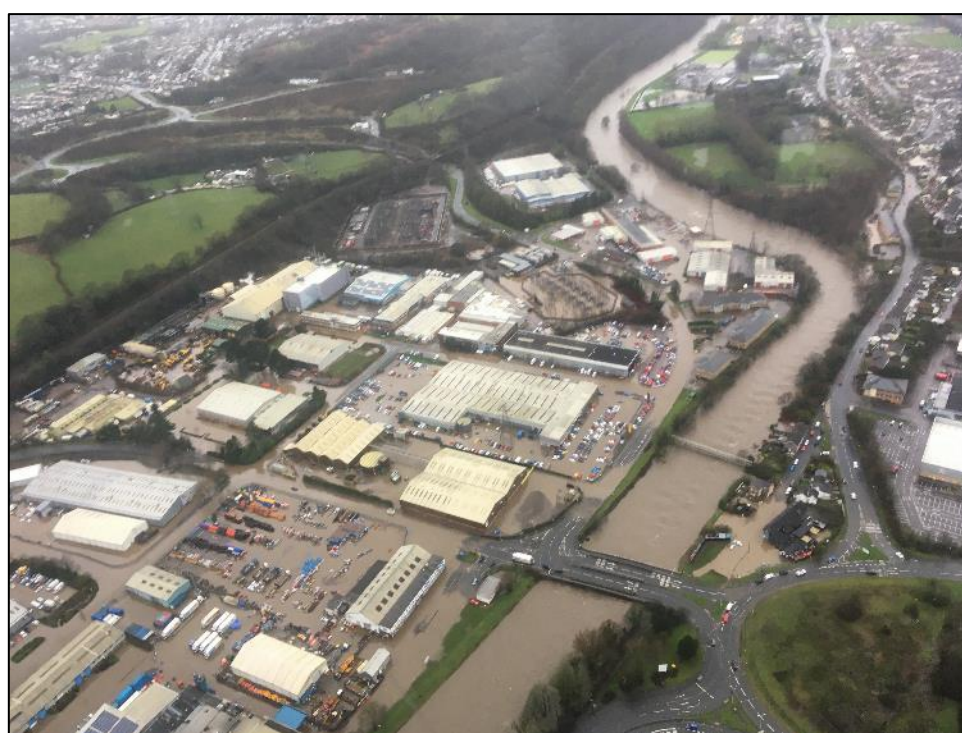
The flooding that occurred at Treforest Industrial Estate did not remain confined to areas adjacent to the main river channel, with commercial properties up to 450 metres inland from the River Taf reporting internal flooding. The main river overtopped both its eastern and western banks, resulting in internal flooding to the majority of commercial premises throughout the industrial estate. Figure 3 depicts an aerial view of the flooding at Treforest Industrial Estate and Upper Boat, to the north of RCT16.

Figure 3: Aerial view of Treforest Industrial Estate and Upper Boat following Storm Dennis (Image: National Police Air Service)

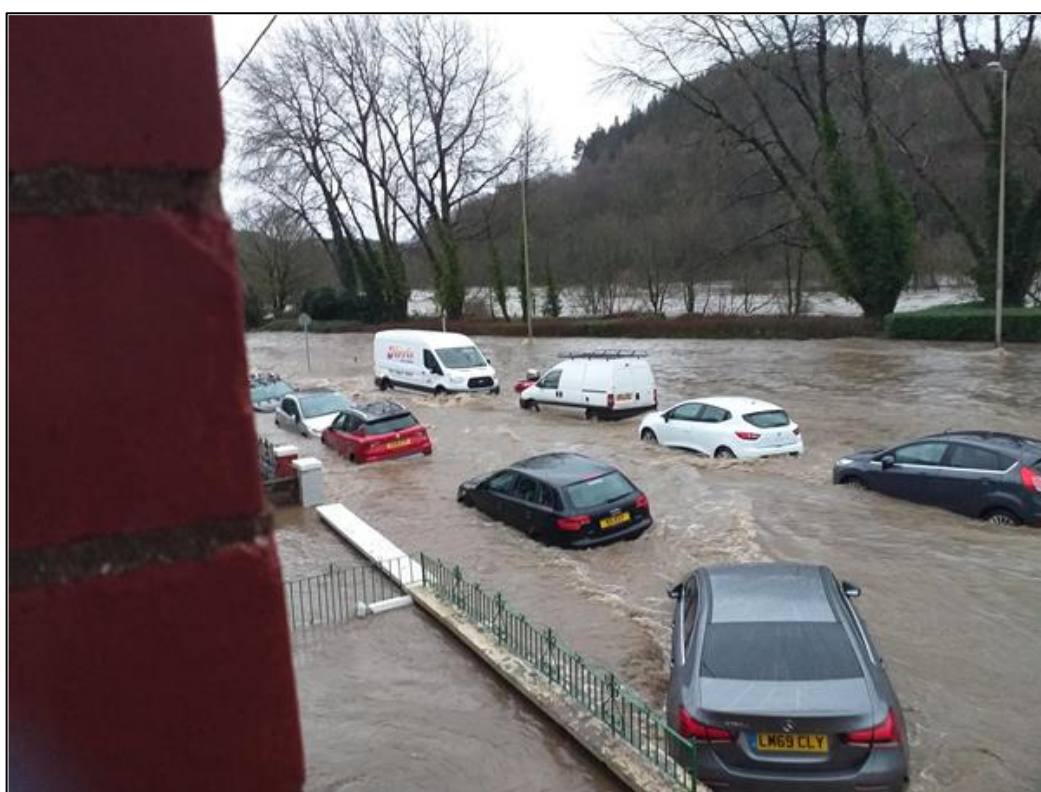
Accounts from residents at Oxford Street and Rhyd-Yr-Helyg note a significant amount of water conveyed along the highway network towards their properties during the storm event. This flow path is considered to have originated further upstream following the overtopping of the River Taf at Treforest Industrial Estate and Upper Boat, which then conveyed behind formal flood defences towards Oxford Street and Rhyd-yr-Helyg during the storm event. Photographic evidence provided by residents at Oxford Street show water flowing south along the highway, behind the eastern embankment, during the morning of Sunday 16th February 2020 (Figure 4).

Figure 4: Photo showing main river flooding along the A4054 Oxford Road during Storm Dennis (image provided by resident)

A total of 103 residential properties at Oxford Street and Rhyd-yr-Helyg were internally impacted by the River Taf, with residents reporting flood depths of over 1.8 meters.

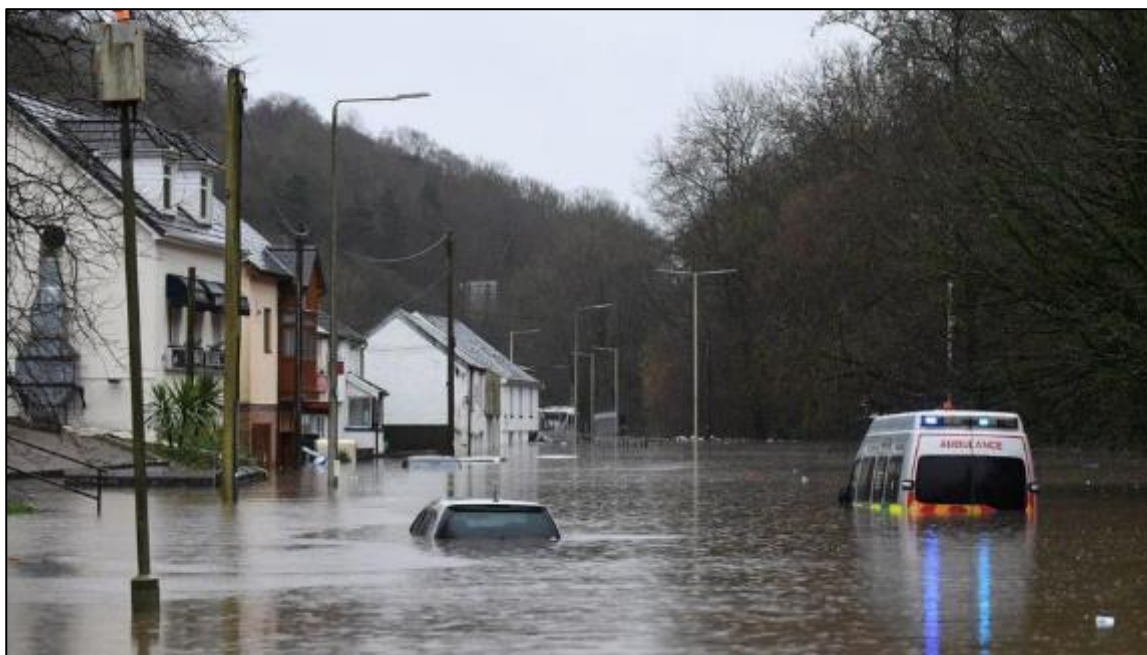
The impacts of flooding from the main river at Cardiff Road were exacerbated by the surcharging of the 'Cross Keys' culvert inlet (Figure 8) associated to the Nant Garw ordinary watercourse. Exceedance flows from the surcharged inlet conveyed onto Cardiff Road, contributing the flooding of properties in this area. Flood depths along Cardiff Road reportedly reached over a metre in depth, as depicted in Figures 5 and 6.

Figure 5: Image of the flooding on Cardiff Road near A4054/A468 roundabout during Storm Dennis, looking south. (Image: Tom Martin/Wales News Service)

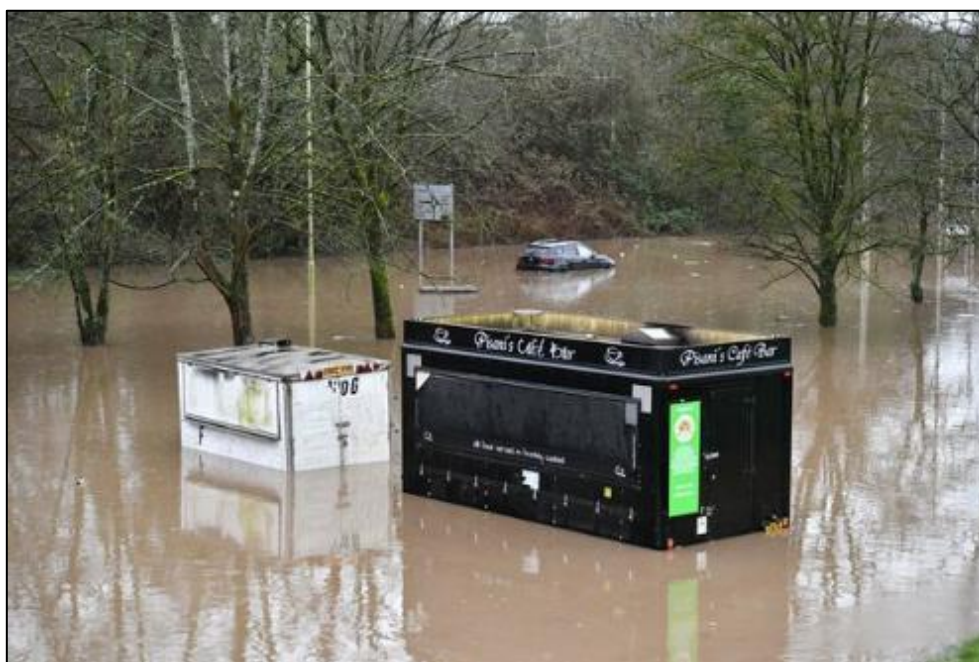
Figure 6: Image of the flooding on Cardiff Road near A4054/A468 roundabout during Storm Dennis, looking north. (Image: PA/Wales Online)

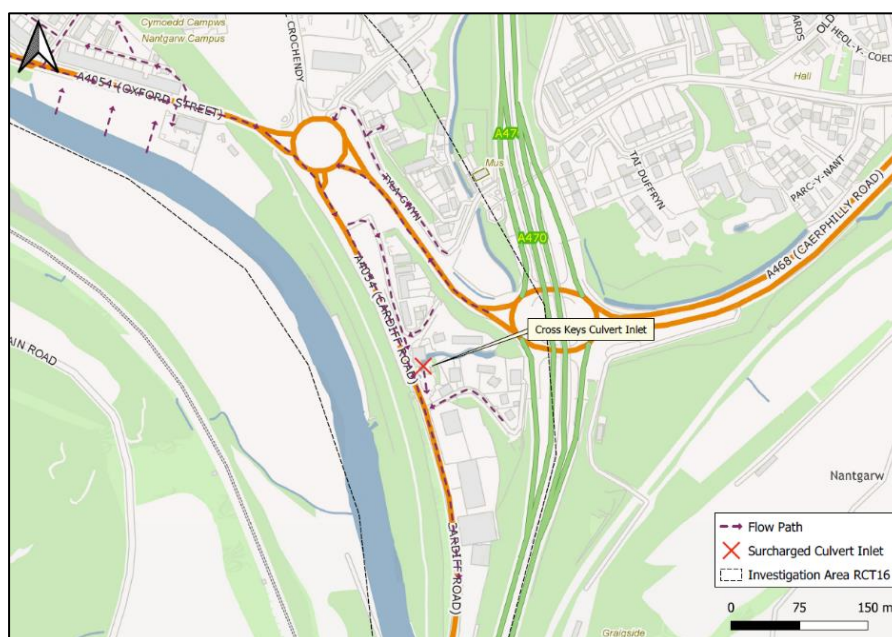
An isolated incident of surface water flooding occurred at Quarry Street, where two residential properties experienced internal flooding during Storm Dennis as a result of localised pluvial flows from the adjacent street, Tyla Gwyn. The observed flow pathways resulting in internal flooding at Cardiff Road are illustrated in Figure 7.

Figure 7: Indicative flow paths observed during Storm Dennis to the south of RCT16

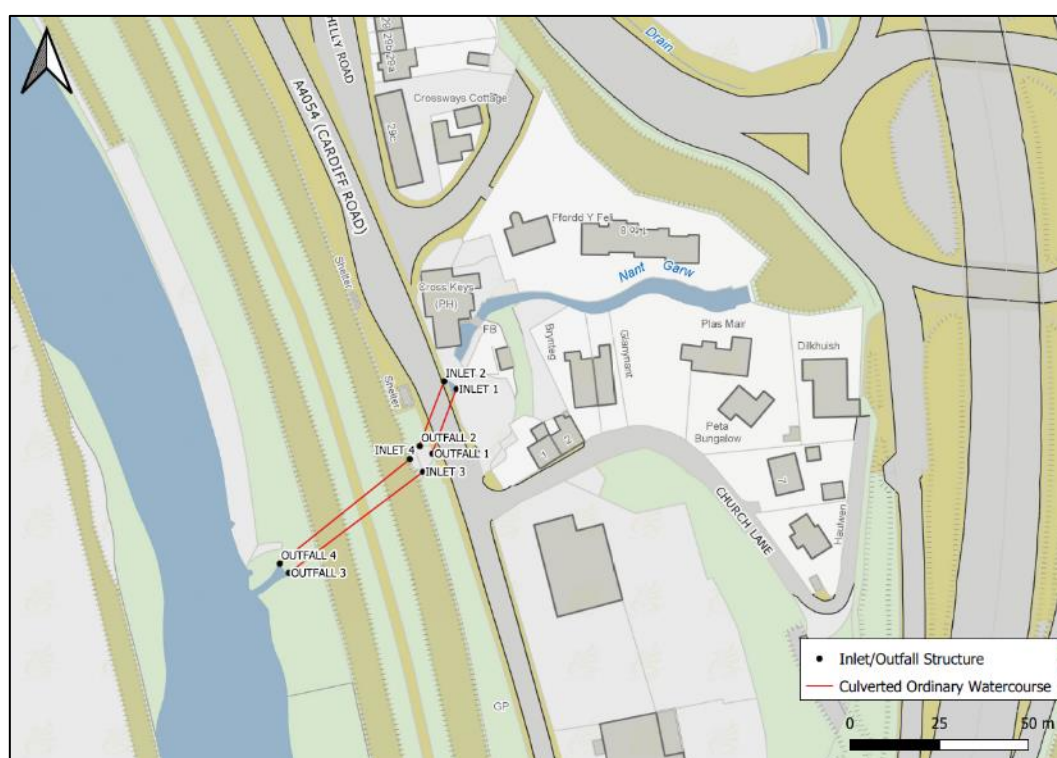
Figure 8: The Nant Garw culverted ordinary watercourse which runs beneath the A4054 Cardiff Road

Comprising of four culvert sections in a double-barrel configuration, the survey revealed that the culvert was in good structural condition, with only one of the four

sections having structural defects present. However, the serviceable condition of the culvert network identified accumulated debris within three of the four culvert sections and both outfall sections were unable to be fully inspected due to the level of the outfall within the main river at the time of the survey, which suggests the culverts are subject to debris settlement and outfall control.

The primary cause of debris accumulation within the culvert network is believed to be the low positioning of the structure with respect to the main river, leading to significant ‘outlet control’⁶ and the settling of fluvial deposits. During Storm Dennis, it is likely that the unprecedentedly high river levels resulted in the culvert outlet becoming completely submerged, thus resulting in ‘full flow outlet control’ and an increased risk of blockage and/or surcharge.

Upon review of the CCTV inspection data discussed in Section 3.1, as well as the culvert capacity assessments stipulated above, it is considered that the primary cause of surcharge to the 'Cross Keys' culvert inlet during Storm Dennis was due to hydraulic overload, which contributed to the internal flooding of 6 residential and 18 non-residential properties along Cardiff Road.

R3B	<p>The LLFA and LDA to investigate the standard of protection and the condition of the culvert structure and network as a whole.</p>
					R3C	<p>The LLFA to jet and cleanse the ordinary watercourse culvert network.</p>

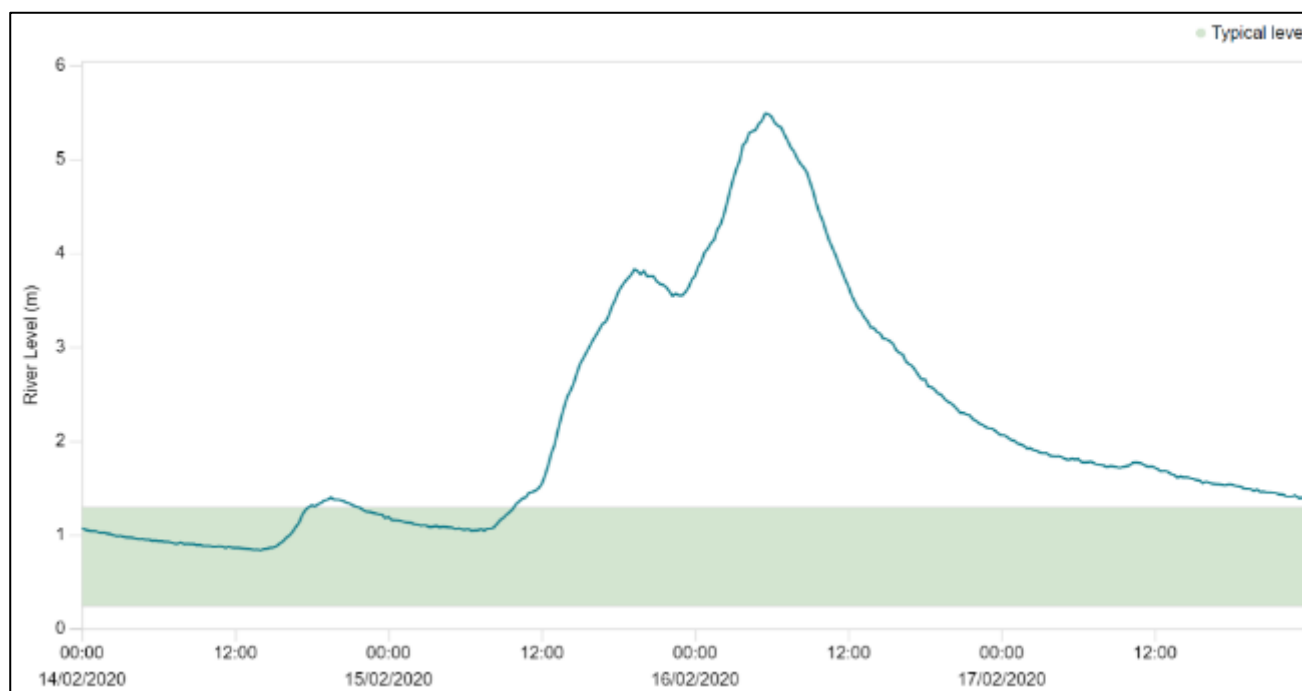
NRW issued a 'Flood Alert' (indicating possible flooding) for the entirety of the River Taf at approximately 13:30 on the 15th February; at which point the main river was over 2 metres in depth and continuing to rise at Upper Boat station. At approximately midnight on the 16th February the River Taf began to rise again, reaching a peak river level of 5.49 metres at 06:00 on the 16th February; the highest level recorded for the River Taf at Upper Boat since 2001.

The green bar displayed on the hydrograph shows the typical level of the River Taf at the Upper Boat station, ranging between approximately 0.2 and 1.2 metres. The river level was above this green line for over 48 hours, highlighting the severity of the storm event and its unprecedented nature. At its peak, the River Taf at Upper Boat was over four meters higher than its average level.

Figure 10: The River Taf River levels at Upper Boat station between the 14th and 17th February 2020 (Natural Resources Wales)

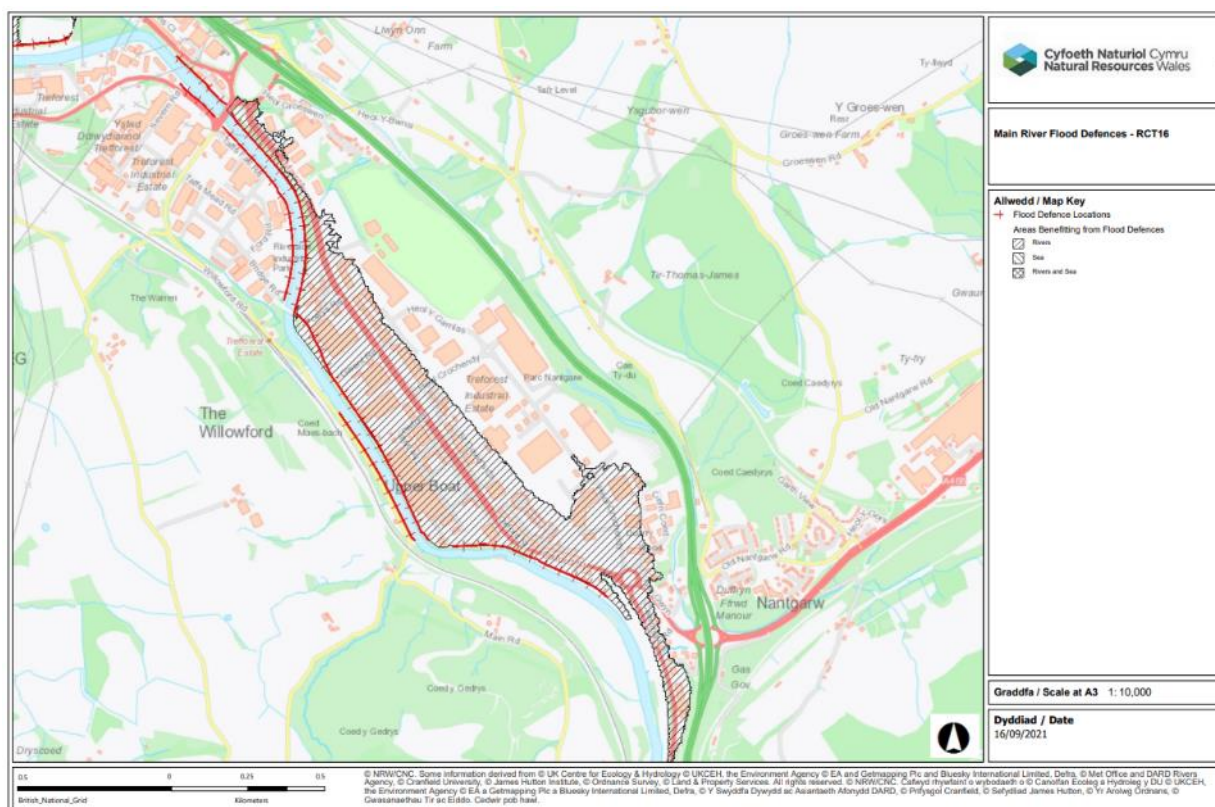
As illustrated in Figure 14 (demarcated by a bold red line), there are approximately 2.5 kilometres, and 1.25 kilometres, of formally designated flood defence infrastructure along the eastern, and western banks, of the River Taf at RCT16, respectively. This infrastructure is operated and maintained by NRW.

According to NRW, flood defence infrastructure throughout the Treforest Industrial Estate, including at Oxford Street and Rhyd-yr-Helyg, provides a standard of protection up to a 1 in 100 annual probability flood event (Q100) (black hatched area in Figure 16). Flood defence infrastructure at Upper Boat and William’s Place provide a reduced standard of protection of 1 in 20 annual probability (Q20) flood event.

Figure 14: Natural Resources Wales’ map for Main River Flood Defences and areas benefiting at RCT16. Contains Natural Resources Wales information © Natural Resources Wales and database right. All rights reserved

The current indicative design standard of protection for flood defences on a main river is Q100 flood event plus, for new defences, an allowance for climate change. This is stated within the Welsh Government’s National Strategy for Flood and Coastal Erosion Risk Management which encourages main river flood alleviation schemes to provide a SOP up to 1 in 100 annual probability (Q100)⁵. It is thereby inferred that the majority of the existing flood defence infrastructure at RCT16 is in accordance with current indicative standards, with the exception of the defences at Upper Boat, which are below indicative design standards.

Whilst some of the flood defences identified at RCT16 are below the current indicative standard, the unprecedented rise of river levels in the Taf during Storm Dennis resulted in the overtopping of assets up to Q100 SOP. NRW’s ‘Flood Incidence Response Review’⁴ does in fact outline that no flood defences failed in the lower Taf region and that the flooding was the result of river flows exceeding the design standard of the defences.

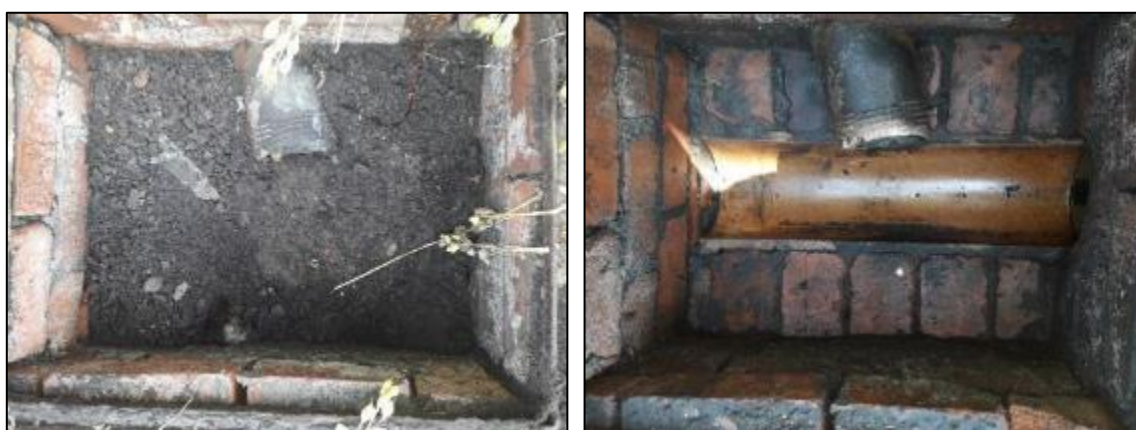
CCTV inspections undertaken in the months following the storm event confirm this, with surveys completed on Oxford Street and Rhyd-Yr-Helyg identifying large silt and debris deposits within many sections of the highway drainage network. Figure 15 depicts the operational condition of the highway drainage at Oxford Street before and after cleansing operations took place. A total of 25 tonnes of silt and debris was removed by a Council appointed contractor during cleansing operations.

Figure 15: Photo of a manhole at Oxford Street captured before (left) and after (right) surveying and cleansing operations during June 2020

CCTV inspections also identified structural defects within the drainage network on Oxford Street, including collapses within the drainage infrastructure near to the system's main river outlet. A section of the outlet structure was also damaged during Storm Dennis.

Whilst a lack of baseline highway drainage inspection data restricts the determination of whether the identified structural defects were caused during Storm Dennis or present beforehand, the severity of the flood incident at RCT16, caused by the overtopping of the River Taf, indicates that the condition of the highway drainage infrastructure would have had little to no impact on the extent of flooding observed.
