Former Scrap Yard

Former Chemical Manufacturing site

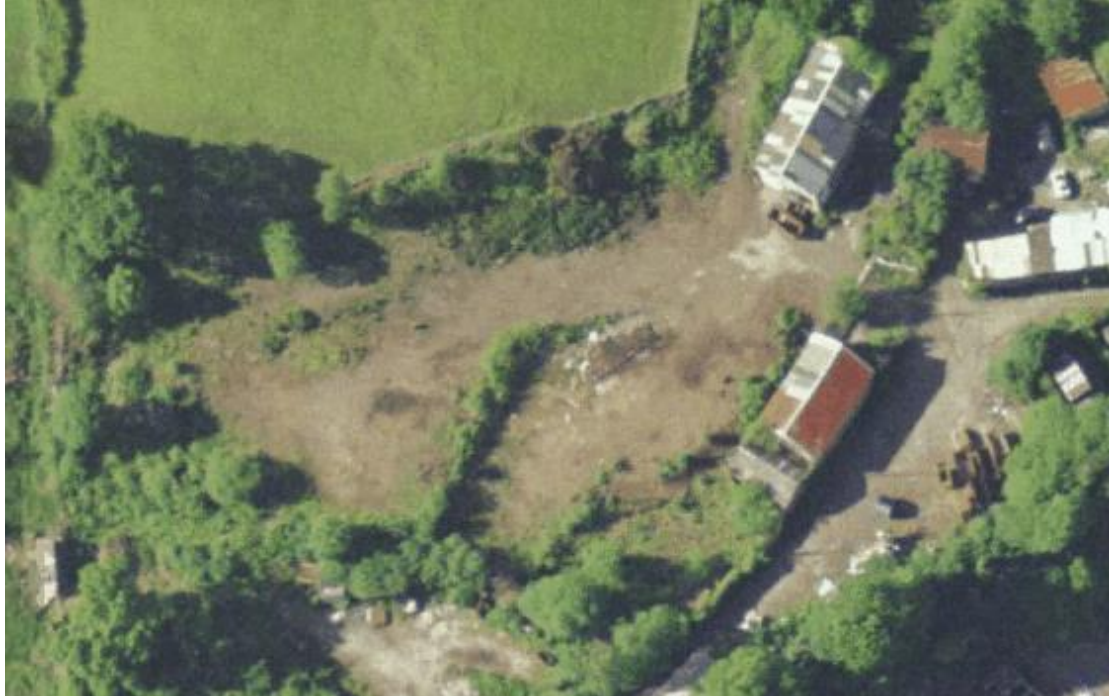
The scrap yard had ceased trading a number of years before the land was redeveloped in 2019, but as this aerial image from Google dated 2006 shows, it was still in a contaminated state. Dark patches can be seen on the site's surface, most likely oil/hydrocarbon staining originating from its former use as a scrap yard.

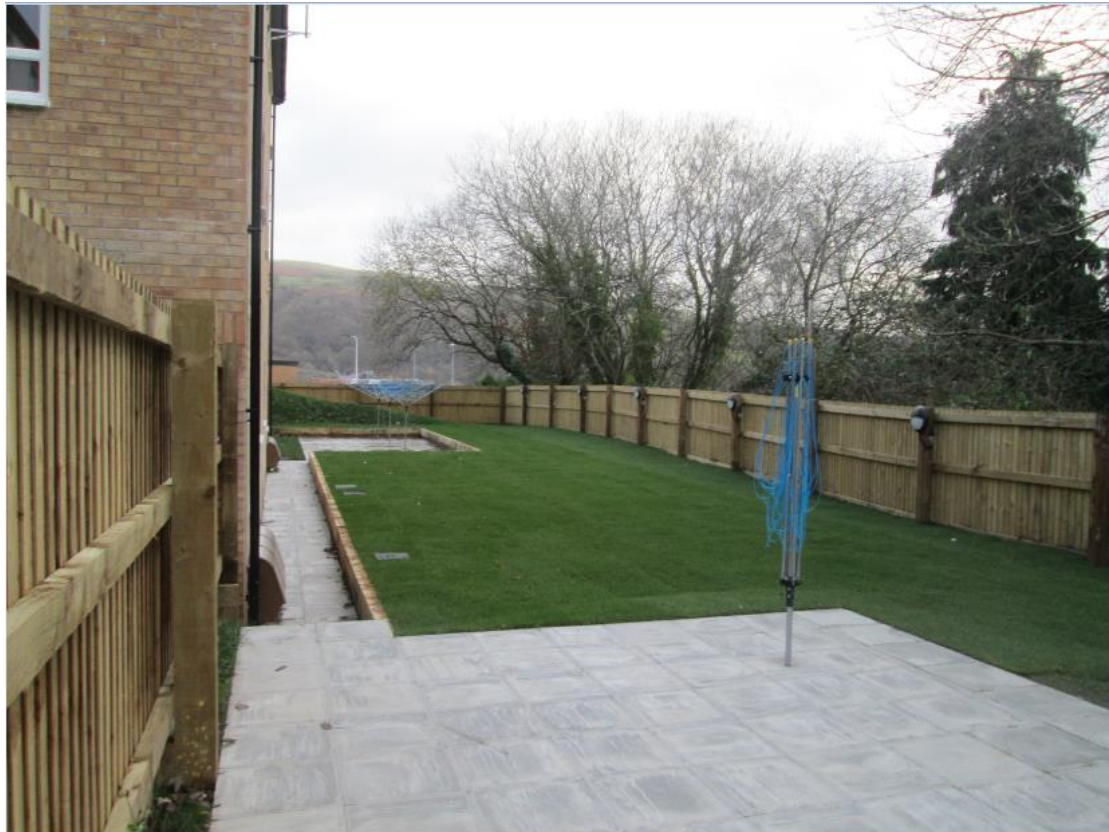
The photograph below shows the clean soil capping in the garden areas. The depth of cover and the quality of the soils were confirmed by measurement and chemical testing at a laboratory.

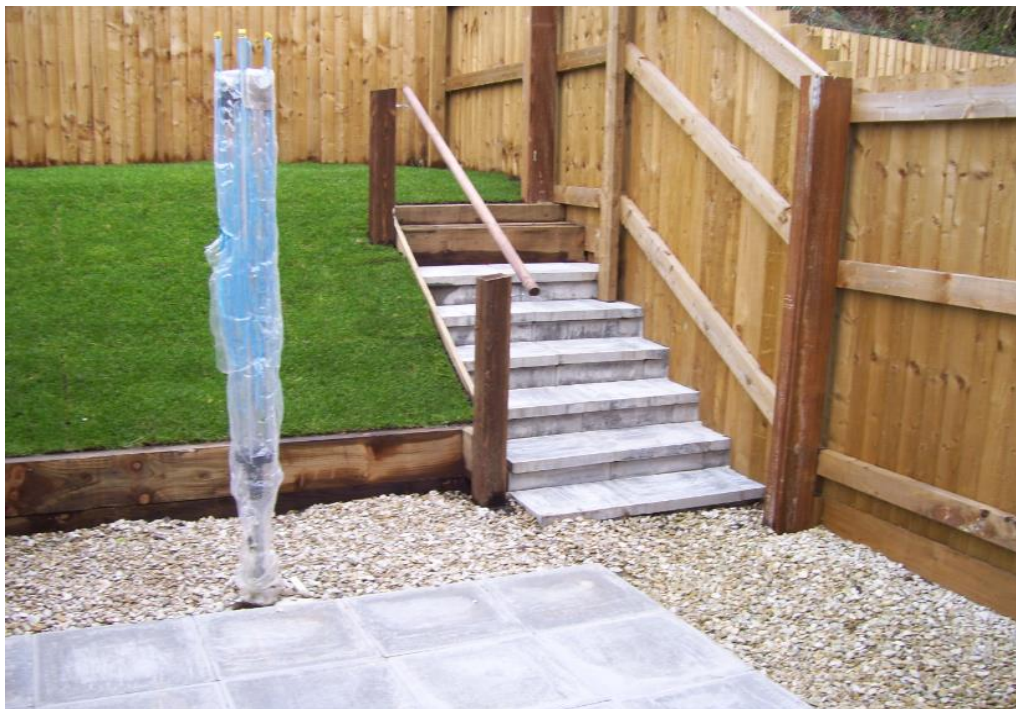
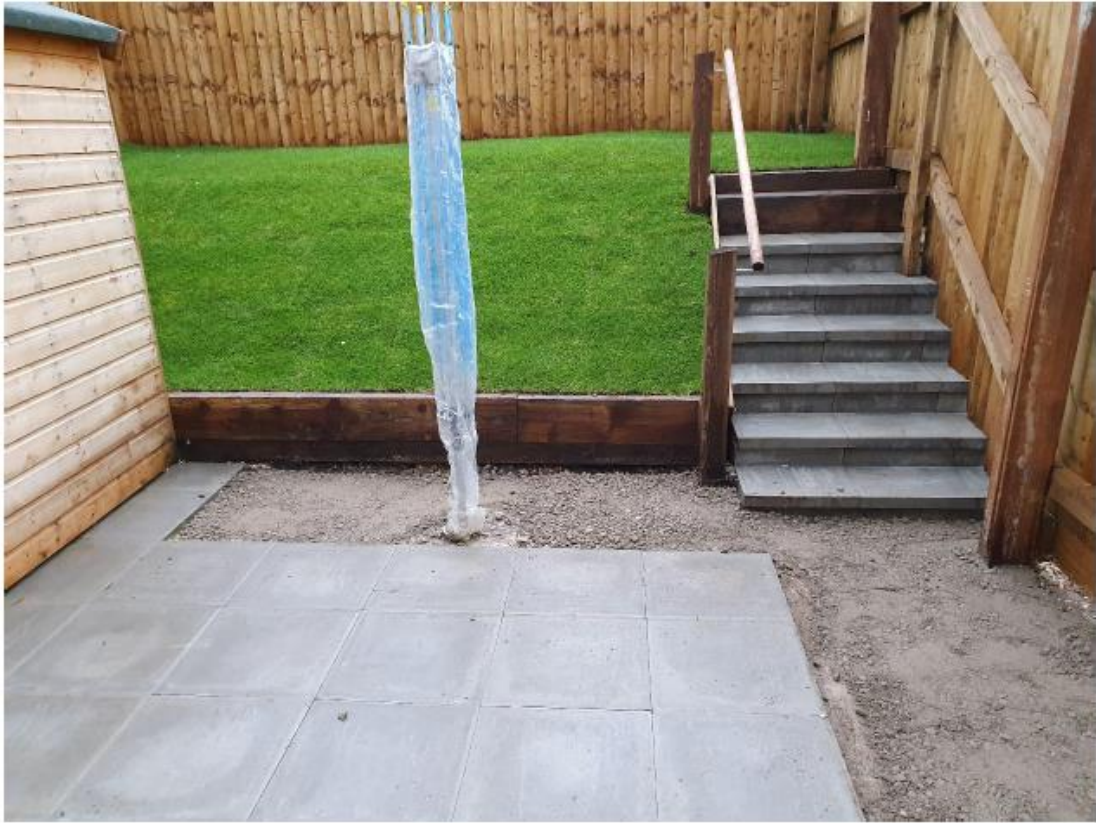
During a site visit it was noted that areas of loose stone were present in some gardens. This finish was not in accordance with the approved remediation strategy and it was not considered to provide sufficient protection for the residents. Before the homes could be occupied the developer had to remove the chippings and replace them with concrete. Permanently removing the exposure routes to the soil beneath.

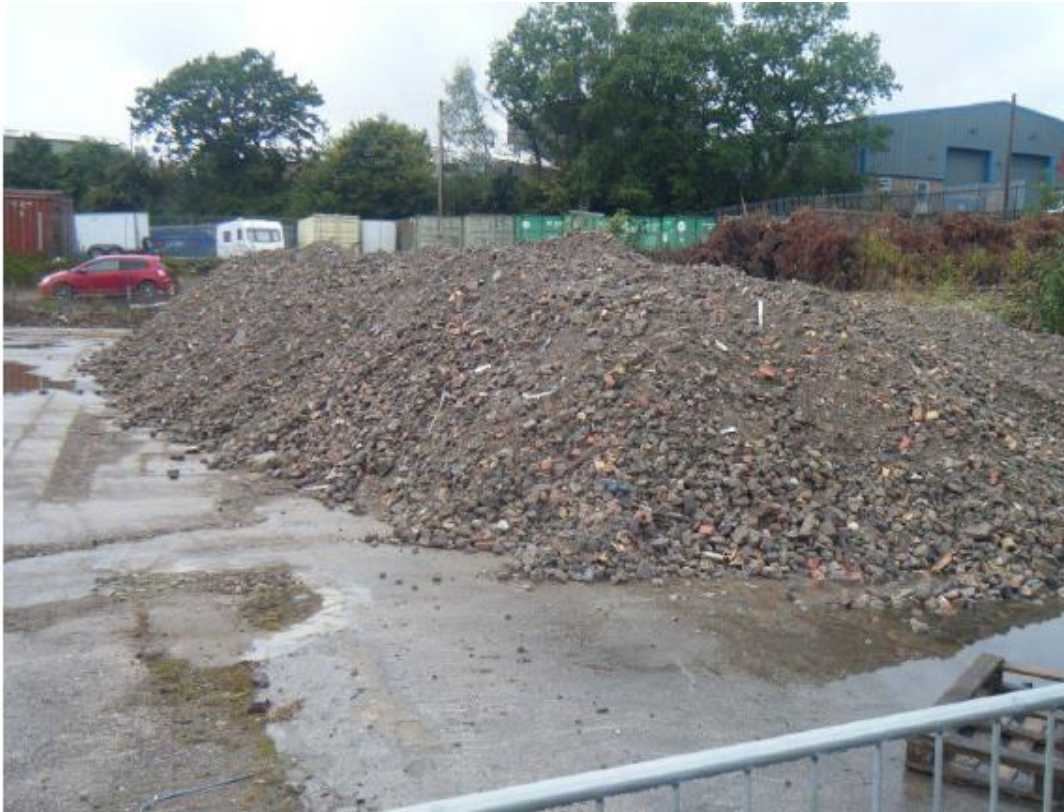
The buildings on the former chemical manufacturing site had already been demolished and stockpiles crushed demolition material were present on the hardstanding which had been left in place to reduce rainwater infiltration and the mobilisation of contamination within the soils on site.

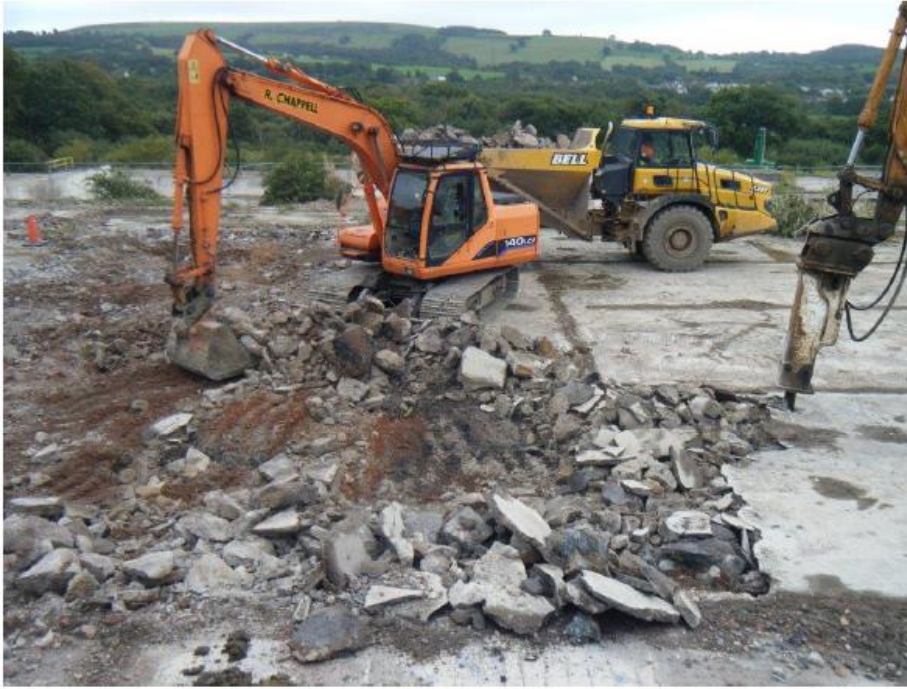
Investigations had already identified key process areas and drainage runs where contamination was present. The remedial strategy required the removal of the worst impacted soils.

The concrete floor slabs were broken out in these areas to gain access to the soils.

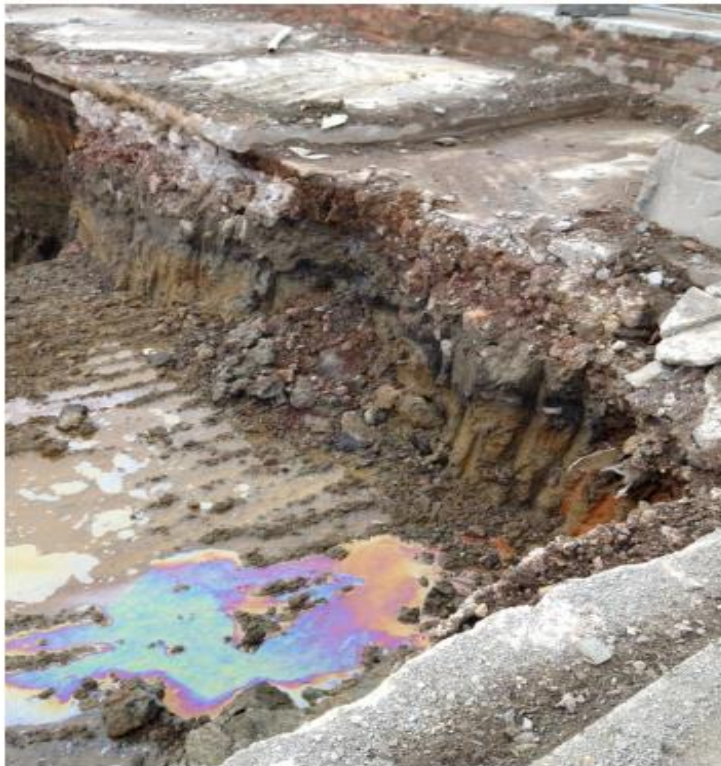
The following photograph shows hydrocarbon contamination (rainbow-coloured sheen) escaping from an underground drainage pipe.

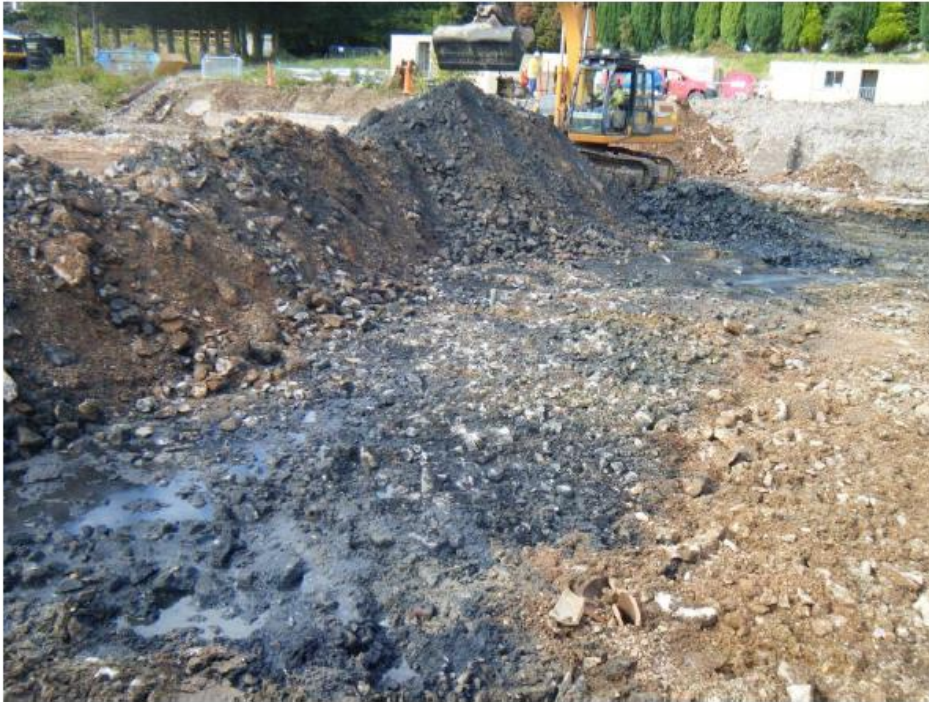
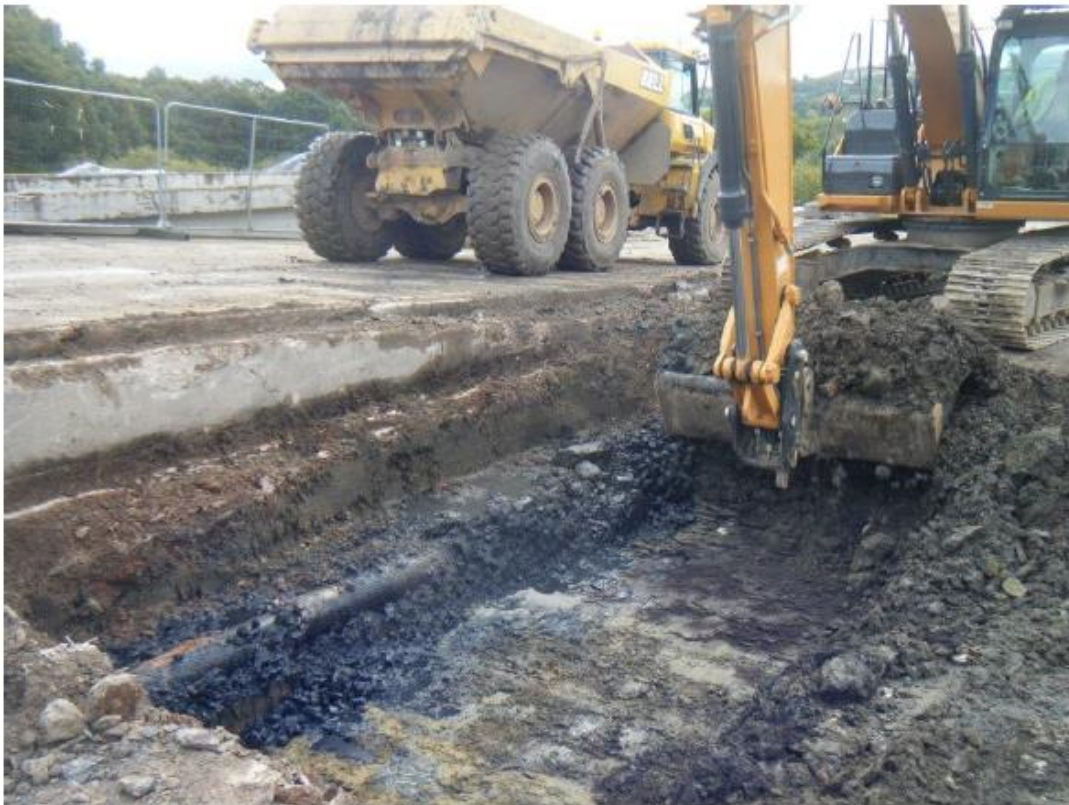
Where contamination had been present in the soils for much longer the soils were stained dark and had a strong chemical odour.

The two photographs below show historical solvent contamination (black deposits) in soils associated with drainage runs.

Diggers were able to chase out the contamination and impacted soils were sent off site for disposal.

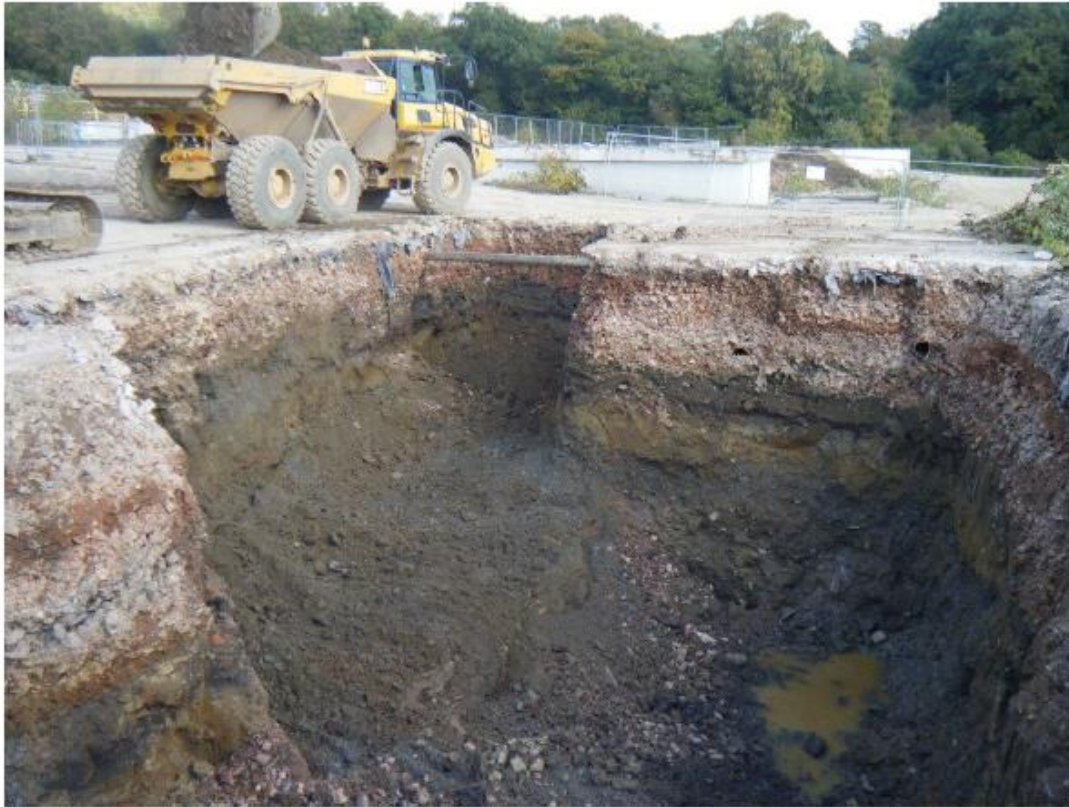
Some of the resulting excavations were deep as the solvents had tracked along permeable layers to greater depths. Soils samples were collected from the base and sides of the excavations and tested at the lab to provide evidence of the standard of the clean-up work.

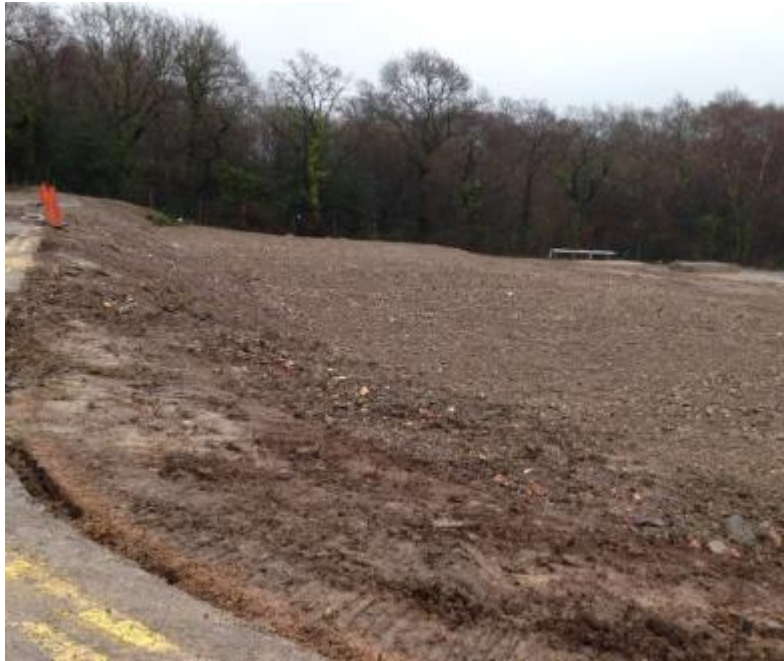
The excavations were then backfilled with clean materials to leave a site which, after further phase of investigation and groundworks, was subsequently developed for housing.

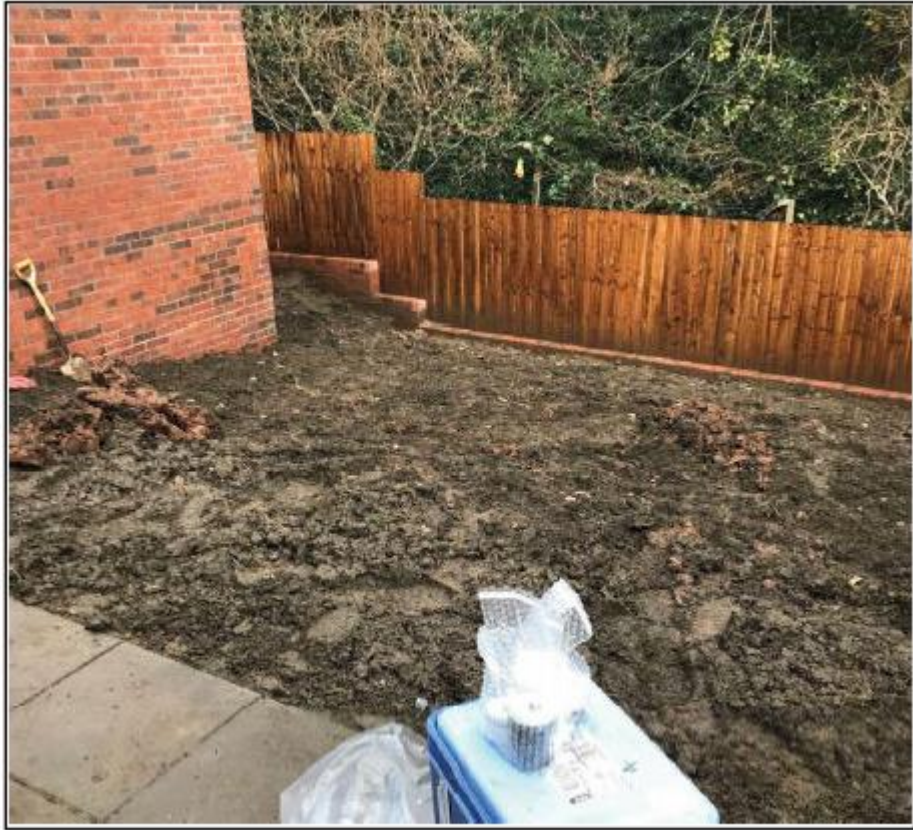
The photograph below shows the depth of clean cap cover being verified (approx. 600mm) within one of the gardens (last photograph).
