CYNGOR BWRDEISTREF SIROL
RHONDDA CYNON TAF
COUNTY BOROUGH COUNCIL

DYMA WŶS I CHI i gyfarfod hybrid o **PWYLLGOR TROSOLWG A CHRAFFU** yn cael ei gynnal ar **DYDD LLUN, 28AIN CHWEFROR, 2022** am **5.00 PM**.

5. ADRODDIADAU YMCHWILIO I LIFOGYDD ADRAN 19

Derbyn adroddiadau Ymchwilio i Lifogydd Adran 19 y Cyngor o dan Ddeddf Rheoli Llifogydd a Dŵr 2010.

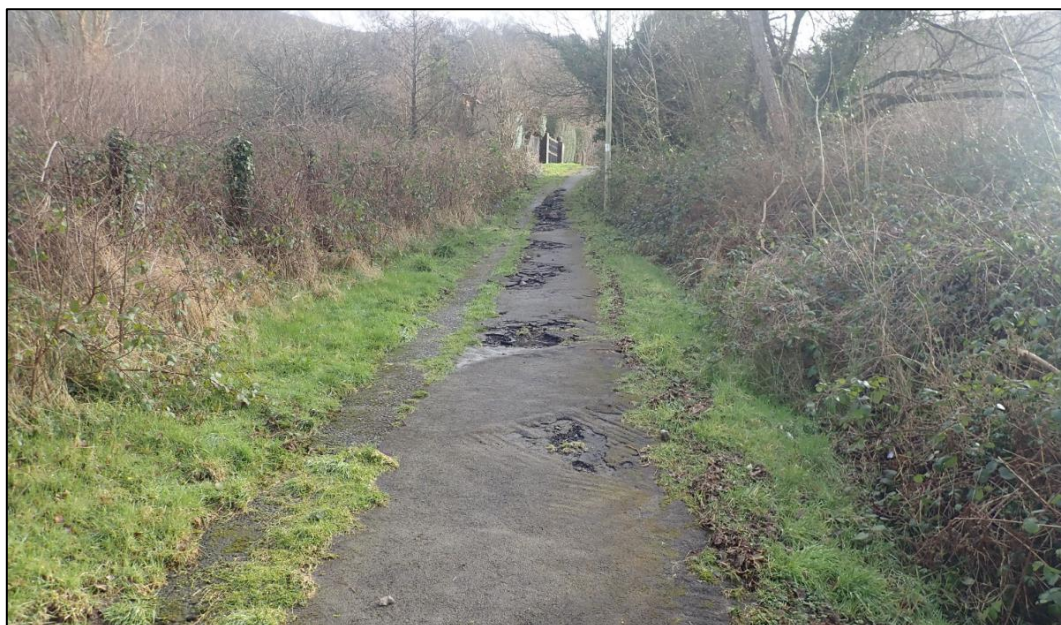
Figure 11: Evidence of damages to the top of the path looking up towards Heol Nant (captured by FRM officers on 17th February 2020)

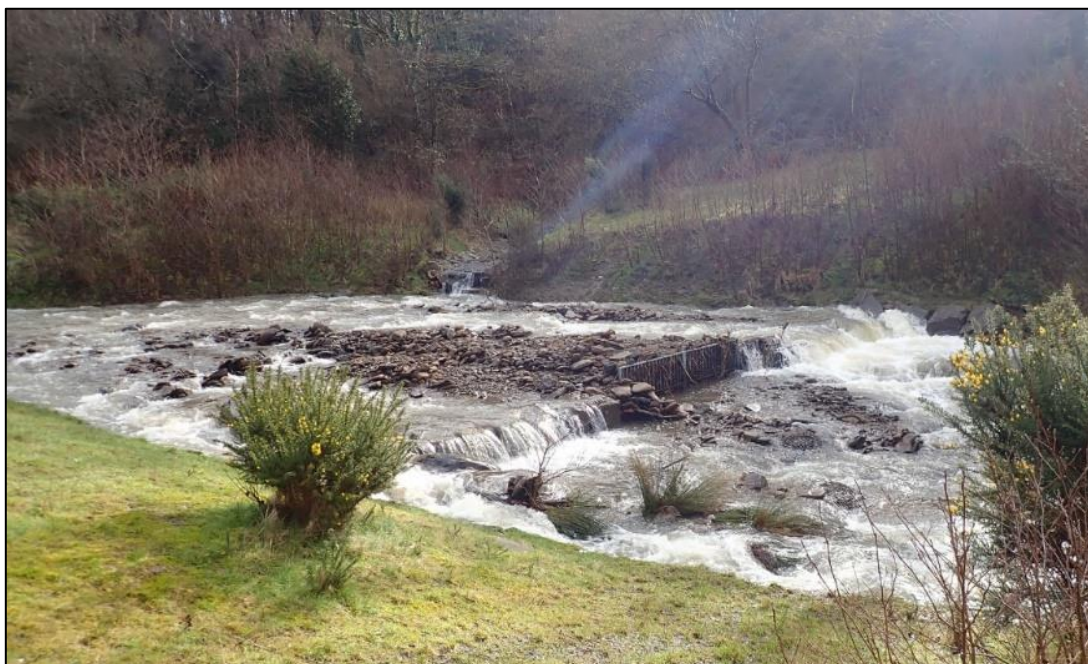
Figure 22: Initial upstream debris screen in the Nant Cae Dudwg watercourse (captured by RCT's Flood Risk Management team on 17th February 2020)

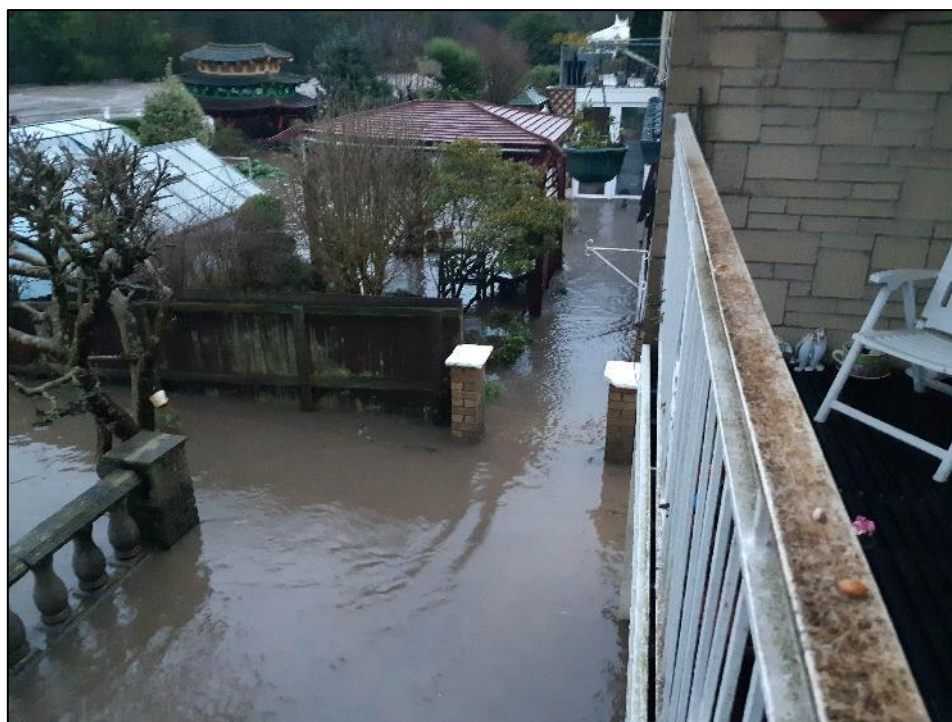
Figure 7: Image showing main river flooding to the south of Nant-y-Dall Avenue during Storm Dennis (image provided by resident)

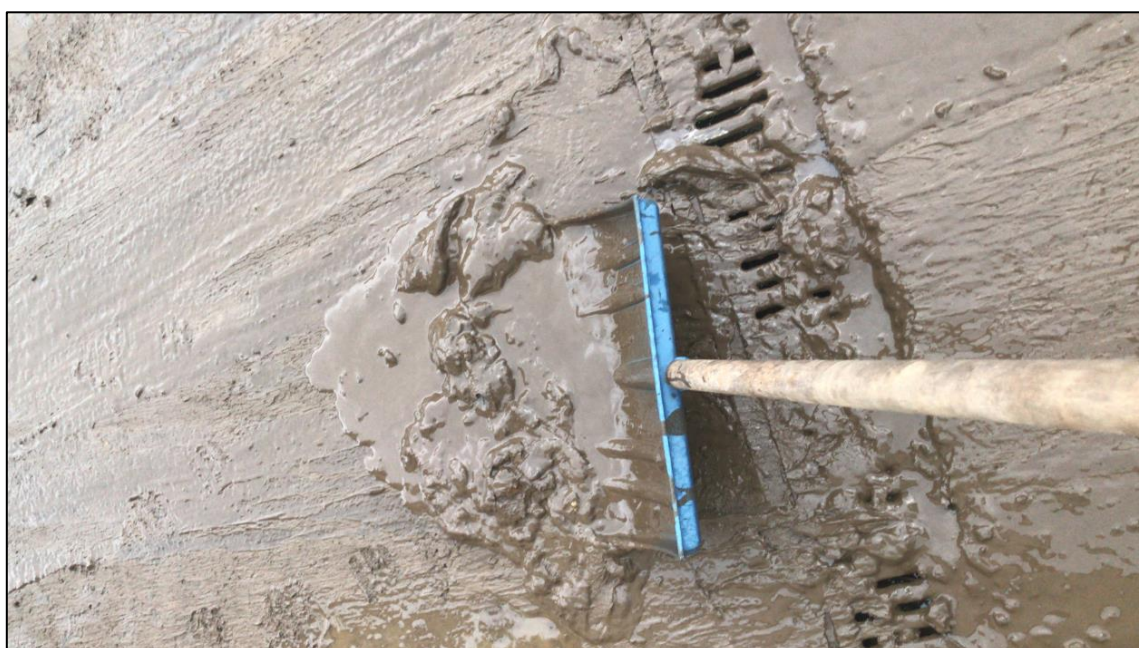
Figure 12: Photo shows deposits of mud blocking the surface water drainage infrastructure at Park Lane following the flooding during Storm Dennis (image provided by resident)

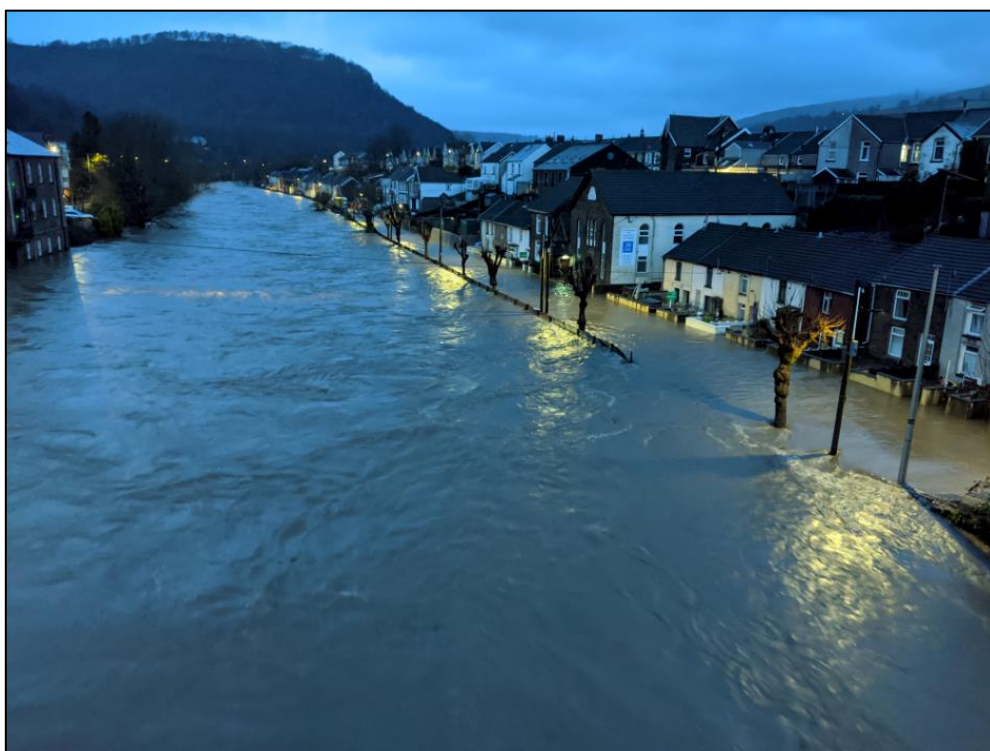
Figure 3: Image of the River Taf overtopping its eastern embankment onto Sion Street during the early hours on Sunday 16th February 2020 during Storm Dennis (image provided by resident)

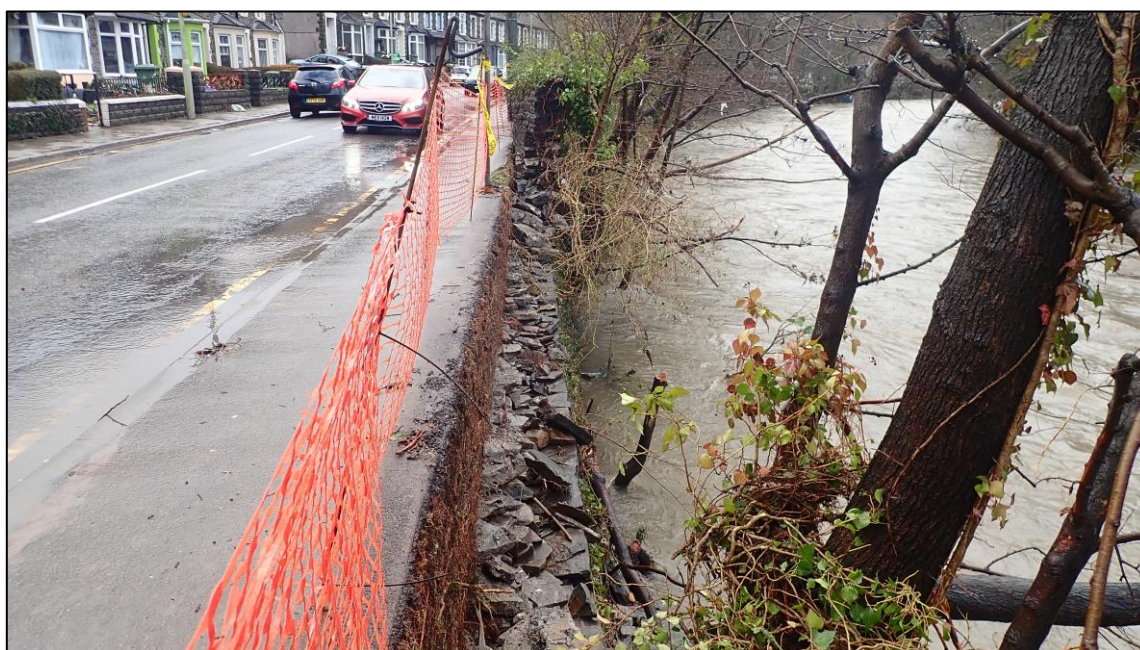
Figure 5: Collapsed river wall (NFD) on Berw Road following Storm Dennis (captured by RCT's Flood Risk Management team on 17th February 2020)

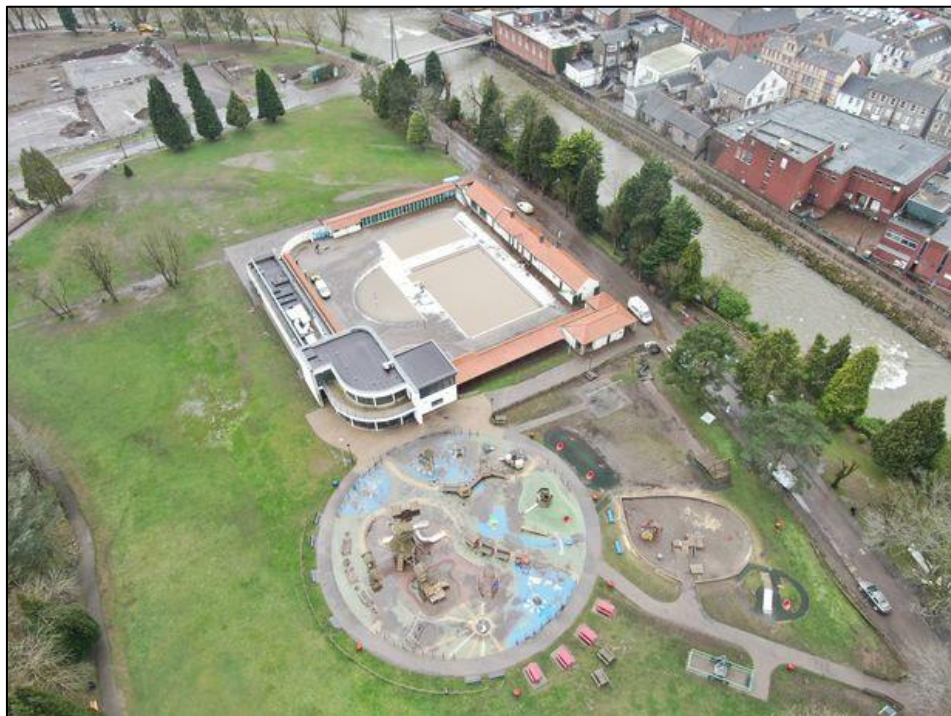
Figure 8: Image showing the flood damage to the National Lido of Wales at Ynysangharad Park following Storm Dennis (Image: Jonathan Lawrence/WalesOnline)
