CYNGOR BWRDEISTREF SIROL
RHONDDA CYNON TAF
COUNTY BOROUGH COUNCIL

COMMITTEE SUMMONS

YOU ARE SUMMONED to a hybrid meeting of the **OVERVIEW AND SCRUTINY COMMITTEE** to be held on **MONDAY, 28TH FEBRUARY, 2022** at **5.00 PM.**

5. SECTION 19 FLOOD INVESTIGATION REPORTS

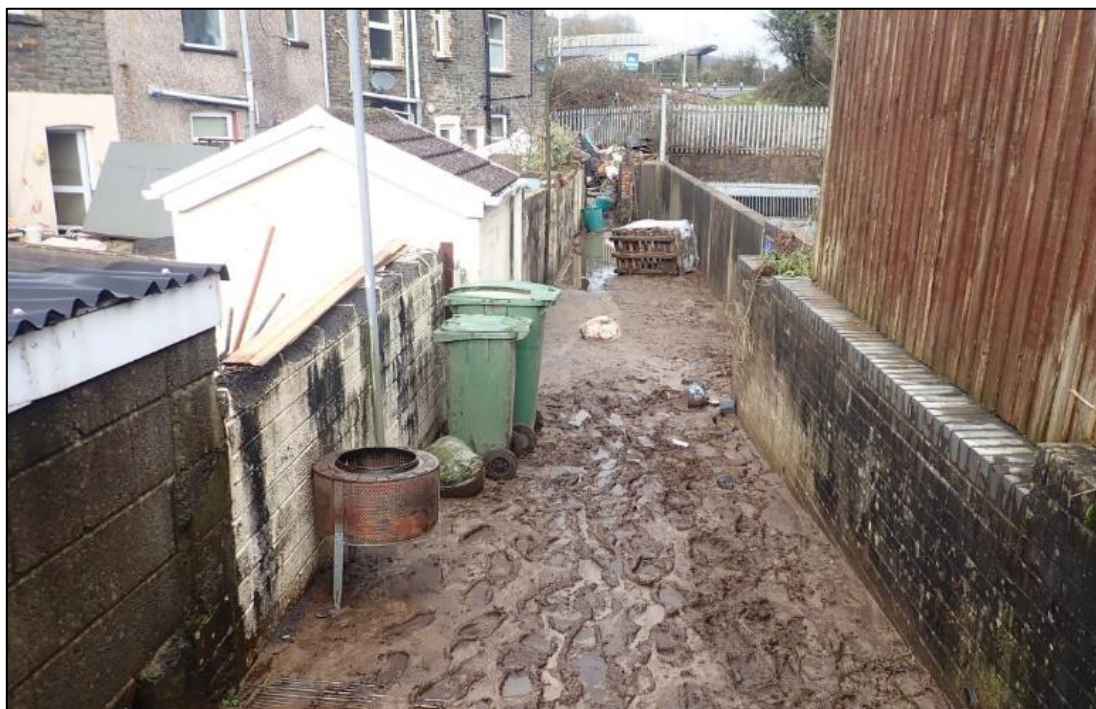
Post event inspections found evidence of collapsed concrete boundary walls, exemplifying the force of the water emanating from the watercourse and flowing through the gardens during the event. The images below reveal the severe and long-lasting damages caused by the flood event to properties at Cilfynydd Road (Figure 6).

Figure 5: View of the lane between the Nant Cae Dudwg inlet and the rear gardens of properties on Cilfynydd Road captured by FRM officers on 17th February 2020.

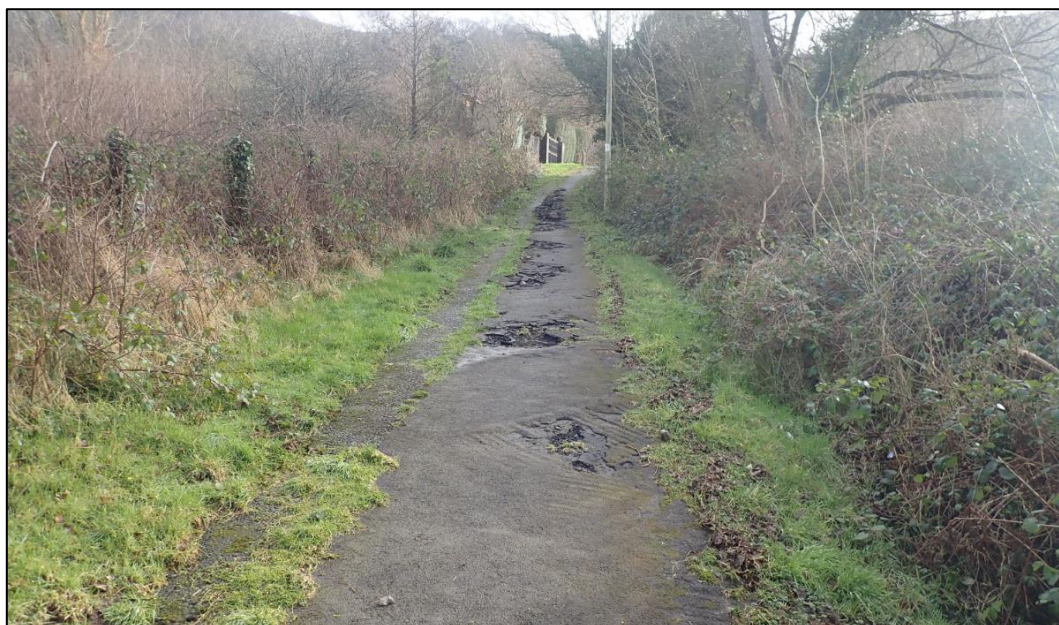
Figure 11: Evidence of damages to the top of the path looking up towards Heol Nant (captured by FRM officers on 17th February 2020)

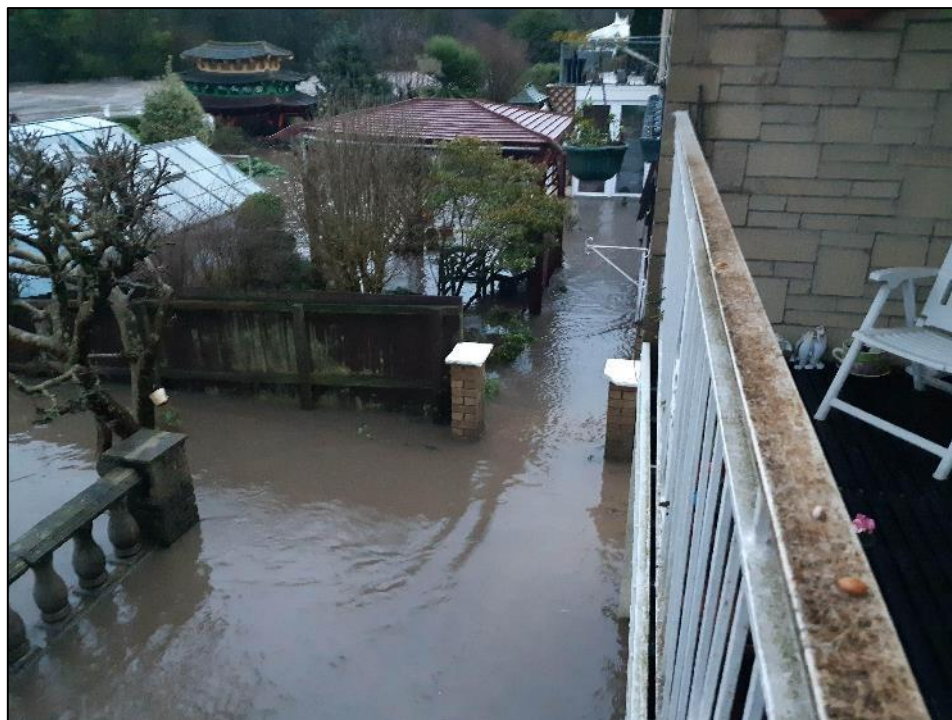
Figure 7: Image showing main river flooding to the south of Nant-y-Dall Avenue during Storm Dennis (image provided by resident)

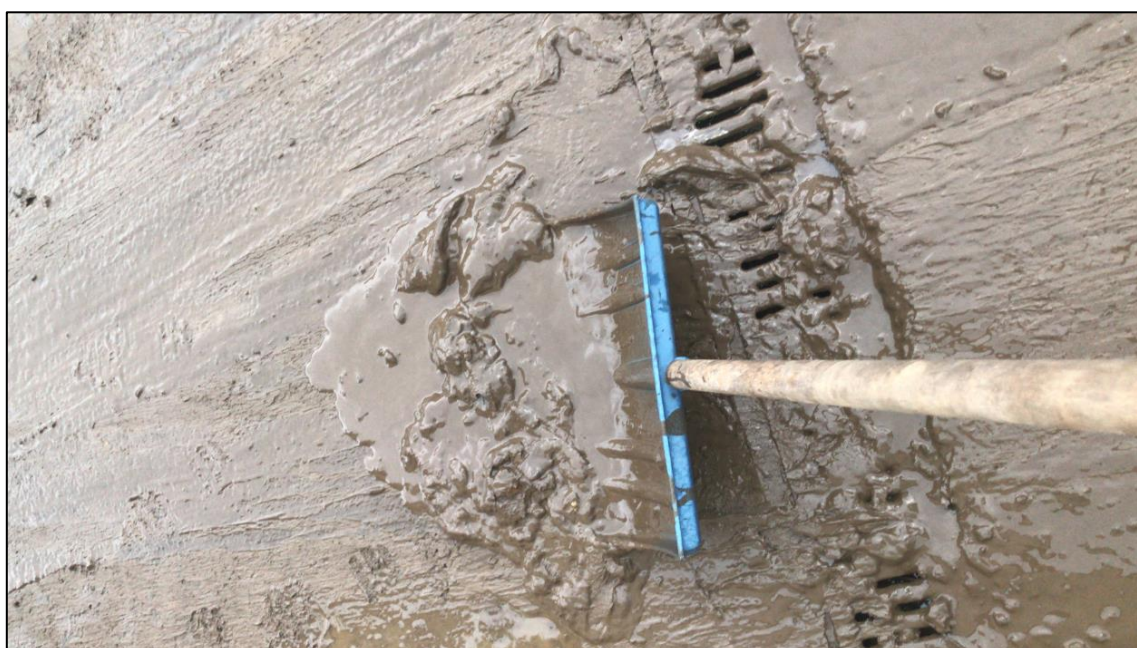
Figure 12: Photo shows deposits of mud blocking the surface water drainage infrastructure at Park Lane following the flooding during Storm Dennis (image provided by resident)

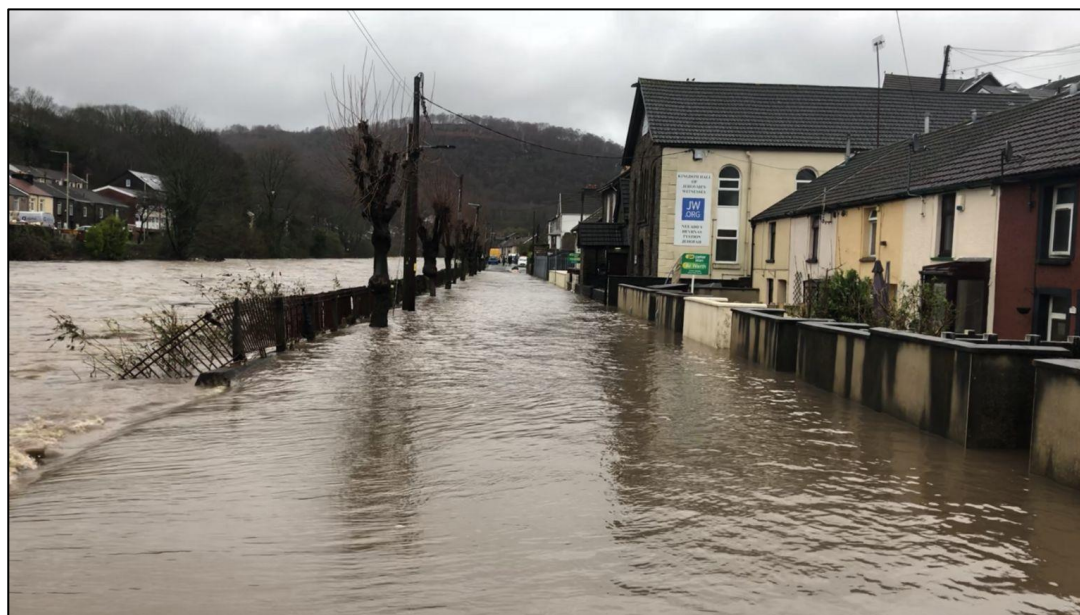
Figure 4: Flooding at Sion Street following Storm Dennis (Image: BBC News)

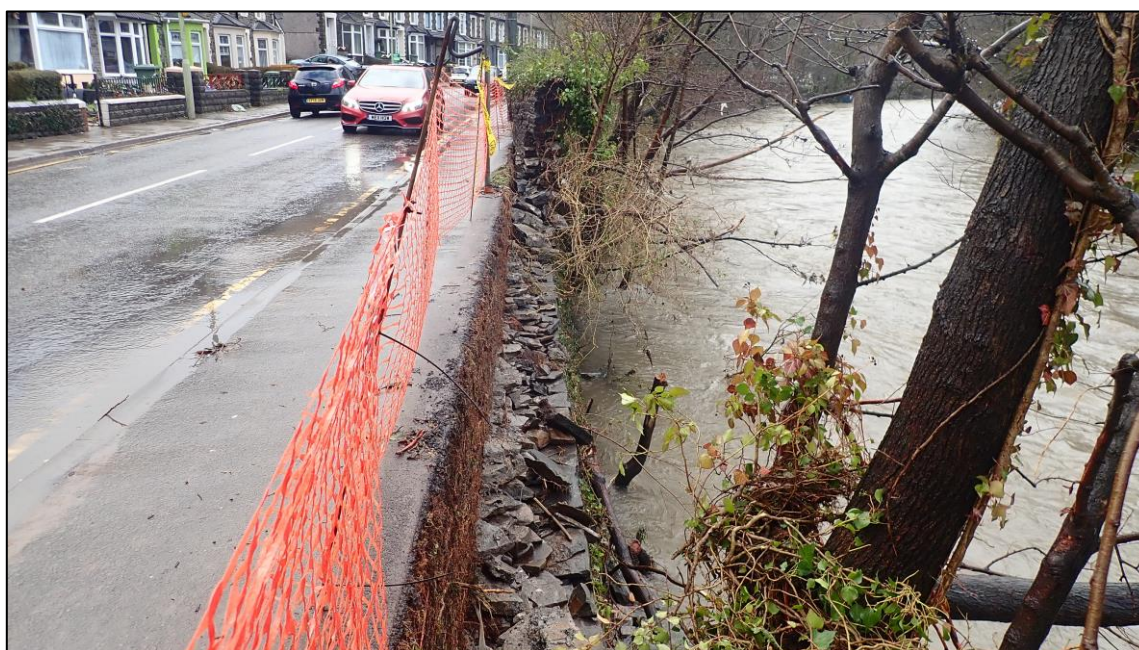
Figure 5: Collapsed river wall (NFD) on Berw Road following Storm Dennis (captured by RCT's Flood Risk Management team on 17th February 2020)

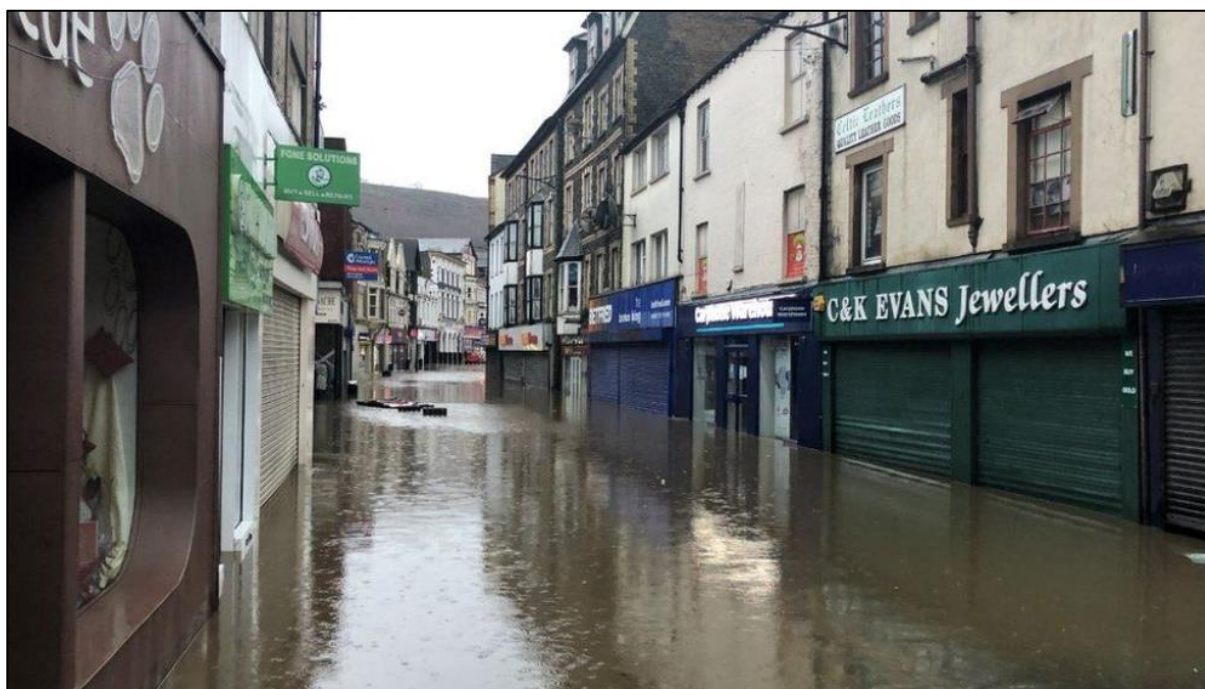
Figure 7: Flooding to commercial properties on Taff Street following Storm Dennis (Image: BBC News)

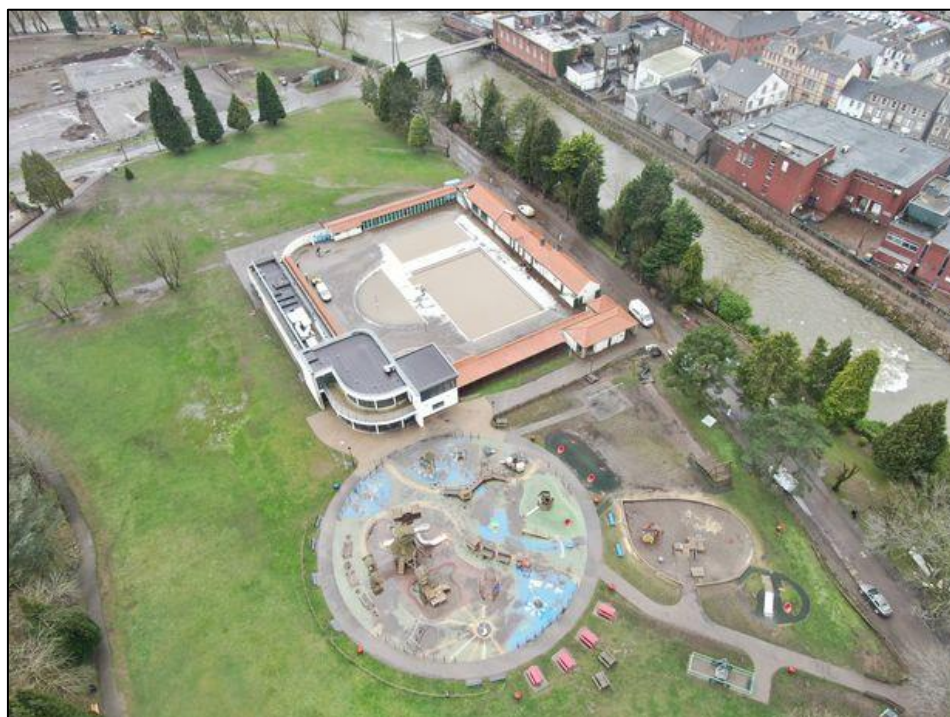
Figure 8: Image showing the flood damage to the National Lido of Wales at Ynysangharad Park following Storm Dennis (Image: Jonathan Lawrence/WalesOnline)

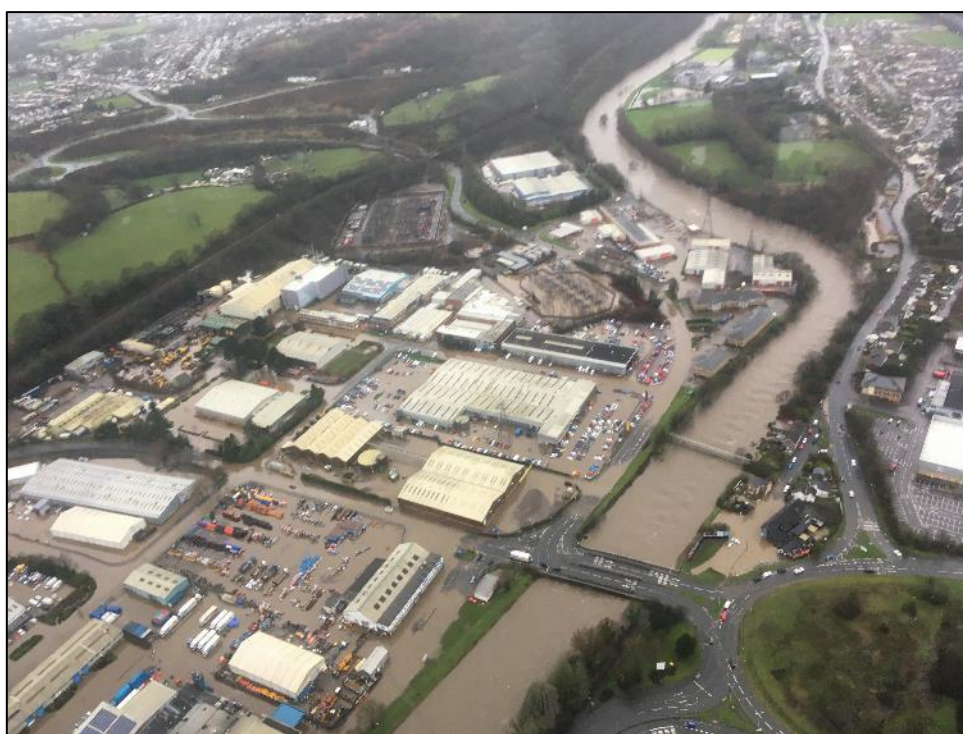
Figure 3: Aerial view of Treforest Industrial Estate and Upper Boat following Storm Dennis (Image: National Police Air Service)
