**Appendix L - Treorchy**

# Flood and Water Management Act 2010

## Section 19 Flood Investigation Report

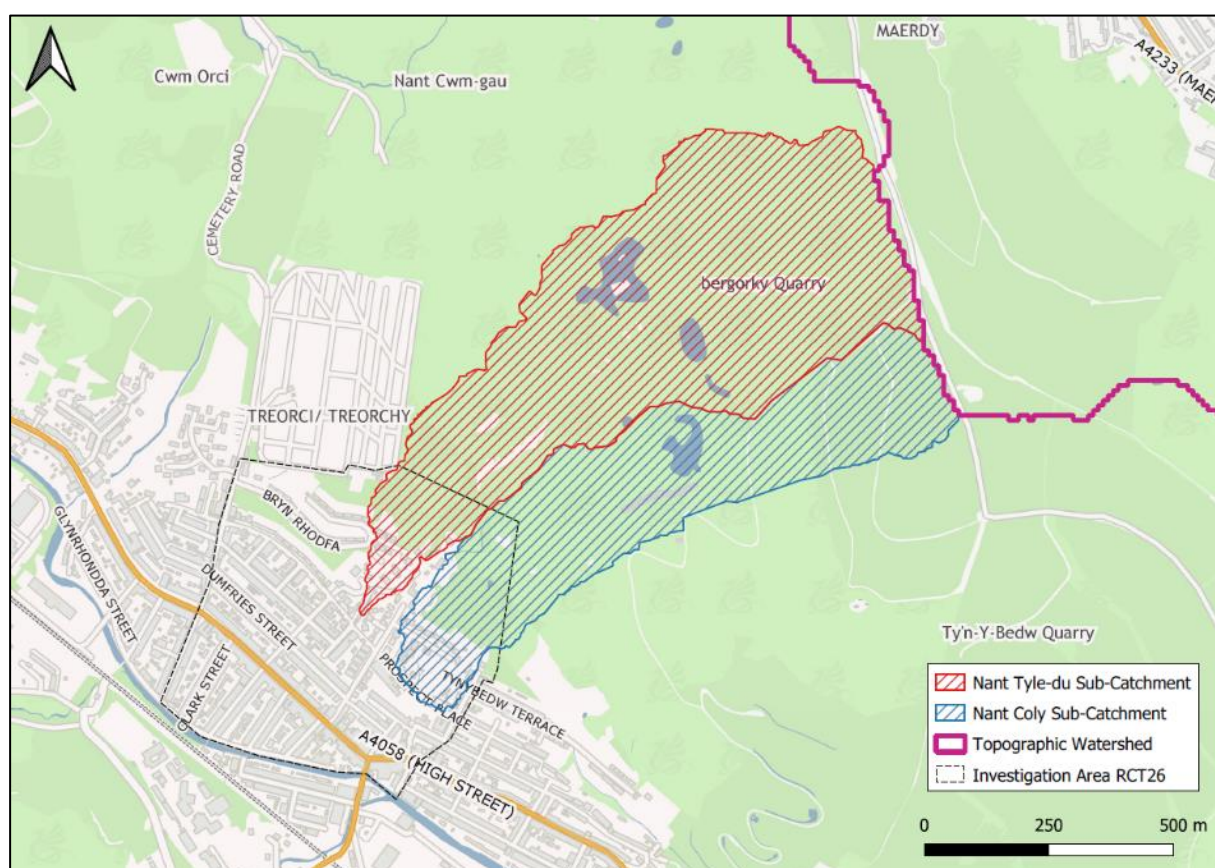
**Figure 3:** Rainfall Topographic Watershed and sub-catchments above investigation area RCT26

On review of Table 2, the principal source of flooding in this incident originated from intense rainfall generating significant surface water runoff from the steep hillsides to the north and east of Treorchy draining to lower ground. This runoff was routed towards the investigation area via several ordinary watercourses, many of which became overwhelmed and/or blocked during Storm Dennis which resulted in property flooding.

Figure 3 depicts the topographic watershed of the Rhondda Fawr and Fach valleys (bold pink line), with rainfall to the south west of the watershed draining to the Rhondda Fawr catchment. The catchment above investigation area RCT26 can be sub-divided into further sub-catchment to illustrate the area of land that would expect to drain towards the investigation area (hatched areas in Figure 3). The flood incident at investigation area RCT26 will be further described in two parts: the incident at ‘Nant Tyle-du’ sub-catchment (red hatched area, Figure 3) and the incident at ‘Nant Coly’ sub-catchment (blue hatched area, Figure 3).

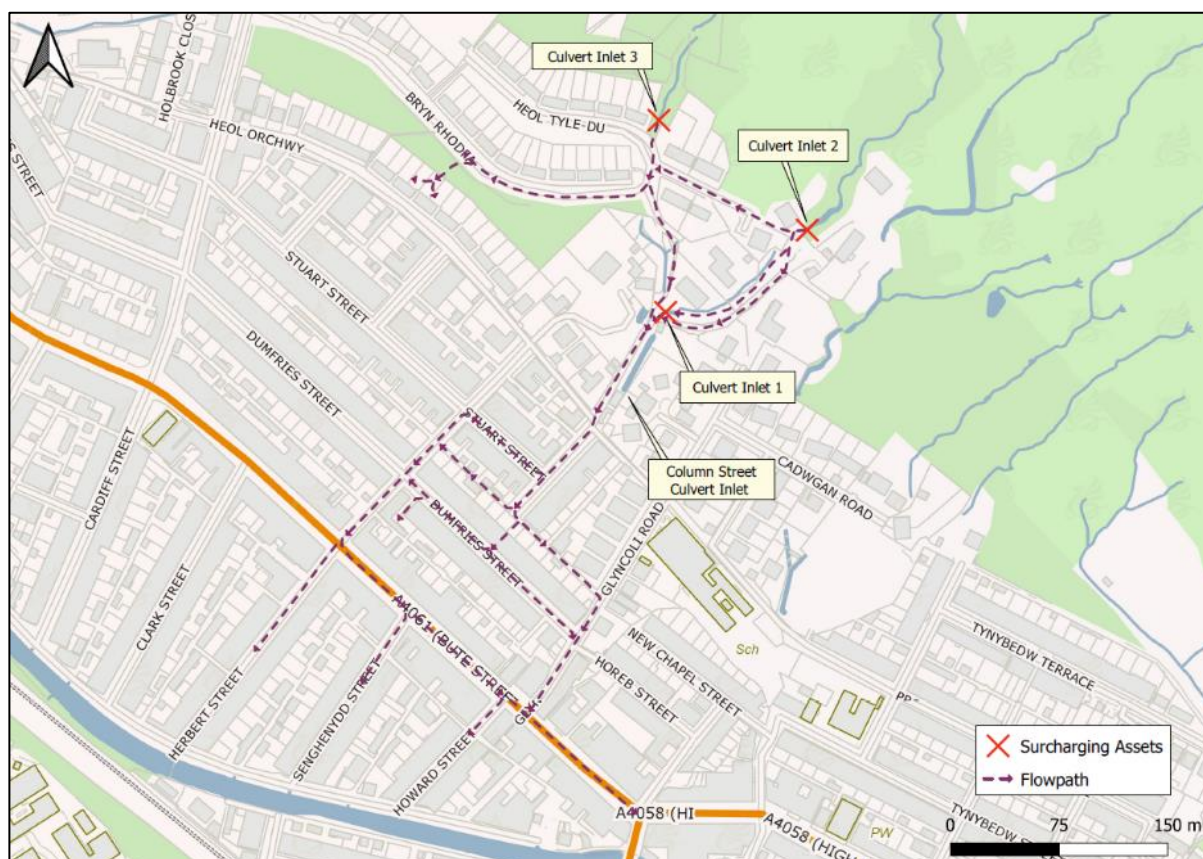
**Figure 4:** Observed flow paths within 'Nant Tyle-du' sub-catchment during Storm Dennis (16<sup>th</sup> February 2020)

Figure 4 depicts the observed pathways of flooding within the 'Nant Tyle-du' sub-catchment during Storm Dennis. The infrastructure known to have surcharged and contributed to the flooding are also illustrated in Figure 4.

Several calls were received from residents at Column Street and Dumfries Street on the 16<sup>th</sup> February 2020 to report water ingress into multiple residential properties associated to culvert blockages upstream of Column Street. Upon a site inspection undertaken by RCT's Flood Risk Management team on the 17<sup>th</sup> February 2020, three culvert inlets associated to the Nant Tye-du ordinary watercourse and its tributaries were identified as sources of flooding during the storm event. The location of the culvert inlets are illustrated in Figure 4.

The site inspection also identified evidence of a third surcharged culvert inlet located at Heol Tyle-Du (labelled 'Culvert Inlet 3' in Figure 4). This inlet conveys flows from the Nant Tyle-du ordinary watercourse towards the 'Column Street Culvert Inlet'. 'Culvert Inlet 3' was observed as surcharging by residents during the event, resulting in water conveying down Heol Tyle Du towards Bryn Rhodfa. At a low point along Bryn Rhodfa, water overtopped the kerb line before cascading down the hillside towards the rear of properties at Heol Orchwy. Four residential properties along Heol Orchwy were confirmed as internally flooded as a result of this flow path.

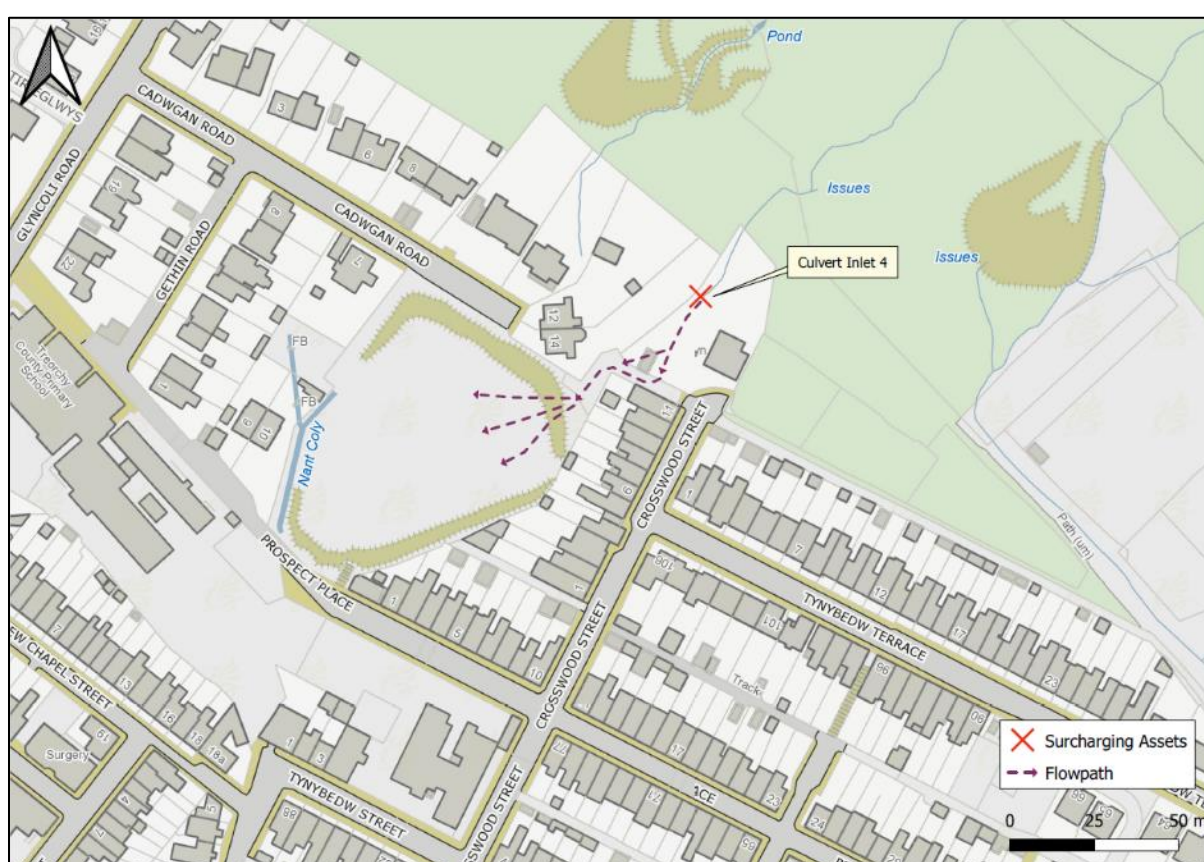
**Figure 9:** Observed flow paths within the 'Nant Coly' sub-catchment during Storm Dennis (16<sup>th</sup> February 2020)

Figure 9 depicts the observed pathways of flooding within the 'Nant Coly' sub-catchment during Storm Dennis. The infrastructure known to have surcharged and contributed to the flooding is illustrated in Figure 9.

Calls were received by residents at Crosswood Street to report water emanating from a culvert inlet situated north of Crosswood Street. Upon wider inspection of the area and discussions with residents, undertaken by RCT's Flood Risk Management team on 21<sup>st</sup> February 2020, one culvert inlet, labelled 'Culvert Inlet 4' in Figure 9, showed evidence of surcharge.

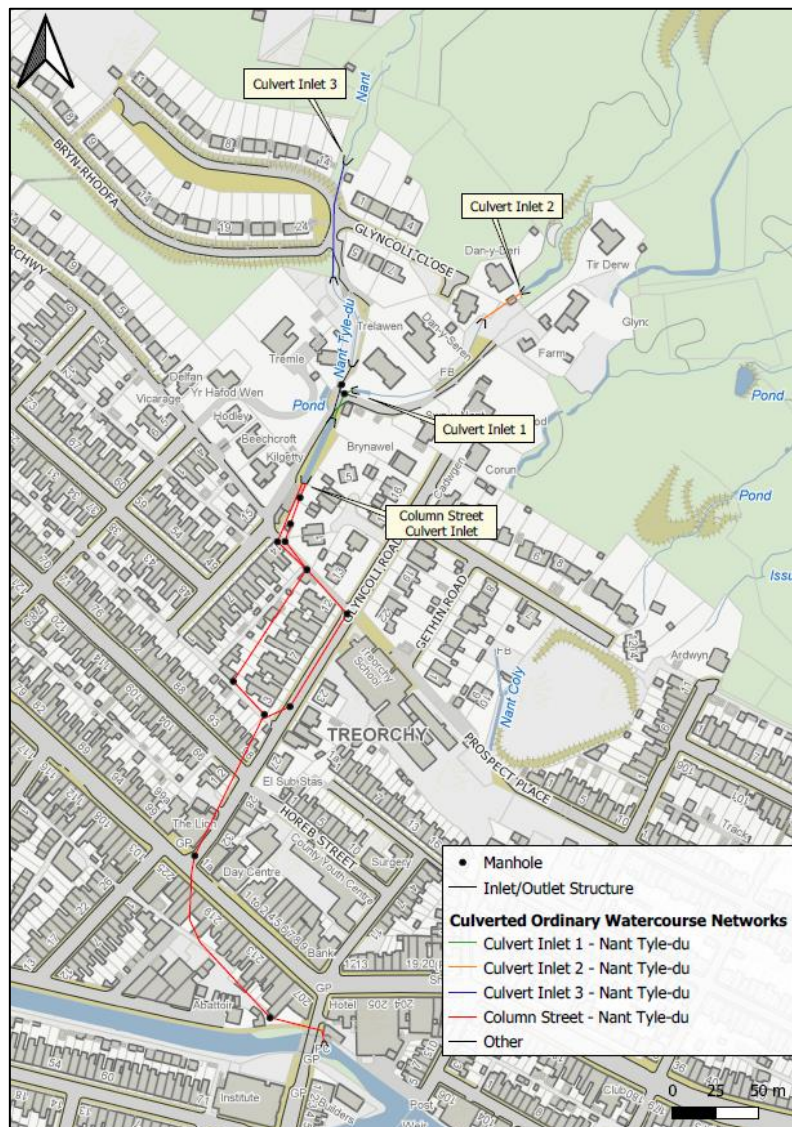
**Figure 11:** Surveyed culverted ordinary watercourse networks within the 'Nant Tyle-du' sub-catchment

Figure 11 outlines the four networks surveyed within the 'Nant Tyle-du' sub-catchment and highlights the culvert inlets known to have surcharged. All four culvert networks are associated to the Nant Tyle-du ordinary watercourse and its tributaries.

Culvert networks within the investigation area (Figures 11 and 17) were surveyed post event to ascertain the internal condition of the networks, the results of which fed into a review of the hydraulic performance of the network to ascertain its current standard of protection using Causeway Flow modelling. The results of the culvert inlet capacity assessments are summarised in the Table below (refer to Figure 11 for culvert labels).

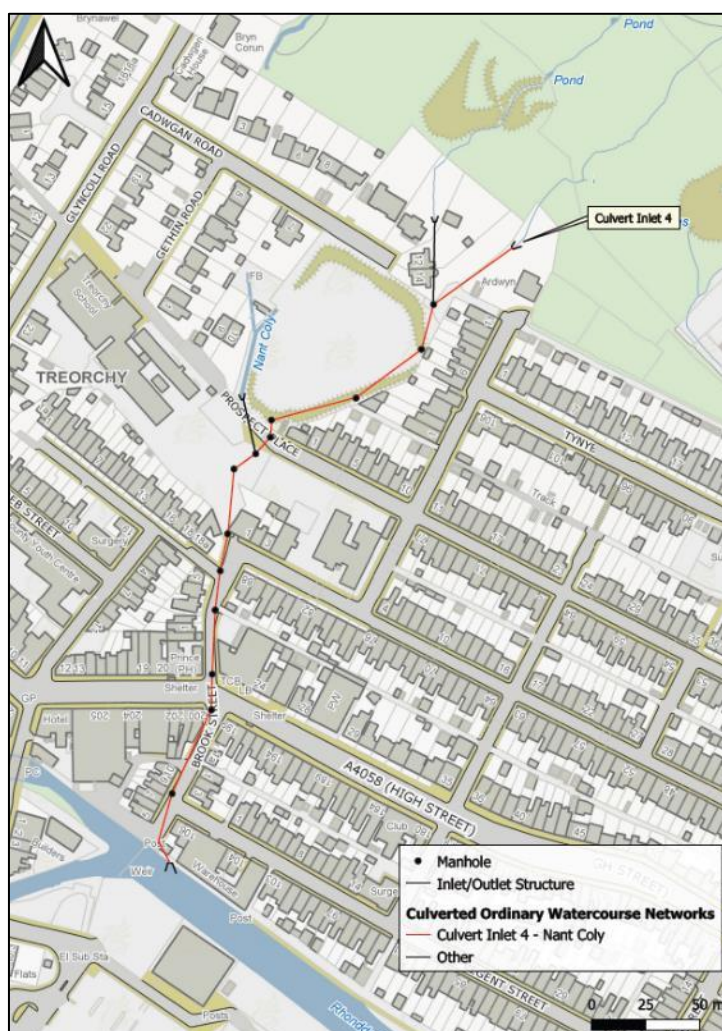
**Figure 17:** Surveyed culverted ordinary watercourse network within the 'Nant Coly' sub-catchment

Figure 17 depicts the 'Culvert Inlet 4' culverted ordinary watercourse network associated to the Nant Coly ordinary watercourse within the 'Nant Coly' sub-catchment.

'Culvert Inlet 4' was identified as the source of flooding to one residential property at Crosswood Street. The inlet was inspected by RCT's Flood Risk Management team in the days following the storm event and was found to be in poor condition (Figure 18).

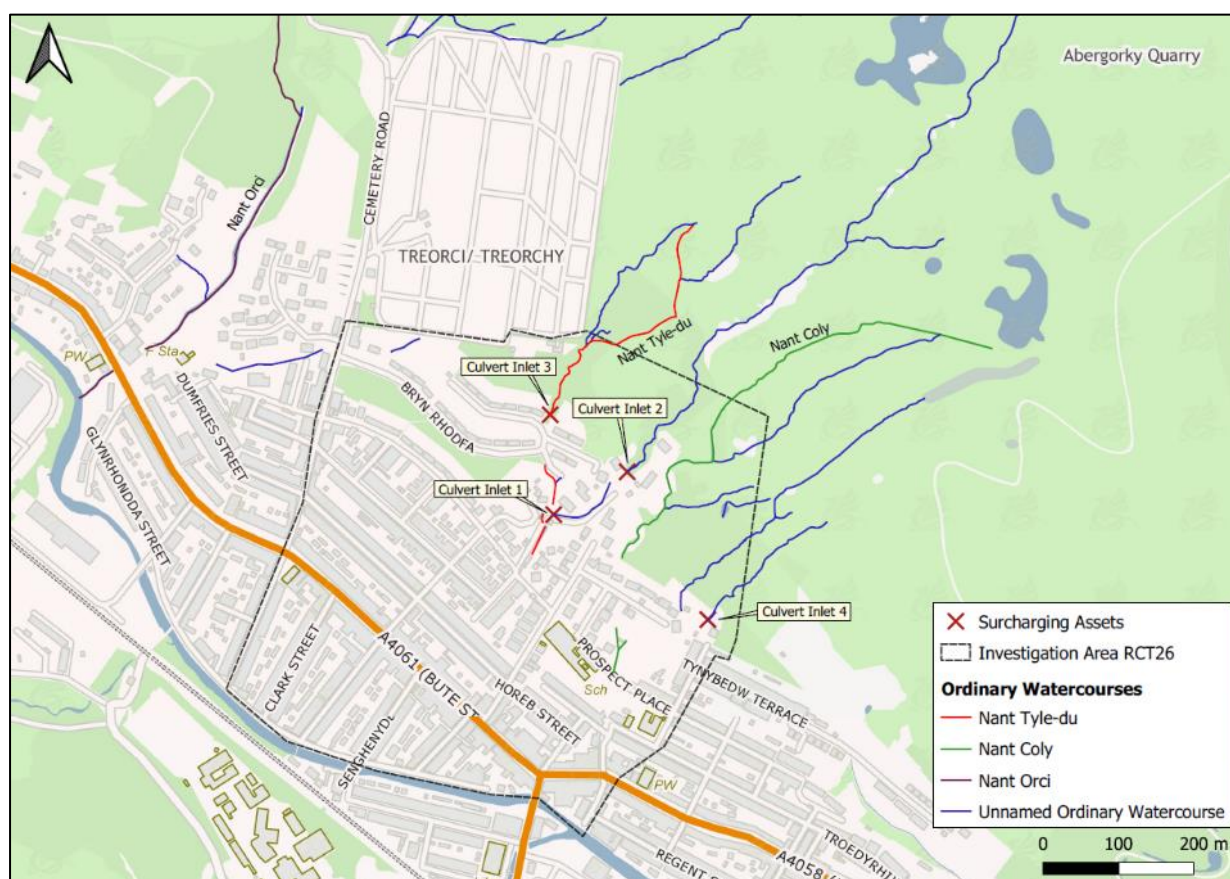
**Figure 19:** Map of Ordinary Watercourses which flow through investigation area RCT26

Several sections of natural ditches and open watercourses which drain the steep catchment above Treorchy are identified to flow through the investigation area, as illustrated in Figure 19. The most notable watercourses include the Nant Tyle-du and the Nant Coly. The Nant Orci drains the hillsides to the northwest of RCT26 and flows outside of the investigation area boundary.

Following the storm event, RCT Flood Risk Management officers carried out a site walk-over assessment of the ordinary watercourses upstream of the culvert inlets identified as sources of flooding (highlighted in Figure 19) to assess the condition of the watercourse for any signs of overtopping, evidence of scour and any land movement of the hillsides.

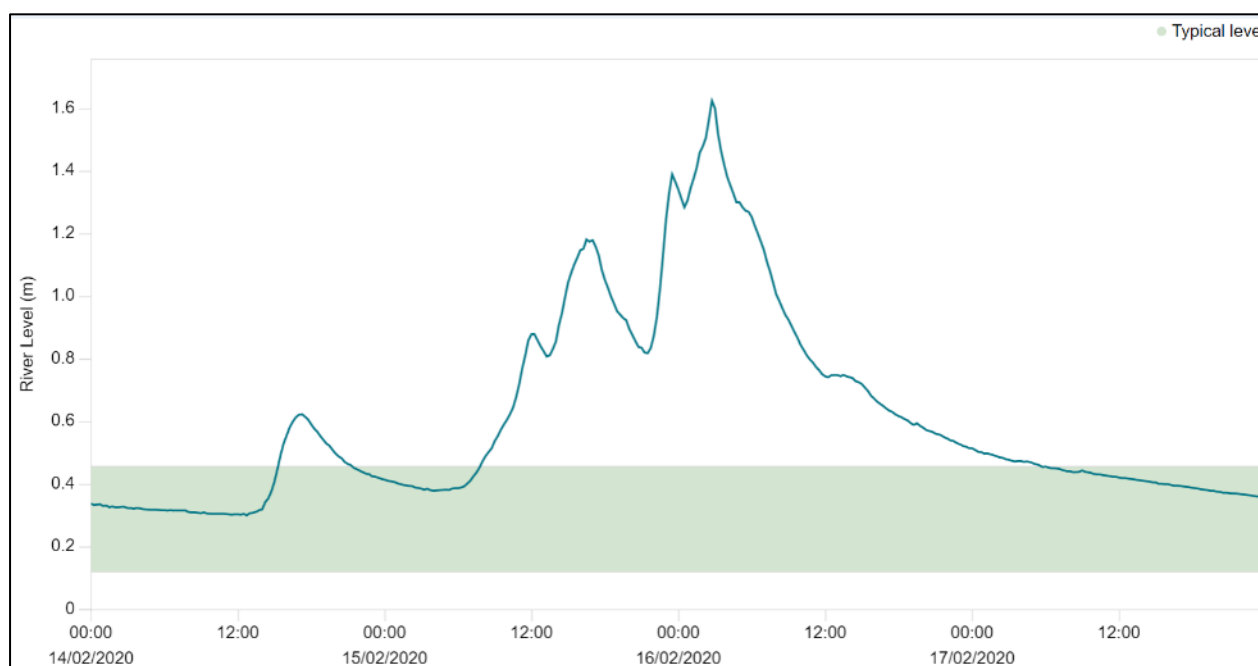
**Figure 26:** The Rhondda Fawr River levels at Tynewydd station between the 14th and 17th February 2020 (Natural Resources Wales)

The hydrograph in Figure 26 illustrates the rapid rise in levels of the River Rhondda Fawr in response to rainfall, captured NRW's Tynewydd station, located approximately 3 km upstream of RCT26. The River Rhondda Fawr at Tynewydd reached its highest peak recorded at 02:45 on 16<sup>th</sup> February 2020, reaching 1.62 metres.

The green bar displayed on the hydrograph shows the typical level of the River Rhondda Fawr at Tynewydd station, ranging between 0.1 and 0.5 meters. At its peak, the River Rhondda Fawr was over twice its average level, stressing the extreme and unprecedented levels that RCT's rivers rose to during the storm's peak intensity.
