**5. ADRODDIADAU YMCHWILIO I LIFOGYDD ADRAN 19**

**Atodiad L - Treorci**

# **Flood and Water Management Act 2010**

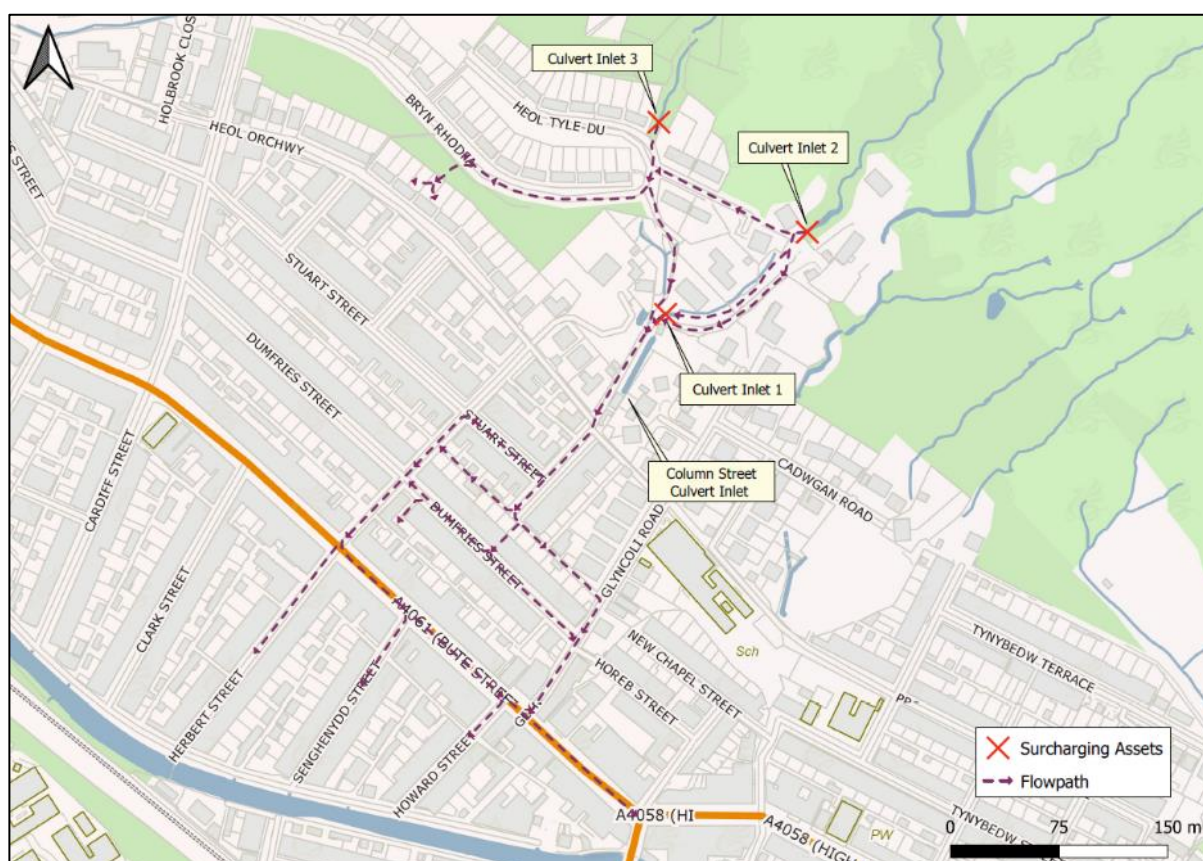
**Figure 4:** Observed flow paths within 'Nant Tyle-du' sub-catchment during Storm Dennis (16<sup>th</sup> February 2020)

Figure 4 depicts the observed pathways of flooding within the 'Nant Tyle-du' sub-catchment during Storm Dennis. The infrastructure known to have surcharged and contributed to the flooding are also illustrated in Figure 4.

Several calls were received from residents at Column Street and Dumfries Street on the 16<sup>th</sup> February 2020 to report water ingress into multiple residential properties associated to culvert blockages upstream of Column Street. Upon a site inspection undertaken by RCT's Flood Risk Management team on the 17<sup>th</sup> February 2020, three culvert inlets associated to the Nant Tye-du ordinary watercourse and its tributaries were identified as sources of flooding during the storm event. The location of the culvert inlets are illustrated in Figure 4.

The site inspection also identified evidence of a third surcharged culvert inlet located at Heol Tyle-Du (labelled 'Culvert Inlet 3' in Figure 4). This inlet conveys flows from the Nant Tyle-du ordinary watercourse towards the 'Column Street Culvert Inlet'. 'Culvert Inlet 3' was observed as surcharging by residents during the event, resulting in water conveying down Heol Tyle Du towards Bryn Rhodfa. At a low point along Bryn Rhodfa, water overtopped the kerb line before cascading down the hillside towards the rear of properties at Heol Orchwy. Four residential properties along Heol Orchwy were confirmed as internally flooded as a result of this flow path.

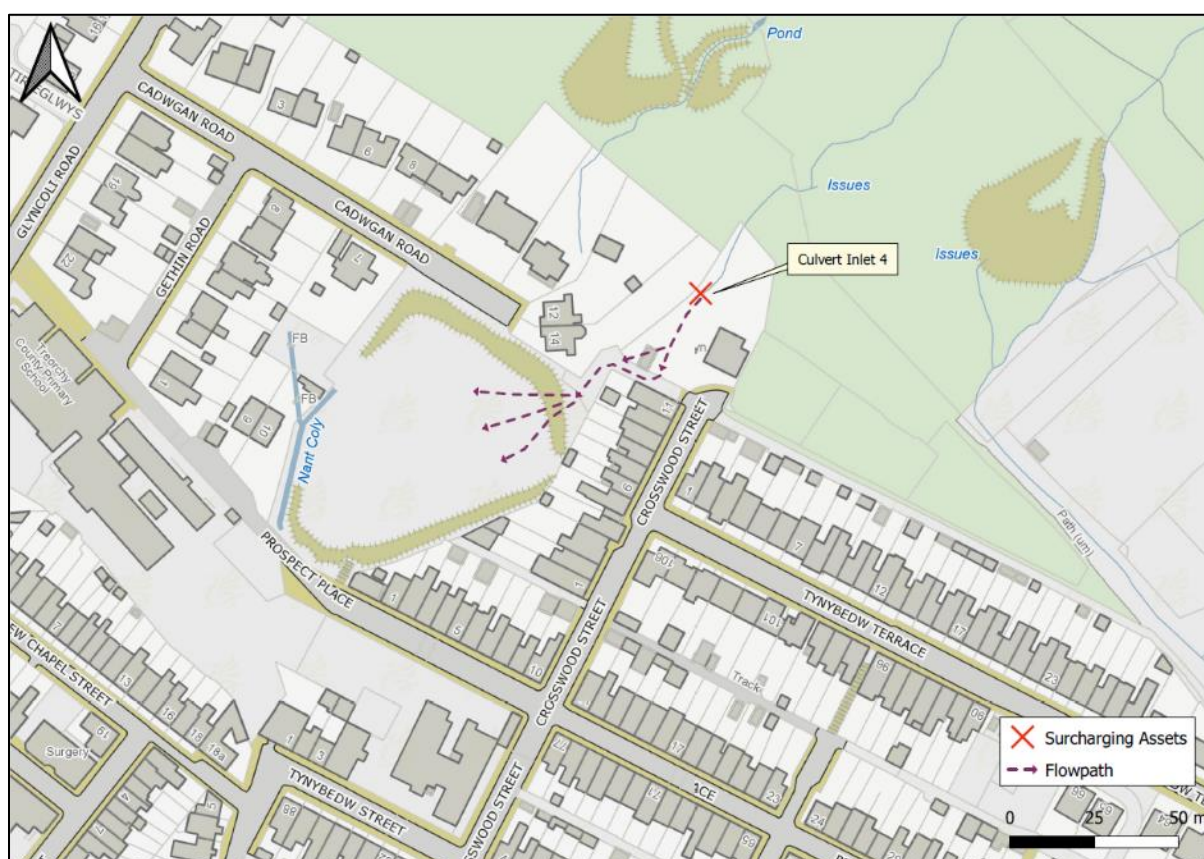
**Figure 9:** Observed flow paths within the 'Nant Coly' sub-catchment during Storm Dennis (16<sup>th</sup> February 2020)

Figure 9 depicts the observed pathways of flooding within the 'Nant Coly' sub-catchment during Storm Dennis. The infrastructure known to have surcharged and contributed to the flooding is illustrated in Figure 9.

Calls were received by residents at Crosswood Street to report water emanating from a culvert inlet situated north of Crosswood Street. Upon wider inspection of the area and discussions with residents, undertaken by RCT's Flood Risk Management team on 21<sup>st</sup> February 2020, one culvert inlet, labelled 'Culvert Inlet 4' in Figure 9, showed evidence of surcharge.

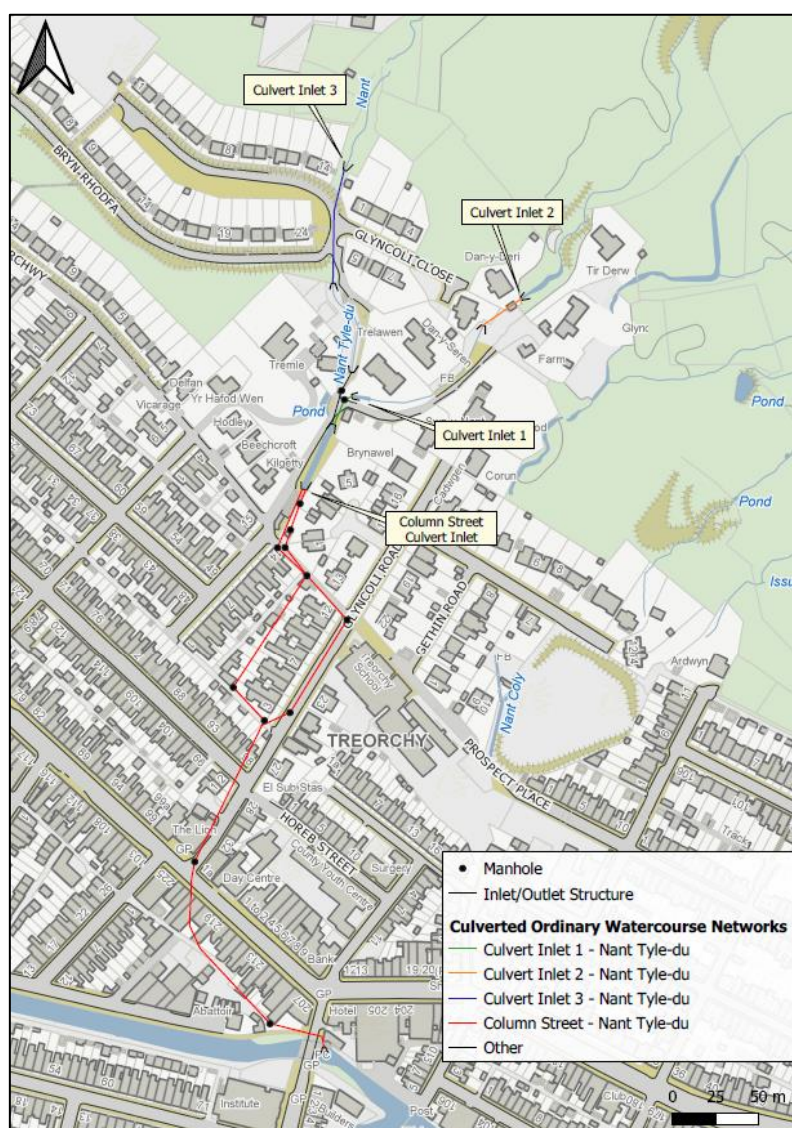
**Figure 11:** Surveyed culverted ordinary watercourse networks within the 'Nant Tyle-du' sub-catchment

Figure 11 outlines the four networks surveyed within the 'Nant Tyle-du' sub-catchment and highlights the culvert inlets known to have surcharged. All four culvert networks are associated to the Nant Tyle-du ordinary watercourse and its tributaries.

Culvert networks within the investigation area (Figures 11 and 17) were surveyed post event to ascertain the internal condition of the networks, the results of which fed into a review of the hydraulic performance of the network to ascertain its current standard of protection using Causeway Flow modelling. The results of the culvert inlet capacity assessments are summarised in the Table below (refer to Figure 11 for culvert labels).

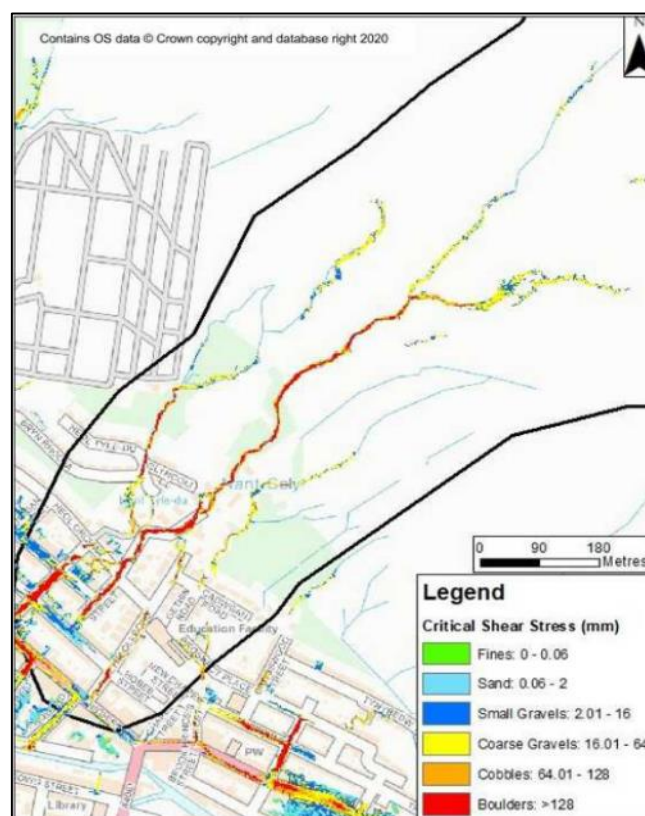
**Figure 25:** Critical shear street results in the Q100 flood event produced by JBA's hydraulic modelling

Hydraulic modelling was undertaken by JBA to calculate the shear stresses produced during a 1 in 100 annual probability event (Q100) (Figure 25). The model results show that during a Q100 flood event, akin to extreme storm events such as Storm Dennis, significant velocities in the ordinary watercourse channels generate shear stresses capable of entraining sediment up to cobble and boulder size through most of the channel lengths. This is particularly apparent along the Nant Tyle-du and its tributaries, where debris and sediment mobilisation has been attributed as the primary cause of surcharge at 'Culverts 1, 2 and 3'.

Shear stresses along the Nant Coly and its tributaries are less severe which also supports the conclusion that morphological processes had less impact on the surcharge of 'Culvert Inlet 4'. The surcharging at this inlet has been attributed to the watercourse and culvert inlet becoming hydraulically overwhelmed during the storm event.

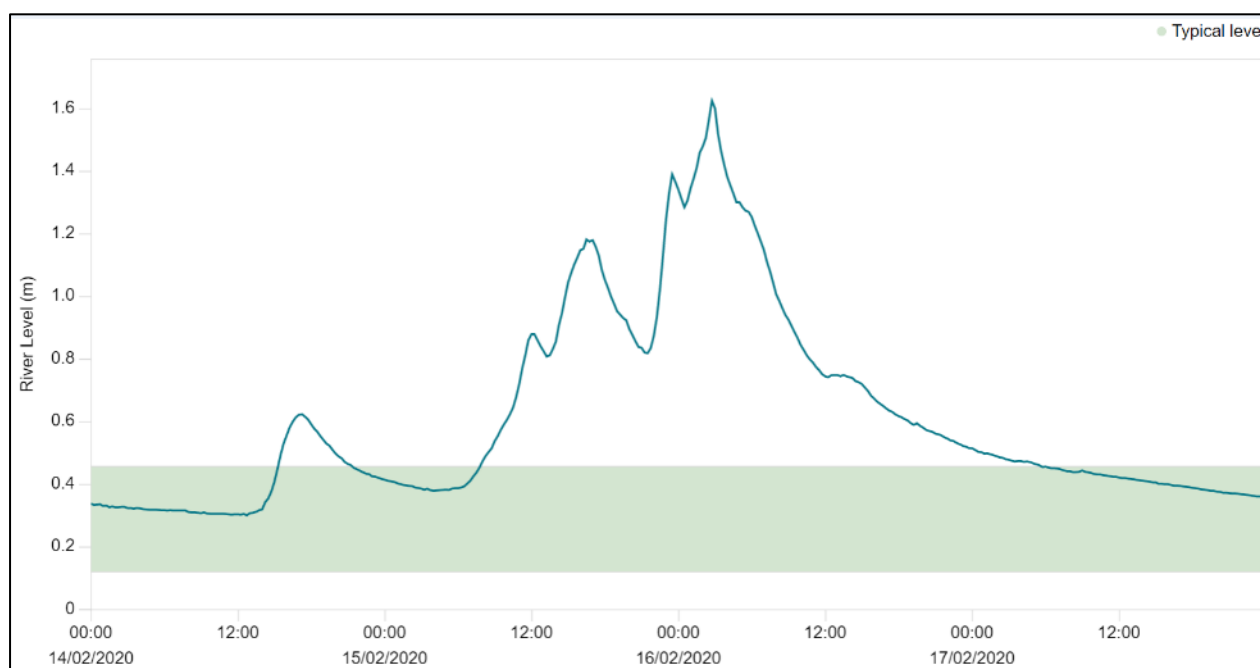
**Figure 26:** The Rhondda Fawr River levels at Tynewydd station between the 14th and 17th February 2020 (Natural Resources Wales)

The hydrograph in Figure 26 illustrates the rapid rise in levels of the River Rhondda Fawr in response to rainfall, captured NRW's Tynewydd station, located approximately 3 km upstream of RCT26. The River Rhondda Fawr at Tynewydd reached its highest peak recorded at 02:45 on 16<sup>th</sup> February 2020, reaching 1.62 metres.

The green bar displayed on the hydrograph shows the typical level of the River Rhondda Fawr at Tynewydd station, ranging between 0.1 and 0.5 meters. At its peak, the River Rhondda Fawr was over twice its average level, stressing the extreme and unprecedented levels that RCT's rivers rose to during the storm's peak intensity.
