CYNGOR BWRDEISTREF SIROL
RHONDDA CYNON TAF
COUNTY BOROUGH COUNCIL

DYMA WŶS I CHI i gyfarfod hybrid o **PWYLLGOR TROSOLWG A CHRAFFU** yn cael ei gynnal ar **DYDD LLUN, 28AIN CHWEFROR, 2022** am **5.00 PM**.

5. ADRODDIADAU YMCHWILIO I LIFOGYDD ADRAN 19

Derbyn adroddiadau Ymchwilio i Lifogydd Adran 19 y Cyngor o dan Ddeddf Rheoli Llifogydd a Dŵr 2010.

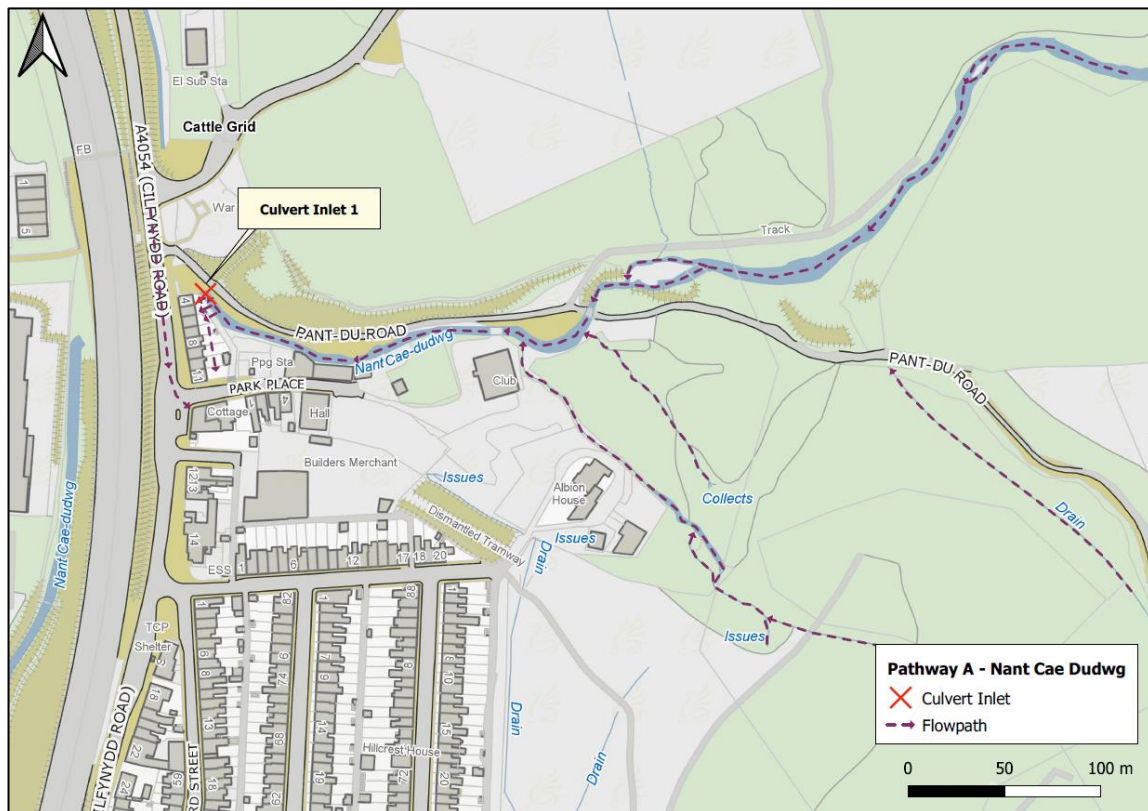
Several calls were received from residents at Cilfynydd Road on the 16th February 2020, to report that water from the Nant Cae Dudwg watercourse had overtopped the flood wall at the inlet (labelled 'Culvert Inlet 1' in Figure 4) and was threatening to enter the rear gardens of properties situated directly downstream of the culvert inlet. The inlet location is provided in Figure 4.

Figure 4: Map illustrating flow path A and the Nant Cae Dudwg culvert inlet, 'Culvert Inlet 1'

During the early hours of Sunday 16th February, the Nant Cae Dudwg ordinary watercourse overtopped the flood wall at the inlet, causing water to accumulate within the lane behind properties at Cilfynydd Road. The result of which saw riverine debris including silt and mud being deposited in the lane area. This resulted in blockages to the surface water drainage gullies in the lane, reducing the capacity of the drainage network to manage the excess water (Figure 5).

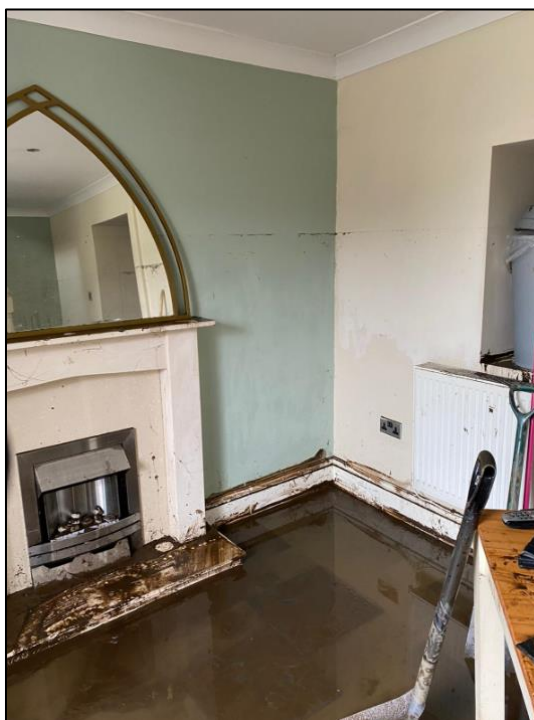
Figure 7: Water depth marks in a property at Cilfynydd Road following Storm Dennis (image provided by resident)

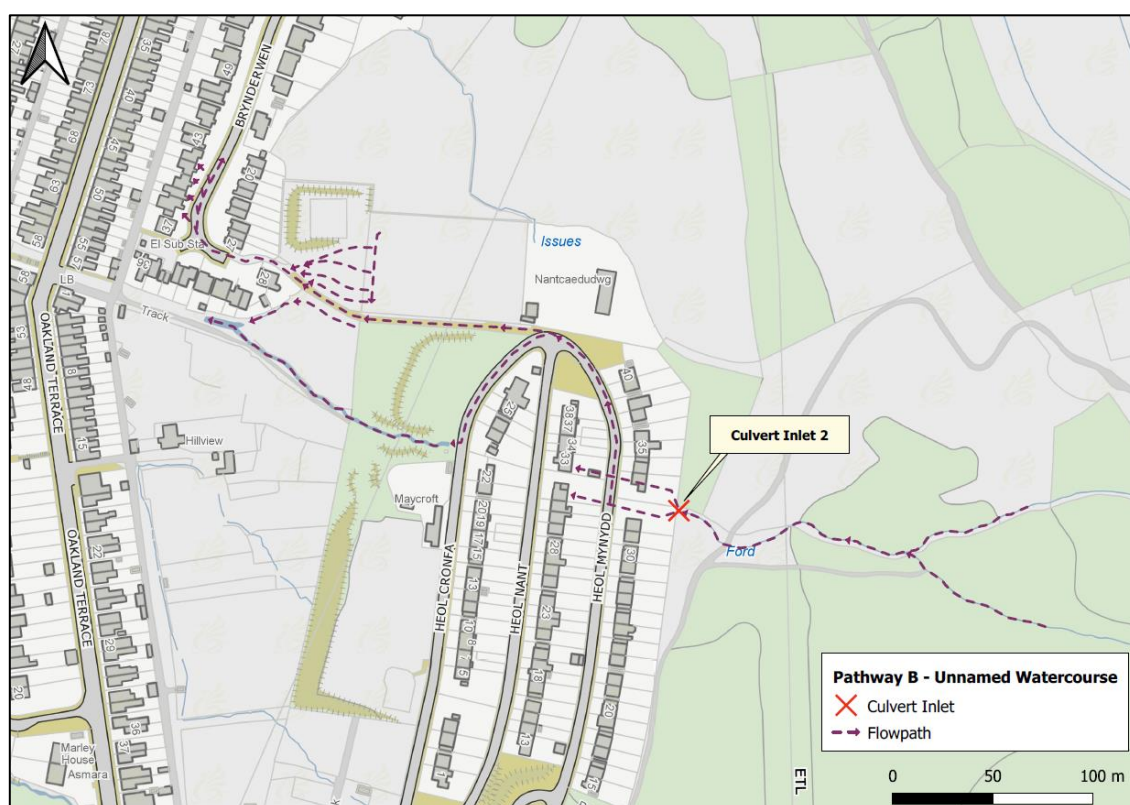
Pathway B, shown in Figure 3, shows where surface water flows from the east of Cilfynydd enter the town through an unnamed ordinary watercourse. The watercourse crosses the town via several culverts before discharging into the River Taff. Calls were received from residents at Heol Mynydd and Heol Nant to report that water from the unnamed watercourse to the rear of Heol Mynydd was overtopping near the inlet and beginning to flood properties. The inlet's location, labelled 'Culvert Inlet 2', is provided in Figure 8.

Figure 8: Map illustrating flow path B the culvert inlet of the unnamed watercourse, 'Culvert Inlet 2'

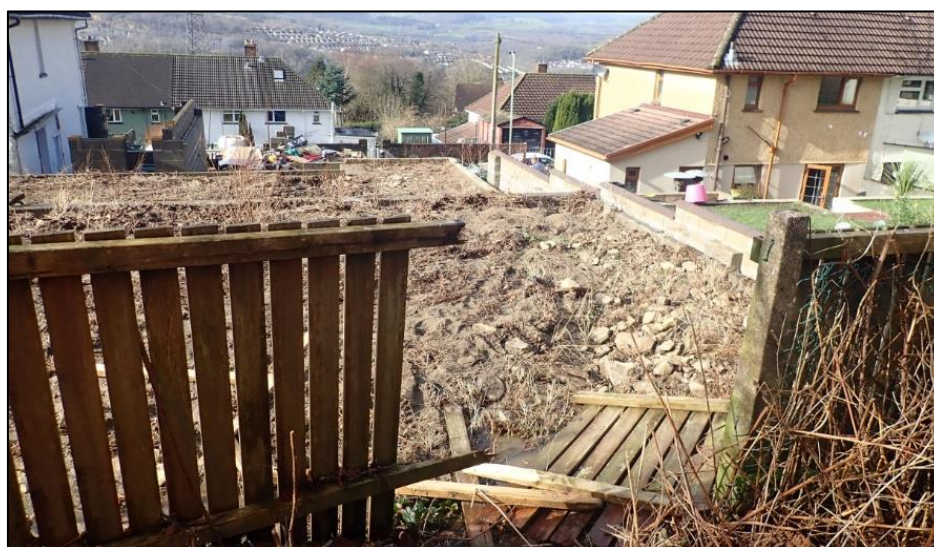
Post event inspections identified the inlet's debris screen as blocked with woody debris mobilised during the event, reducing the inlet's capacity to manage the flow and causing the inlet to surcharge and flood. According to residents, water was observed to have overtopped the garden walls to the rear of Heol Mynydd, flowing through the properties and out onto the street (Figure 9). Water then continued to flow downhill, flooding two properties on Heol Nant from the rear. As the water cascaded over the

Figure 9: Damages to rear garden of a property at Heol Mynydd following the storm event (captured by FRM officers on 17th February 2020)

Four properties were identified as internally flooded due to the floodwater's initial pathway. Emergency clearance works were undertaken by the Council's Highway and Streetcare Depot to remove the debris from the inlet and cleanse the highway drainage infrastructure.

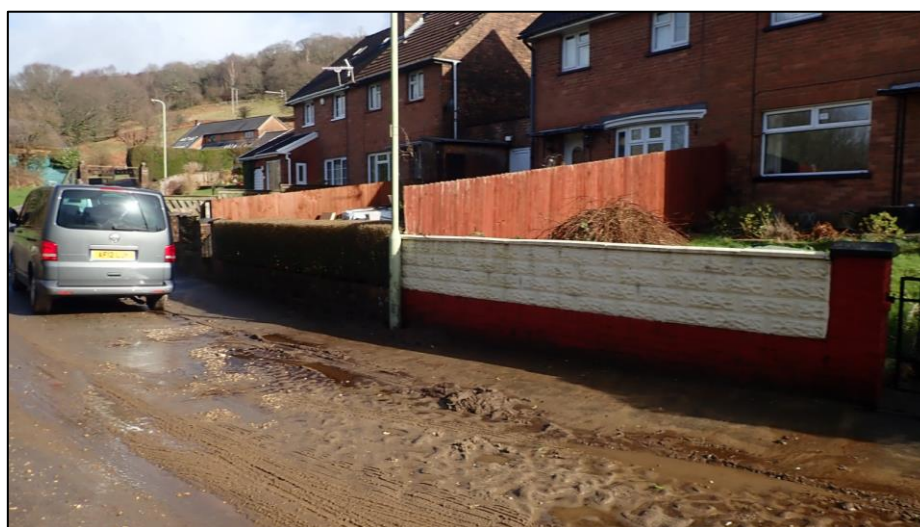
roads and gardens of Heol Nant and Heol Cronfa, much of the water made its way back into the watercourse towards Oakland Terrace. Mud and silt deposited along the highway were identified by the inspection teams (Figure 10) indicating the flow path of the water during the storm event.

Figure 10: Road damages and debris deposited along Heol Cronfa following the storm event (captured by FRM officers on 17th February 2020)

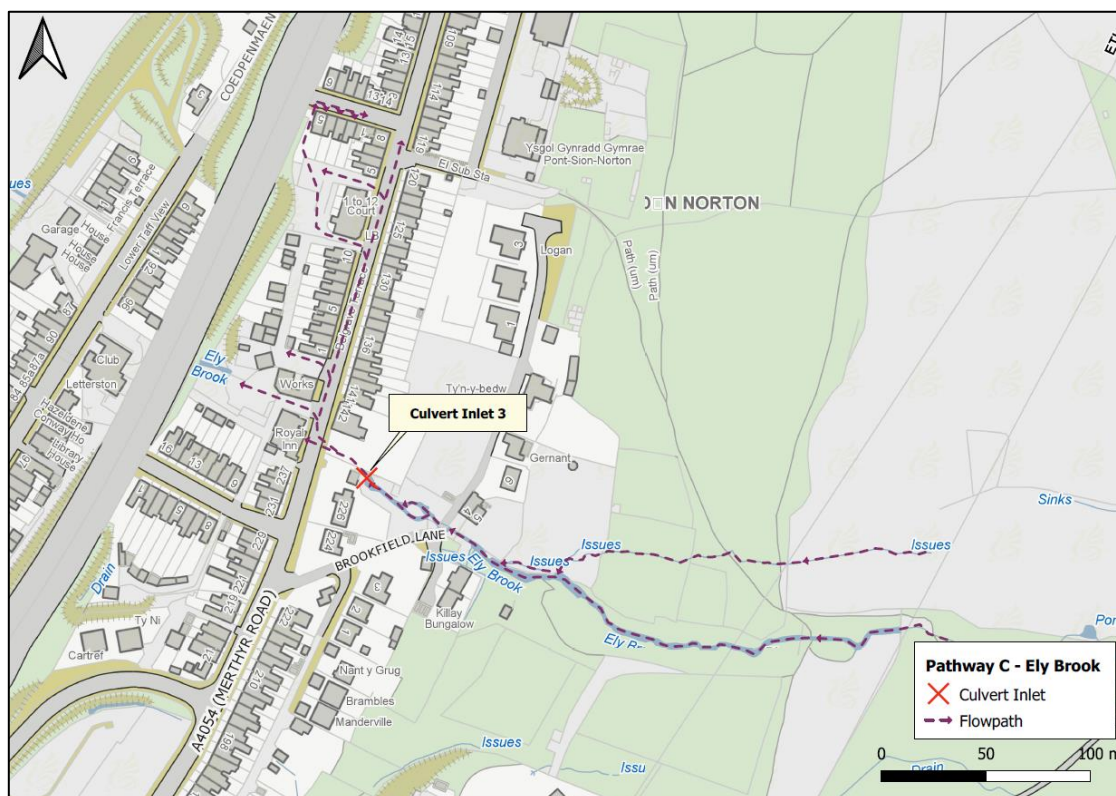
Pathway C, shown in Figure 3, shows where surface water flows enter the investigation area from the southeast corner of the catchment. The surface water flows through the Ely Brook ordinary watercourse, passes through the southern catchment via several culverts, and ultimately discharges into the River Taff. On its course of flow, the Ely Brook culvert ('Culvert Inlet 3', Figure 13) surcharged at the inlet opposite the Royal Oak Inn and resulted in flooding to properties and the highway during the storm event. The inlet location is shown in Figure 13.

The evidence suggests the inlet became blocked with debris during the storm event which caused water to overflow from the culvert inlet and flow down the driveway of a residential property opposite the Royal Oak Inn, and onto Pontshonnorton Road. Post event inspections also identified a section of the tarmac driveway to have suffered from subterranean hydraulic pressure, i.e., the driveway appears to indicate that water from the culvert network erupted, through the tarmac and contributed to the flooding along Pontshonnorton Road (Figure 14).

Figure 13: Map illustrating flow path C and the Ely Brook culvert inlet, 'Culvert Inlet 3'

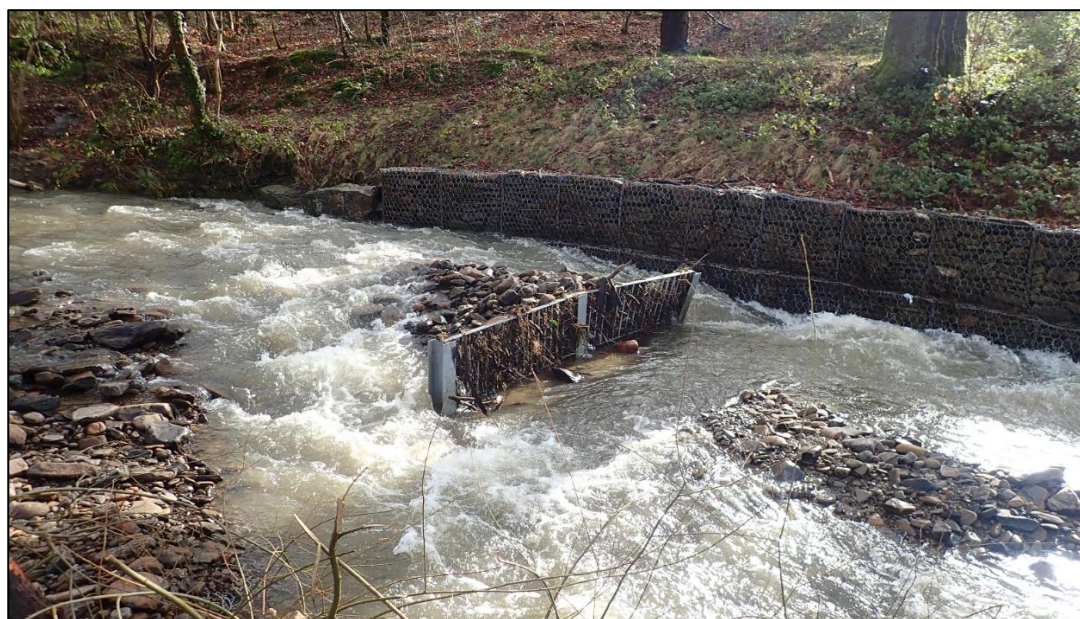
A general assessment of the Nant Cae Dudwg watercourse revealed significant deposition of large stones and boulders within the channel. Figures 22 and 23 were captured on the 17th February 2020 and show significant accumulation of natural material across the full width of the upper catchment debris screens. A Council appointed contractor carried out the removal of all large debris from the watercourse following Storm Dennis which totaled approximately 350 tons.

Figure 23: Second upstream debris screen in the Nant Cae Dudwg watercourse (captured by RCT's Flood Risk Management team on 17th February 2020)

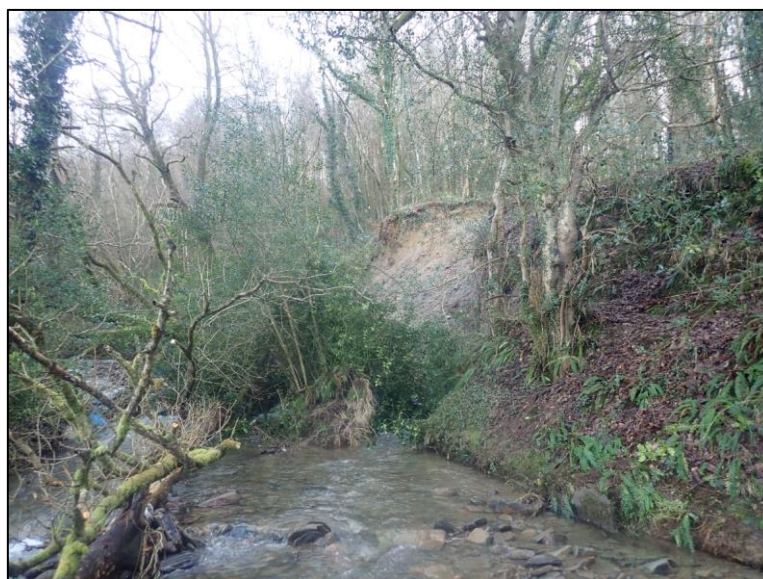
Evidence of embankment scour and localised landslips were identified along sections of the Nant Cae Dudwg watercourse (Figures 26 and 27). It is considered that this scoured material contributed to the volume of debris deposited along the watercourses' upper debris screens.

Figure 26: Photo of localised landslip on the embankment of the Nant Cae Dudwg watercourse (image captured by RCT's Flood Risk Management team on 02/03/2020)

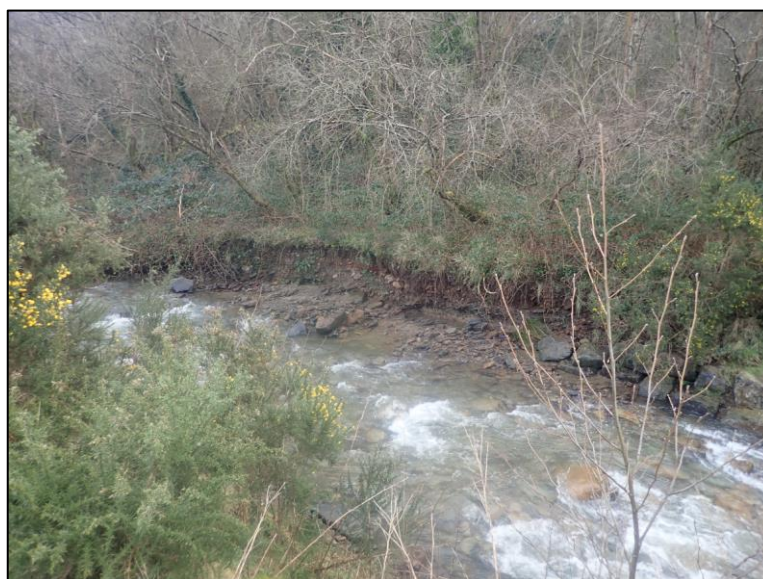
Figure 27: Photo of embankment scour to the Nant Cae Dudwg watercourse (image captured by RCT's Flood Risk Management team on 02/03/2020)

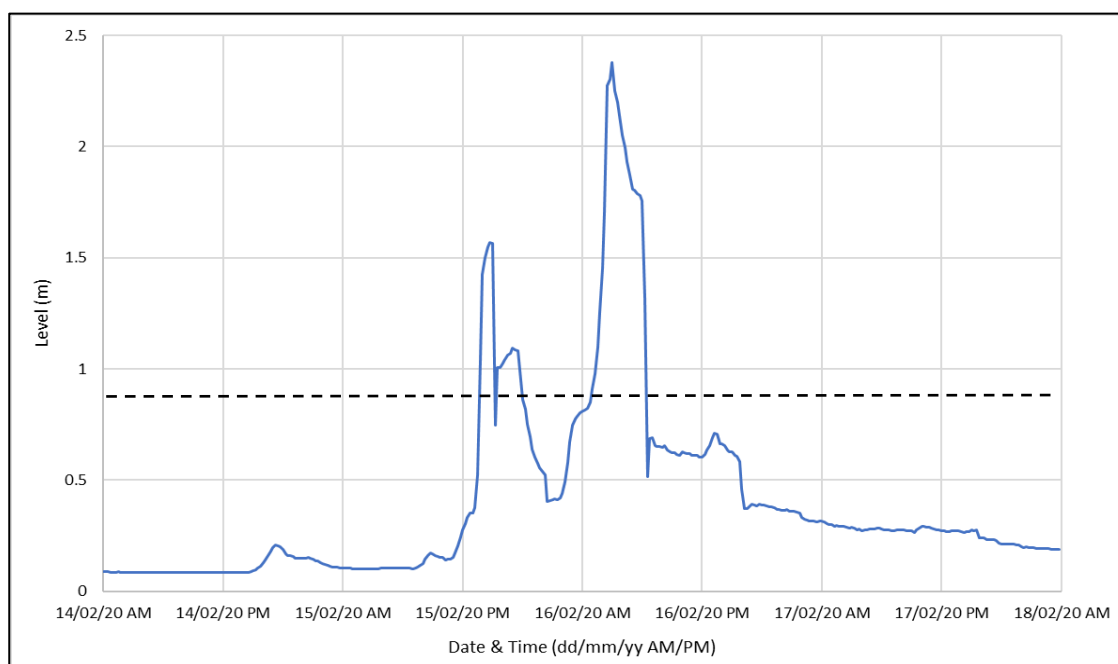
Based on data captured by RCT's Nant Cae Dudwg monitoring station, the storm resulted in two significant peaks in the level of flow within the Nant Cae Dudwg watercourse. Both peaks are illustrated in Figure 28. The initial peak triggered the alarm system at 13:45 on 15th February 2020 which resulted in a peak watercourse level of 1.567 meters at 14:45. During this hour the Nant Cae Dudwg rose suddenly by 528mm. The second and most prominent peak activated the alarm system at 01:00 on 16th February 2020 and caused a peak level of 2.37m at 03:00.

Figure 28: Water level in the Nant Cae Dudwg ordinary watercourse during the 14 – 18th February 2020 captured by RCT's monitoring station. Dashed line represents the alarm trigger threshold (0.9m)

Based on data captured by the monitoring station, and accounts provided by residents, it is considered that the volume of water in the Nant Cae Dudwg watercourse exceeded the capacity of the inlet and headwall structures during the early hours of Sunday 16th February 2020. This resulted in the watercourse backing up the channel where the flood water overtopped the flood wall before ultimately entering the affected properties from the rear.

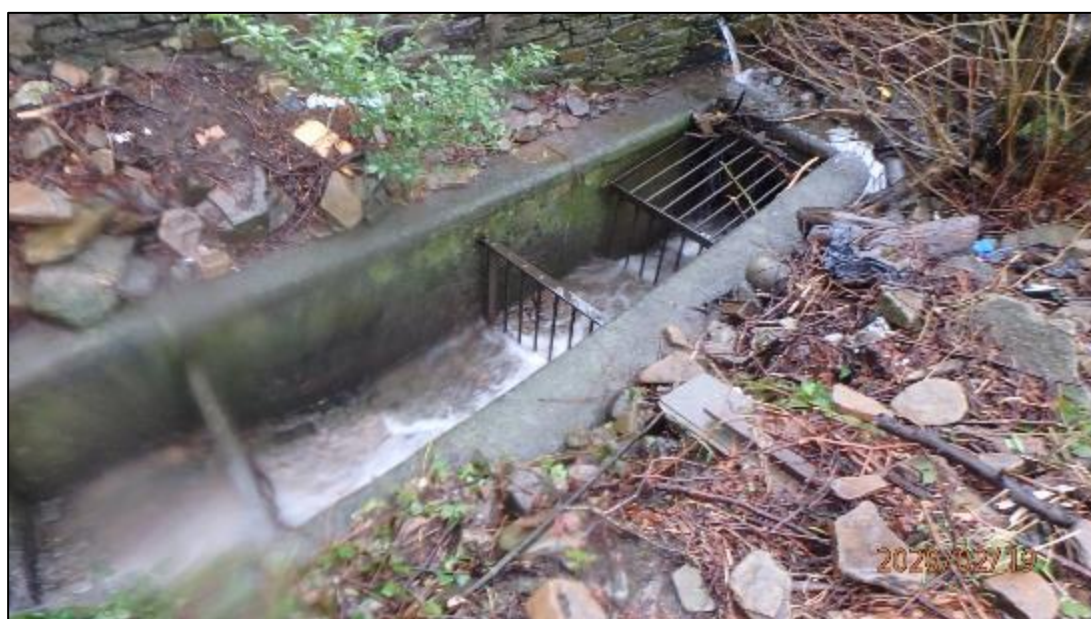
The site inspection also identified evidence of a third surcharged culvert inlet located near Dumfries Street (labelled 'Culvert Inlet 3' in Figure 4). This culvert inlet conveys flows from the Nant Coedcaetyllefforest ordinary watercourse. Evidence of cleared debris was identified (Figure 7) post event, indicating that the culvert inlet became blocked during Storm Dennis, resulting in surcharge.

Figure 7: 'Culvert Inlet 3' to the rear of Dumfries Street which surcharged during Storm Dennis (captured by RCT's Flood Risk Management team on 19th February 2021)

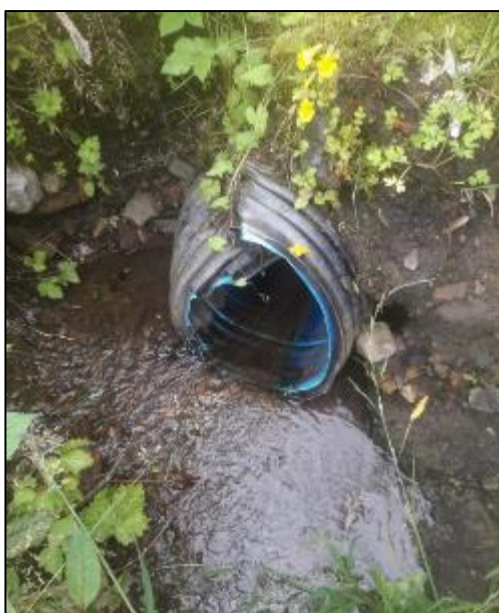
The culvert network length between 'Culvert Inlet 1' and 'Culvert Inlet 2', situated behind New Park Garage, consists of a 450mm plastic pipe which was noted as deformed during CCTV survey operations (Figure 12). Upon site inspections of the inlet during storm event conditions, water is observed to bypass 'Culvert Inlet 1' and flow over the top of the pipework towards 'Culvert Inlet 2'. This flow path is assumed to have occurred during Storm Dennis.

Figure 12: 'Culvert Inlet 1' captured during CCTV survey operations on 30/06/2020

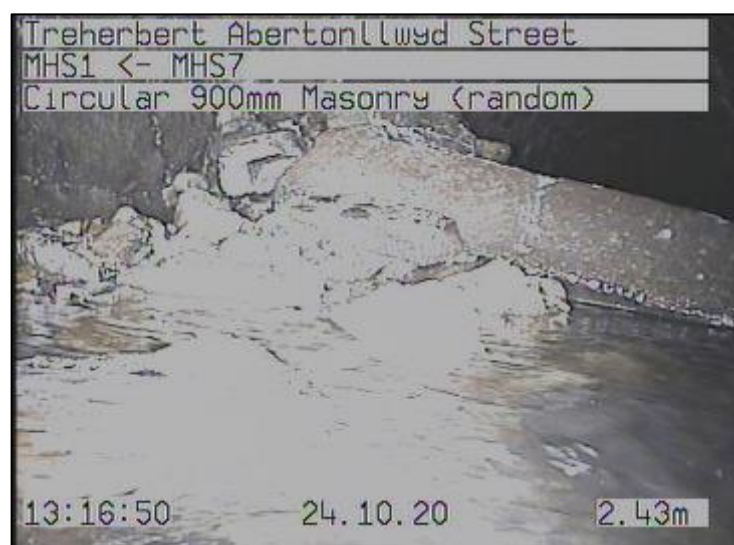
Surcharging at 'Manhole 1' was also identified as a secondary source of flooding to properties at Abertonllwyd and Dunraven Streets during Storm Dennis. Both CCTV survey operations were also abandoned downstream of 'Manhole 1' due to settled deposits and large debris identified within the network (depicted in Figure 15). The culvert network downstream of 'Manhole 1' was also graded as being in very poor structural condition.

Figure 15: Internal view of 'Abertonllwyd Street Culvert Network 1' downstream of 'Manhole 1' (CCTV survey footage captured 24/10/2020)

The poor condition of the culvert network downstream of 'Manhole 1' is considered to have contributed to its surcharging during Storm Dennis. The debris identified within the network is also indicative of the high flow rates which enabled the erosion and transportation of a significant volume of debris from the upper catchment and subsequent deposition within the culvert network during the storm event.

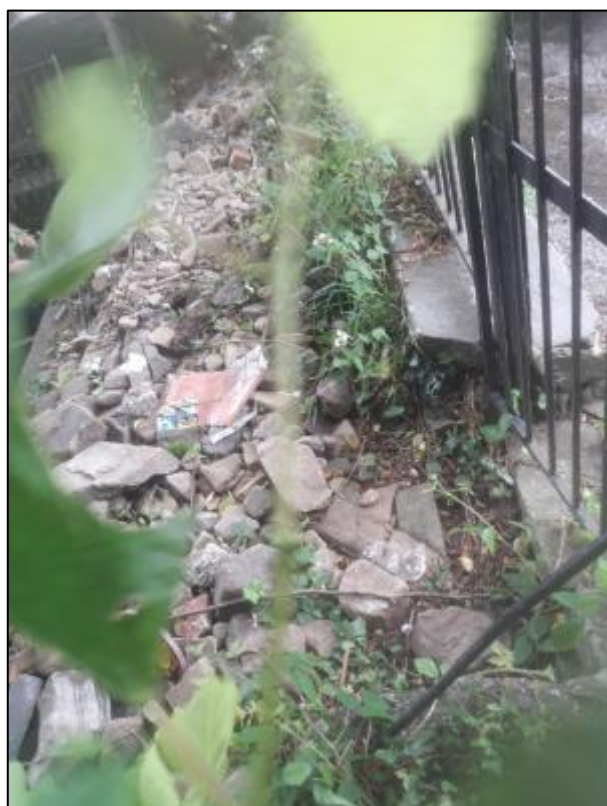
The 'Dumfries Street Culvert Network' was also surveyed to be in poor condition, with significant operational and structural defects identified throughout the network. The volume of settled deposits led to operators abandoning the CCTV survey operations on two occasions. As a result, approximately 5 tonnes of debris was removed from the network (shown in Figure 16).

Figure 16: Debris removed from the 'Dumfries Street Culvert Network' during cleansing operations (image captured on 29/06/2020)

Similarly to the Abertonllwyd Street culvert networks, the debris identified within the Dumfries Street network highlights the strength of the ordinary watercourse flows that would have been travelling down the hillsides above RCT27 and entering the culvert networks during the storm event. Its poor condition is considered to have contributed to the surcharging of 'Culvert Inlet 3', however, the blockage to the inlet structure has been determined as the most significant contributor to the flood flow path along Dumfries and Dunraven Streets during Storm Dennis.

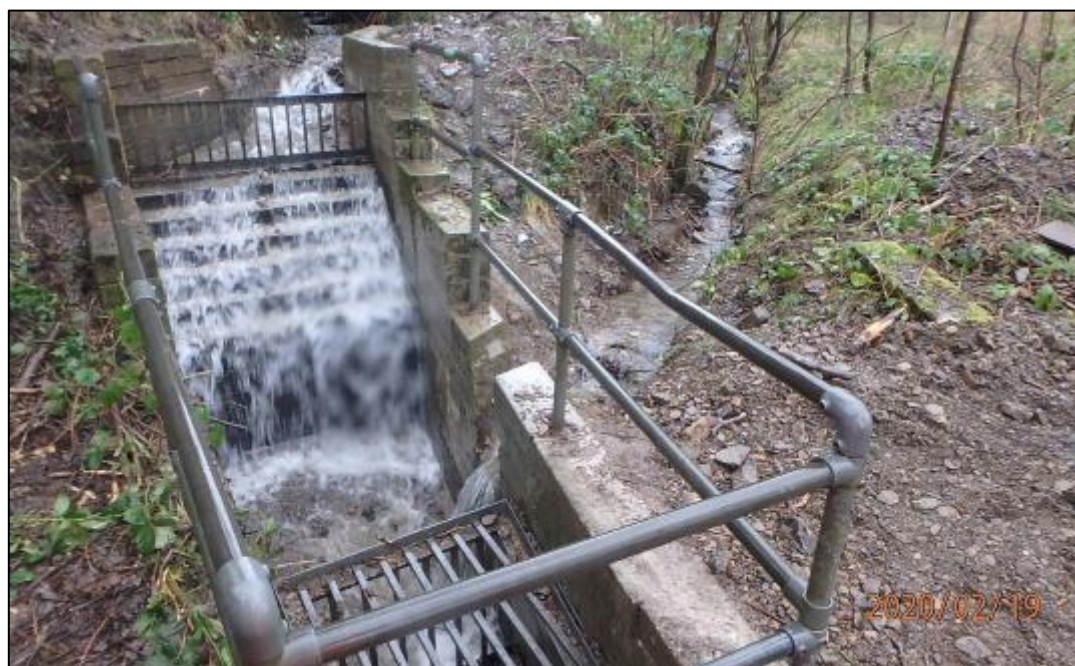
The 'Culvert Inlet 6' structure was identified by first responders as being blocked with debris and was subsequently cleansed. Figure 18 captured post event by FRM officers depicts the inlet following clearance works.

Figure 18: Photo of 'Culvert Inlet 6' captured by RCT's Flood Risk Management team following debris clearance post Storm Dennis (19/02/2020)

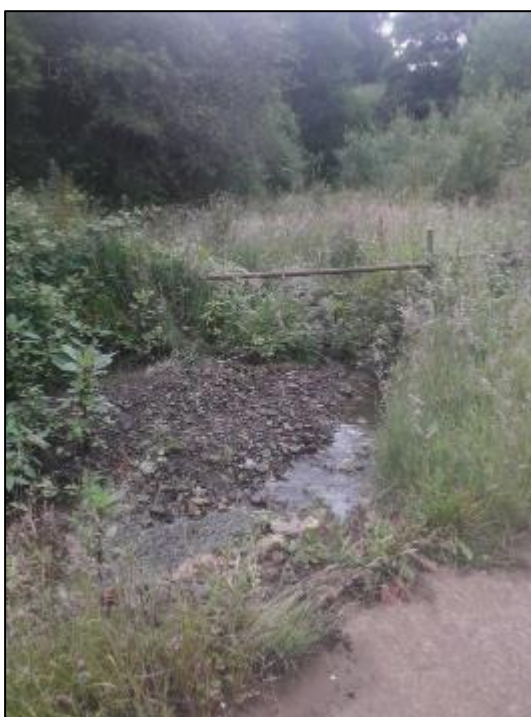
According to on-site officers, several sections of open watercourse upstream of the 'Abertonllwyd Street Culvert Network 1' (Figure 11) had significant build-up of debris within the channels, indicating significant mobilisation of debris occurred during the storm event (depicted in Figure 20). The conveyance of sediment, silt and stone downstream is considered to have contributed to the surcharging of 'Culvert Inlet 1' and 'Culvert Inlet 2' during Storm Dennis. This debris is also considered to have entered the culvert network, contributing to the surcharge of 'Manhole 1' during the event.

Figure 20: Image of debris accumulation within the unnamed ordinary watercourse channel upstream of 'Culvert Inlet 1' (Figure 4) (captured during CCTV operations on 30/06/2020)

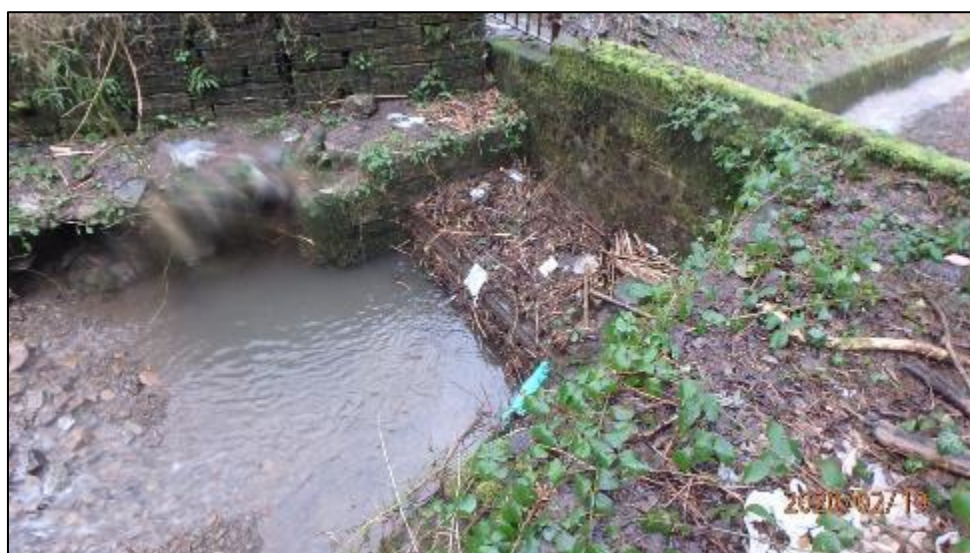
The upstream sections of the Nant Coedcaetylefforest ordinary watercourse (Area 1, Figure 21) showed evidence of debris deposition within the man-made channel, along with significant accumulation of material across the upper debris screens and headwall structure. Figure 22 and 23 depicts the material, which consists of coarse stone, silt and woody debris, within the upper channel. This material is assumed to have been mobilised from the upper reaches above the A4061 (Rhigos Road) and carried downstream by the high flows during Storm Dennis.

Figure 23: Photo of debris accumulation in the upper reaches of the Nant Coedcaetylefforest ordinary watercourse (below the A4061) (captured by RCT's Flood Risk Management team on 19/02/2020)

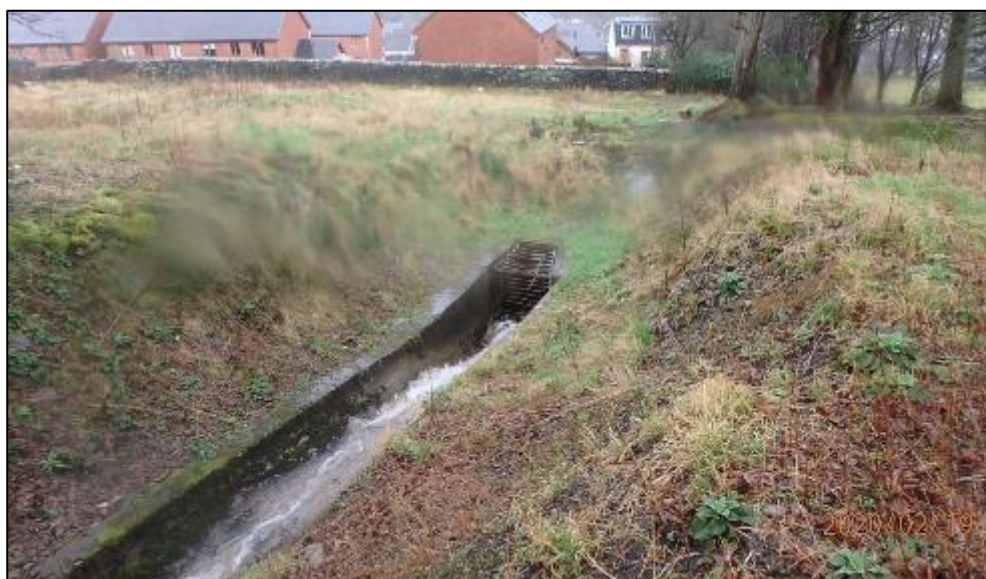
Below the headwall structure, the channel and culvert inlet (Area 2, Figure 21) did not show evidence of debris conveyance or blockage to the inlet, as shown in Figure 24. It is considered that the upstream debris screens at Area 1 succeeded in minimising the volume of debris travelling downstream.

Figure 24: Culvert inlet at Area 2 which conveys the Nant Coedcaetylleforest ordinary watercourse towards Area 3 (captured by RCT's Flood Risk Management team on 19/02/2020)

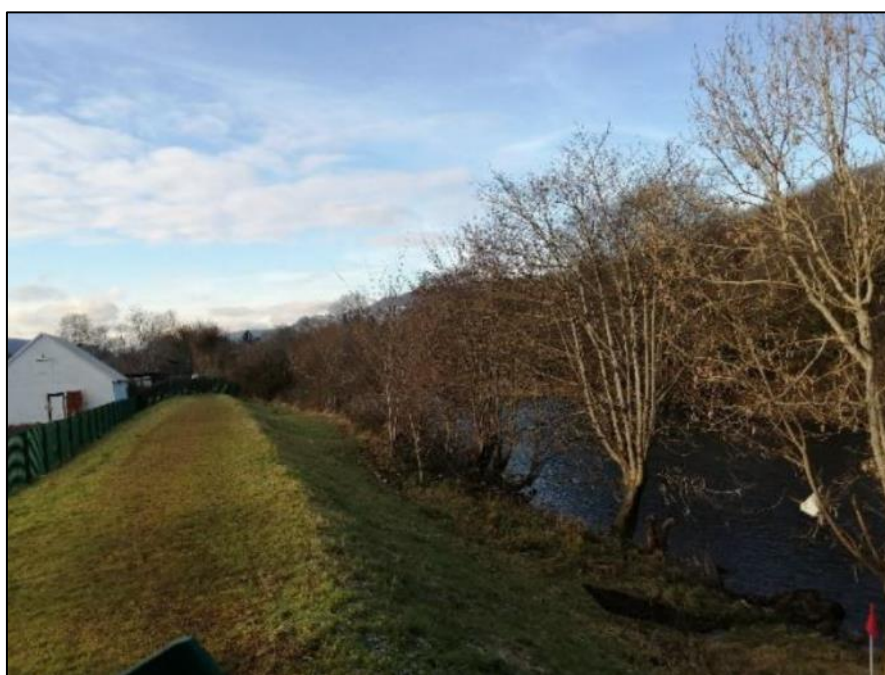
Figure 3: A view of the River Taf and southern riverbank, looking north-east (Redstart's Flood Investigation Report)

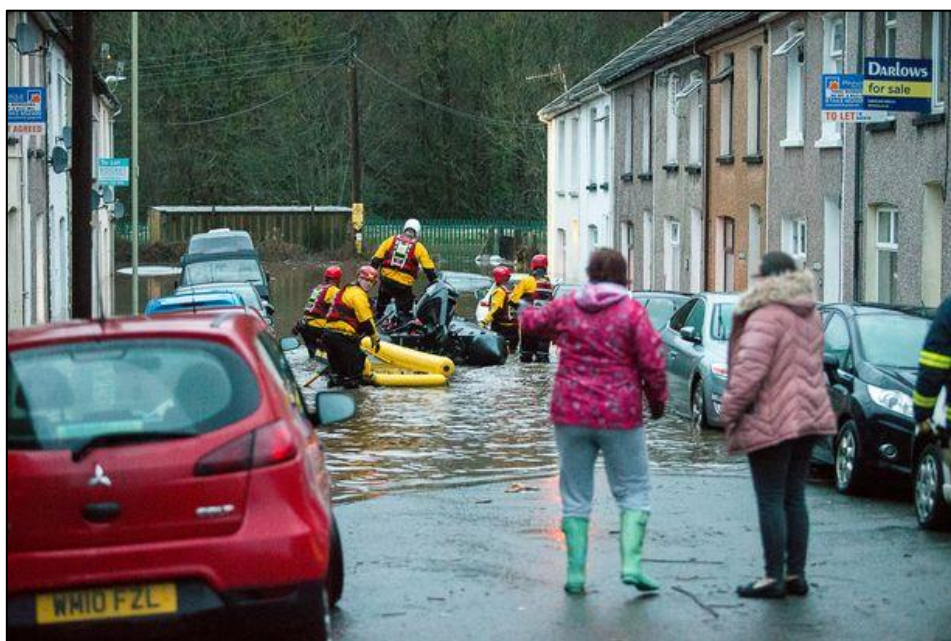
Figure 5: Image capturing South Wales Fire and Rescue Service undertaking evacuations within Egypt Street on 16th February 2020, (Image: Huw Evans Picture Agency Ltd)

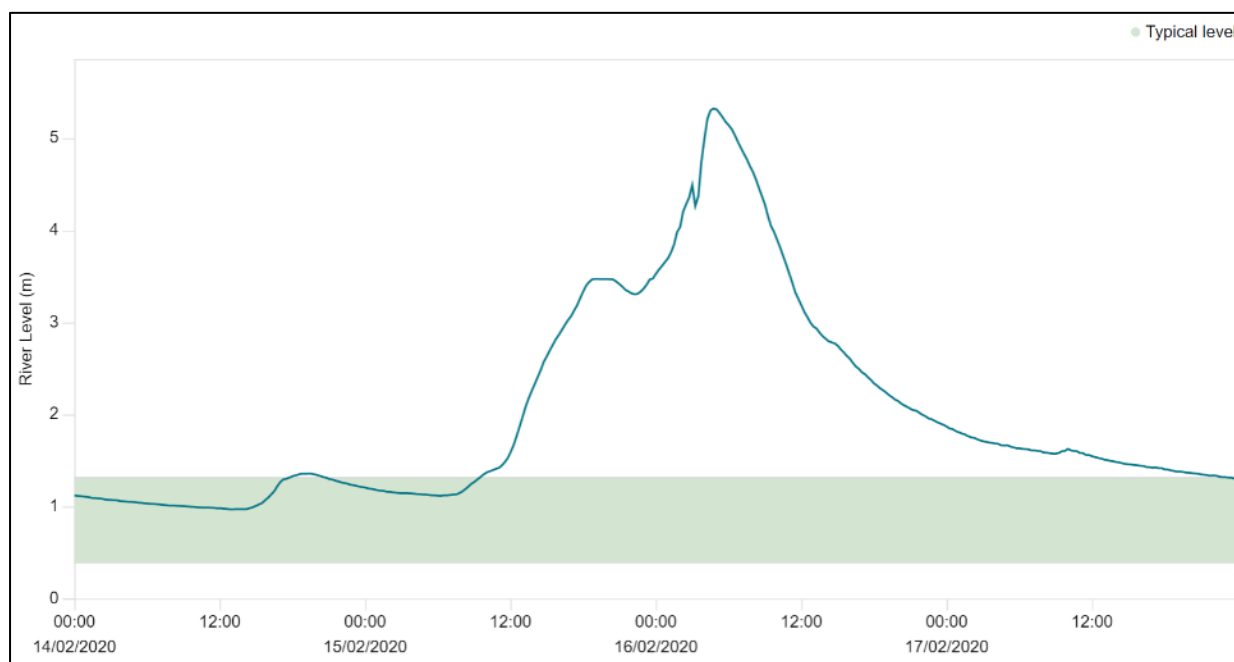
NRW issued a 'Flood Alert' (indicating possible flooding) for the entirety of the River Taf at approximately 13:30 on the 15th of February; at which point the main river was over 2 metres in depth and continuing to rise at Pontypridd station. At approximately midnight on the 16th February the River Taf began to rise again, reaching a peak river level of 5.32 metres at 04:45 on the 16th of February; the highest level recorded for the River Taf at Pontypridd since 1970.

The green bar displayed on the hydrograph shows the typical level of the River Taf at the Pontypridd station, ranging between 0.4 and 1.3 metres. The river level was above this green line for over 48 hours, highlighting the severity of the storm event and its unprecedented nature. At its peak, the River Taf at Pontypridd was almost four meters higher than its average level.

Figure 8: The River Taf levels at Pontypridd station between the 14th and 17th February 2020 (Natural Resources Wales)

With significantly high river levels being recorded upstream in both the River Taf and the River Rhondda, it is accepted that the River Taf reached record-high levels beyond the confluence of the two rivers at Pontypridd. As a result, the river overtopped its banks downstream of the confluence, resulting in significant flooding to Treforest.

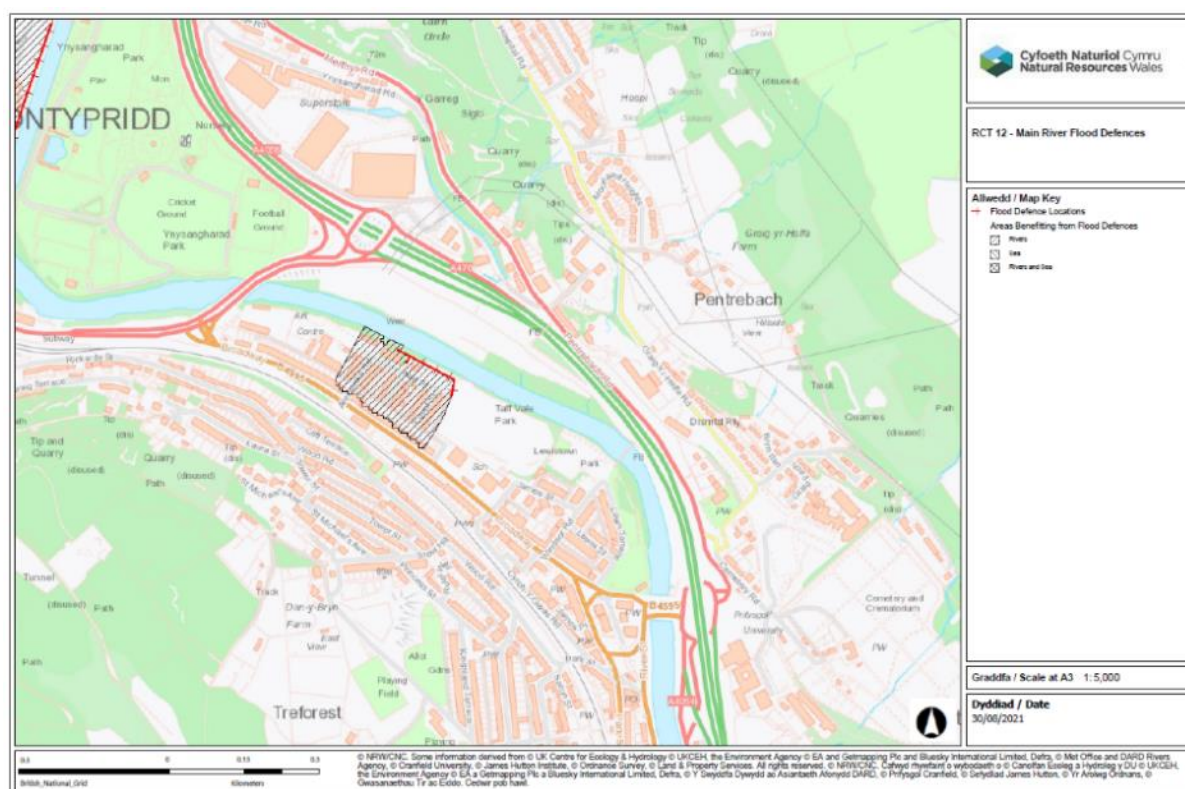
As illustrated in Figure 11 (demarcated by a bold red line), there are approximately 150 metres of formally designated flood defence infrastructure along the western bank of the River Taf at RCT12. This infrastructure is operated and maintained by NRW.

According to NRW, this infrastructure provides a standard of protection up to 1 in 75 annual probability flood event (Q75) to several properties within the investigation area (black hatched area in Figure 11), including properties at Alexandra Road, Nile Street, Egypt Street and Niagara Street.

Figure 11: Natural Resources Wales’ map for Main River Flood Defences and areas benefiting at RCT12. Contains Natural Resources Wales information © Natural Resources Wales and database right. All rights reserved

The current indicative design standard of protection for flood defences on a main river is 1 in 100 annual probability (Q100) flood event plus, for new defences, an allowance for climate change. This is stated within the Welsh Government’s National Strategy for Flood and Coastal Erosion Risk Management which encourages main river flood alleviation schemes to provide a Standard of Protection (SOP) up to Q100⁵. It is thereby inferred that the current SOP of flood defence infrastructure at RCT12 is below current indicative standards.

Whilst the flood defences identified at RCT12 are below the current indicative standard, the unprecedented rise of river levels in the Taf during Storm Dennis resulted in the overtopping of assets up to Q100 SOP. NRW’s ‘Flood Incidence Response Review’⁴ does in fact outline that no flood defences failed in the lower Taf region and that the flooding was the result of river flows exceeding the construction design standard.

R1B	NRW to investigate the standard of protection provided by flood defences at RCT12 and “consider improvements to NRW flood alleviation schemes and structures on a prioritised basis”. Aligns with recommendation ‘Action FD3’ within NRW’s Flood Incident Management Review.
					R1C	NRW to review its flood warning service provision, especially for extreme events. This will form part of NRW’s Flood Warning Service Review Implementation Programme and aligns with the recommendations set out in their ‘Flood Incidence Management Review’.
2	Surface water drainage network across RCT12	Rhondda Cynon Taf CBC Highway Authority	Surface Water	Highway Authority and Lead Local Flood Authority	R2A	The Highways Authority to jet and cleanse the highway drainage network and action repairs accordingly.

- NRW to undertake minor repairs to Egypt Street flood wall.
- Following the completion of NRW's Lower Taf Flood Modelling Project, NRW propose to undertake an initial assessment of the viability of potential flood risk management options. Consideration should be given to areas at high risk of flooding from rivers on a prioritised basis. **(R1A, R1B)**
- Following the completion of NRW's Lower Taf Flood Modelling Project, NRW propose further threshold work and flood warning area amendments. **(R1A, R1C)**
- NRW will undertake a review of the modelled outputs and adopt changes to their maintenance program within the investigation area if required. **(R1A)**

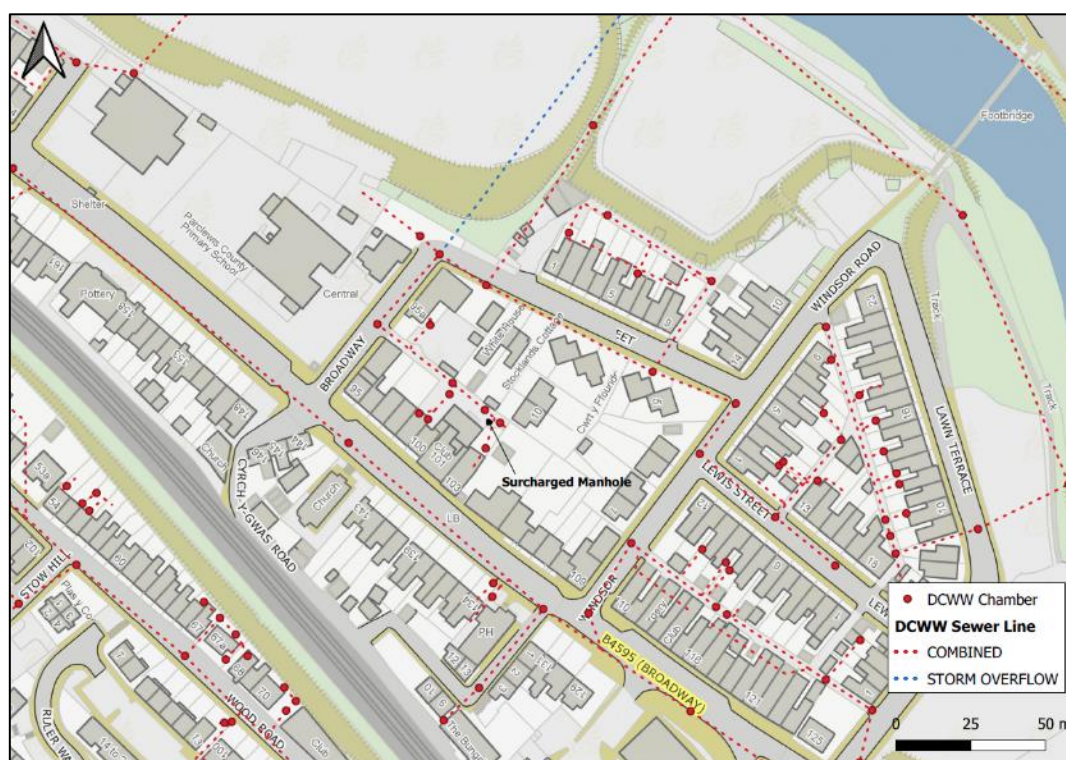
In addition to the highway drainage infrastructure within RCT12, the overtopping of the River Taf and the intensity of rainfall during Storm Dennis is considered to have overwhelmed parts of DCWW's combined drainage infrastructure during the storm event. This is evidenced by the surcharging of a DCWW combined sewer manhole on James Street (illustrated in Figure 12), resulting in the internal flooding of a nearby residential property which is also situated at a localised low point.

Figure 12: Location of surcharging manhole on DCWW's Combined Sewer network

Furthermore, reports from properties on Niagara Street during the flood event also refer to being impacted by sewage. Surcharging from the combined sewer network in this area may have occurred during the storm event, however, this cannot be confirmed due to the dominant impact of fluvial flooding sourced by the River Taf during the event. The unprecedented height of main river levels within the River Taf may have also impacted the ability of DCWW's infrastructure to manage the discharge of water during the storm event.

As outlined in 'FRM – Storm Dennis – Overview Report'², DCWW sewers have a current design standard of Q30, as per the 'Sewers for Adoption 7th Edition'⁶ guidance document. Given that the design standard was markedly exceeded during Storm Dennis, the maintenance condition of DCWW apparatus is not considered to have significantly impacted the flooding experienced.

R2B	The LLFA and Highway Authority to evaluate surface water management options to alleviate pluvial flooding at locations across the investigation area.
3	DCWW combined sewer and associated manhole	DCWW	Sewer	DCWW	R3A	DCWW to evaluate the standard of service and the condition of the combined sewer network servicing RCT12.

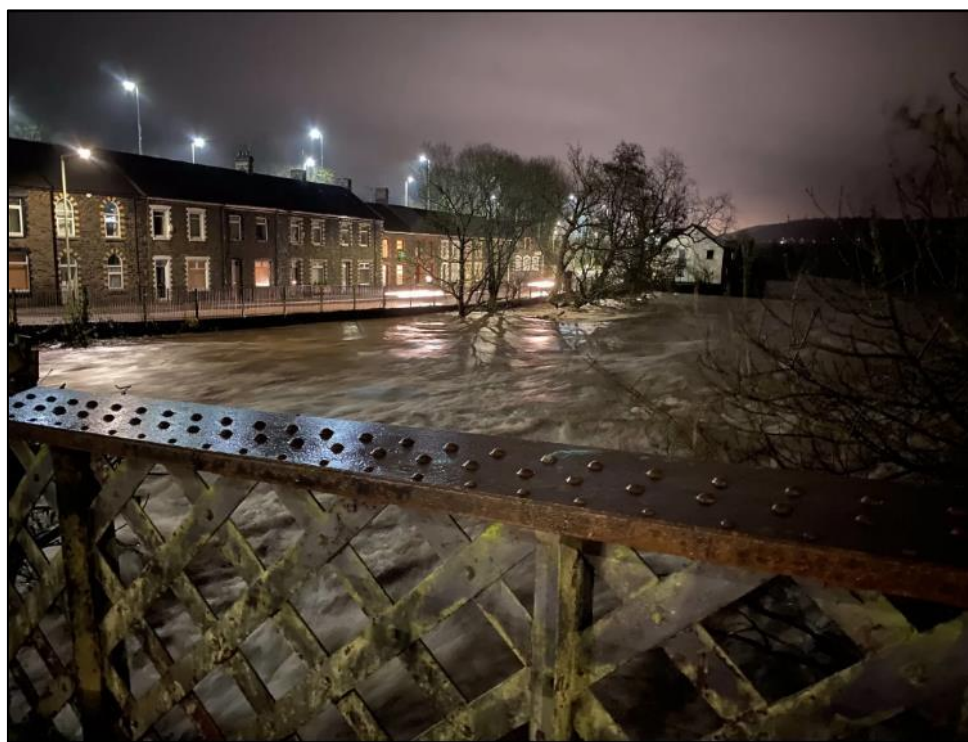
The primary source of internal flooding within the sub-catchment was the overtopping of the River Taf during the early hours of Sunday 16th February. Figure 4 depicts the swollen River Taf flowing rapidly through Treforest prior to its overtopping.

Figure 4: A downstream view of the River Taf at Castle Inn Bridge, Cardiff Road prior to its overtopping during Storm Dennis (Image: Storm Dennis, pontypriddtowncouncil.gov.uk)

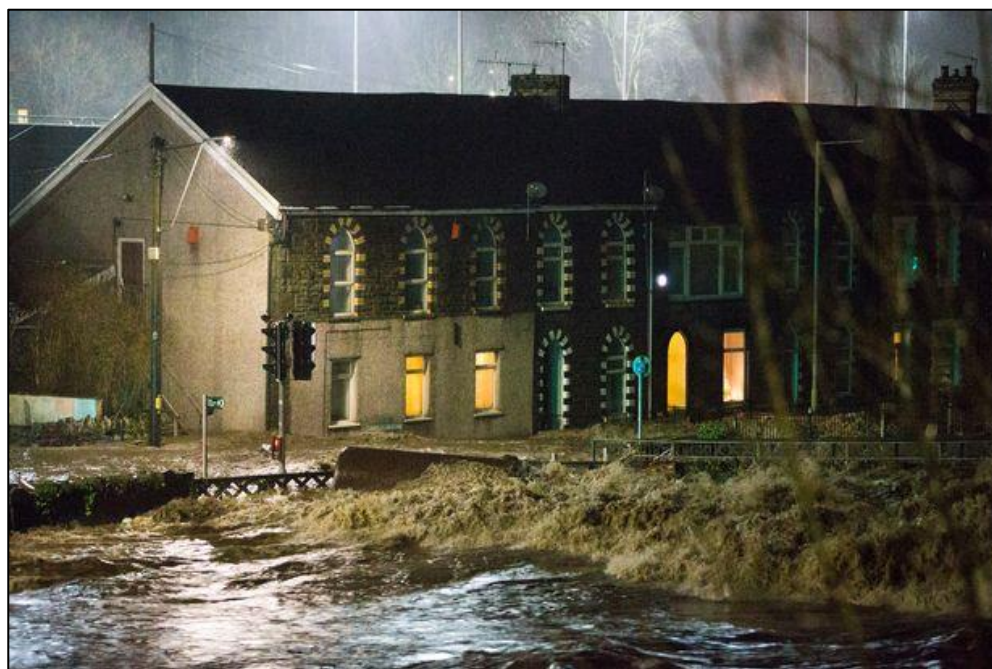
The primary flow pathway was the conveyance of fluvial flood water over the main river’s eastern embankment and onto the A4054 (Cardiff Road) at multiple locations near the Castle Inn Bridge footbridge. Figure 5 illustrates the rapid onset of flooding from the River Taf at Cardiff Road once it had overtopped.

Figure 5: Photo of the rapid onset of flooding from the River Taf at Cardiff Road during Storm Dennis
(Image: Wales Online)

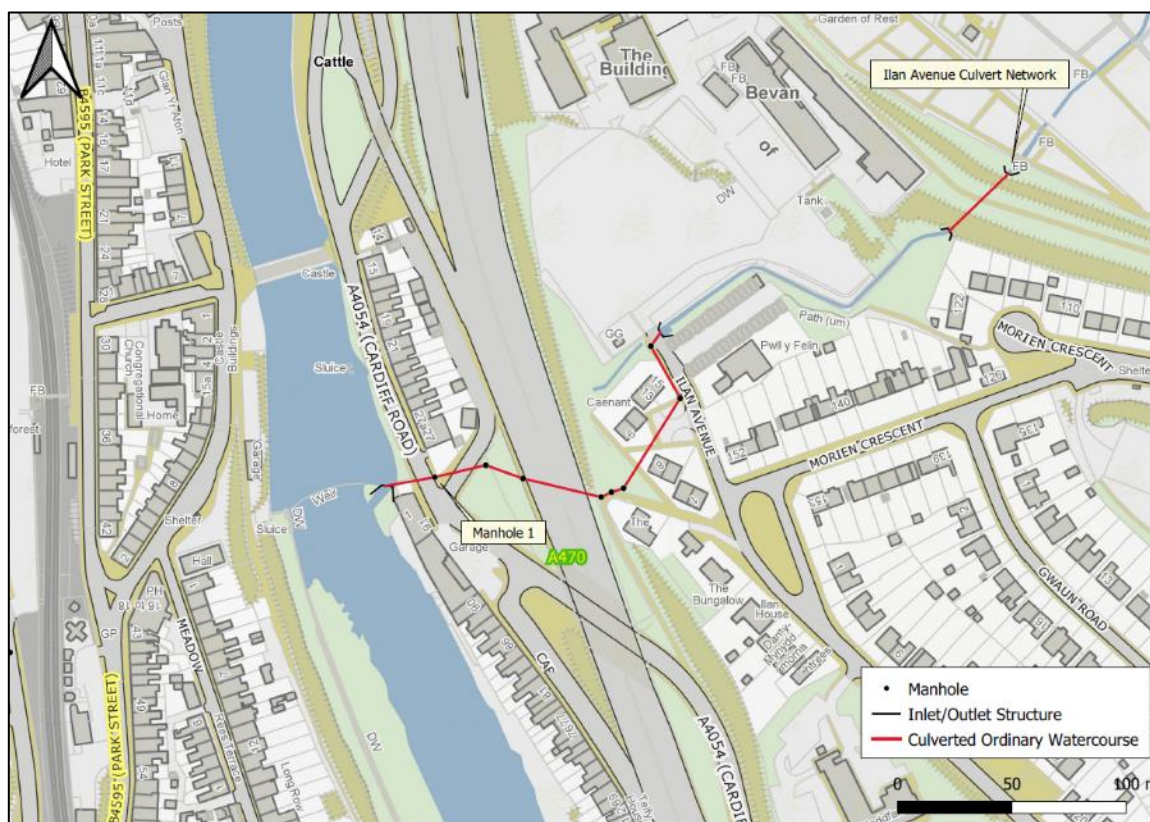
Figure 9: Ilan Avenue culverted ordinary watercourse location plan

Following Storm Dennis, a CCTV survey inspection of the culvert network was undertaken to ascertain both the operational condition of the network and its structural integrity. The survey identified some debris within the Ilan Avenue culvert network, with approximately two tonnes of material being removed from the system following the inspection. Little to no debris was identified at both culvert inlets following the storm event, indicating that the identified debris was already present in the network prior to

the storm event. Due to the lack of pre-storm survey data, it is not possible to conclusively determine whether this debris was present in the system prior to the storm event, if the material entered the system as a result of the exceptional weather conditions, or whether they are influenced by the outfall arrangement into the Main River.

R3B	The LLFA and LDA to investigate the standard of protection and the condition of the culvert structure and network as a whole.
					R3C	The LLFA to jet and cleanse the ordinary watercourse culvert network.
