CYNGOR BWRDEISTREF SIROL
RHONDDA CYNON TAF
COUNTY BOROUGH COUNCIL

DYMA WŶS I CHI i gyfarfod hybrid o **PWYLLGOR TROSOLWG A CHRAFFU** yn cael ei gynnal ar **DYDD LLUN, 28AIN CHWEFROR, 2022** am **5.00 PM**.

5. ADRODDIADAU YMCHWILIO I LIFOGYDD ADRAN 19

Derbyn adroddiadau Ymchwilio i Lifogydd Adran 19 y Cyngor o dan Ddeddf Rheoli Llifogydd a Dŵr 2010.

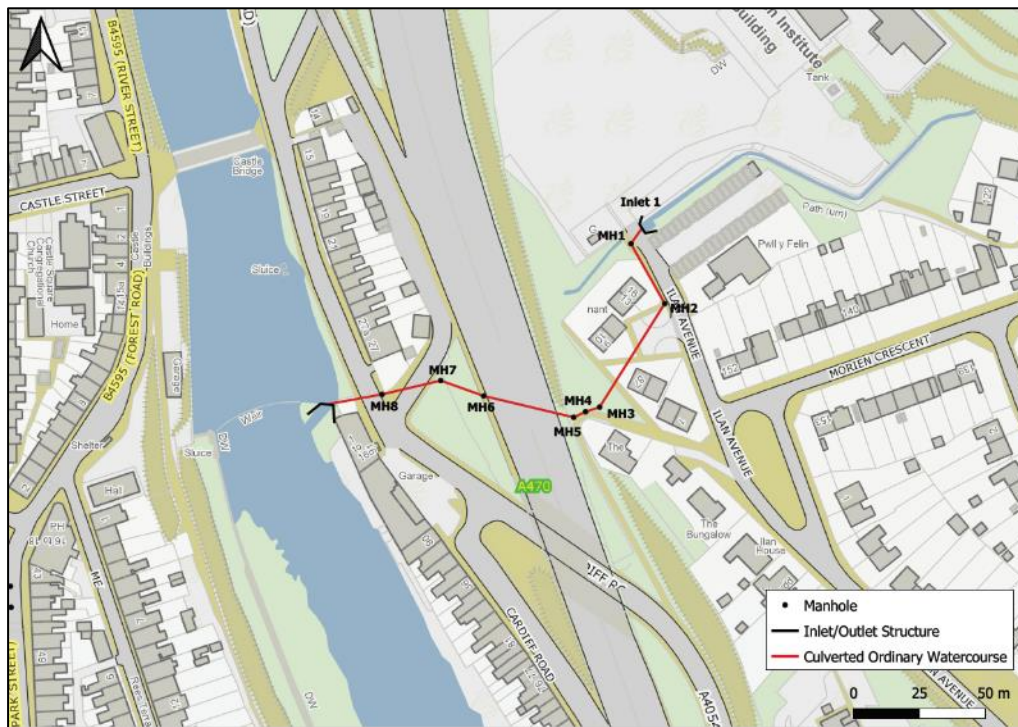
Figure 18: Ilan Avenue culverted ordinary watercourse network with annotated Manhole labels

Whilst the overtopping of the River Taf has been determined as the primary cause of flooding to the majority of properties within RCT14, the capacity of the ‘Ilan Avenue’ culvert network (illustrated in Figure 18) has also been assessed to ascertain its current standard of protection following the observed surcharging of a manhole at Cardiff Road following Storm Dennis (Figure 10).

The assessment infers that the upstream section of the network, at the culvert inlet adjacent to Ilan Avenue, has adequate hydraulic capacity to accommodate storm events up to Q200 in free-flowing conditions. This is significantly reduced to Q2 in blockage conditions however, no blockage to the upstream inlets was observed during Storm Dennis.

The capacity of the Ilan Avenue downstream network (which conveys flows beneath the A470 and Cardiff Road) was assessed as having a SOP below current design standards for new culverts as defined by CIRIA C789. This is further reduced to Q2 in blockage conditions.

R3B	The LLFA and LDA to investigate the standard of protection and the condition of the culvert structure and network as a whole.
					R3C	The LLFA to jet and cleanse the ordinary watercourse culvert network.

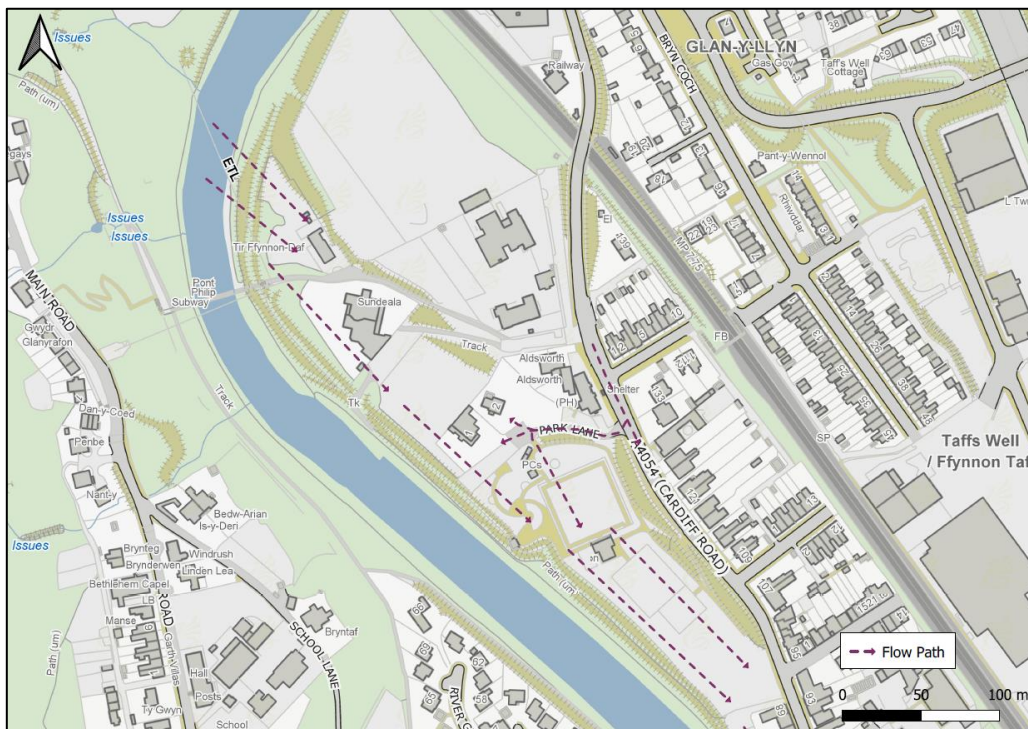
Figure 3: Observed flow paths during Storm Dennis in the north of investigation area RCT17

It was reported by residents that the River Taf initially overtopped its eastern riverbank to the north of the investigation area (depicted in Figure 3), resulting in between 1.5 metres and 2.5 metres of internal flooding to those properties situated on the floodplain at this location.

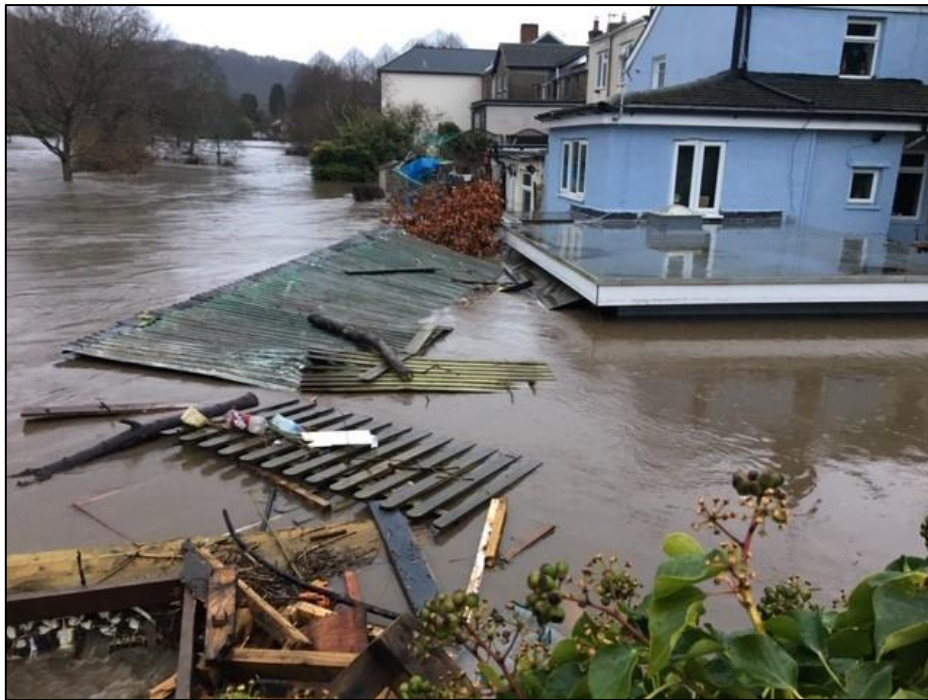
Figure 5: Image showing the overtopping of the River Taf to the rear of Cardiff Road which submerged the rear gardens and ground floor of several properties during Storm Dennis (image provided by resident)

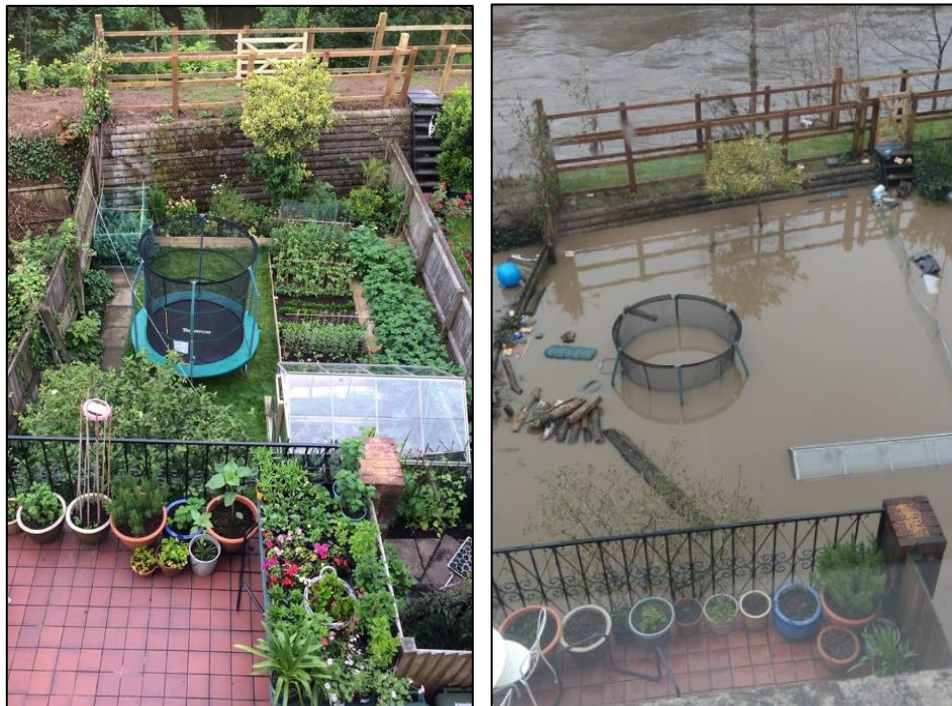
Once flood water had entered the rear gardens of properties on Cardiff Road, it was unable to recede due to the difference in height between the gardens and the existing flood defences, as depicted in Figure 6. This resulted in up to 2.5 metres of fluvial flood water becoming trapped in the rear gardens of properties on Cardiff Road for approximately 12 hours during the storm event.

Figure 6: Images capturing the rear garden of a property on Cardiff Road before (left) and during Storm Dennis (right) (images provided by resident)

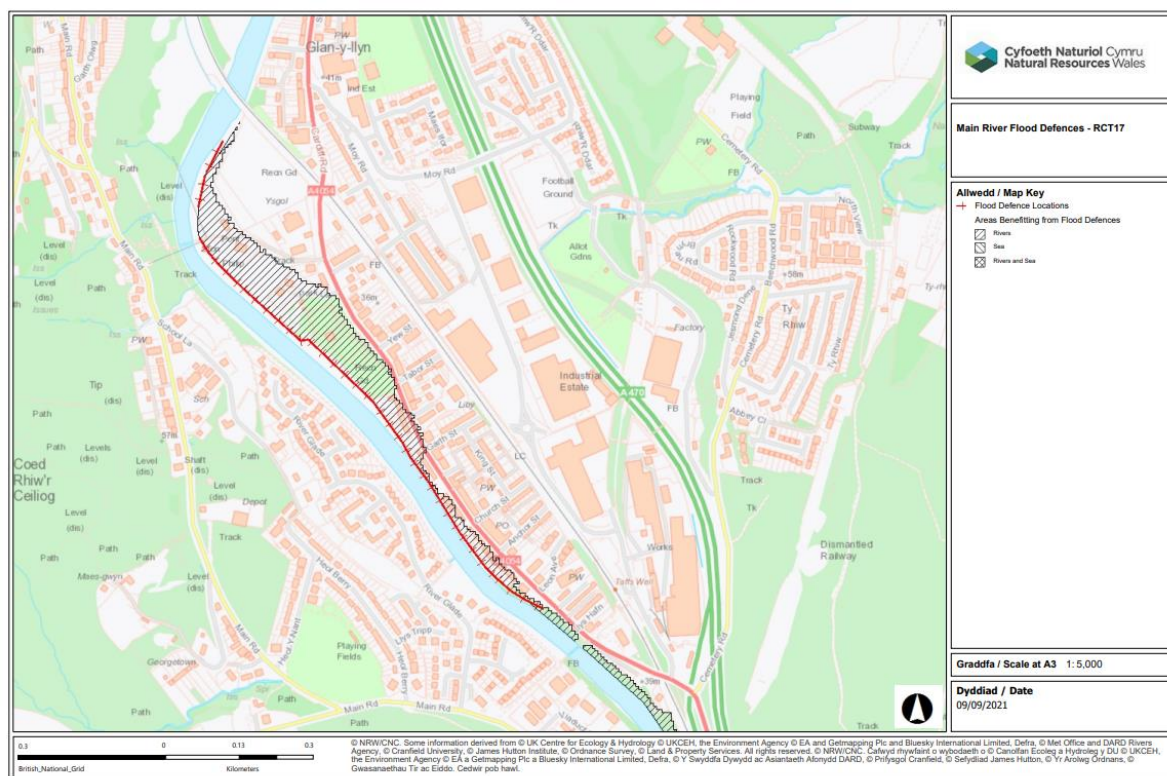
As illustrated in Figure 11 (demarcated by a bold red line), there are approximately 1.5 kilometres of formally designated flood defence infrastructure along the eastern bank of the River Taf at RCT17. This infrastructure is operated and maintained by NRW.

According to NRW, this infrastructure provides a Standard of Protection (SOP) of 1 in 100+ annual probability flood event (Q100+) to the majority of the impacted properties within the investigation area (black hatched area in Figure 11).

Figure 11: Natural Resources Wales’ map for Main River Flood Defences and areas benefiting at RCT17. Contains Natural Resources Wales information © Natural Resources Wales and database right. All rights reserved

NRW's 'Flood Incidence Response Review'⁴ outlines that no flood defences failed in the lower Taf region and that the flooding was the result of river flows exceeding the construction design standard.

<p>R1B</p> <p>NRW to investigate the standard of protection provided by flood defences throughout RCT17 and “consider improvements to NRW flood alleviation schemes and structures on a priorities basis”. Aligns with recommendation ‘Action FD3’ within NRW’s Flood Incident Management Review.</p>
					<p>R1C</p> <p>NRW to review its flood warning service provision, especially for extreme events. This will form part of NRW’s Flood Warning Service Review Implementation Programme and aligns with the recommendations set out in their ‘Flood Incidence Management Review’.</p>
2	River Taf	Private Landowner	Main River	Natural Resources Wales	<p>R2A</p> <p>NRW to work with the landowner to assess and review the risk of flooding from the River Taf at the location known to have overtopped during the event to identify the viability</p>

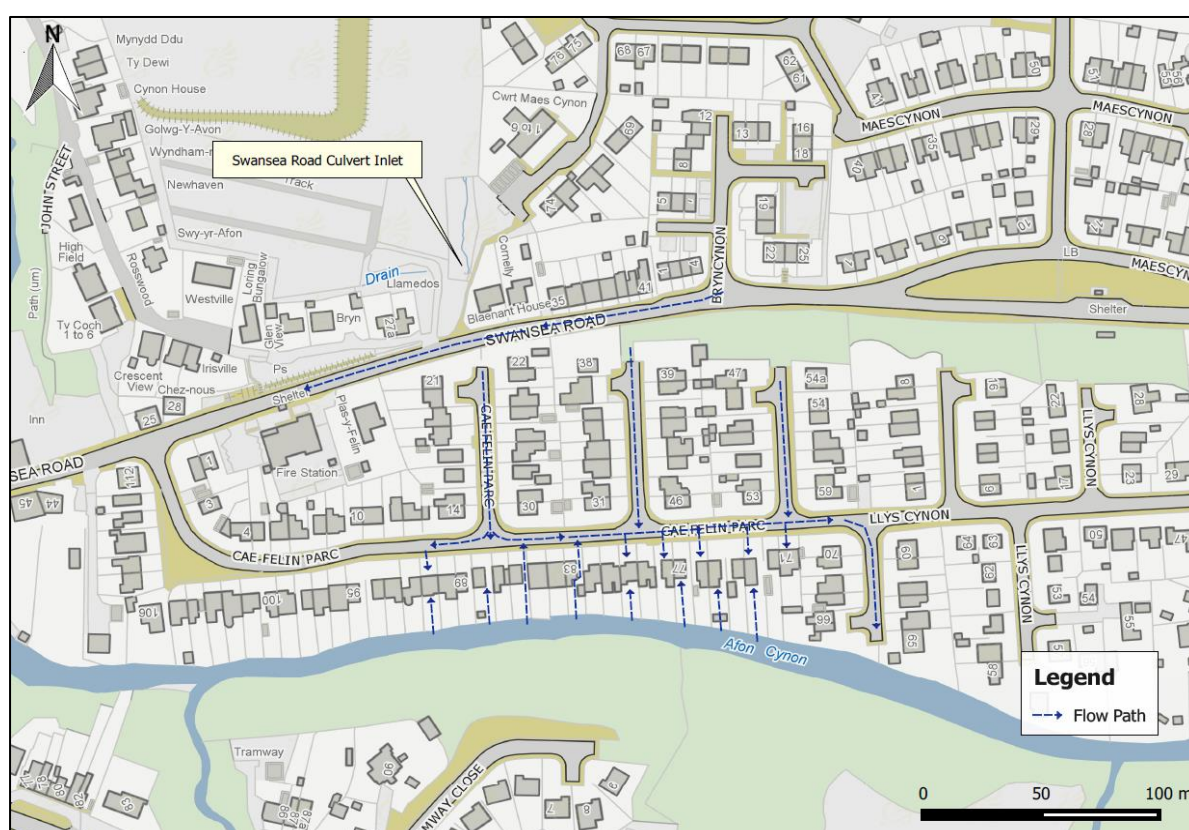
It was also reported by residents that a secondary source of flooding, identified as surface water runoff travelling along the roads above Cae Felin Parc, also contributed to the flooding of properties at Cae Felin Parc during Storm Dennis. Surface water was unable to drain via the highway and private surface water drainage network because the networks were overwhelmed by the intense rainfall.

Figure 3: Observed flow paths at Cae Felin Parc and Swansea Road in Hirwaun during Storm Dennis

Reports of a suspected surcharged culvert inlet located at Swansea Road (labelled 'Swansea Road Culvert Inlet' in Figure 3) were also received by some residents, however following further engagement with RCT's Highways and Streetcare Depot and the Hirwaun Fire Station, it was confirmed that the inlet did not surcharge during Storm Dennis.

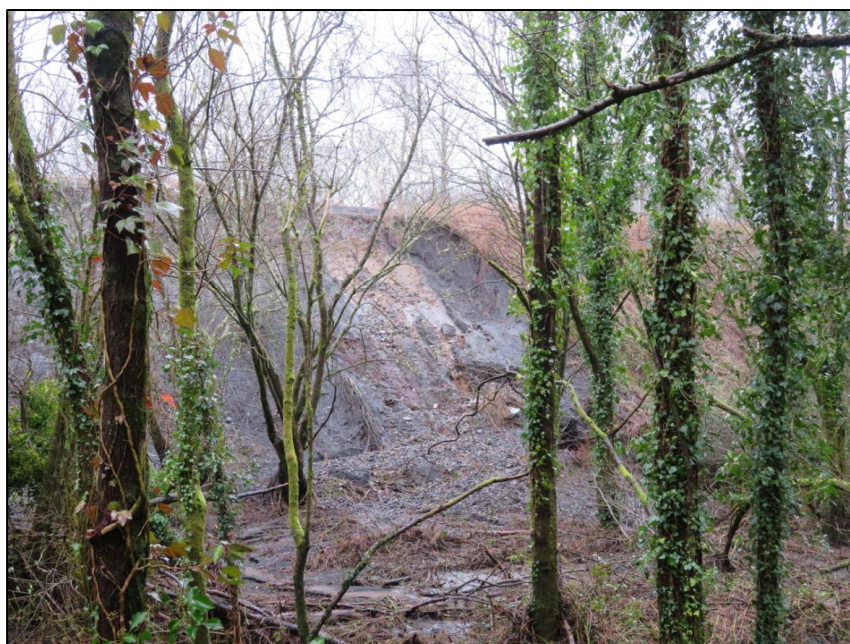
Additionally, there was a landslide reported upstream of the investigation area, to the rear of the railway track, with no properties reported as being affected by flooding. Further downstream, to the east of Devonshire Drive, eroded material sourced by the landslide was identified at the River Cynon culvert inlet, causing flooding onto the Village Green however no properties were affected at this location. Evidence of the landslide is provided in Figure 4.

Figure 4: Landslip of the hillside above the railway line, Hirwaun on the 16th February 2020 (image captured by resident)

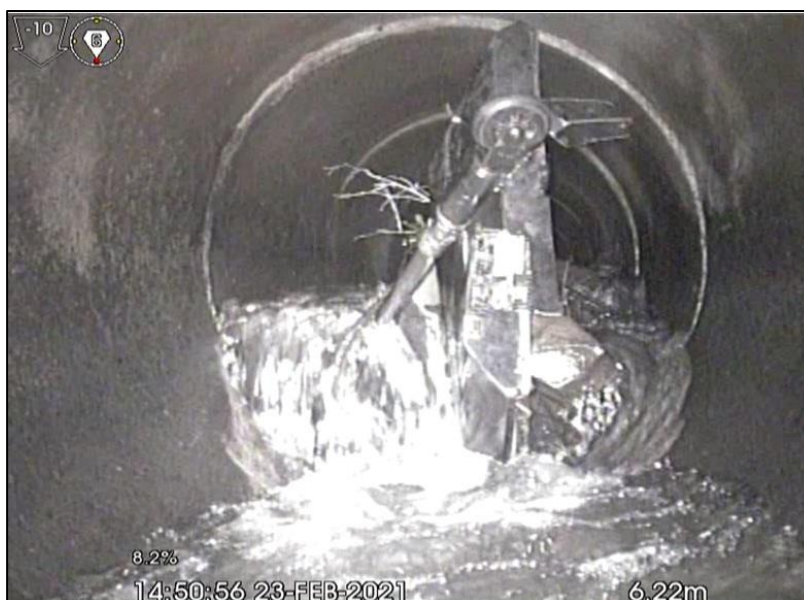
The condition of the Swansea Road culvert network was surveyed to be in poor condition, with multiple sections graded as 4-5 due to settled debris, fractures and

cracks reducing the culvert's cross-sectional area. Approximately 6 meters downstream of the culvert inlet the CCTV survey was abandoned due to a large obstruction identified in the network (Figure 7).

Figure 7: Obstruction identified approximately 6 meters downstream of the Swansea Road culvert inlet

Although the network was identified in poor condition, flooding was not observed from the inlet or anywhere along the network.

In response to the settled debris identified within the culvert networks, several jetting and cleansing operations were undertaken by a Council appointed contractor to clear the debris from within the culvert networks. An estimated 205 tonnes of material was removed from the Swansea Road and Meadow Lane culvert networks during cleansing exercises.

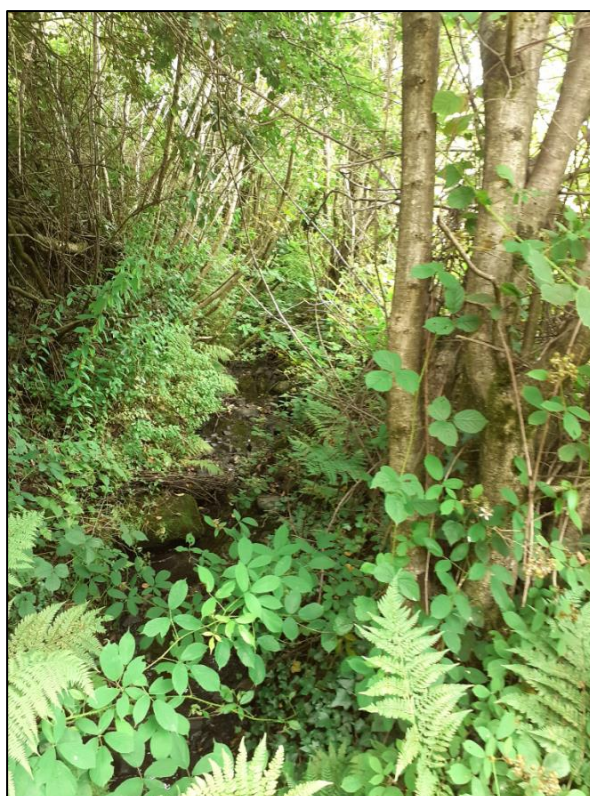
The hillside and associated watercourses were inspected to assess their condition for any evidence of scour or land movement of the hillside which would indicate potential overland flows had occurred. The assessment found no significant erosion of the channels, however both watercourses were mostly undefined and overgrown with dense vegetation which impacted the on-site assessment (Figure 11).

LIDAR data reveals that the watercourse and hillside which drains into 'Meadow Lane Culvert Inlet 2' is relatively flat in the upper section, directly below the A465, which would allow water to pond in this area before flowing overland. There is also a hedge line adjacent to the watercourse which is considered to have aided in the diversion of surface water directly towards the impacted properties. The area of hillside is identified under private landownership.

Figure 11: Undefined and overgrown ordinary watercourse channel above Meadow Lane Culvert Inlet 2 (image captured by RCT's Flood Risk Management team following Storm Dennis)

The intensity of rain falling on the already saturated catchment of Hirwaun during Storm Dennis is considered to have overwhelmed the unnamed watercourse below the A465 causing water to spill out of bank and flow overland towards the properties below.

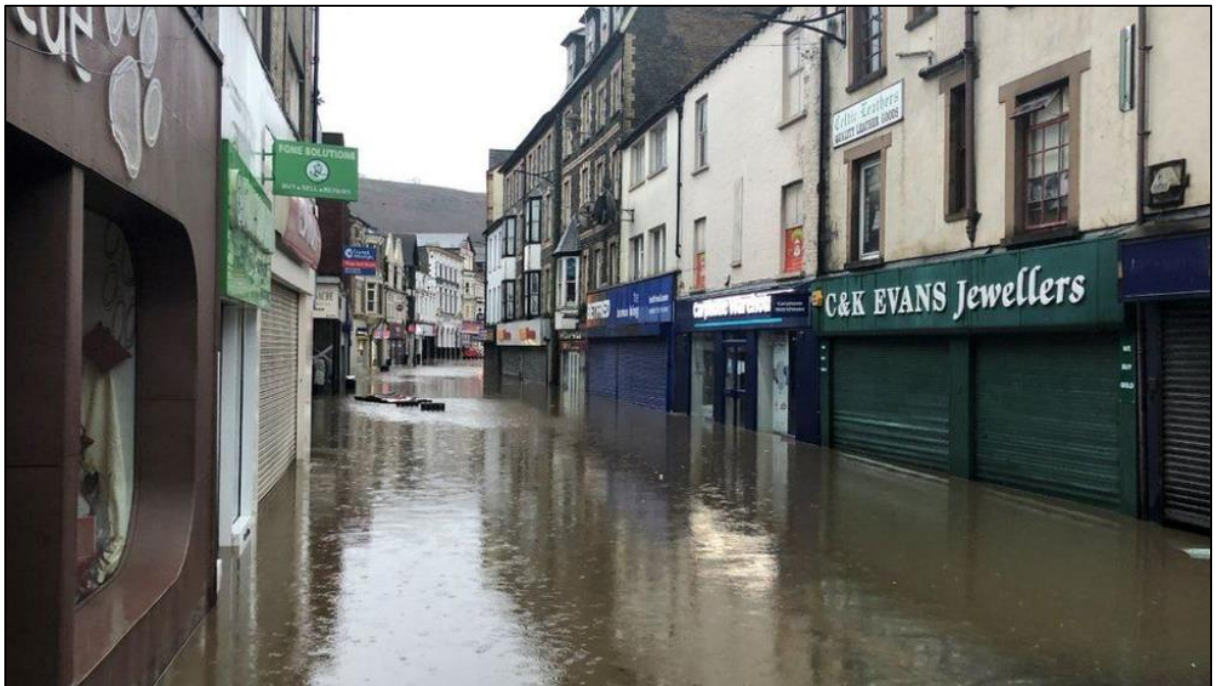
South of Bridge Street, the River Taf also overtopped both its eastern and western banks, resulting in significant flooding to Pontypridd Town Centre and Ynysangharad Park. A total of 75 commercial properties on Taff Street and Mill Street (Figure 7), in addition to the National Lido of Wales at Ynysangharad Park, were internally flooded as a result of the overtopping (Figures 8). A footbridge connecting Taff Street and Ynysangharad Park was also damaged during the event.

Figure 7: Flooding to commercial properties on Taff Street following Storm Dennis (Image: BBC News)

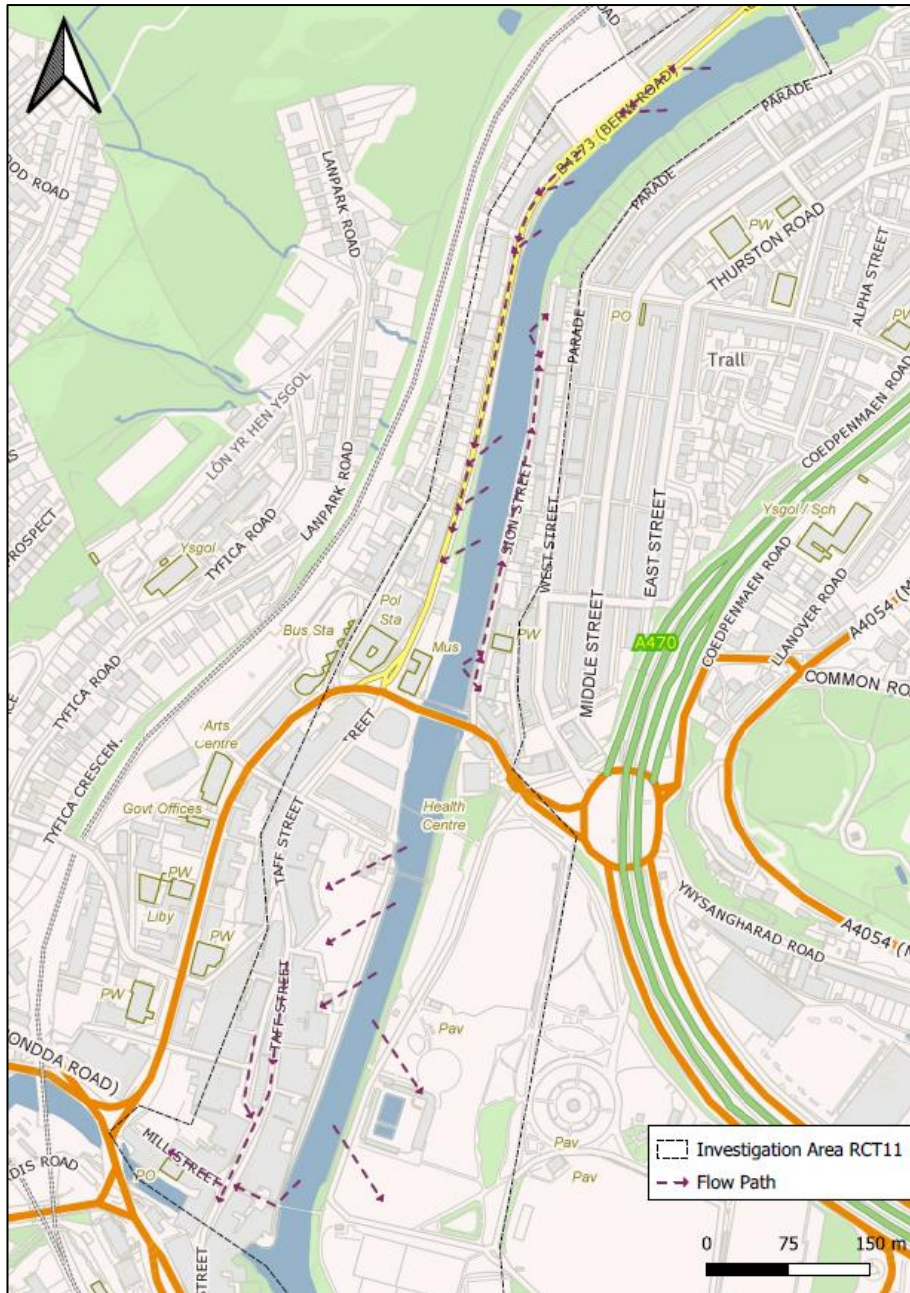
As illustrated in Figure 9, the River Taf overtopped immediately adjacent to Gas Road Car Park, resulting in the internal flooding of nearby properties as fluvial flows conveyed into the rear basements of buildings on Taff Street. Further south, flood water entered properties from both the rear and the front as fluvial flows conveyed over 100 metres from the River Taf onto Taff Street and Mill Street. Flood depths of up to 1 metre were recorded throughout Taff Street and Mill Street as flood water accumulated for several hours at localised low points.

Figure 9: Indicative flow paths observed at RCT11 during Storm Dennis

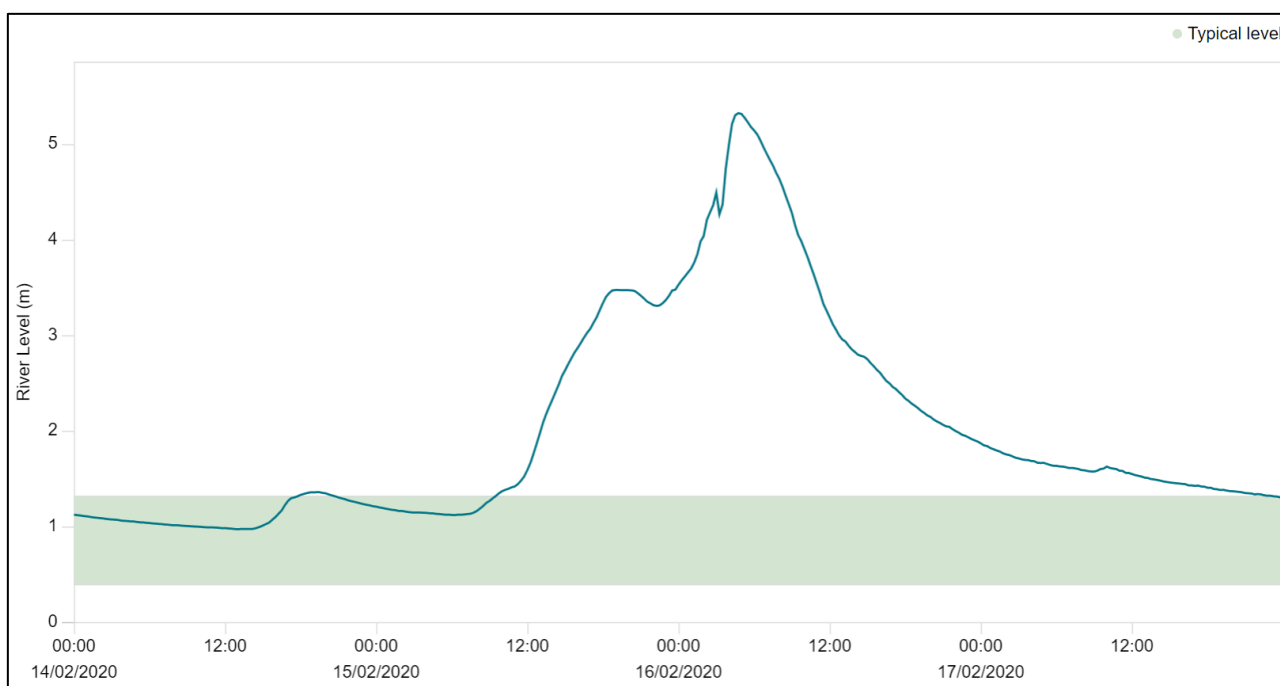
The green bar displayed on the hydrograph shows the typical level of the River Taf at the Pontypridd station, ranging between 0.4 and 1.3 metres. The river level was above this green line for over 48 hours, highlighting the severity of the storm event and its unprecedented nature. At its peak, the River Taf at Pontypridd was almost four meters higher than its average level.

Figure 10: The River Taf levels at Pontypridd station between the 14th and 17th February 2020 (Natural Resources Wales)

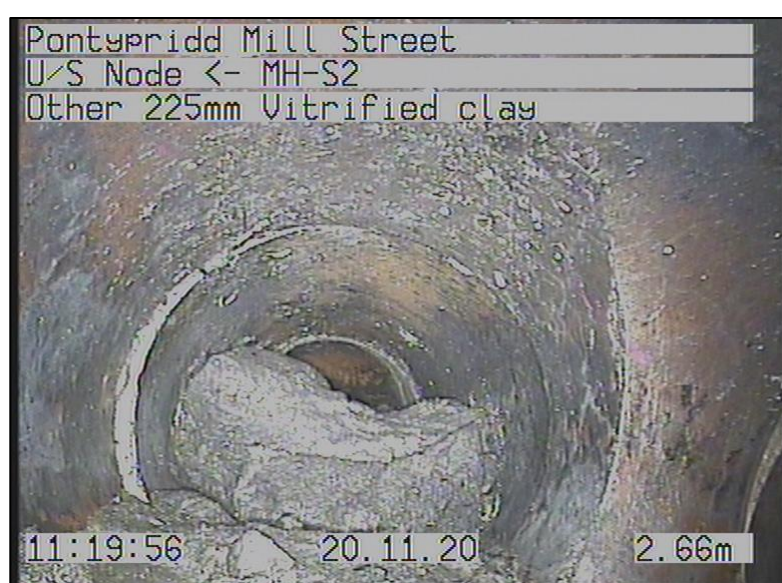
CCTV inspections undertaken in the months following the storm event confirm this, with surveys completed on Mill Street identifying settled deposits of silt and debris within the highway drainage network. Figure 13 depicts the operational condition of the highway drainage at Mill Street prior to its cleansing. A cross-sectional area loss of 60% was observed due to silt accumulation within the network.

Figure 13: Photo of silt accumulation within the Mill Street surface water drainage network prior to cleansing operations

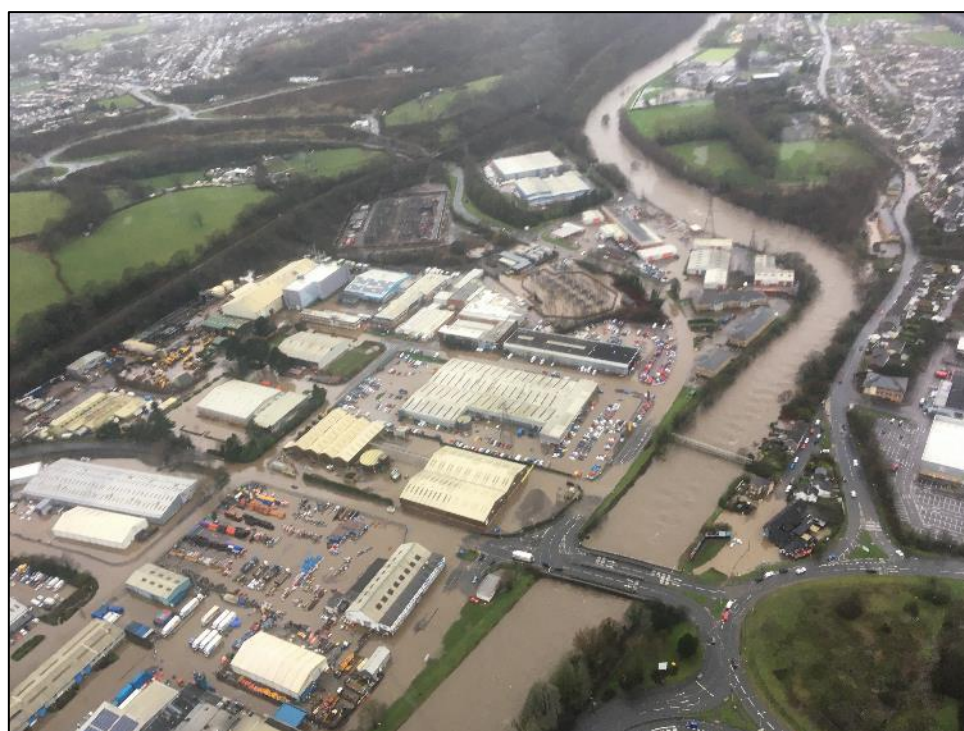
The flooding that occurred at Treforest Industrial Estate did not remain confined to areas adjacent to the main river channel, with commercial properties up to 450 metres inland from the River Taf reporting internal flooding. The main river overtopped both its eastern and western banks, resulting in internal flooding to the majority of commercial premises throughout the industrial estate. Figure 3 depicts an aerial view of the flooding at Treforest Industrial Estate and Upper Boat, to the north of RCT16.

Figure 3: Aerial view of Treforest Industrial Estate and Upper Boat following Storm Dennis (Image: National Police Air Service)

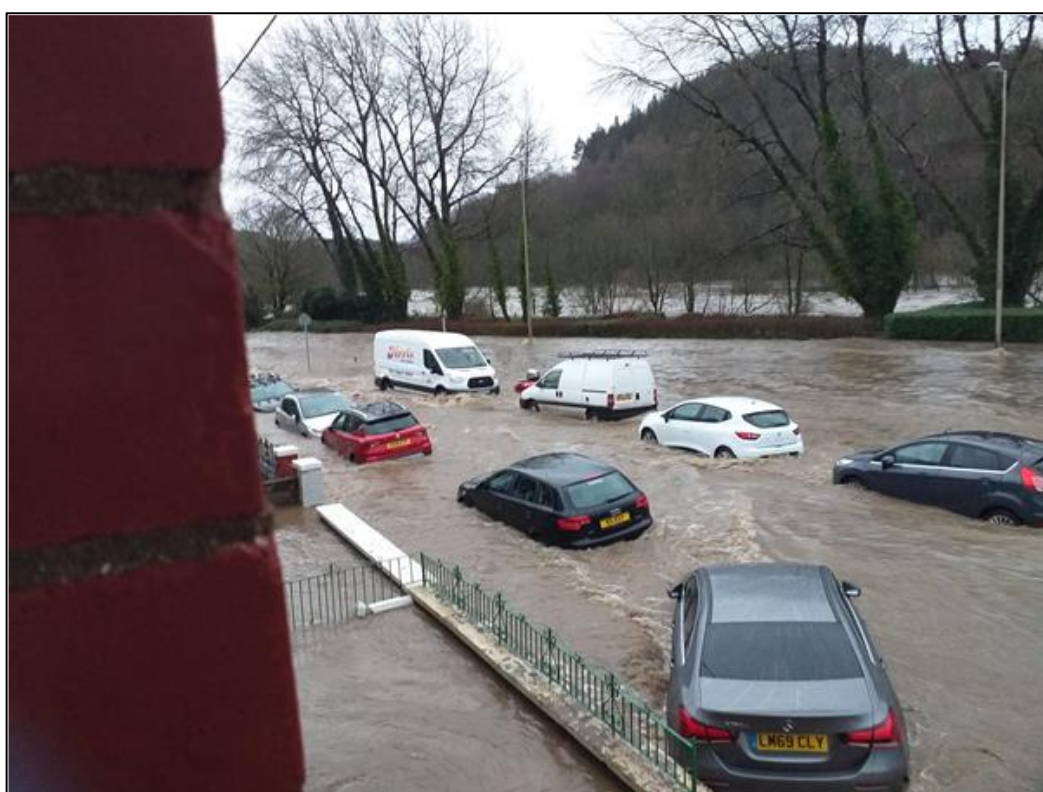
Accounts from residents at Oxford Street and Rhyd-Yr-Helyg note a significant amount of water conveyed along the highway network towards their properties during the storm event. This flow path is considered to have originated further upstream following the overtopping of the River Taf at Treforest Industrial Estate and Upper Boat, which then conveyed behind formal flood defences towards Oxford Street and Rhyd-yr-Helyg during the storm event. Photographic evidence provided by residents at Oxford Street show water flowing south along the highway, behind the eastern embankment, during the morning of Sunday 16th February 2020 (Figure 4).

Figure 4: Photo showing main river flooding along the A4054 Oxford Road during Storm Dennis (image provided by resident)

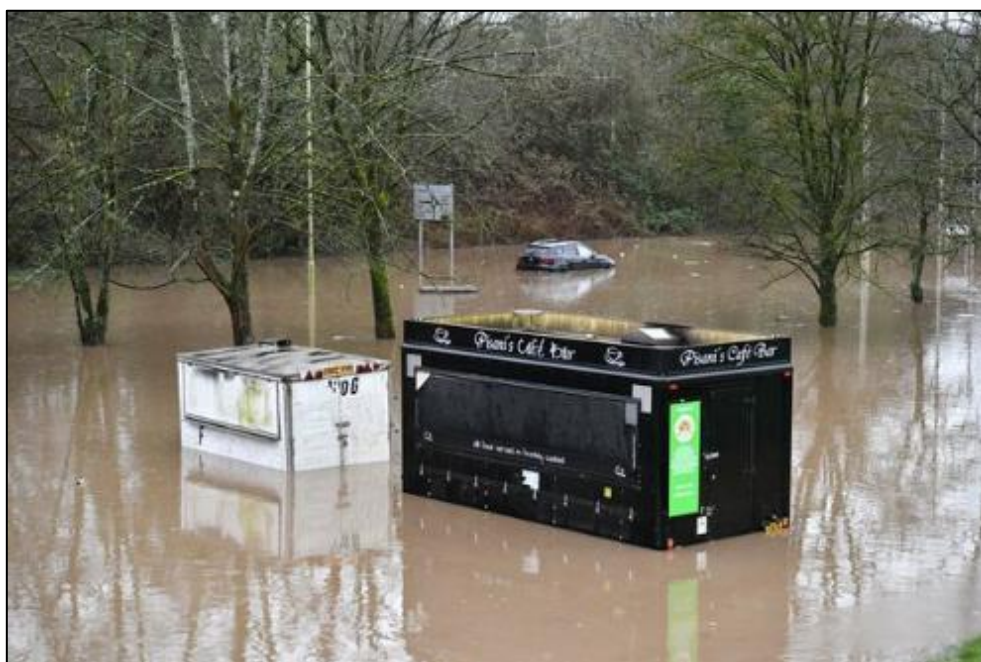
Figure 6: Image of the flooding on Cardiff Road near A4054/A468 roundabout during Storm Dennis, looking north. (Image: PA/Wales Online)

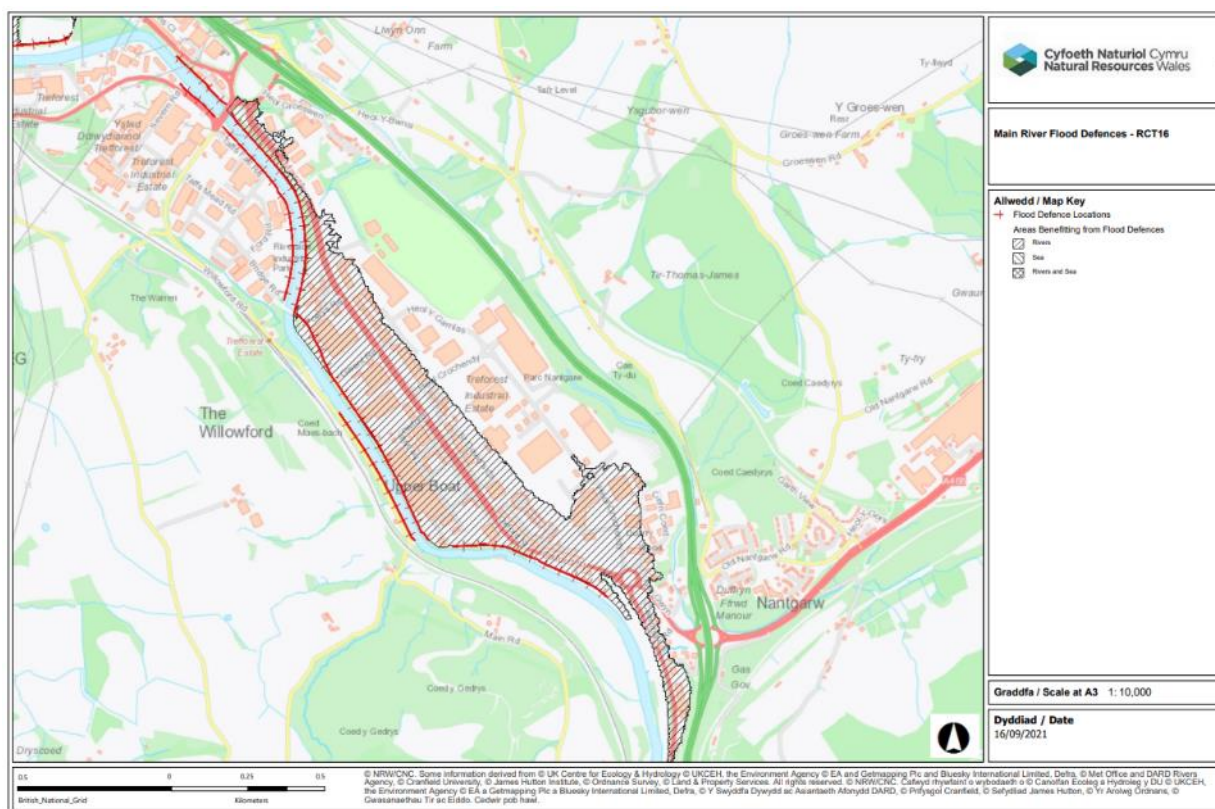
As illustrated in Figure 14 (demarcated by a bold red line), there are approximately 2.5 kilometres, and 1.25 kilometres, of formally designated flood defence infrastructure along the eastern, and western banks, of the River Taf at RCT16, respectively. This infrastructure is operated and maintained by NRW.

Figure 14: Natural Resources Wales’ map for Main River Flood Defences and areas benefiting at RCT16. Contains Natural Resources Wales information © Natural Resources Wales and database right. All rights reserved

Whilst some of the flood defences identified at RCT16 are below the current indicative standard, the unprecedented rise of river levels in the Taf during Storm Dennis resulted in the overtopping of assets up to Q100 SOP. NRW’s ‘Flood Incidence Response Review’⁴ does in fact outline that no flood defences failed in the lower Taf region and that the flooding was the result of river flows exceeding the design standard of the defences.

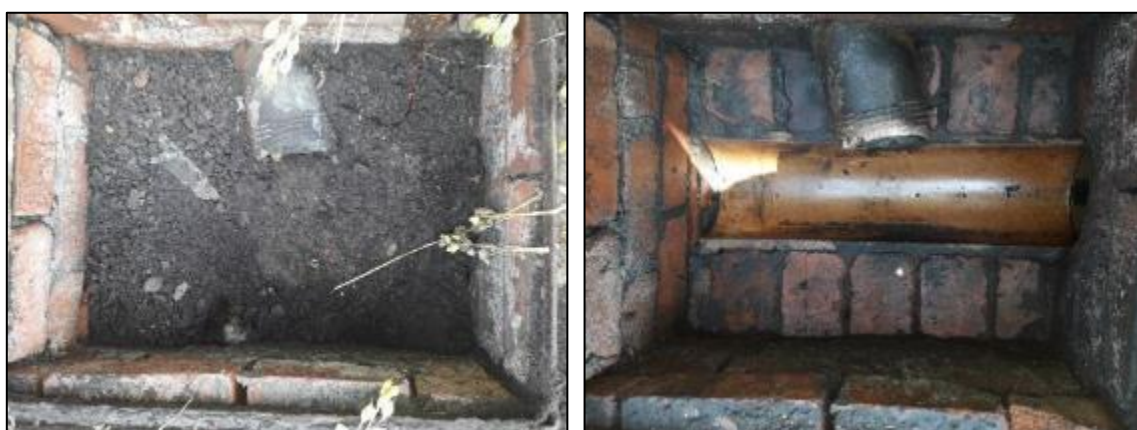
CCTV inspections undertaken in the months following the storm event confirm this, with surveys completed on Oxford Street and Rhyd-Yr-Helyg identifying large silt and debris deposits within many sections of the highway drainage network. Figure 15 depicts the operational condition of the highway drainage at Oxford Street before and after cleansing operations took place. A total of 25 tonnes of silt and debris was removed by a Council appointed contractor during cleansing operations.

Figure 15: Photo of a manhole at Oxford Street captured before (left) and after (right) surveying and cleansing operations during June 2020

CCTV inspections also identified structural defects within the drainage network on Oxford Street, including collapses within the drainage infrastructure near to the system's main river outlet. A section of the outlet structure was also damaged during Storm Dennis.

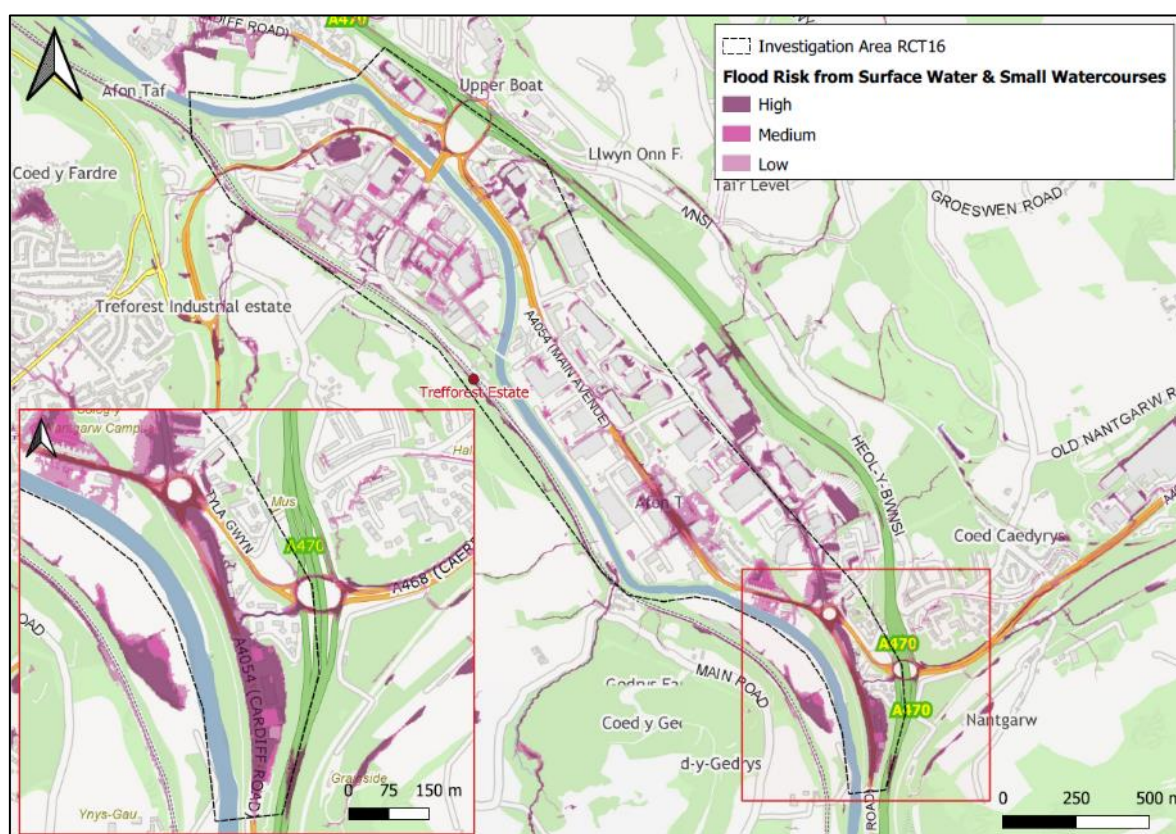
Figure 16: NRW's Flood Risk Assessment Wales (FRAW) map for Surface Water and Ordinary Watercourse flood sources at RCT16. Contains Natural Resources Wales information © Natural Resources Wales and database right. All rights reserved.

Notable areas where surface water flows are considered to have exacerbated the main river flooding include Williams Place, Cardiff Road, and parts of Rhyd-yr-Helyg and Oxford Street, where the FRAW map indicates a high to low risk of pluvial flooding (Figure 16). At Quarry Street, localised surface water flows generated by intense

rainfall and conveying via local topography from Tyla Gwyn and the A4054/A468 roundabout are considered the primary cause of flooding to two residential properties.
