CYNGOR BWRDEISTREF SIROL
RHONDDA CYNON TAF
COUNTY BOROUGH COUNCIL

COMMITTEE SUMMONS

YOU ARE SUMMONED to a hybrid meeting of the **OVERVIEW AND SCRUTINY COMMITTEE** to be held on **MONDAY, 28TH FEBRUARY, 2022** at **5.00 PM.**

5. SECTION 19 FLOOD INVESTIGATION REPORTS

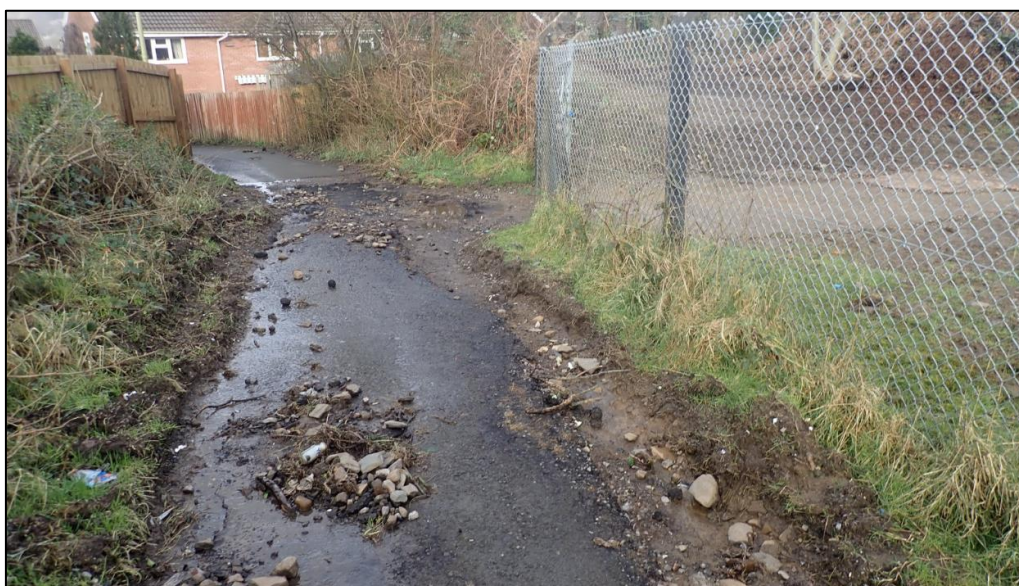
Residents at Brynderwen, situated further downstream, reported significant surface water runoff travelling down the lane from Heol Nant towards the southern end of Brynderwen during Storm Dennis. The overtopping of the watercourse behind Heol Mynydd was likely the primary contributing source of flood water, however, discussions with the local community report that overland flows originating from the field behind Brynderwen contributed to the initial flooding. The area of land has been identified as falling under private ownership.

Figure 12: Evidence of deposited debris and damages to the bottom of the path looking down towards Brynderwen. Overland flows were observed flowing through land to the right behind the fencing (captured by FRM officers on 17th February 2020).

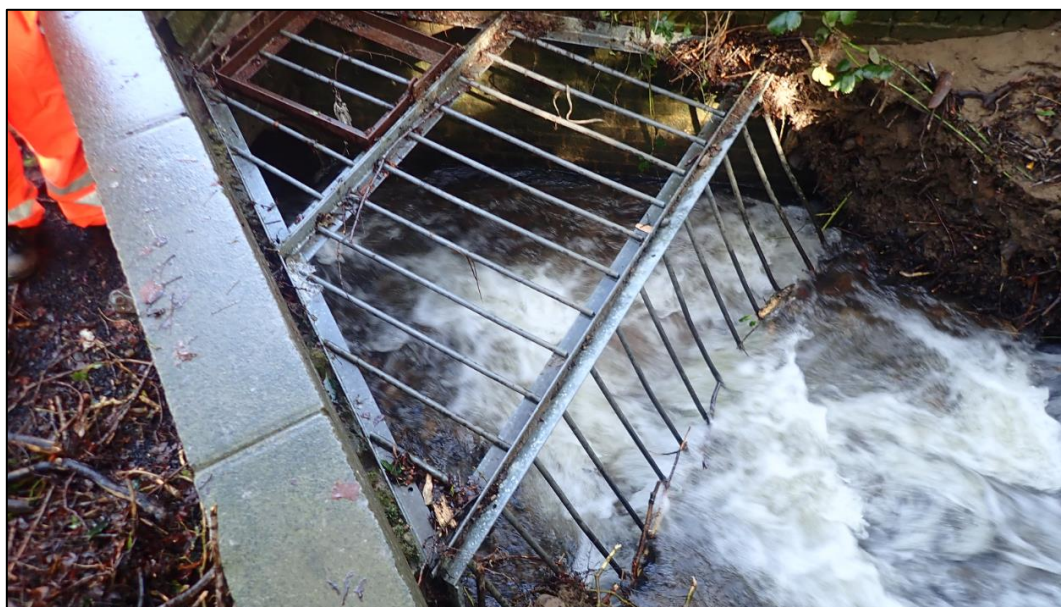
The source of the flooding at Pontshonnorton Road was initially identified as originating from a blocked culvert inlet located opposite the Royal Oak Inn. The inlet structure was identified by first responders as being blocked with debris and was subsequently cleansed. Figure 19 captured post event by FRM officers depicts the

inlet following clearance works. The inlet is identified as a privately owned inlet but similarly to the Heol Mynydd culvert, the Council's Highway Authority maintain an inspection schedule of the asset pre storm events. The inlet was also inspected and cleared of debris on the 8th and 15th February 2020, respectively.

Figure 19: Ely Brook culvert inlet to the rear of Pontshonnorton Road which surcharged during Storm Dennis due to blockages at the inlet (captured by FRM officers on 17th February 2020 following clearance works)

Internal surveys of the Ely Brook network have highlighted several sections of the culvert drainage system that are in poor condition following the flood event. The culvert section immediately downstream of the inlet known to surcharge is in the poorest condition, both structurally and operationally according to CCTV survey data.

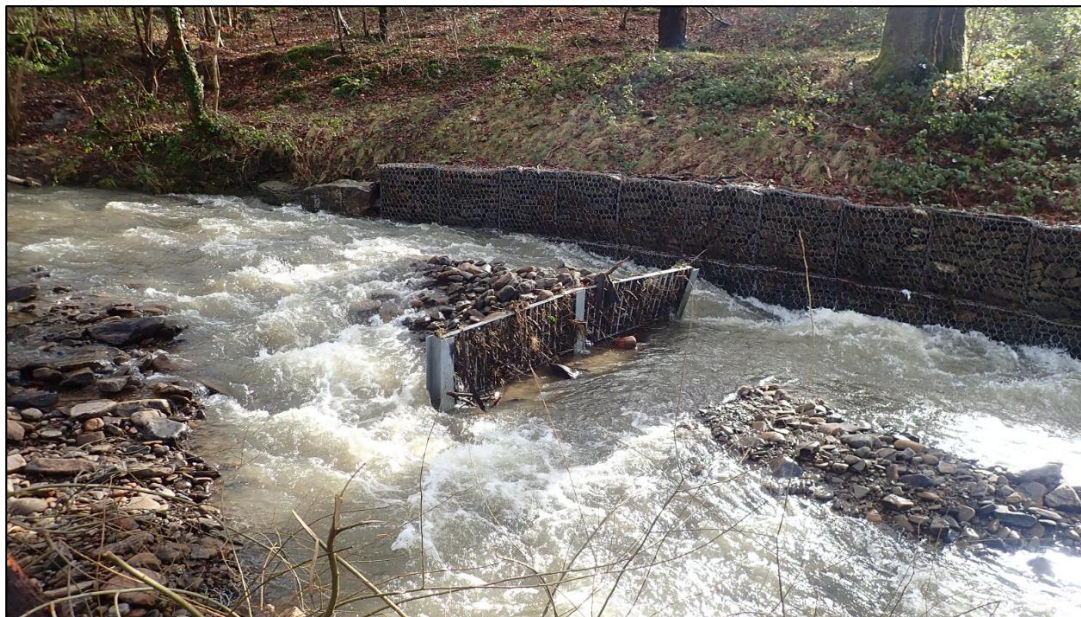
A general assessment of the Nant Cae Dudwg watercourse revealed significant deposition of large stones and boulders within the channel. Figures 22 and 23 were captured on the 17th February 2020 and show significant accumulation of natural material across the full width of the upper catchment debris screens. A Council appointed contractor carried out the removal of all large debris from the watercourse following Storm Dennis which totaled approximately 350 tons.

Figure 23: Second upstream debris screen in the Nant Cae Dudwg watercourse (captured by RCT's Flood Risk Management team on 17th February 2020)

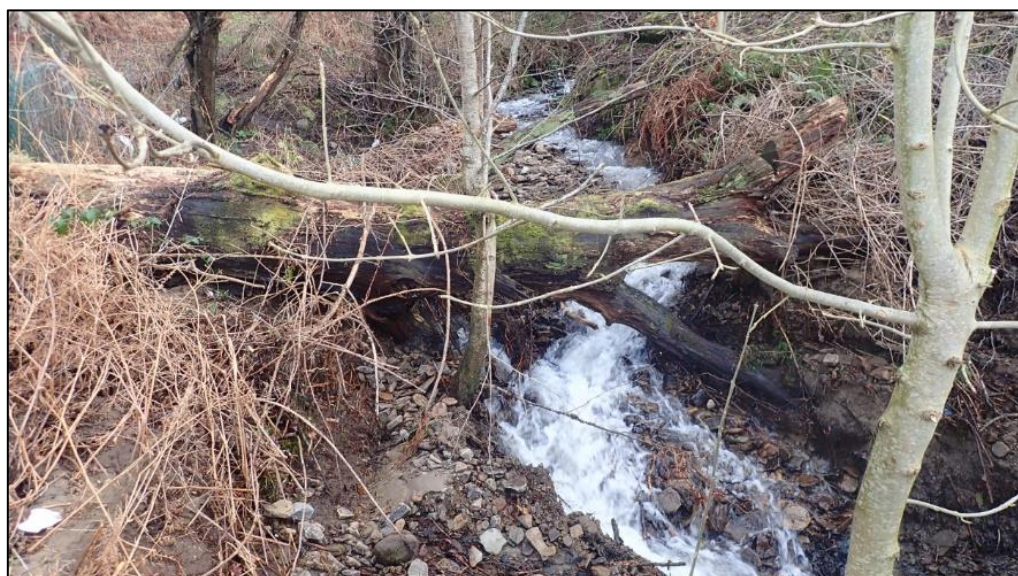
Post event inspections undertaken by RCT's FRM officers also identified a collapsed tree within the watercourse (Figure 29), just upstream of the culvert inlet. It is not believed that the collapsed tree contributed to the flooding at Cilfynydd, however it does provide evidence of the powerful flows within the watercourse during the storm event which caused embankment scouring as well as mobilisation of debris, contributing to the inlet blockage downstream. Emergency clearance works were undertaken by the Council's Depot to remove the tree from the watercourse.

Figure 29: Tree collapse in the unnamed ordinary watercourse to the rear of Heol Mynydd (captured by FRM officers on 17th February 2020)

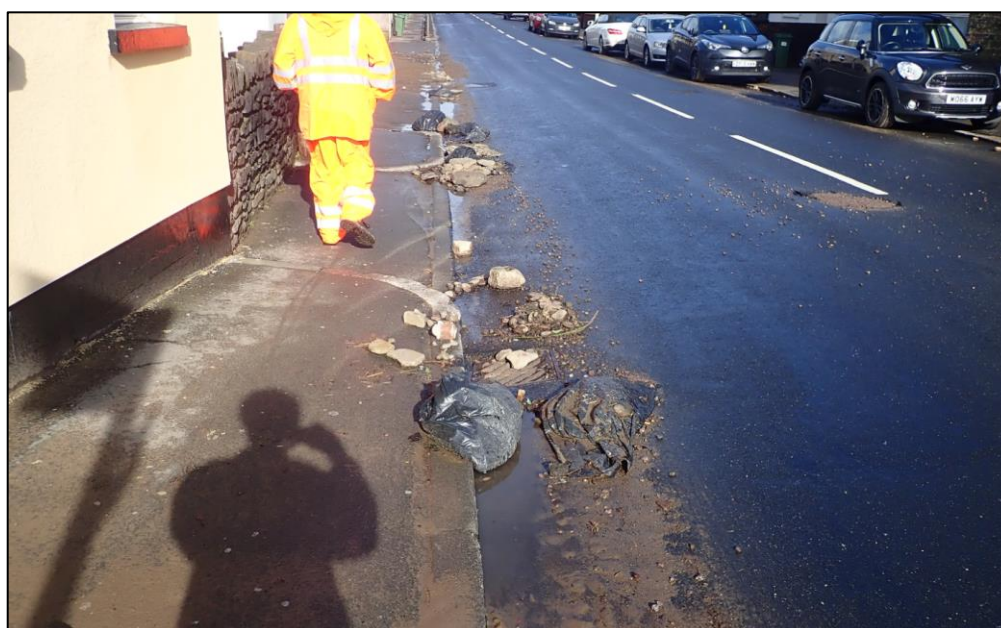
Overland flows from private land and runoff originating from the surcharged inlet to the rear of Heol Mynydd caused water to travel towards Heol Nant and Heol Cronfa, and onwards toward Brynderwen via a small pathway. Deposited mud, silt and debris was evident across these streets, along with several reports of blocked highway drainage gullies, illustrating the flow path of water during the event. Likewise, water sourced by the Ely Brook watercourse travelled north along Pontshonnorton Road, depositing debris on its course, causing blockages to the highway drainage infrastructure (Figure 31).

Figure 31: Debris left after the storm event at Pontshonnorton Road (captured by FRM officers on 17th February 2020)

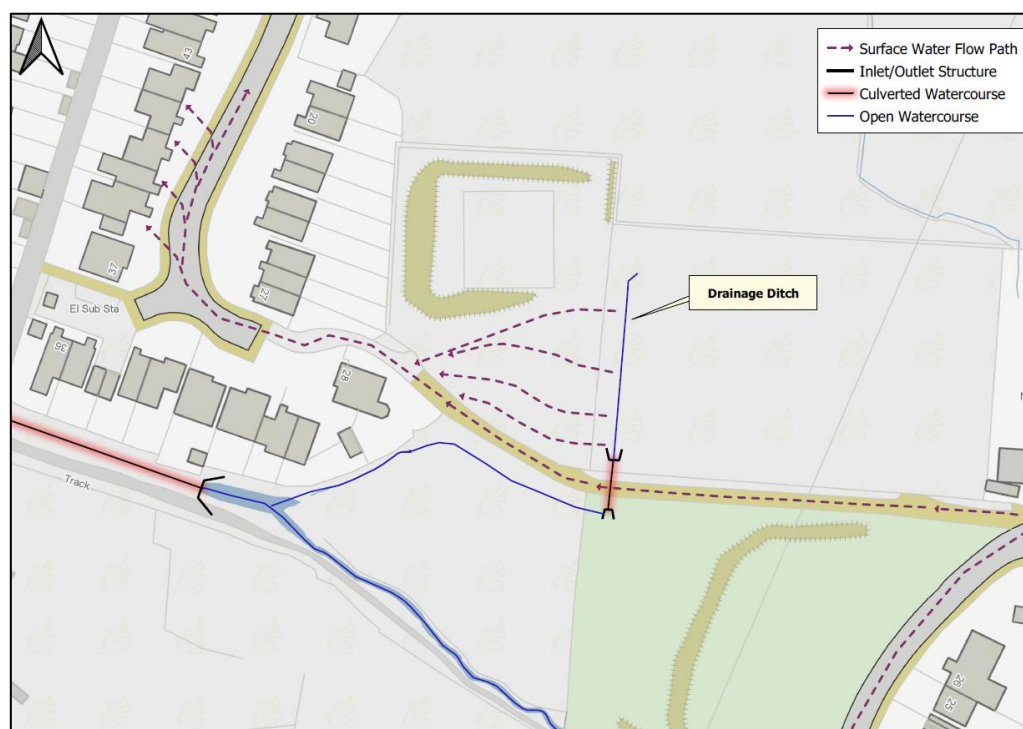
The inspection noted that the land drainage channel is culverted beneath the lane before outfalling into the adjacent stream that flows towards Oakland Terrace culvert network. Residents report that the inlet became blocked during the event, resulting in water overtopping the channel (Figure 32) and flowing towards the downstream field and onwards to impact properties at Brynderwen. The land drainage channel and observed flow paths have been illustrated in Figure 33.

Figure 33: Location of the identified land drainage ditch and observed surface water flow paths during Storm Dennis

Despite the land drainage channel being identified as a secondary source of flooding, the primary source of flooding to properties in this area originated from the surcharged culvert inlet to the rear of Heol Mynydd.

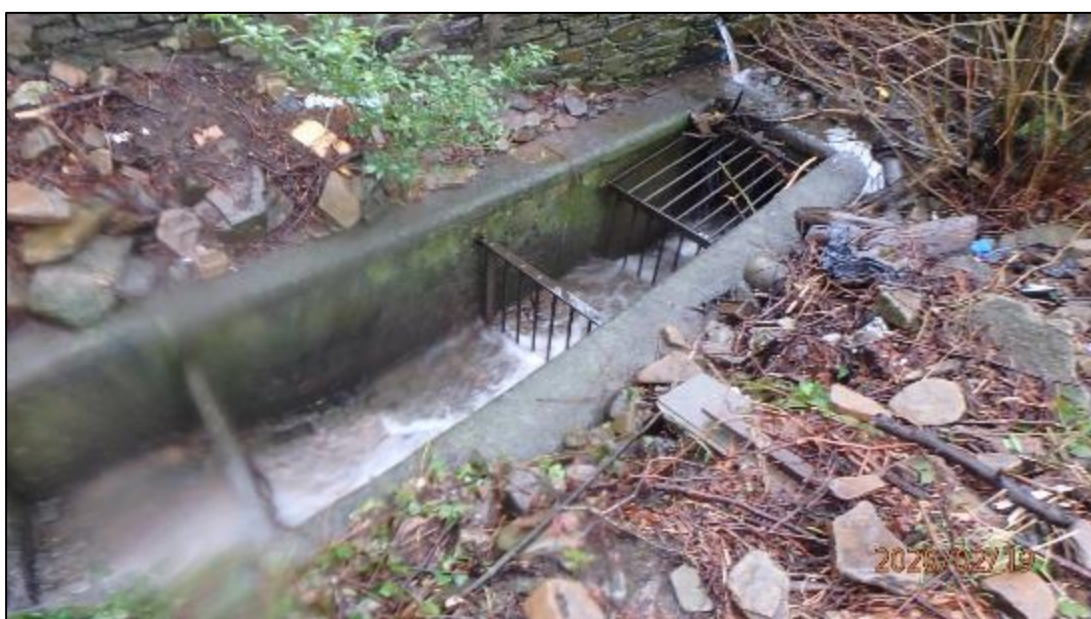
The site inspection also identified evidence of a third surcharged culvert inlet located near Dumfries Street (labelled 'Culvert Inlet 3' in Figure 4). This culvert inlet conveys flows from the Nant Coedcaetylefforest ordinary watercourse. Evidence of cleared debris was identified (Figure 7) post event, indicating that the culvert inlet became blocked during Storm Dennis, resulting in surcharge.

Figure 7: 'Culvert Inlet 3' to the rear of Dumfries Street which surcharged during Storm Dennis (captured by RCT's Flood Risk Management team on 19th February 2021)

The channel immediately upstream of 'Culvert Inlet 3' (Area 3, Figure 21) is identified as man-made and therefore showed no signs of bank erosion. Upon an inspection of the surrounding area post Storm Dennis however, material on the banking area was evident (Figure 7). This material is not considered to have originated from Area 1.

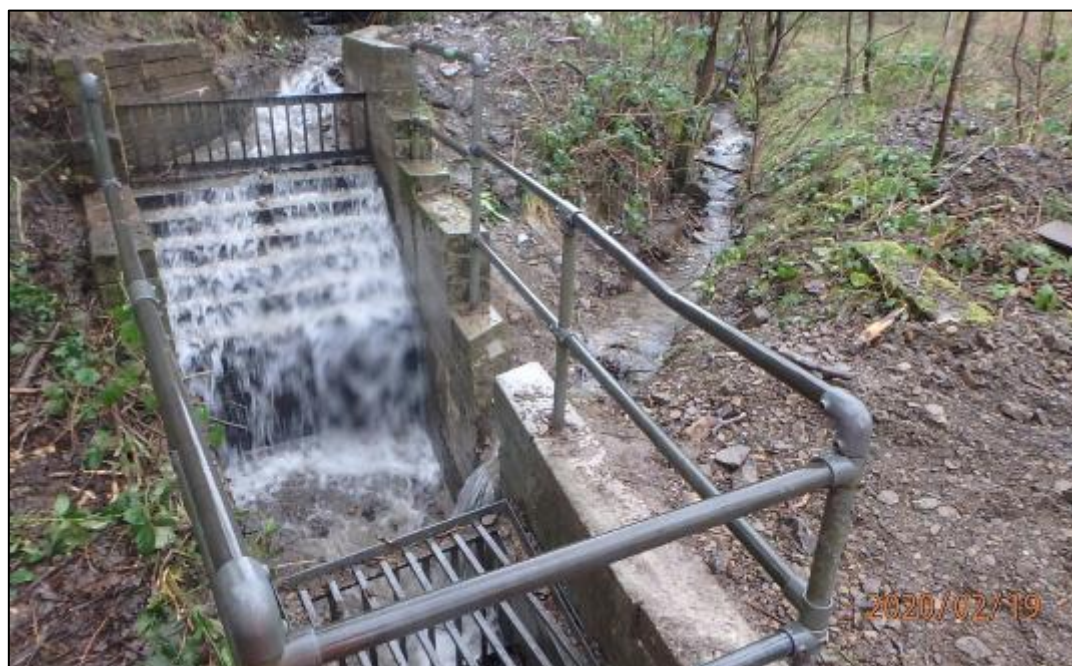
The source of flooding to three properties at Ross Rise and Tyle Fforest was identified as originating from two surcharged culvert inlets located to the north of Tyn-y-coedcae, labelled 'Culvert Inlet 5 and 6' in Figure 17.

The 'Culvert Inlet 6' structure was identified by first responders as being blocked with debris and was subsequently cleansed. Figure 18 captured post event by FRM officers depicts the inlet following clearance works.

Figure 18: Photo of 'Culvert Inlet 6' captured by RCT's Flood Risk Management team following debris clearance post Storm Dennis (19/02/2020)

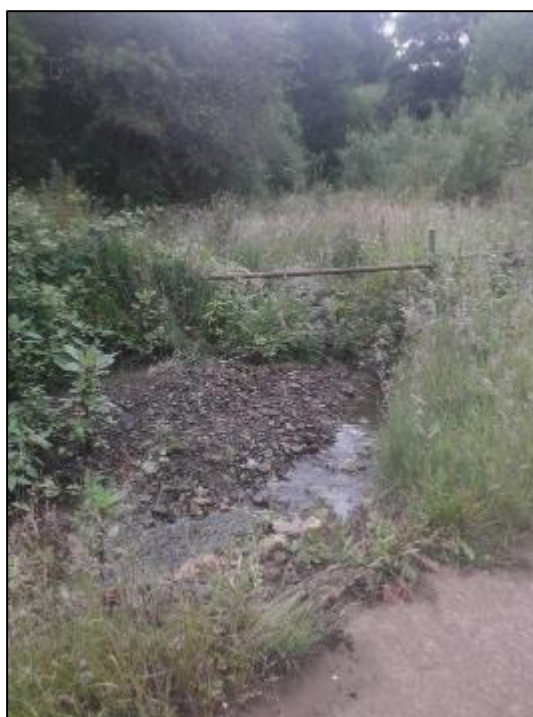
According to on-site officers, several sections of open watercourse upstream of the 'Abertonllwyd Street Culvert Network 1' (Figure 11) had significant build-up of debris within the channels, indicating significant mobilisation of debris occurred during the storm event (depicted in Figure 20). The conveyance of sediment, silt and stone downstream is considered to have contributed to the surcharging of 'Culvert Inlet 1' and 'Culvert Inlet 2' during Storm Dennis. This debris is also considered to have entered the culvert network, contributing to the surcharge of 'Manhole 1' during the event.

Figure 20: Image of debris accumulation within the unnamed ordinary watercourse channel upstream of 'Culvert Inlet 1' (Figure 4) (captured during CCTV operations on 30/06/2020)

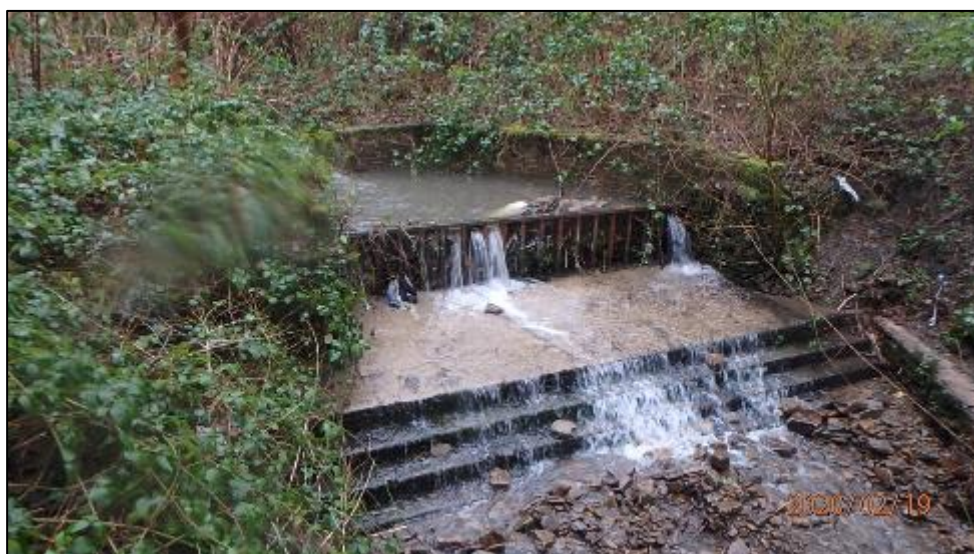
The upstream sections of the Nant Coedcaetylefforest ordinary watercourse (Area 1, Figure 21) showed evidence of debris deposition within the man-made channel, along with significant accumulation of material across the upper debris screens and headwall structure. Figure 22 and 23 depicts the material, which consists of coarse stone, silt and woody debris, within the upper channel. This material is assumed to have been mobilised from the upper reaches above the A4061 (Rhigos Road) and carried downstream by the high flows during Storm Dennis.

Figure 22: Photo of debris deposition behind the upper debris screen of the Nant Coedcaetylleforest ordinary watercourse (captured by RCT's Flood Risk Management team on 19/02/2020)

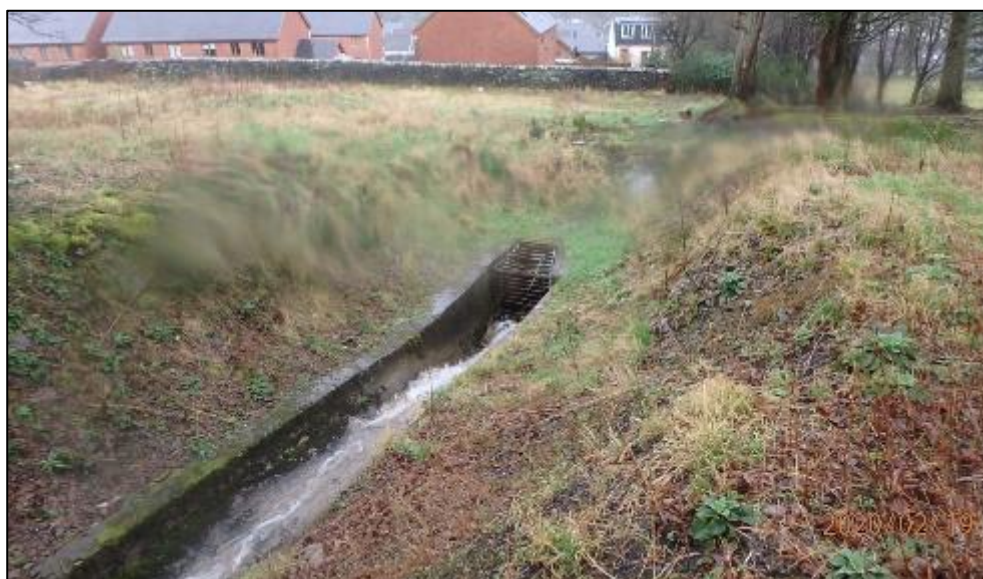
Below the headwall structure, the channel and culvert inlet (Area 2, Figure 21) did not show evidence of debris conveyance or blockage to the inlet, as shown in Figure 24. It is considered that the upstream debris screens at Area 1 succeeded in minimising the volume of debris travelling downstream.

Figure 24: Culvert inlet at Area 2 which conveys the Nant Coedcaetylleforest ordinary watercourse towards Area 3 (captured by RCT's Flood Risk Management team on 19/02/2020)

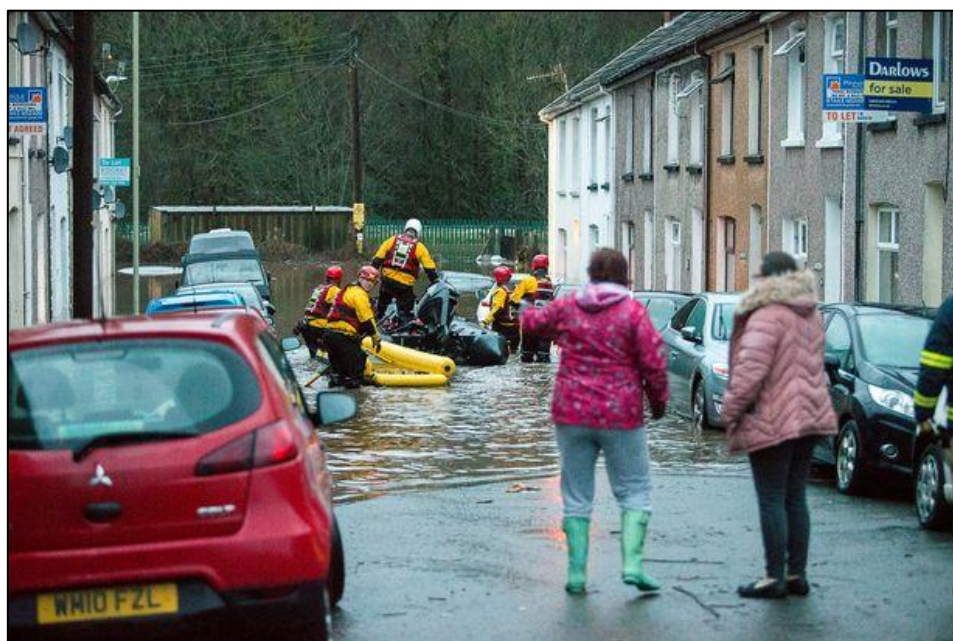
Figure 5: Image capturing South Wales Fire and Rescue Service undertaking evacuations within Egypt Street on 16th February 2020, (Image: Huw Evans Picture Agency Ltd)

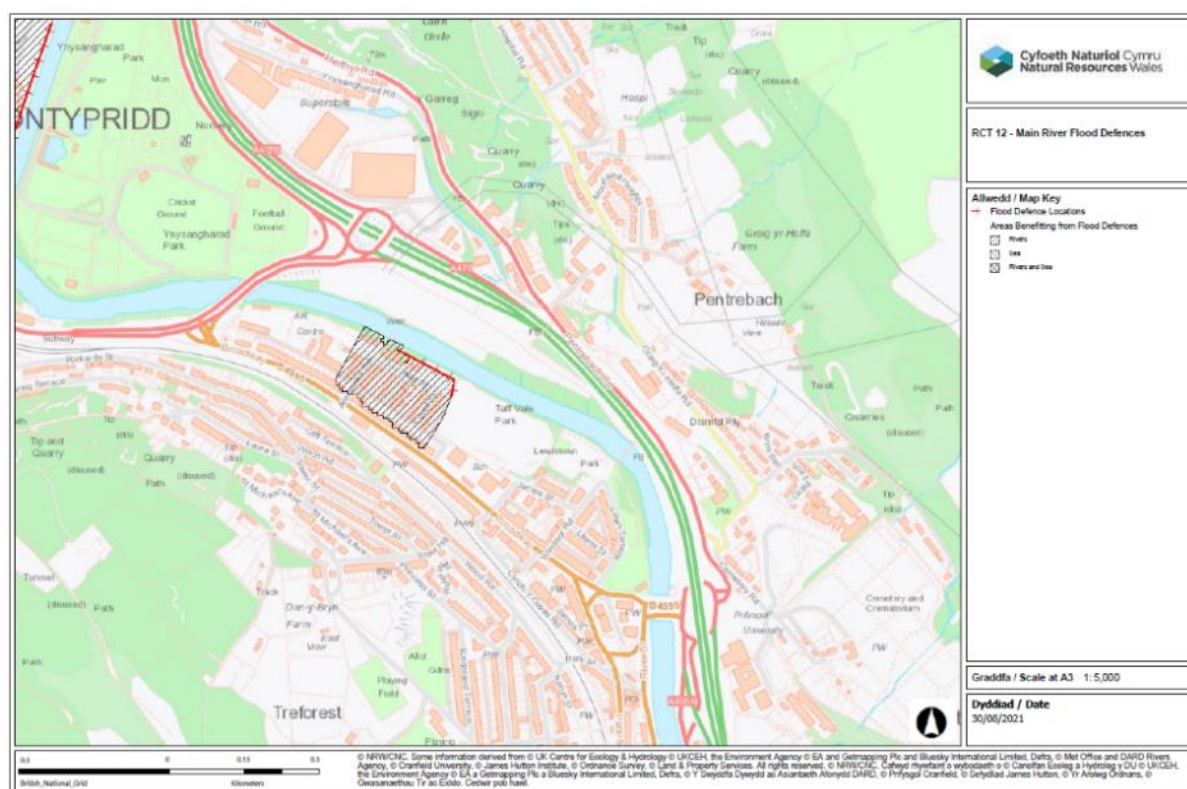
As illustrated in Figure 11 (demarcated by a bold red line), there are approximately 150 metres of formally designated flood defence infrastructure along the western bank of the River Taf at RCT12. This infrastructure is operated and maintained by NRW.

According to NRW, this infrastructure provides a standard of protection up to 1 in 75 annual probability flood event (Q75) to several properties within the investigation area (black hatched area in Figure 11), including properties at Alexandra Road, Nile Street, Egypt Street and Niagara Street.

Figure 11: Natural Resources Wales’ map for Main River Flood Defences and areas benefiting at RCT12. Contains Natural Resources Wales information © Natural Resources Wales and database right. All rights reserved

The current indicative design standard of protection for flood defences on a main river is 1 in 100 annual probability (Q100) flood event plus, for new defences, an allowance for climate change. This is stated within the Welsh Government’s National Strategy for Flood and Coastal Erosion Risk Management which encourages main river flood alleviation schemes to provide a Standard of Protection (SOP) up to Q100⁵. It is thereby inferred that the current SOP of flood defence infrastructure at RCT12 is below current indicative standards.

Whilst the flood defences identified at RCT12 are below the current indicative standard, the unprecedented rise of river levels in the Taf during Storm Dennis resulted in the overtopping of assets up to Q100 SOP. NRW’s ‘Flood Incidence Response Review’⁴ does in fact outline that no flood defences failed in the lower Taf region and that the flooding was the result of river flows exceeding the construction design standard.

R1B	<p>NRW to investigate the standard of protection provided by flood defences at RCT12 and “consider improvements to NRW flood alleviation schemes and structures on a prioritised basis”. Aligns with recommendation ‘Action FD3’ within NRW’s Flood Incident Management Review.</p>
					R1C	<p>NRW to review its flood warning service provision, especially for extreme events. This will form part of NRW’s Flood Warning Service Review Implementation Programme and aligns with the recommendations set out in their ‘Flood Incidence Management Review’.</p>
2	Surface water drainage network across RCT12	Rhondda Cynon Taf CBC Highway Authority	Surface Water	Highway Authority and Lead Local Flood Authority	R2A	<p>The Highways Authority to jet and cleanse the highway drainage network and action repairs accordingly.</p>

- NRW to undertake minor repairs to Egypt Street flood wall.
- Following the completion of NRW's Lower Taf Flood Modelling Project, NRW propose to undertake an initial assessment of the viability of potential flood risk management options. Consideration should be given to areas at high risk of flooding from rivers on a prioritised basis. **(R1A, R1B)**
- Following the completion of NRW's Lower Taf Flood Modelling Project, NRW propose further threshold work and flood warning area amendments. **(R1A, R1C)**
- NRW will undertake a review of the modelled outputs and adopt changes to their maintenance program within the investigation area if required. **(R1A)**

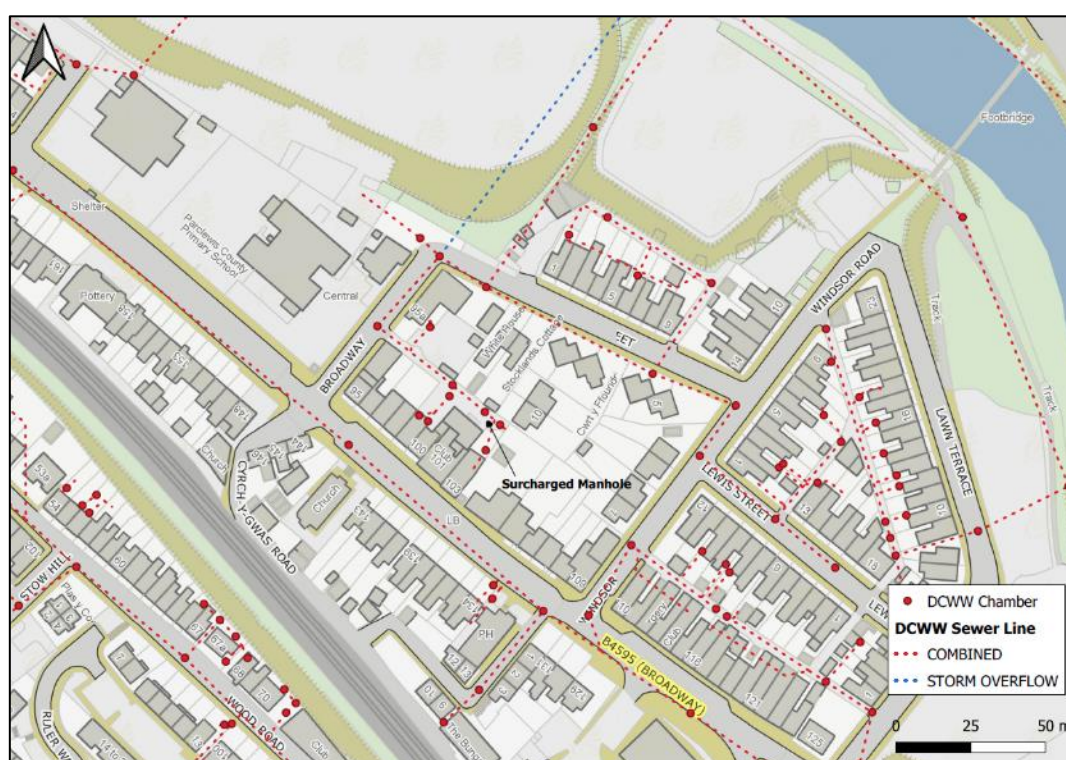
In addition to the highway drainage infrastructure within RCT12, the overtopping of the River Taf and the intensity of rainfall during Storm Dennis is considered to have overwhelmed parts of DCWW's combined drainage infrastructure during the storm event. This is evidenced by the surcharging of a DCWW combined sewer manhole on James Street (illustrated in Figure 12), resulting in the internal flooding of a nearby residential property which is also situated at a localised low point.

Figure 12: Location of surcharging manhole on DCWW's Combined Sewer network

As outlined in 'FRM – Storm Dennis – Overview Report'², DCWW sewers have a current design standard of Q30, as per the 'Sewers for Adoption 7th Edition'⁶ guidance document. Given that the design standard was markedly exceeded during Storm Dennis, the maintenance condition of DCWW apparatus is not considered to have significantly impacted the flooding experienced.

R2B	The LLFA and Highway Authority to evaluate surface water management options to alleviate pluvial flooding at locations across the investigation area.
3	DCWW combined sewer and associated manhole	DCWW	Sewer	DCWW	R3A	DCWW to evaluate the standard of service and the condition of the combined sewer network servicing RCT12.

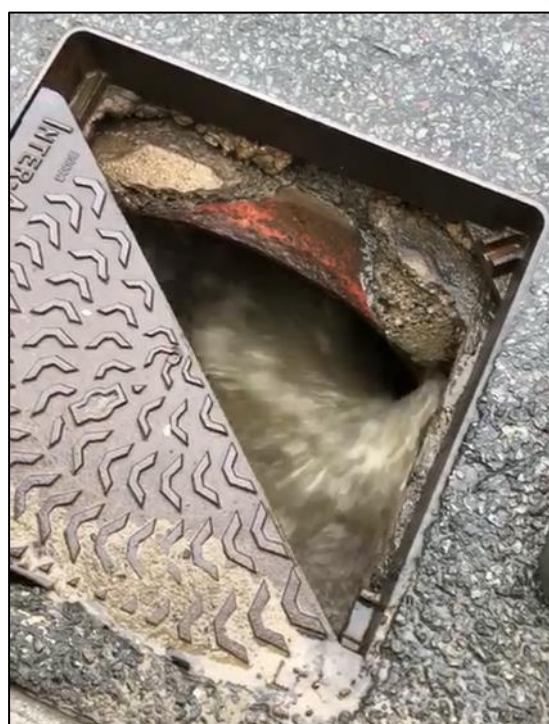
Site inspections undertaken by RCT's Flood Risk Management team during Storm Jorge (February 28th to March 1st) identified a manhole adjacent to the affected properties on Cardiff Road (labelled 'Manhole 1' in Figure 9) surcharging. This resulted in repeat surface water flooding to the external extents of several properties at Cardiff Road.

The surcharging of 'Manhole 1' approximately two weeks after Storm Dennis has been attributed to the raised river levels within the River Taf which prevented water from outfalling from the culverted network and into the River Taf. Figure 10, taken during RCT's site inspection following the receding of flood water, shows 'Manhole 1' surcharging within the chamber.

Figure 10: Photo of 'Manhole 1' surcharging during Storm Jorge (captured by RCT's Flood Risk Management team on 28th February 2020)

Following the observations made at 'Manhole 1' during Storm Jorje, it is considered that the downstream culvert network may have contributed to surface water flooding on Cardiff Road during Storm Dennis; however, the overtopping of the River Taf has been determined as the primary cause of flooding to properties at Cardiff Road in the northern sub-catchment during Storm Dennis.

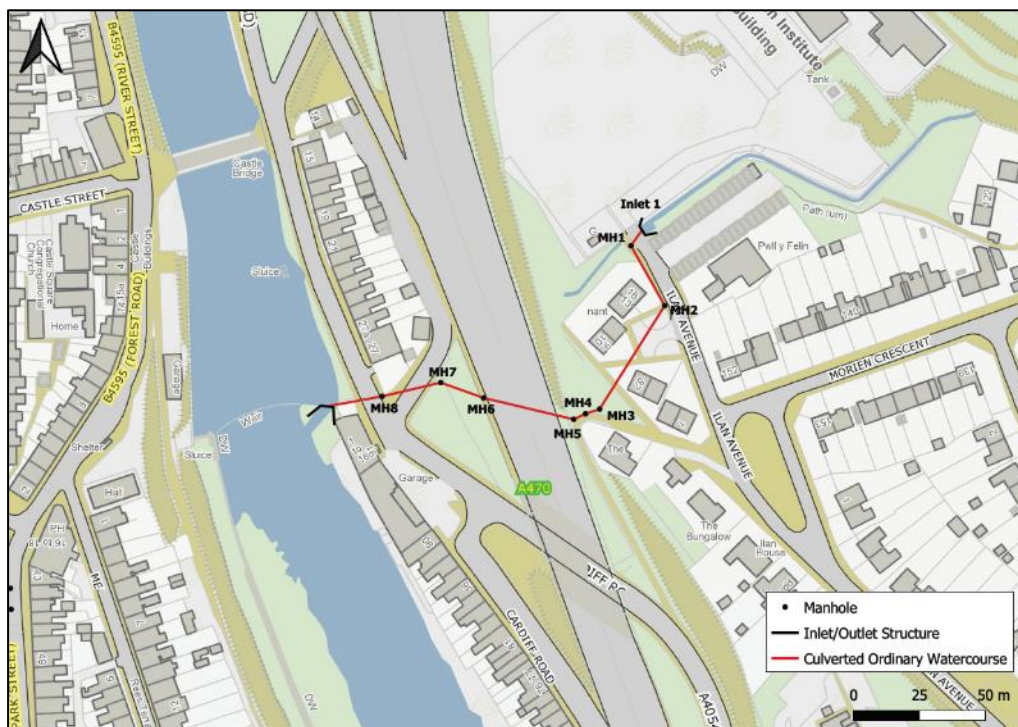
Figure 9: Ilan Avenue culverted ordinary watercourse location plan

Whilst the overtopping of the River Taf has been determined as the primary cause of flooding to the majority of properties within RCT14, the capacity of the ‘Ilan Avenue’ culvert network (illustrated in Figure 18) has also been assessed to ascertain its current standard of protection following the observed surcharging of a manhole at Cardiff Road following Storm Dennis (Figure 10).

Figure 18: Ilan Avenue culverted ordinary watercourse network with annotated Manhole labels

The assessment infers that the upstream section of the network, at the culvert inlet adjacent to Ilan Avenue, has adequate hydraulic capacity to accommodate storm events up to Q200 in free-flowing conditions. This is significantly reduced to Q2 in blockage conditions however, no blockage to the upstream inlets was observed during Storm Dennis.

The capacity of the Ilan Avenue downstream network (which conveys flows beneath the A470 and Cardiff Road) was assessed as having a SOP below current design standards for new culverts as defined by CIRIA C789. This is further reduced to Q2 in blockage conditions.

R3B	The LLFA and LDA to investigate the standard of protection and the condition of the culvert structure and network as a whole.
					R3C	The LLFA to jet and cleanse the ordinary watercourse culvert network.

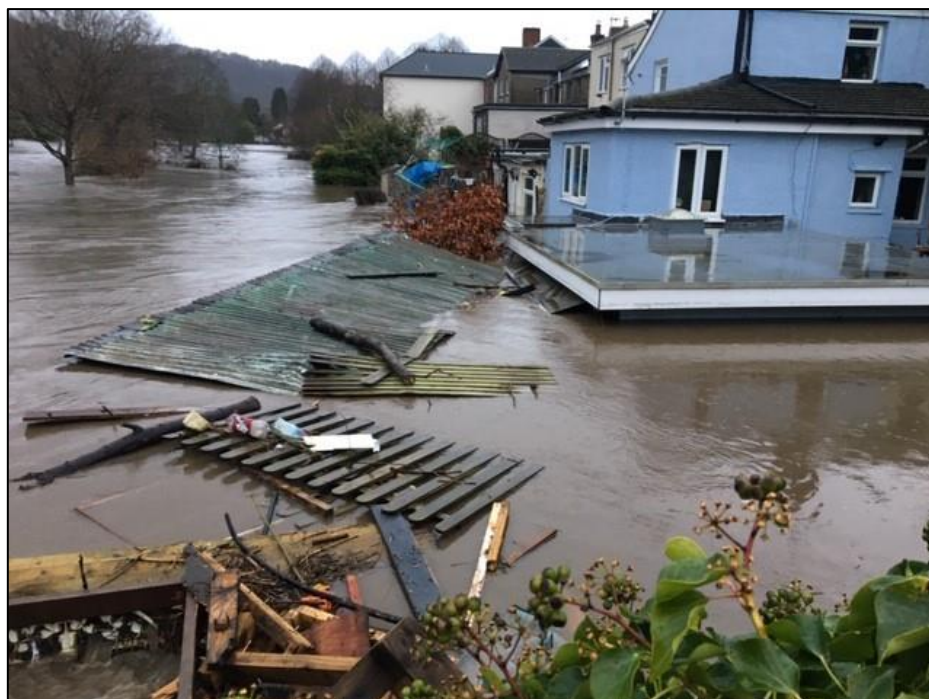
A total of 25 residential and 9 non-residential properties were internally flooded by the River Taf, with several properties on Cardiff Road reporting basement flooding of between 1.5 and 2 metres in depth.

Figure 5: Image showing the overtopping of the River Taf to the rear of Cardiff Road which submerged the rear gardens and ground floor of several properties during Storm Dennis (image provided by resident)

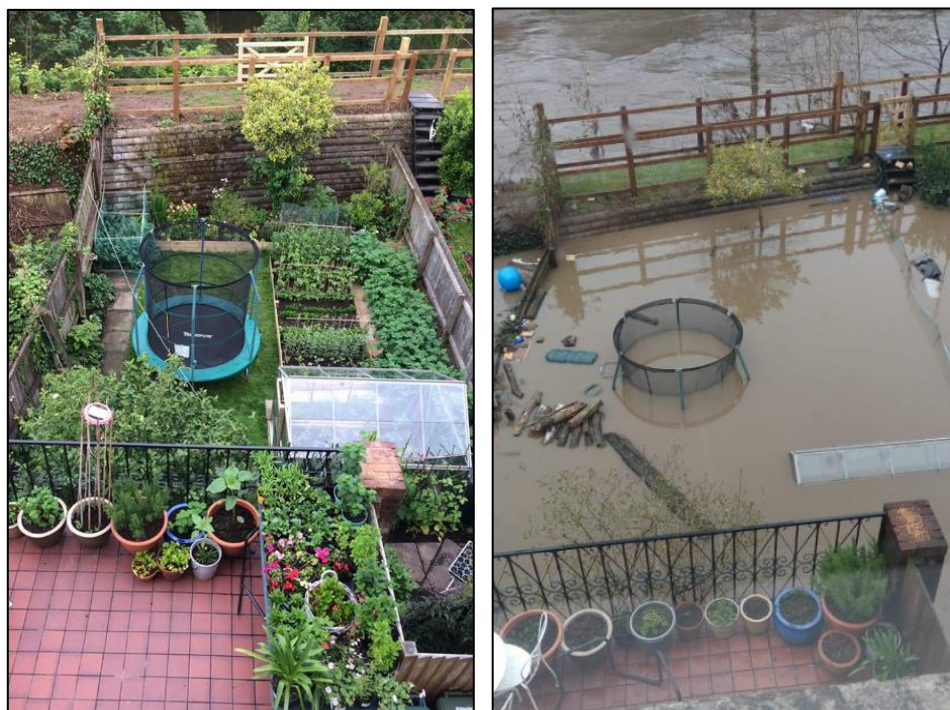
Once flood water had entered the rear gardens of properties on Cardiff Road, it was unable to recede due to the difference in height between the gardens and the existing flood defences, as depicted in Figure 6. This resulted in up to 2.5 metres of fluvial flood water becoming trapped in the rear gardens of properties on Cardiff Road for approximately 12 hours during the storm event.

Figure 6: Images capturing the rear garden of a property on Cardiff Road before (left) and during Storm Dennis (right) (images provided by resident)

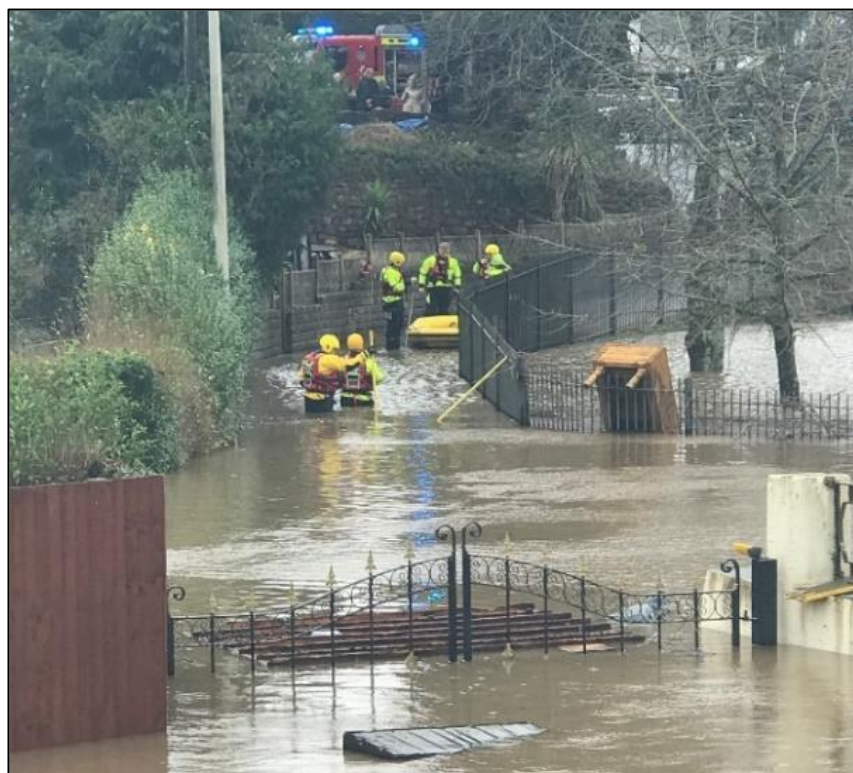
Emergency rescue efforts by the Fire Service were in operation following the overtopping of the River Taf on the 16th February 2020 to evacuate residents from their homes (Figure 7).

Figure 7: Image capturing the rescue efforts by the Fire Service to evacuate residents at Park Lane on 16th February 2020 (image provided by resident)

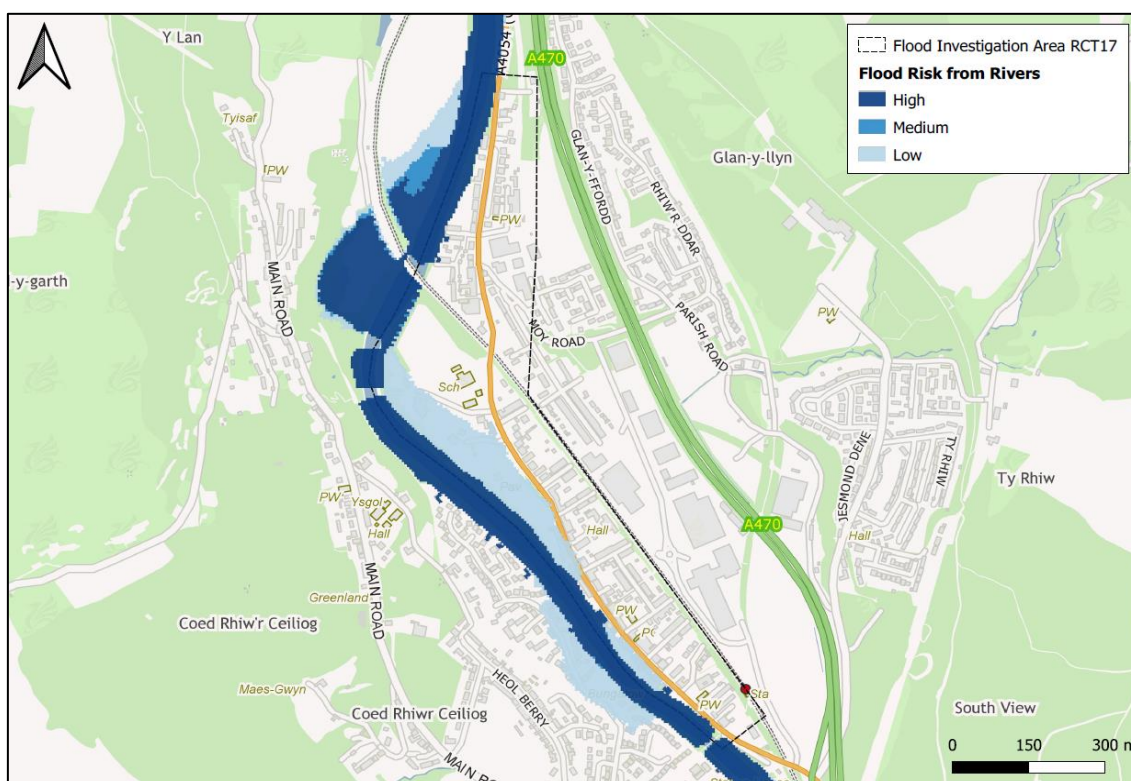
that the flooded area within investigation area RCT17 is in fact at high risk of flooding from the main river without the presence of flood defences. A high risk of flooding means that an area has a chance of flooding greater than 1 in 30 (3.3%) each year. This highlights the potential impact of the overtopping of the River Taf at Taff's Well during extreme storm events.

Figure 9: NRW's Flood Risk Assessment Wales (FRAW) map for River sources. Contains Natural Resources Wales information © Natural Resources Wales and database right. All rights reserved.

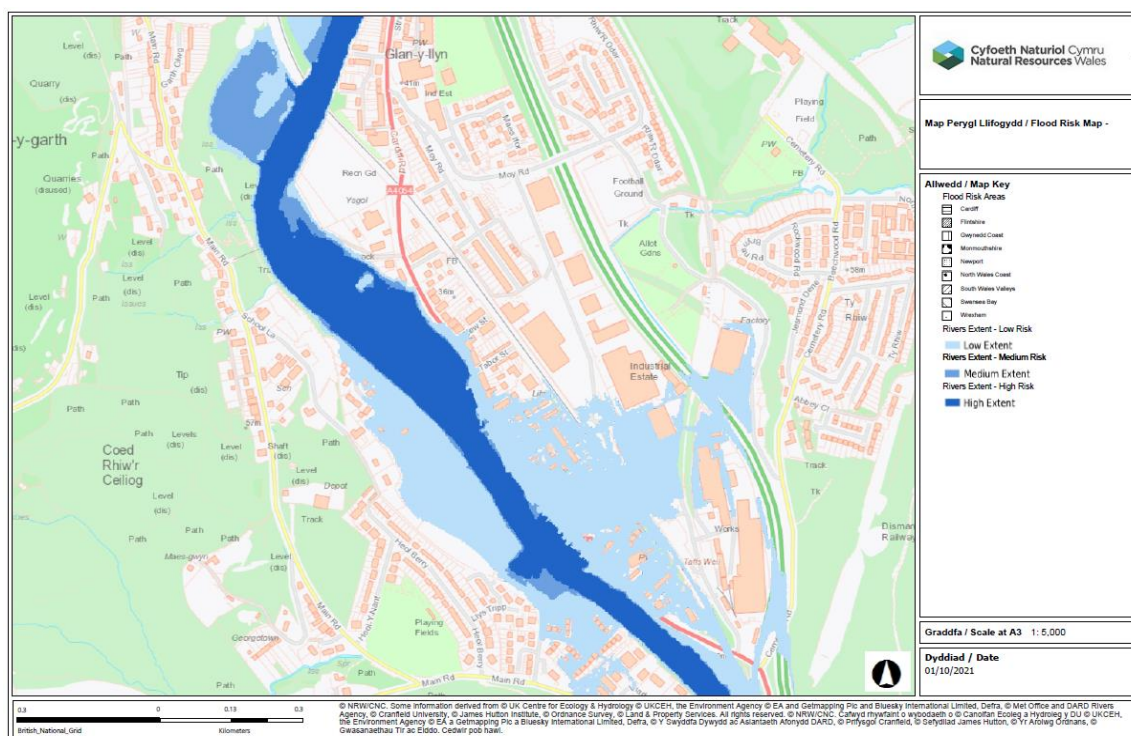
Figure 10: NRW's Flood Risk Assessment Wales (FRAW) map for Medium Risk River Flood Depth in RCT17. Contains Natural Resources Wales information © Natural Resources Wales and database right. All rights reserved

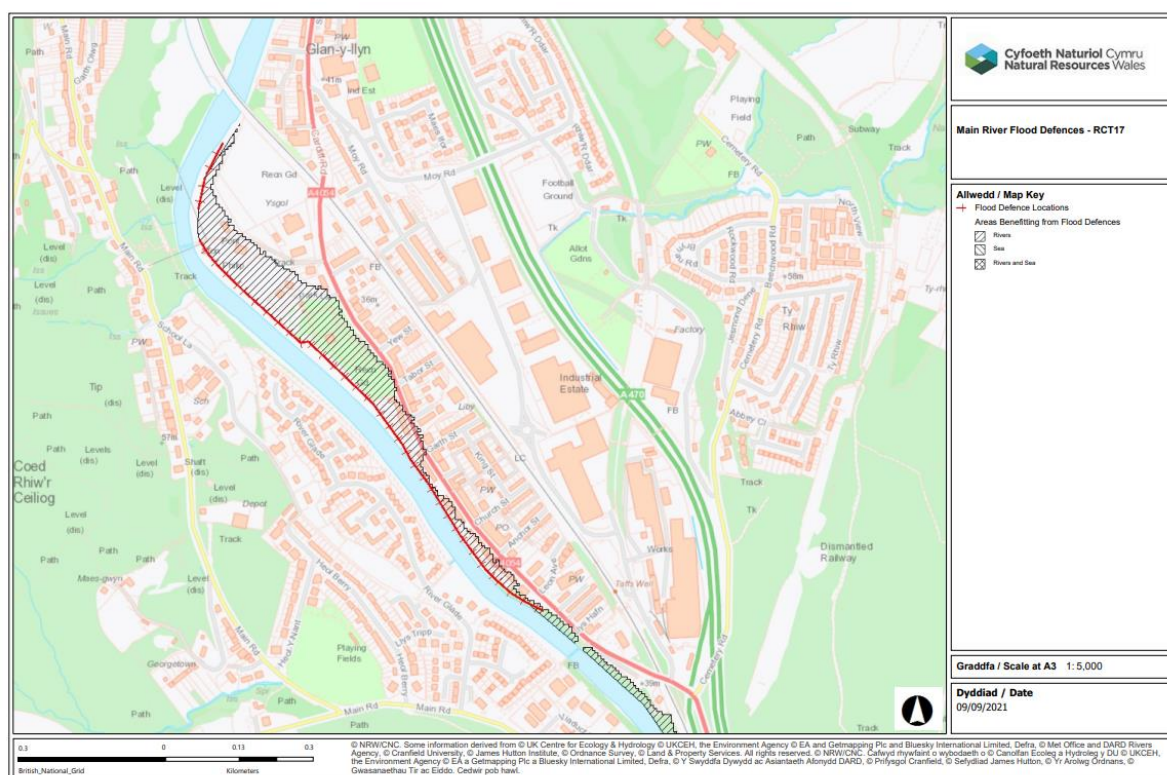
As illustrated in Figure 11 (demarcated by a bold red line), there are approximately 1.5 kilometres of formally designated flood defence infrastructure along the eastern bank of the River Taf at RCT17. This infrastructure is operated and maintained by NRW.

According to NRW, this infrastructure provides a Standard of Protection (SOP) of 1 in 100+ annual probability flood event (Q100+) to the majority of the impacted properties within the investigation area (black hatched area in Figure 11).

Figure 11: Natural Resources Wales' map for Main River Flood Defences and areas benefiting at RCT17. Contains Natural Resources Wales information © Natural Resources Wales and database right. All rights reserved

The current indicative design standard of protection for flood defences on a main river is 1 in 100 annual probability (Q100) flood event plus, for new schemes, an allowance for climate change. This is stated within the Welsh Government's National Strategy for Flood and Coastal Erosion Risk Management which encourages main river flood alleviation schemes to provide a SOP up to Q100⁵. It is thereby inferred that the current SOP of flood defence infrastructure at RCT17 is in accordance with current indicative standards.

<p>R1B</p> <p>NRW to investigate the standard of protection provided by flood defences throughout RCT17 and “consider improvements to NRW flood alleviation schemes and structures on a priorities basis”. Aligns with recommendation ‘Action FD3’ within NRW’s Flood Incident Management Review.</p>
					<p>R1C</p> <p>NRW to review its flood warning service provision, especially for extreme events. This will form part of NRW’s Flood Warning Service Review Implementation Programme and aligns with the recommendations set out in their ‘Flood Incidence Management Review’.</p>
2	River Taf	Private Landowner	Main River	Natural Resources Wales	<p>R2A</p> <p>NRW to work with the landowner to assess and review the risk of flooding from the River Taf at the location known to have overtopped during the event to identify the viability</p>

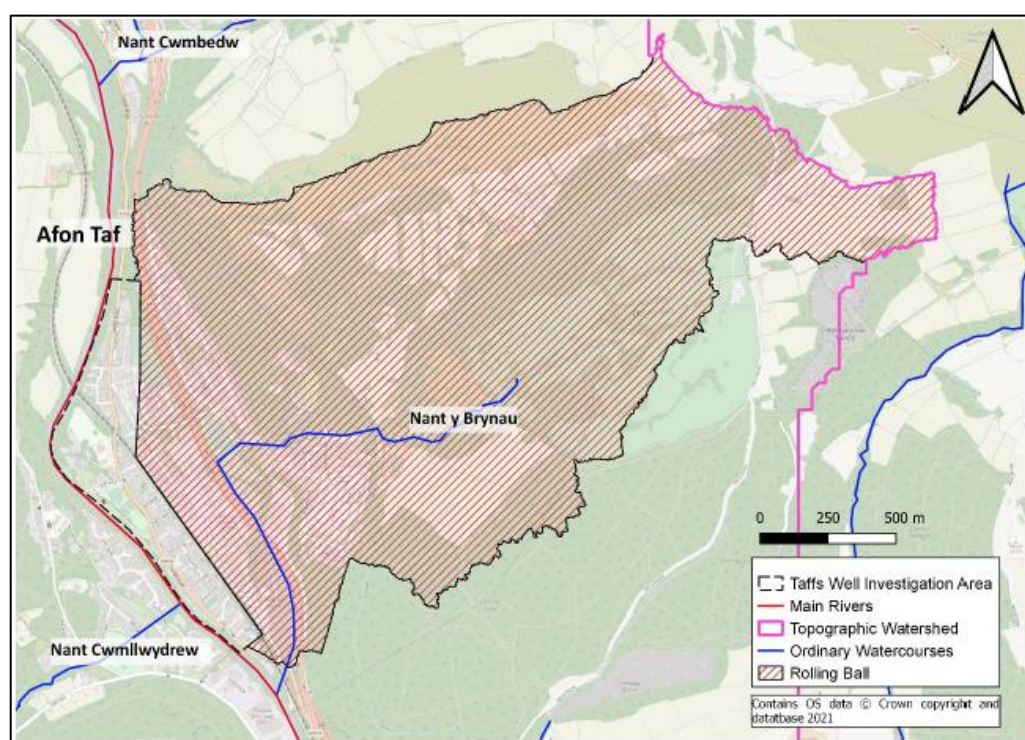
RCT17 has a large topographic watershed (Figure 13) and a high potential for significant overland flows; however, the investigation area is separated from the watershed by the A470 dual carriageway. With the A470 acting as a barrier to the conveyance of surface water, it is believed that the majority of surface water flooding within Taff's Well during Storm Dennis was localised and not a consequence of the predominant valley gradient.

Figure 13: Topographic Watershed above investigation area RCT17

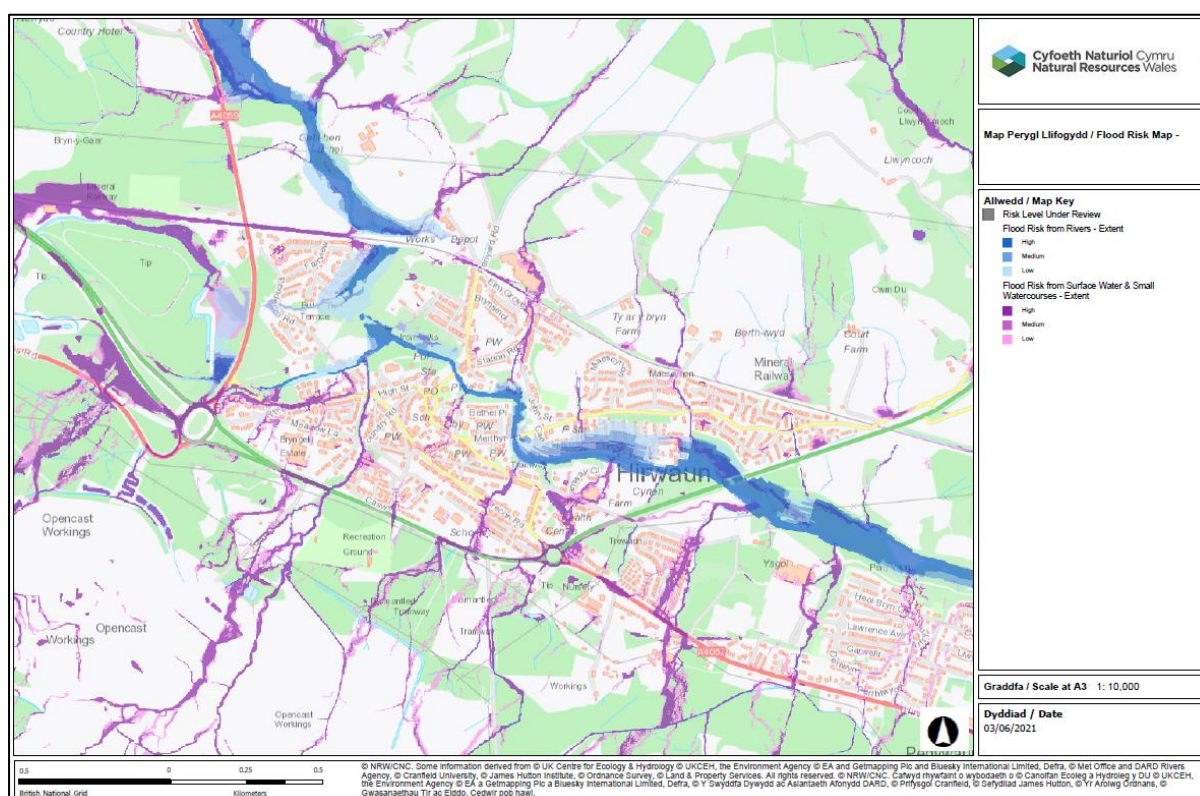
The highest risk posed to people and properties is broadly associated with the River Cynon across the length of the watercourse, with significant risk along sections of Cae Felin Parc and Llys Cynon. A risk of flooding is also noted in the north of the site, sourced from the River Cynon culvert inlet³. Natural Resources Wales' Flood Risk Assessment Wales (FRAW) map also notes a low to high risk of surface water and ordinary watercourse flooding sources from various culvert inlets (Figure 2).

Figure 2: Natural Resources Wales' Flood Risk Assessment Wales (FRAW) map for rivers and ordinary watercourse and surface water flood risk at investigation area RCT01. Contains Natural Resources Wales information © Natural Resources Wales and database right. All rights reserved.
