CYNGOR BWRDEISTREF SIROL
RHONDDA CYNON TAF
COUNTY BOROUGH COUNCIL

COMMITTEE SUMMONS

YOU ARE SUMMONED to a hybrid meeting of the **OVERVIEW AND SCRUTINY COMMITTEE** to be held on **MONDAY, 28TH FEBRUARY, 2022** at **5.00 PM.**

5. SECTION 19 FLOOD INVESTIGATION REPORTS

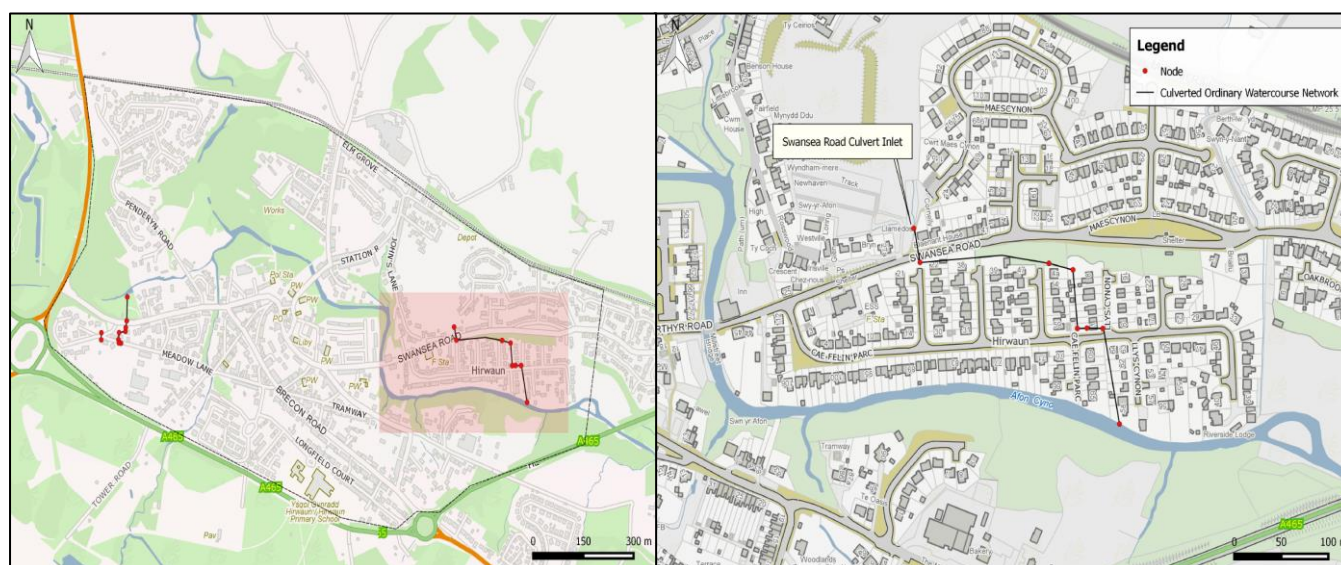
It was suggested by residents that the 'Swansea Road Culvert Inlet' (Figure 3) surcharged during the storm event and caused additional flows towards Cae Felin Parc, however it has since been confirmed that the culvert was not identified as a source of flooding. Despite this, following Storm Dennis, CCTV survey inspections of the culvert network was undertaken to ascertain both the operational condition of the network, and its structural integrity along sections of the network.

The culvert network drains the hillside above investigation area RCT01 which is culverted beneath Hirwaun's residential development and ultimately outfalls into the River Cynon at Cae Felin Parc (illustrated in Figure 6). The culvert network is also identified as falling under mixed public and private ownership.

Figure 6: Swansea Road culverted watercourse network in investigation area RCT01

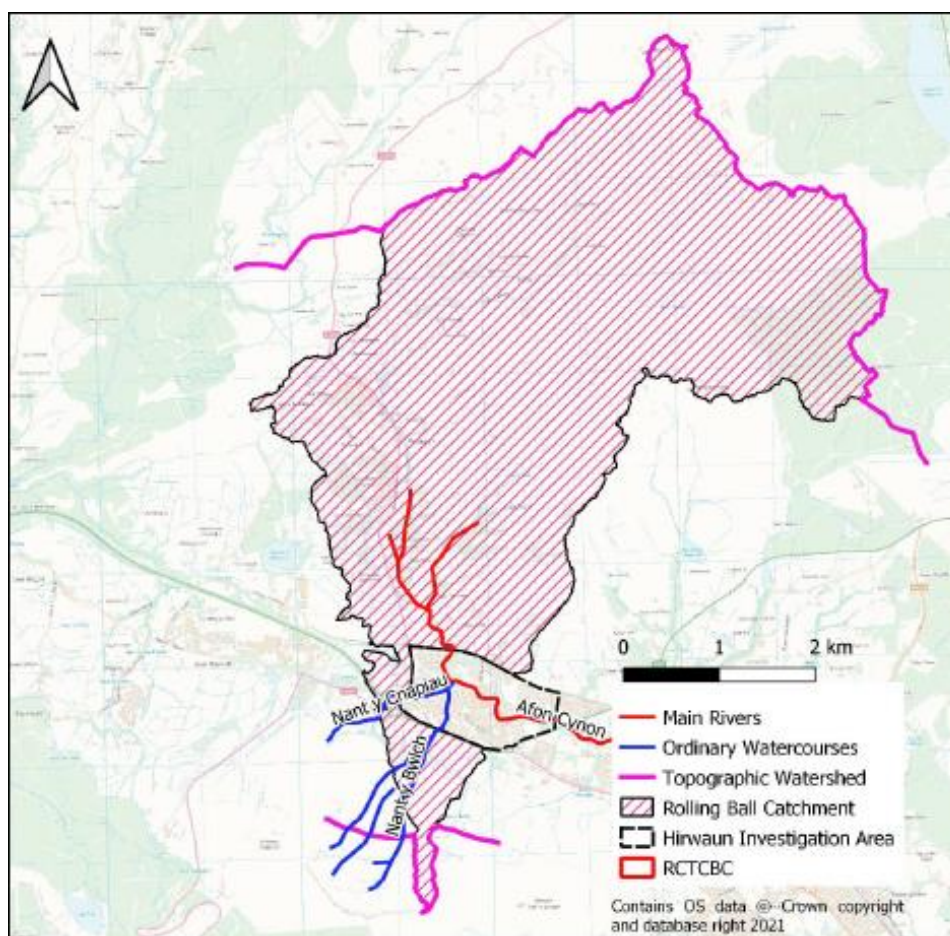
There are several named and unnamed ordinary watercourses which flow through investigation area RCT01. Notable watercourses include the Nant y Cnapiau and Nant y Bwlch which both drain the catchment area to the south and southwest of Hirwaun before discharging into the River Cynon (Figure 9).

Figure 9: Rainfall Topographic Catchment area and named ordinary watercourses draining into the River Cynon at investigation area RCT01

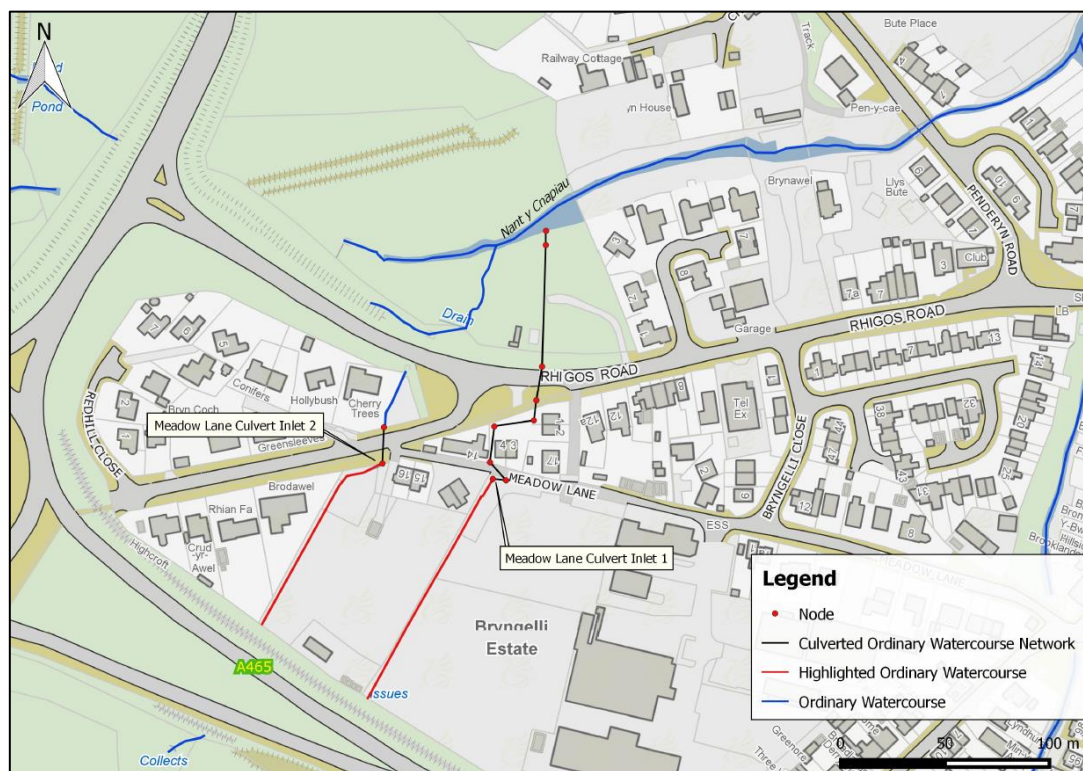
The unnamed watercourses flowing down the hillside below the A465 (highlighted red in Figure 10), before discharging into the Nant y Cnapiau, were investigated by RCT Flood Risk Management officers as potential sources of flooding to properties at Rhigos Road and Beacons View following reports that water originated from the hillside.

Figure 10: Ordinary watercourses and culverted networks identified at Meadow Lane in the southwest of investigation area RCT01. The ordinary watercourses identified as possible causes of flooding during Storm Dennis are shown in red.

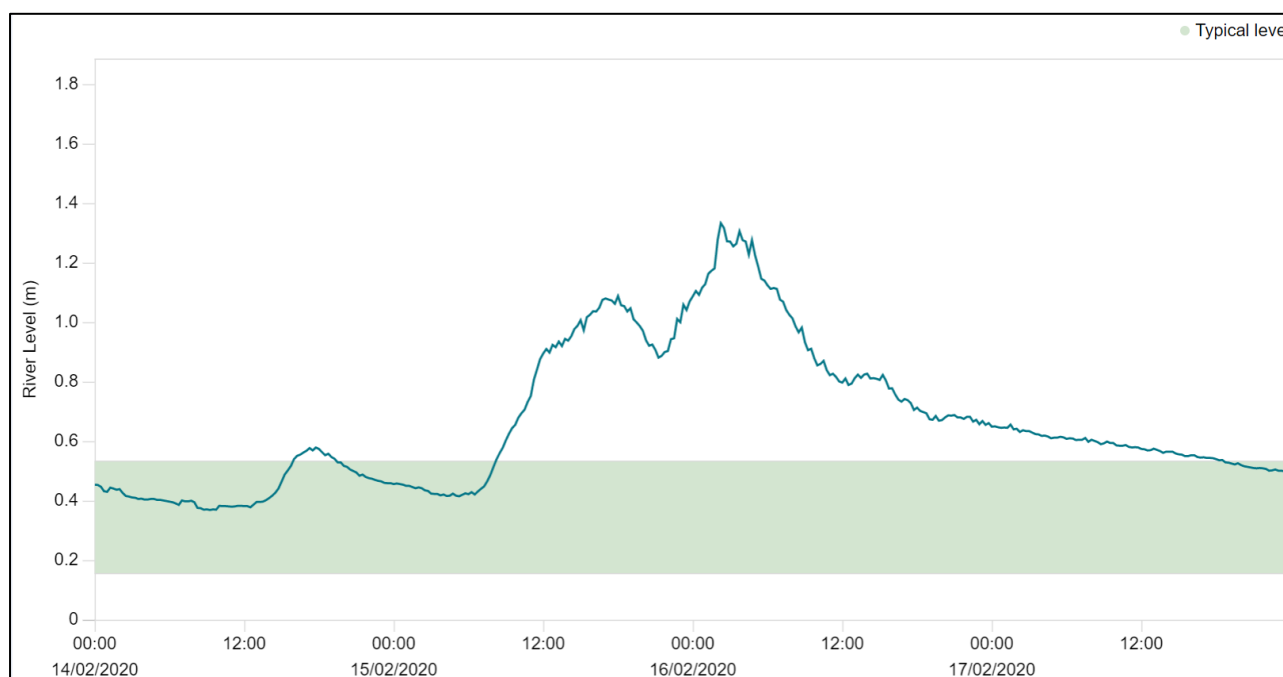
The hydrograph in Figure 12 illustrates the rapid rise in levels of the River Cynon in response to rainfall between the 14 – 17th February 2020, captured at NRW's Hirwaun monitoring station which is situated near Cae Felin Parc.

NRW issued a 'Flood Alert' (indicating possible flooding) for the entirety of the River Cynon at 12:51 on the 15th February, during that time the River Cynon at Hirwaun had reached almost a metre in depth. The River Cynon continued to rise during the early hours of Sunday 16th February morning before reaching a peak level of 1.333 metres at 02:15 on 16th February 2020; the highest level recorded for the Cynon at Hirwaun.

Figure 12: The River Cynon levels at Hirwaun station between the 14th and 17th February 2020 (Natural Resources Wales)

The green bar displayed on the hydrograph shows the typical level of the River Cynon at Hirwaun station, ranging between 0.15 and 0.55 metres. At its peak, the River Cynon at Hirwaun was almost a meter higher than its average level, stressing the

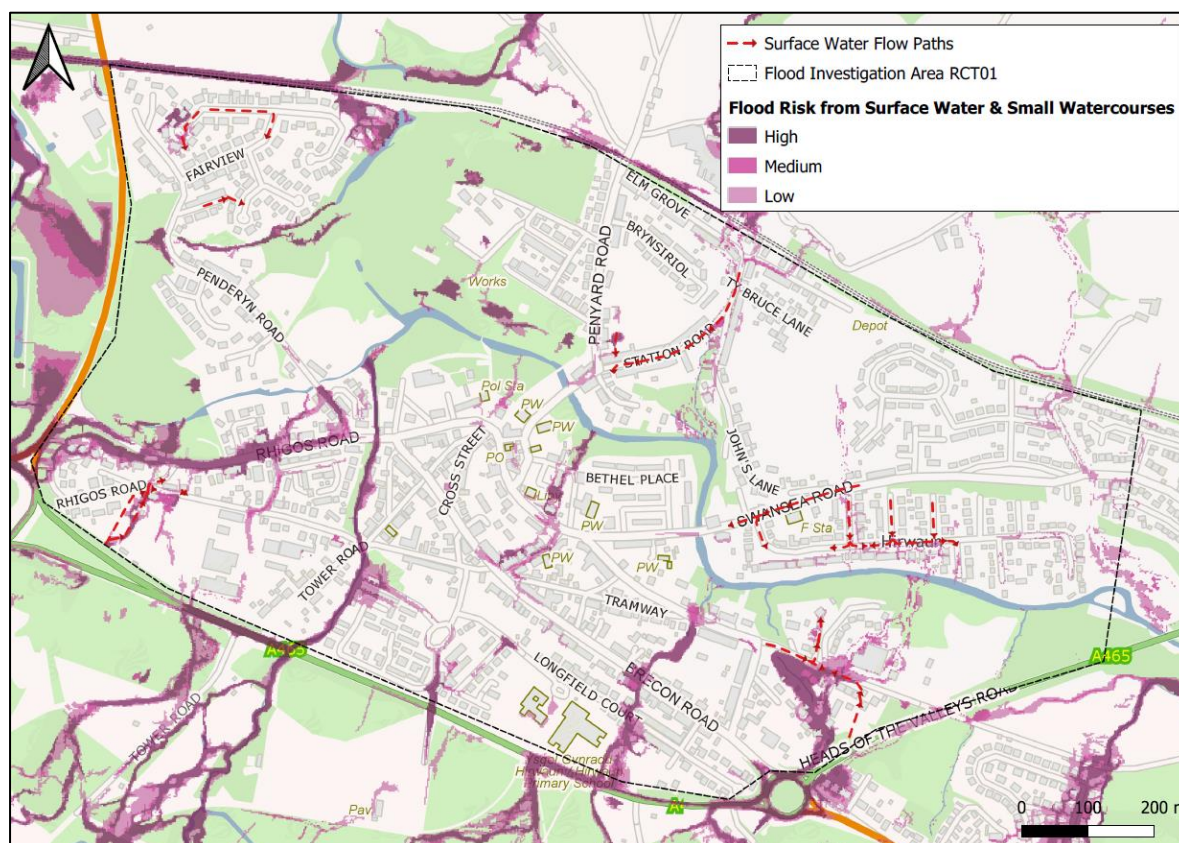
The pathways for surface water runoff during the storm event was observed primarily along the highway network, but also as overland flows originating from areas of hillside within the investigation area. It should be noted that the exact flow routes have not been confirmed due to limited anecdotal evidence, however, NRW's national surface water and ordinary watercourse flood maps provide a reasonable indication of the pathways that would have occurred during the storm event. These indicative surface water flow paths are illustrated in Figure 15 and correlate well with NRW's surface water flood map.

Figure 15: Natural Resources Wales' FRAW map for surface water and ordinary watercourse sources and indicative surface water flow paths within investigation area RCT01. Contains Natural Resources Wales information © Natural Resources Wales and database right. All rights reserved.

Runoff was channeled via several roads, towards properties at Cae Felin Parc, Tramway, Penmark Row, Fairview and Station Road. The gradient of the roads, elevation of properties relative to the road, and the extent of impermeable surfaces surrounding the affected streets is considered to have; increased surface water flows along the highway and attributed to the pooling of water outside properties. In most cases, the surface water flooding at RCT01 was primarily caused by intense rainfall falling on already saturated catchments following Storm Ciara on 7-8th February 2020.

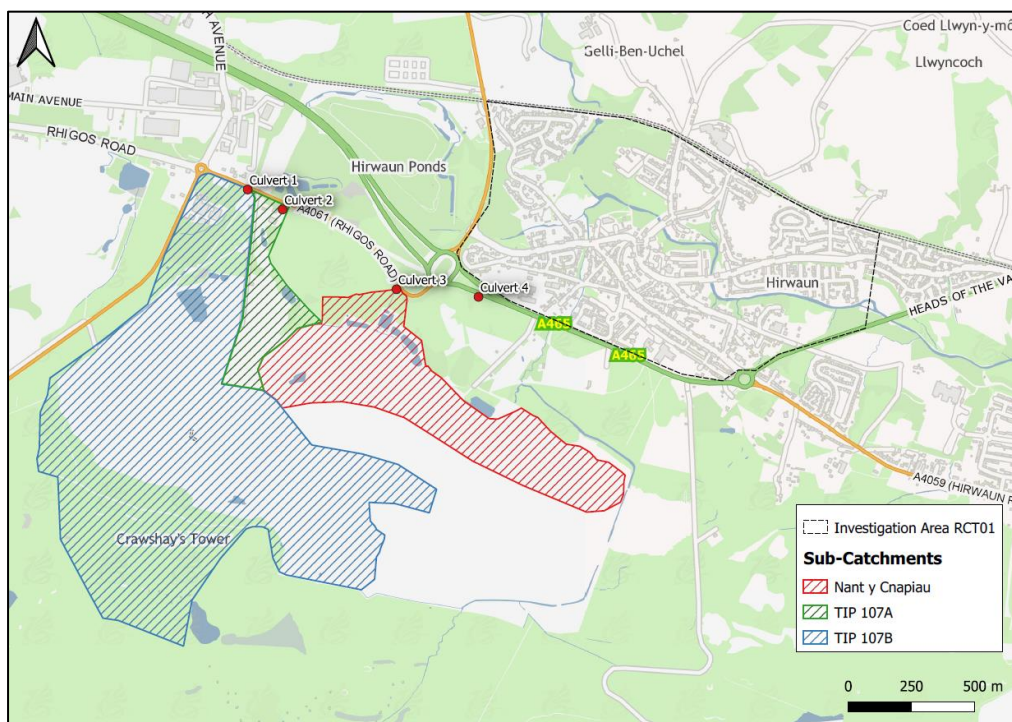
Land reclamation and restoration works have been ongoing at Tower Colliery since its closure in 2008. These works include the re-profiling of the former colliery site back to its pre-mining conditions, which involves the reduction of discharge rates from the site to post-mining conditions, as accepted by the Local Planning Authority. The sub-catchment areas associated to the Tower Colliery planning application are illustrated in Figure 16.

Figure 16: Tower Colliery sub-catchments and associated culvert inlets

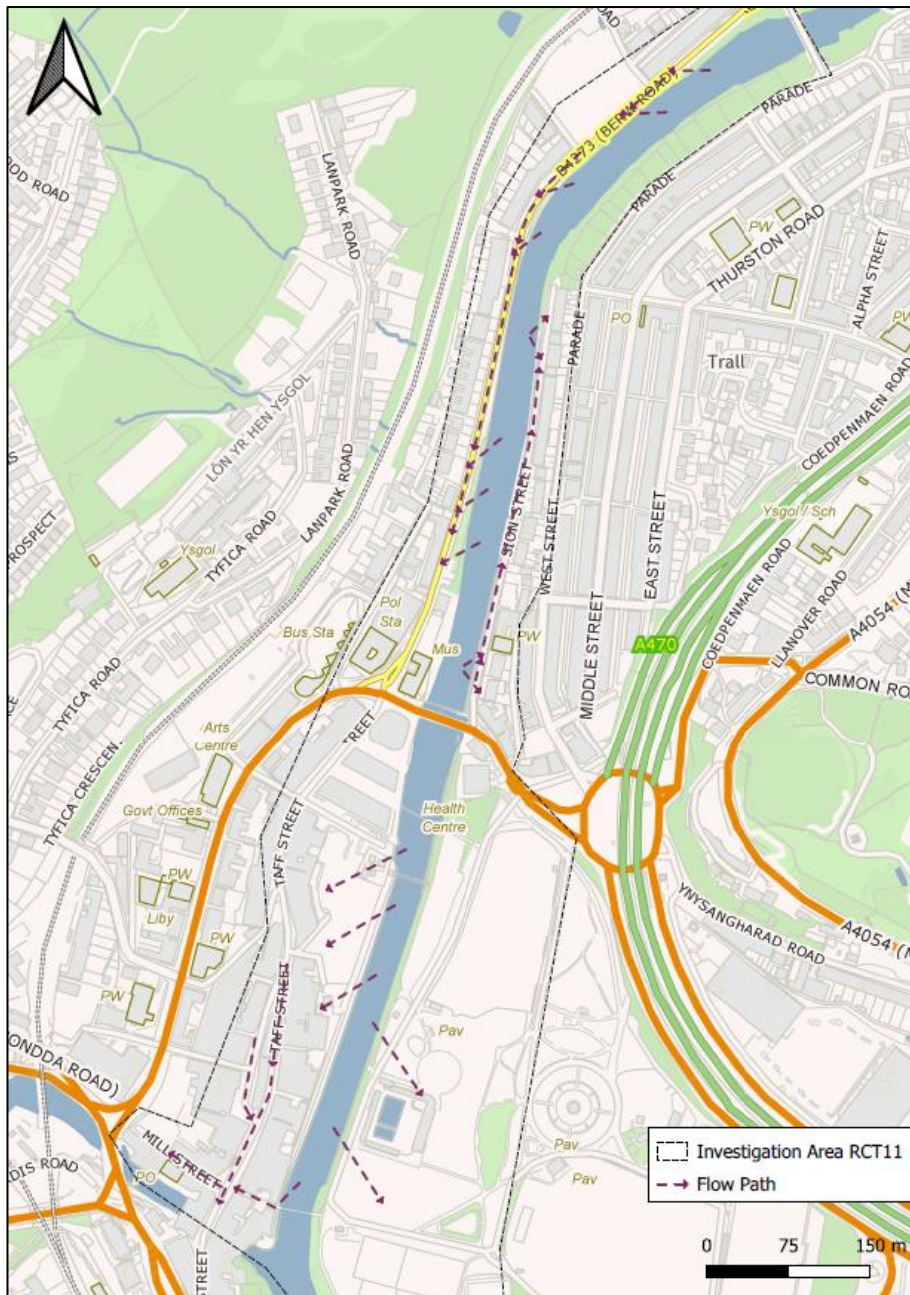
The indicative flow paths and points of overtopping within the investigation area are illustrated in Figure 9.

Figure 9: Indicative flow paths observed at RCT11 during Storm Dennis

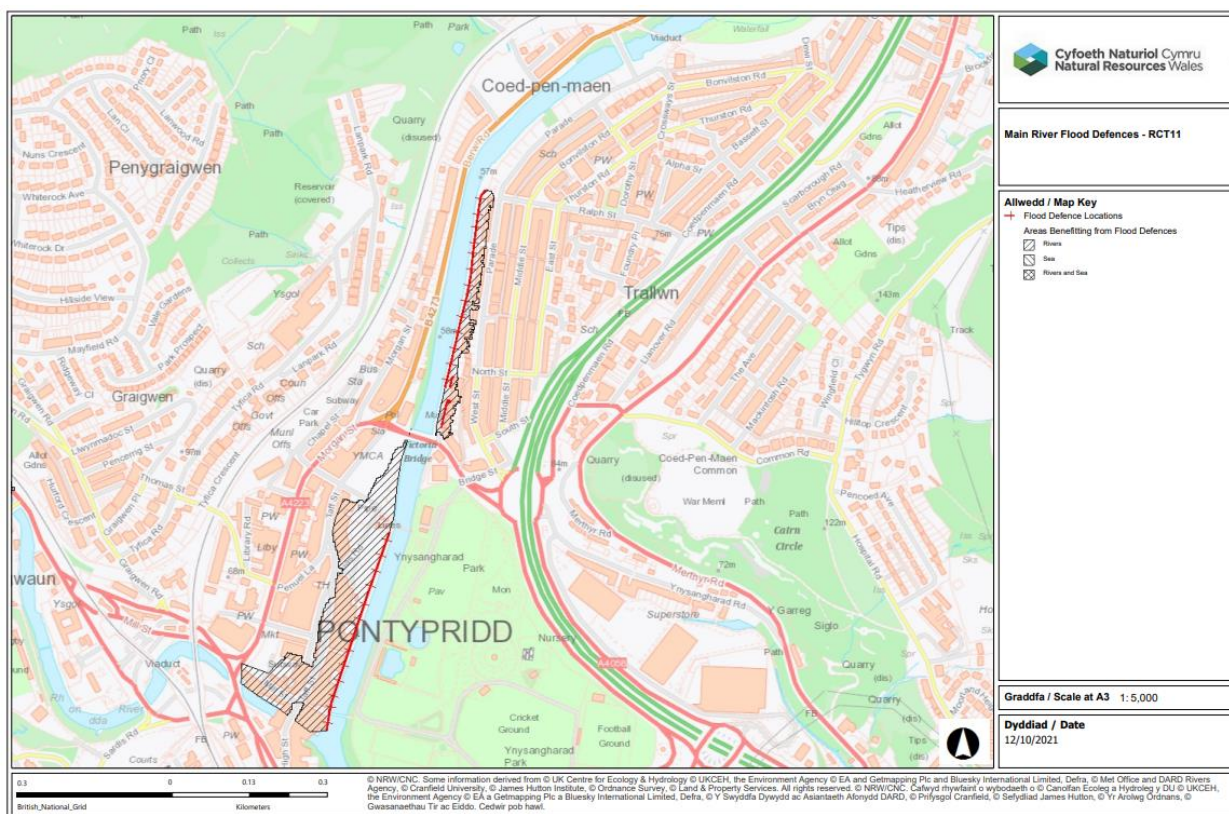
As illustrated in Figure 12 (demarcated by a bold red line), there are approximately 400 metres and 300 metres of formally designated flood defence infrastructure along the eastern and western banks of the River Taf at RCT11, respectively. This infrastructure is operated and maintained by NRW.

According to NRW, flood defence infrastructure throughout Pontypridd town centre and Sion Street provides a standard of protection up to a 1 in 100 annual probability flood event (Q100) to several properties within the investigation area (black hatched area in Figure 12). There are no formal flood defenses under the operation and maintenance of NRW on the western river embankment at Berw Road, any pre-existing highway walls are considered NFD Structures.

Figure 12: Natural Resources Wales’ map for Main River Flood Defences and areas benefiting at RCT11. Contains Natural Resources Wales information © Natural Resources Wales and database right. All rights reserved.

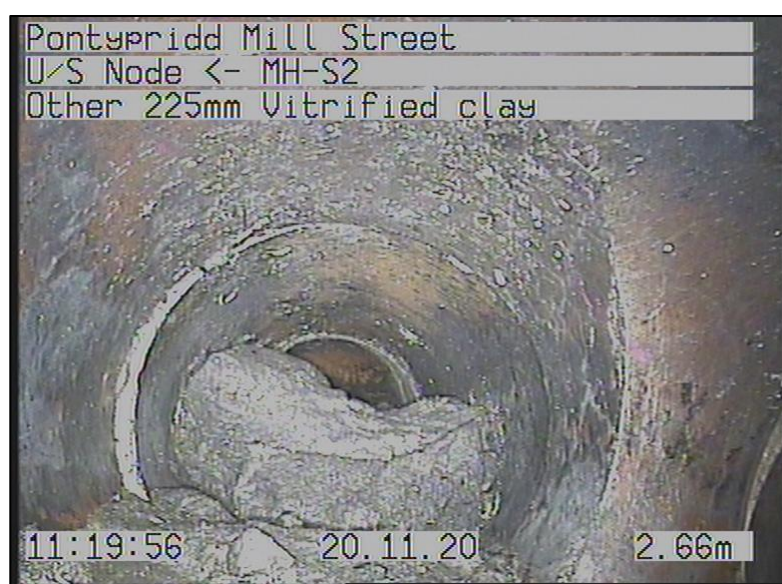
CCTV inspections undertaken in the months following the storm event confirm this, with surveys completed on Mill Street identifying settled deposits of silt and debris within the highway drainage network. Figure 13 depicts the operational condition of the highway drainage at Mill Street prior to its cleansing. A cross-sectional area loss of 60% was observed due to silt accumulation within the network.

Figure 13: Photo of silt accumulation within the Mill Street surface water drainage network prior to cleansing operations

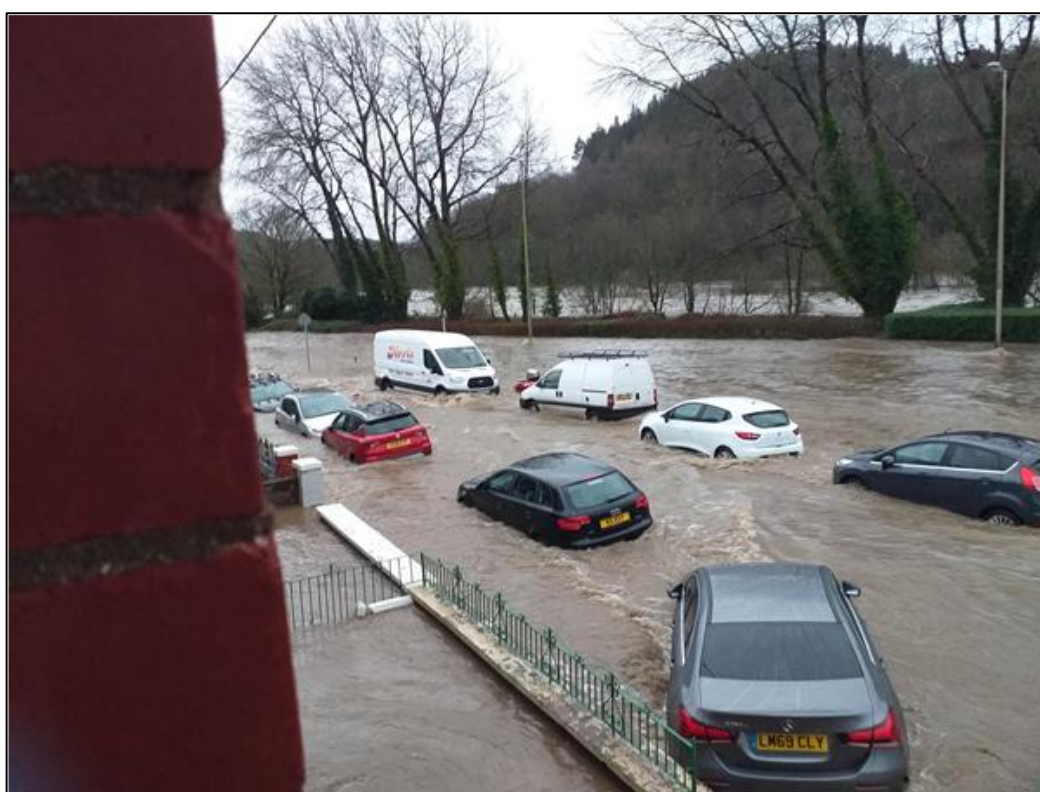
Accounts from residents at Oxford Street and Rhyd-Yr-Helyg note a significant amount of water conveyed along the highway network towards their properties during the storm event. This flow path is considered to have originated further upstream following the overtopping of the River Taf at Treforest Industrial Estate and Upper Boat, which then conveyed behind formal flood defences towards Oxford Street and Rhyd-yr-Helyg during the storm event. Photographic evidence provided by residents at Oxford Street show water flowing south along the highway, behind the eastern embankment, during the morning of Sunday 16th February 2020 (Figure 4).

Figure 4: Photo showing main river flooding along the A4054 Oxford Road during Storm Dennis (image provided by resident)

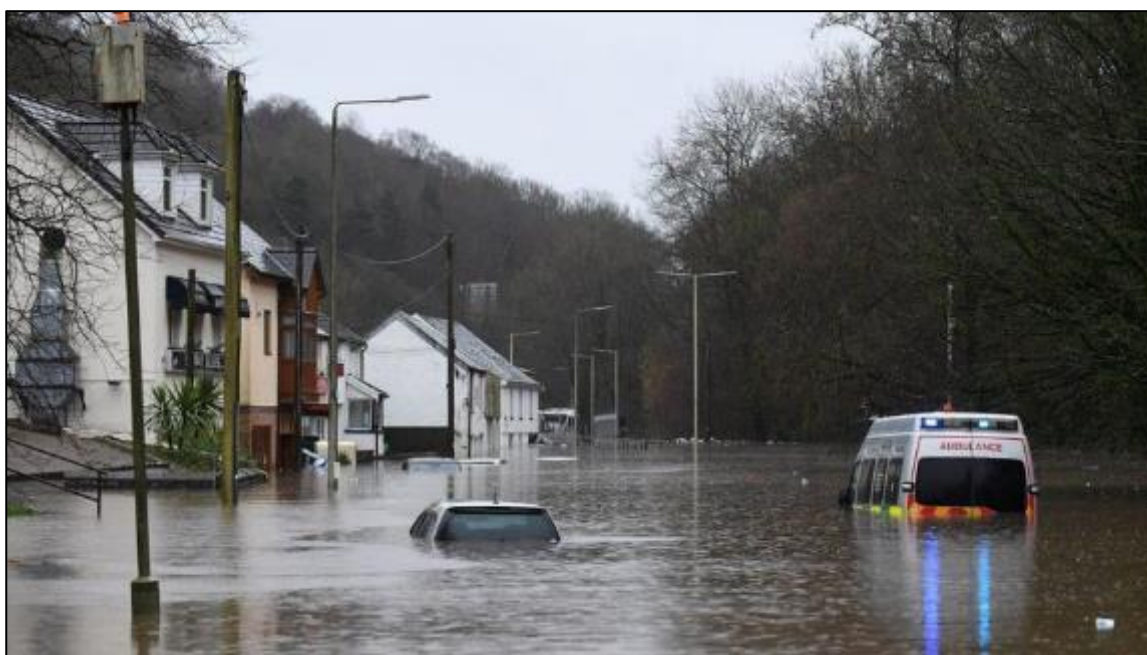
The impacts of flooding from the main river at Cardiff Road were exacerbated by the surcharging of the 'Cross Keys' culvert inlet (Figure 8) associated to the Nant Garw ordinary watercourse. Exceedance flows from the surcharged inlet conveyed onto Cardiff Road, contributing the flooding of properties in this area. Flood depths along Cardiff Road reportedly reached over a metre in depth, as depicted in Figures 5 and 6.

Figure 5: Image of the flooding on Cardiff Road near A4054/A468 roundabout during Storm Dennis, looking south. (Image: Tom Martin/Wales News Service)

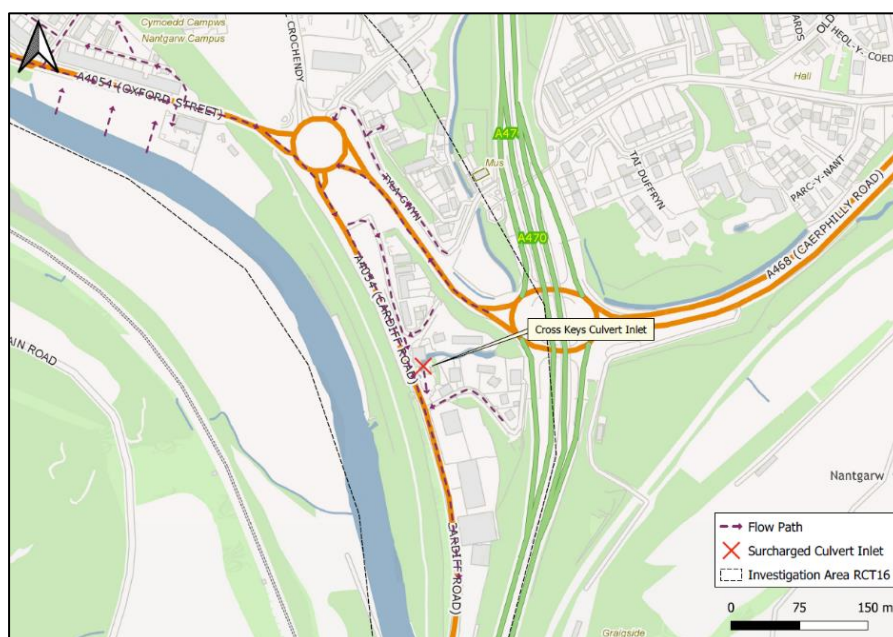
An isolated incident of surface water flooding occurred at Quarry Street, where two residential properties experienced internal flooding during Storm Dennis as a result of localised pluvial flows from the adjacent street, Tyla Gwyn. The observed flow pathways resulting in internal flooding at Cardiff Road are illustrated in Figure 7.

Figure 7: Indicative flow paths observed during Storm Dennis to the south of RCT16

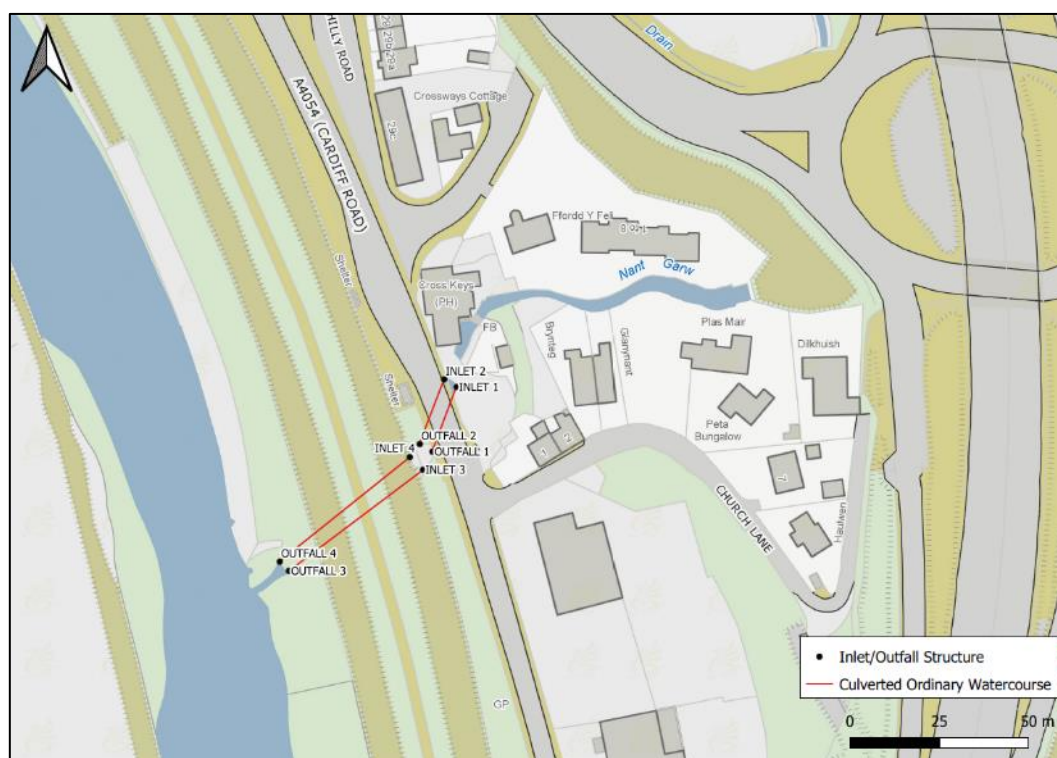
The majority of the Nant Garw ordinary watercourse is open channel, however the watercourse is culverted beneath sections of the A468 (Caerphilly Road), the A470 dual carriageway and the A4054 (Cardiff Road) before it discharges into the River Taf downstream. Following Storm Dennis, a CCTV survey inspection of the culverted ordinary watercourse beneath the A4054 Cardiff Road (Figure 8), known as 'Cross Keys' culvert, was undertaken to ascertain both the operational condition of the network and its structural integrity.

Figure 8: The Nant Garw culverted ordinary watercourse which runs beneath the A4054 Cardiff Road

Comprising of four culvert sections in a double-barrel configuration, the survey revealed that the culvert was in good structural condition, with only one of the four

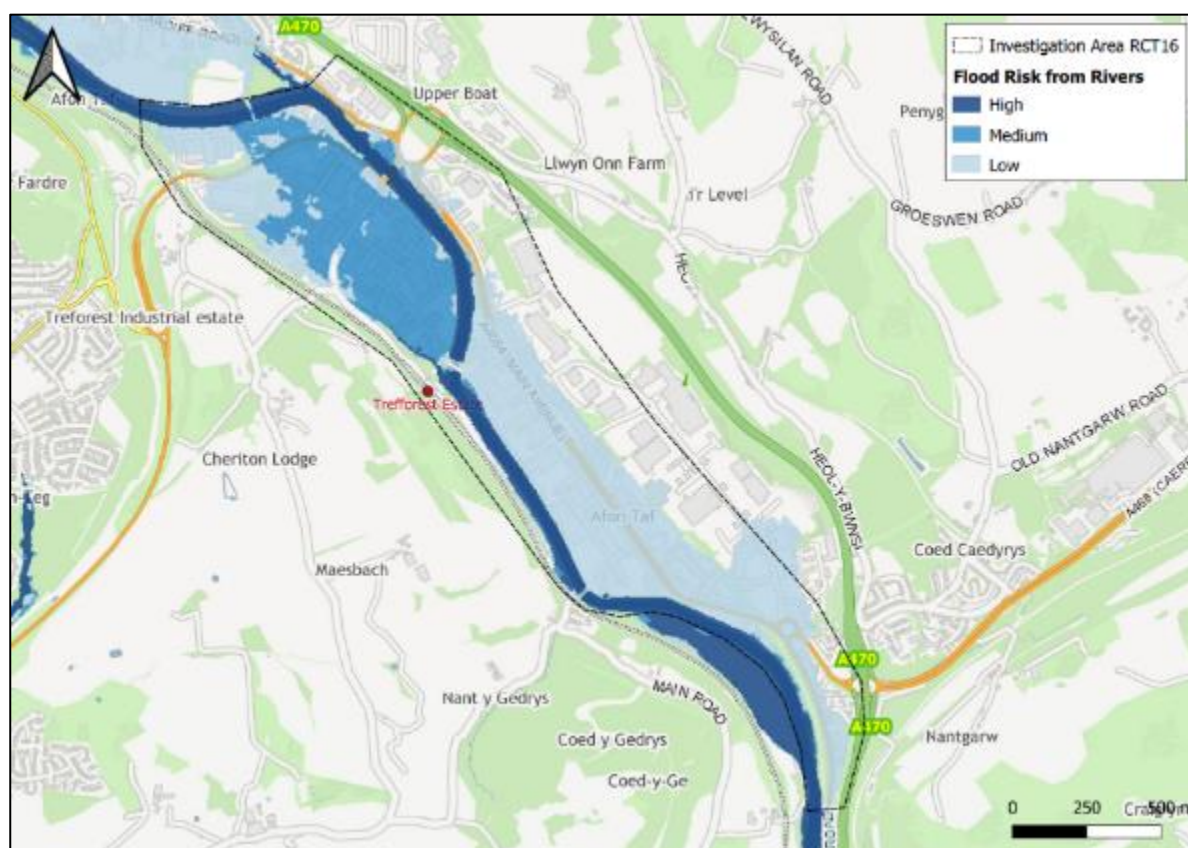
A low risk of flooding means that an area has a chance of flooding of between 1 in 1000 (0.1%) and 1 in 100 (1%) each year; meanwhile, a medium risk of flooding signifies a yearly chance of flooding between 1 in 100 (1%) and 1 in 30 (3.3%). Considering Storm Dennis has been estimated as a 1 in 200 annual probability (Q200) flood event, the area of flooding during Storm Dennis aligns with those depicted by the low flood risk extents (Figure 11).

Figure 11: NRW's FRAW map for River sources at RCT16. Contains Natural Resources Wales information © Natural Resources Wales and database right. All rights reserved.

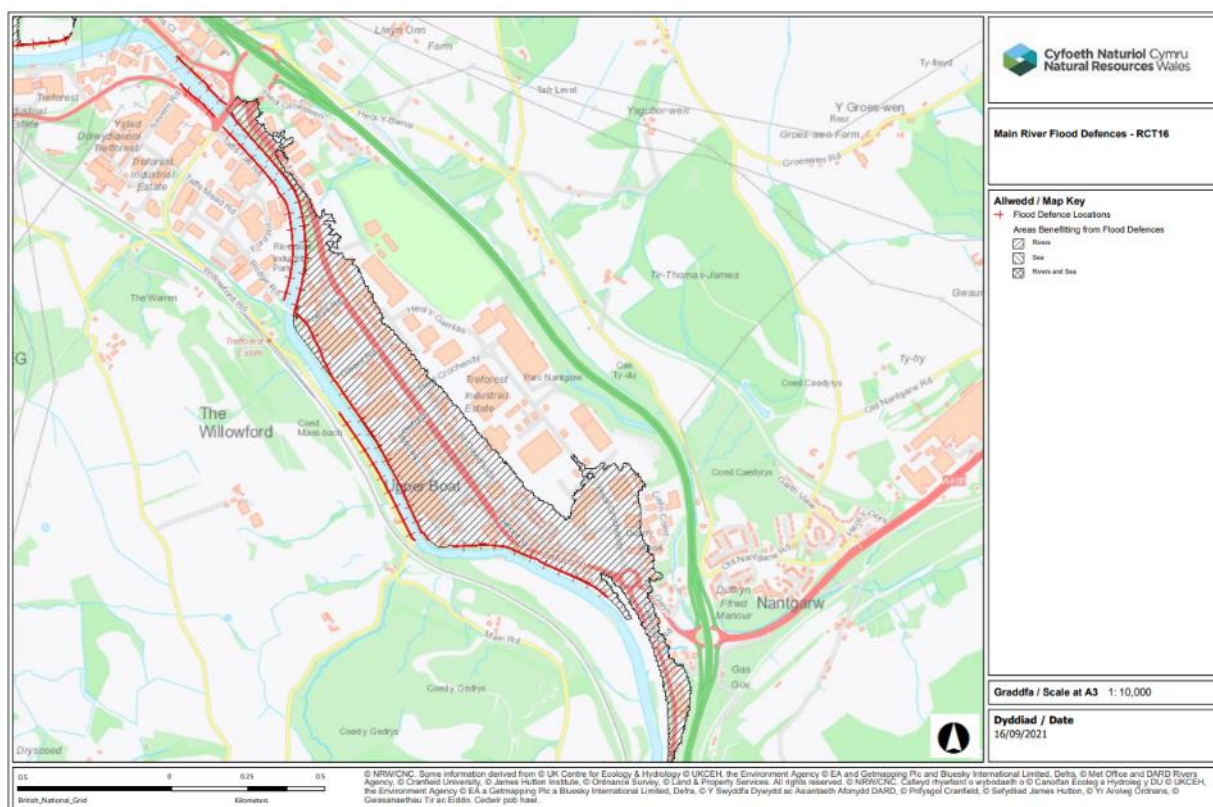
As illustrated in Figure 14 (demarcated by a bold red line), there are approximately 2.5 kilometres, and 1.25 kilometres, of formally designated flood defence infrastructure along the eastern, and western banks, of the River Taf at RCT16, respectively. This infrastructure is operated and maintained by NRW.

According to NRW, flood defence infrastructure throughout the Treforest Industrial Estate, including at Oxford Street and Rhyd-yr-Helyg, provides a standard of protection up to a 1 in 100 annual probability flood event (Q100) (black hatched area in Figure 16). Flood defence infrastructure at Upper Boat and William’s Place provide a reduced standard of protection of 1 in 20 annual probability (Q20) flood event.

Figure 14: Natural Resources Wales’ map for Main River Flood Defences and areas benefiting at RCT16. Contains Natural Resources Wales information © Natural Resources Wales and database right. All rights reserved

Whilst some of the flood defences identified at RCT16 are below the current indicative standard, the unprecedented rise of river levels in the Taf during Storm Dennis resulted in the overtopping of assets up to Q100 SOP. NRW’s ‘Flood Incidence Response Review’⁴ does in fact outline that no flood defences failed in the lower Taf region and that the flooding was the result of river flows exceeding the design standard of the defences.

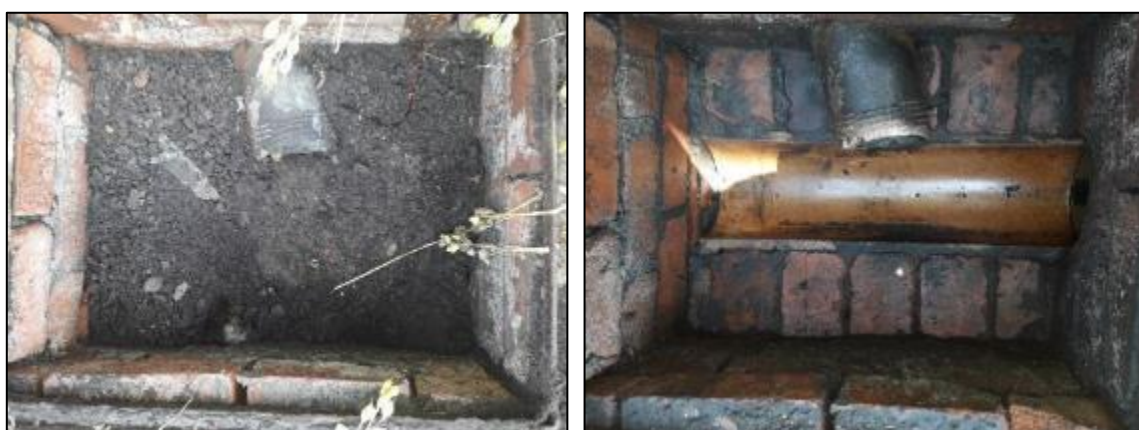
CCTV inspections undertaken in the months following the storm event confirm this, with surveys completed on Oxford Street and Rhyd-Yr-Helyg identifying large silt and debris deposits within many sections of the highway drainage network. Figure 15 depicts the operational condition of the highway drainage at Oxford Street before and after cleansing operations took place. A total of 25 tonnes of silt and debris was removed by a Council appointed contractor during cleansing operations.

Figure 15: Photo of a manhole at Oxford Street captured before (left) and after (right) surveying and cleansing operations during June 2020

CCTV inspections also identified structural defects within the drainage network on Oxford Street, including collapses within the drainage infrastructure near to the system's main river outlet. A section of the outlet structure was also damaged during Storm Dennis.

Whilst a lack of baseline highway drainage inspection data restricts the determination of whether the identified structural defects were caused during Storm Dennis or present beforehand, the severity of the flood incident at RCT16, caused by the overtopping of the River Taf, indicates that the condition of the highway drainage infrastructure would have had little to no impact on the extent of flooding observed.

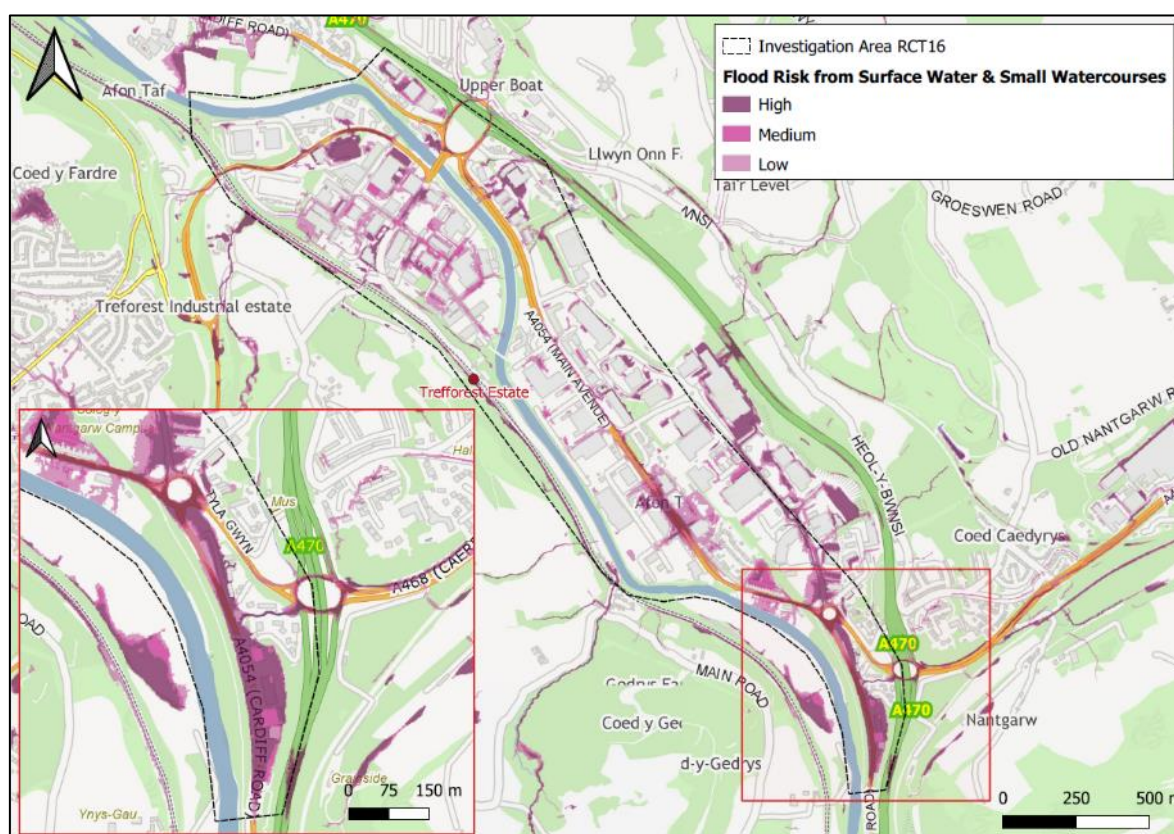
The pathways for surface water runoff during the storm event were observed along the highway network within RCT16. The exact flow routes have not been confirmed due to lack of anecdotal evidence, however, NRW's national surface water and ordinary watercourse flood maps (Figure 16) provide a reasonable indication of the pathways and areas most at risk of flooding from local sources.

Figure 16: NRW's Flood Risk Assessment Wales (FRAW) map for Surface Water and Ordinary Watercourse flood sources at RCT16. Contains Natural Resources Wales information © Natural Resources Wales and database right. All rights reserved.

Notable areas where surface water flows are considered to have exacerbated the main river flooding include Williams Place, Cardiff Road, and parts of Rhyd-yr-Helyg and Oxford Street, where the FRAW map indicates a high to low risk of pluvial flooding (Figure 16). At Quarry Street, localised surface water flows generated by intense
