Flood and Water Management Act 2010

Section 19 Flood Investigation Report

Storm Dennis – Flood Investigation Area RCT25

July 2021

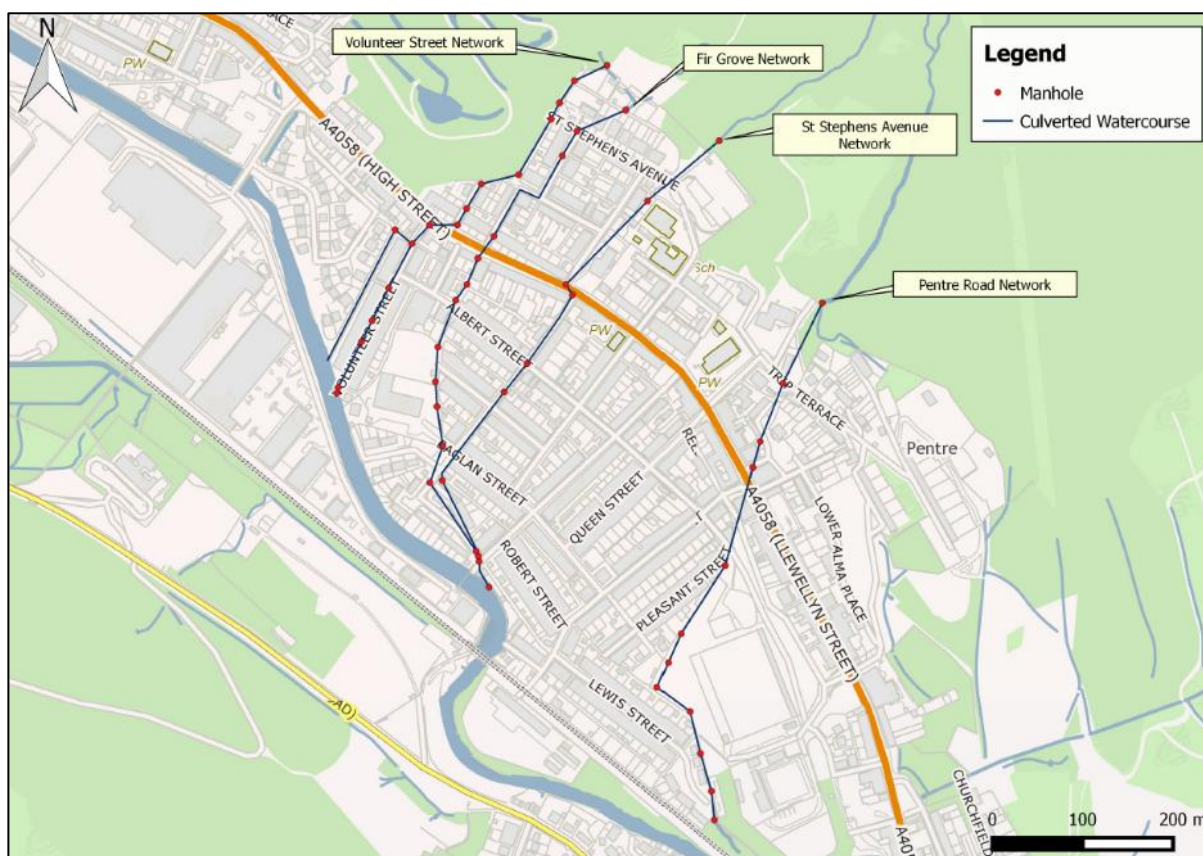
Within investigation area RCT25 there are four main culverted Ordinary Watercourse networks that originate to the north of the village, which flow in a south-westerly direction towards the Rhondda Fawr River depicted within Figure 13. Pentre Road and St Stephen's Avenue inlets are identified as the responsibility of Natural Resources Wales on behalf of Welsh Government as the landowner, whilst the Volunteer Street and Fir Grove inlets are identified as the responsibility of two private individual landowners.

Figure 13: Four culverted watercourse networks in investigation area RCT25

Following the first flood event of 2020 that occurred on 16th February (Storm Dennis), the four culvert inlets were inspected by RCT's Flood Risk Management team. The results of which identified that only Pentre Road inlet was found to have been overcome with debris, reportedly having been washed down from the upper catchment, as shown below in Figures 14 - 17.

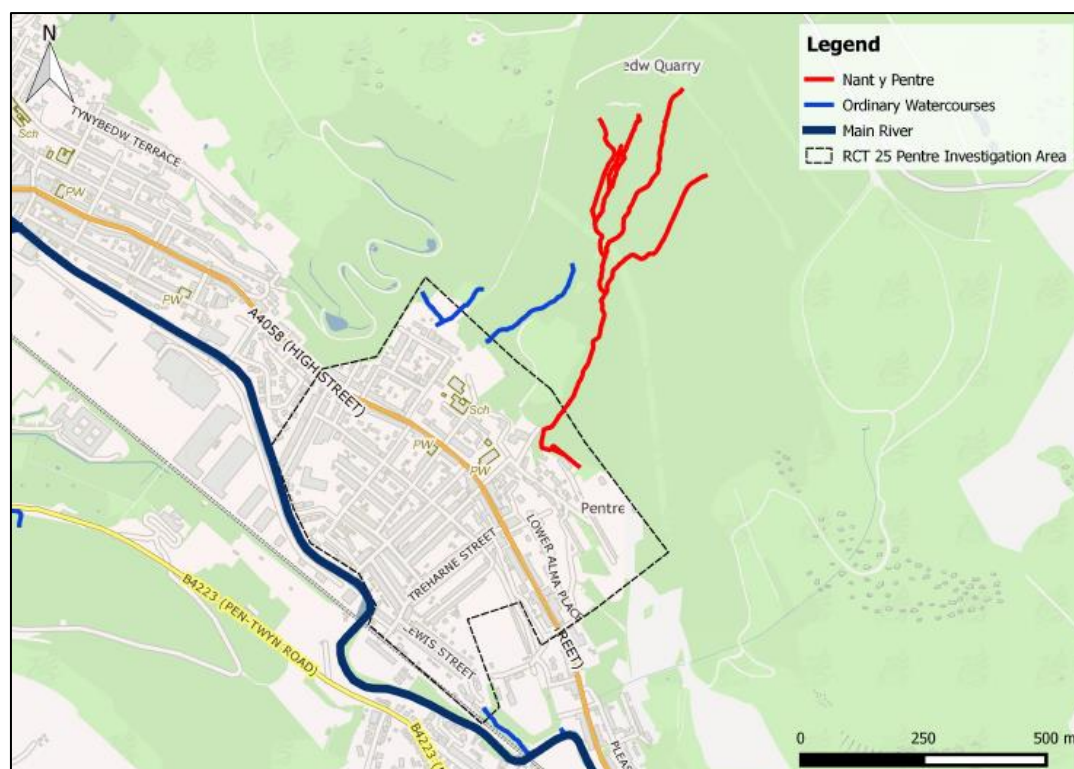
On review of the open watercourse sections identified within investigation area RCT25, four distinct networks were identified. The Nant y Pentre watercourse and its tributaries (highlighted red in Figure 21) was reviewed following the mobilisation of debris washed from the hillside which blocked the Pentre Road culvert inlet.

Figure 21: Ordinary watercourses flowing into Pentre investigation area. Nant y Pentre watercourse is highlighted red.

The Nant y Pentre rises steeply from the town situated at the base of the hillslope. Bed incision has created a deeply confined valley with steep, forested sides that rise sharply from the channel. Due to the steepness of the channel and the confined valley, the delivery of overland or sub-surface flow routes to the channel are accelerated, meaning the catchment will respond rapidly to rainfall.

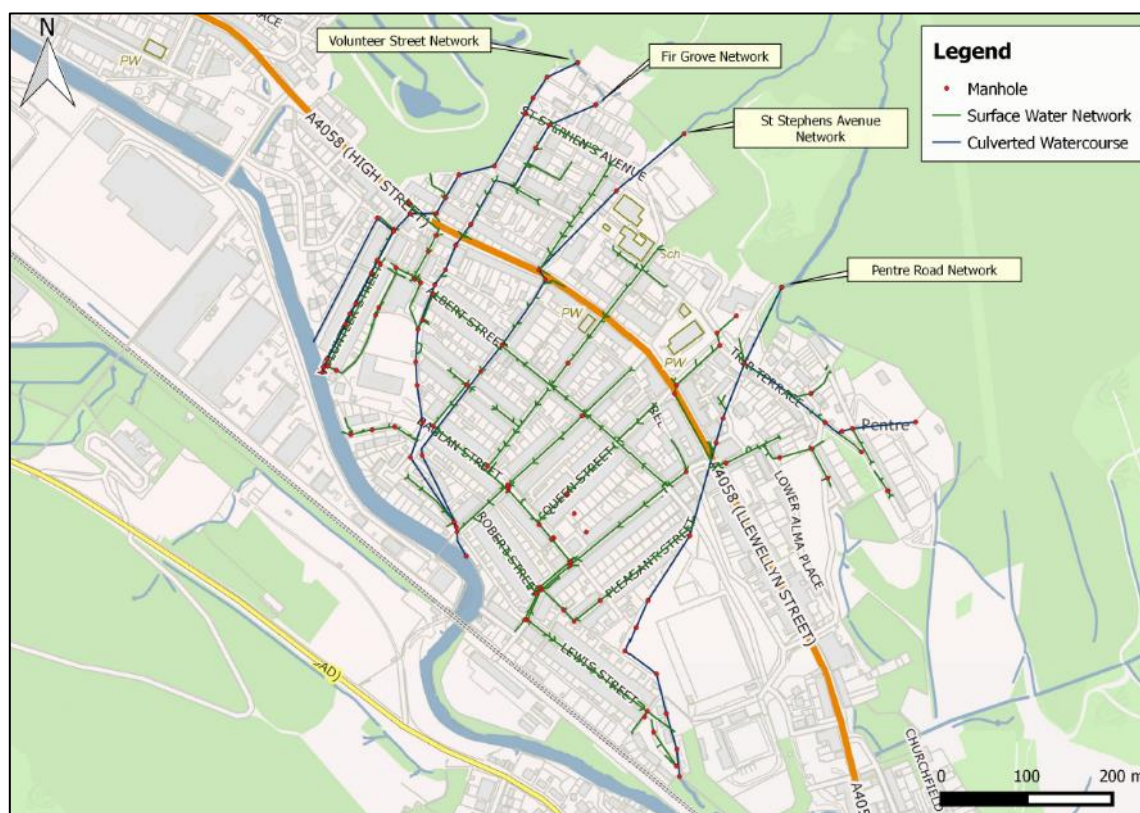
Figure 25 depicts the surface water drainage systems in Pentre, of which there is approximately 5.5 km of highway drainage infrastructure identified. This infrastructure was surveyed and mapped following extensive jetting and cleansing of the network by the Council Highways and Streetcare Depot. CCTV surveys of the highway drainage conditions in Pentre following the February and June storms confirm significant blockages were present, particularly at the Lewis Street storm water network where

the survey had to be abandoned due to two large obstacles blocking the pipe (between manholes SS96957851 and SS96959750, shown in Figure 26).

Figure 25: The extent of the surface water drainage and culverted watercourse systems within investigation area RCT25

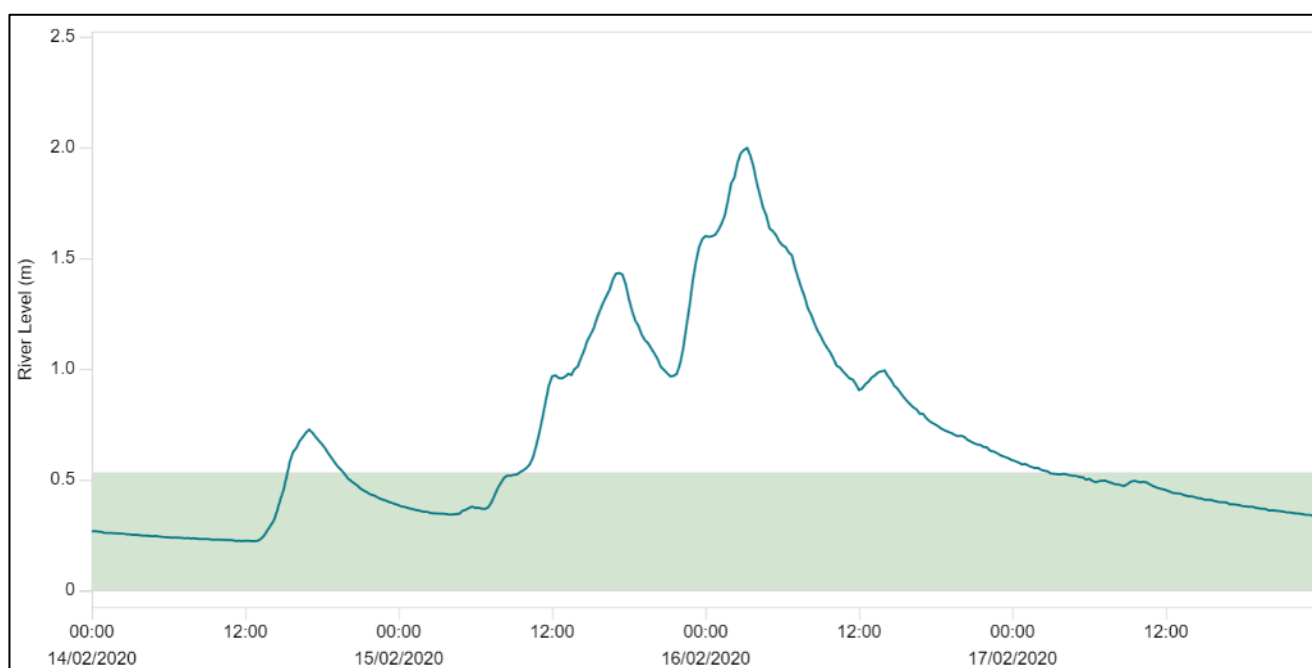
The hydrograph in Figure 27 illustrates the rapid rise in levels of the Rhondda Fawr River in response to rainfall, captured at NRW's Gelli station near Pentre. The Rhondda Fawr River at Gelli reached a peak level of 1.998 meters at 03:30am (16th February); only 0.3 meters lower than its highest level ever recorded.

The green bar displayed on the hydrograph shows the typical level of the Rhondda Fawr River at Gelli station, ranging between 0 and 0.5 meters. At its peak, the Rhondda Fawr River at Gelli was almost a meter and a half higher than its average level, stressing the extreme and unprecedented levels that RCT's rivers rose to during the storm's peak intensity.

Figure 27: The Rhondda Fawr River levels at Gelli station between the 14th and 17th February 2020
(Natural Resources Wales)

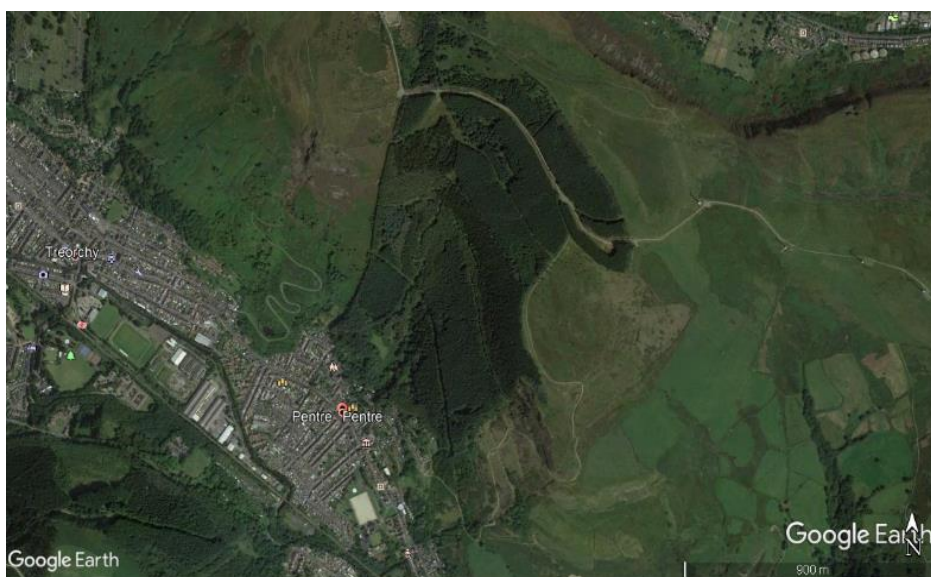
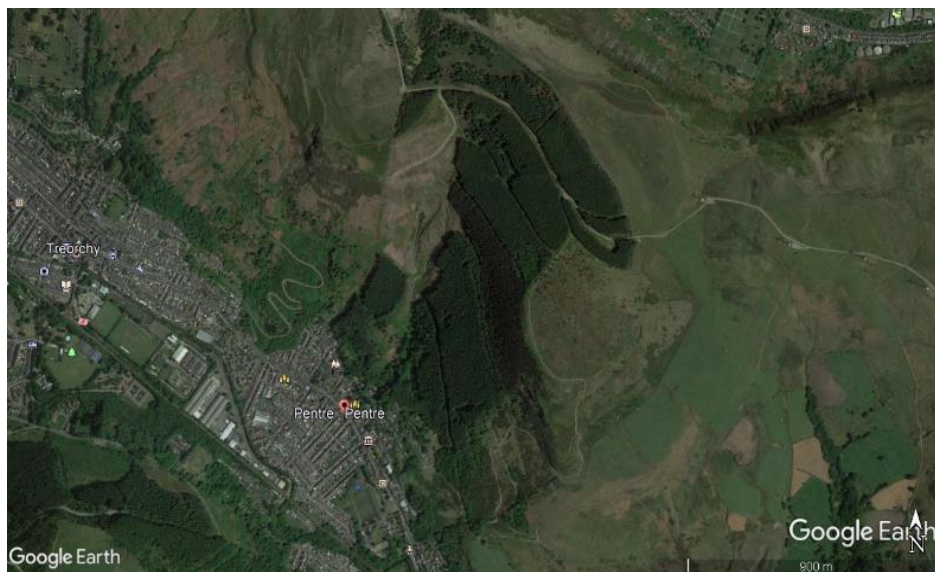
Large areas of woodland to the north of Pentre have been felled during the last 2 years. The area in which tree felling has occurred forms part of the Welsh Government's Woodland Estate (WGWE) which is owned by the Welsh Government and managed by NRW. Figure 28 illustrates the woodland loss observed between 2016 and 2020 in parts of Pentre's upper catchment using historic aerial imagery from Google Earth.

Figure 28: Google Earth imagery of area above Pentre showing change in tree cover between 2016 and 2020

Woodland is currently felled following routine harvesting or removal of Larch infected with 'Phytophthora ramorum' and awaiting 'restocking'. According to NRW's Land Estate Management Review, harvesting was carried out in Pentre mainly over winter 2018/19, although dispatch of timber from the site proceeded until relatively recently⁵.

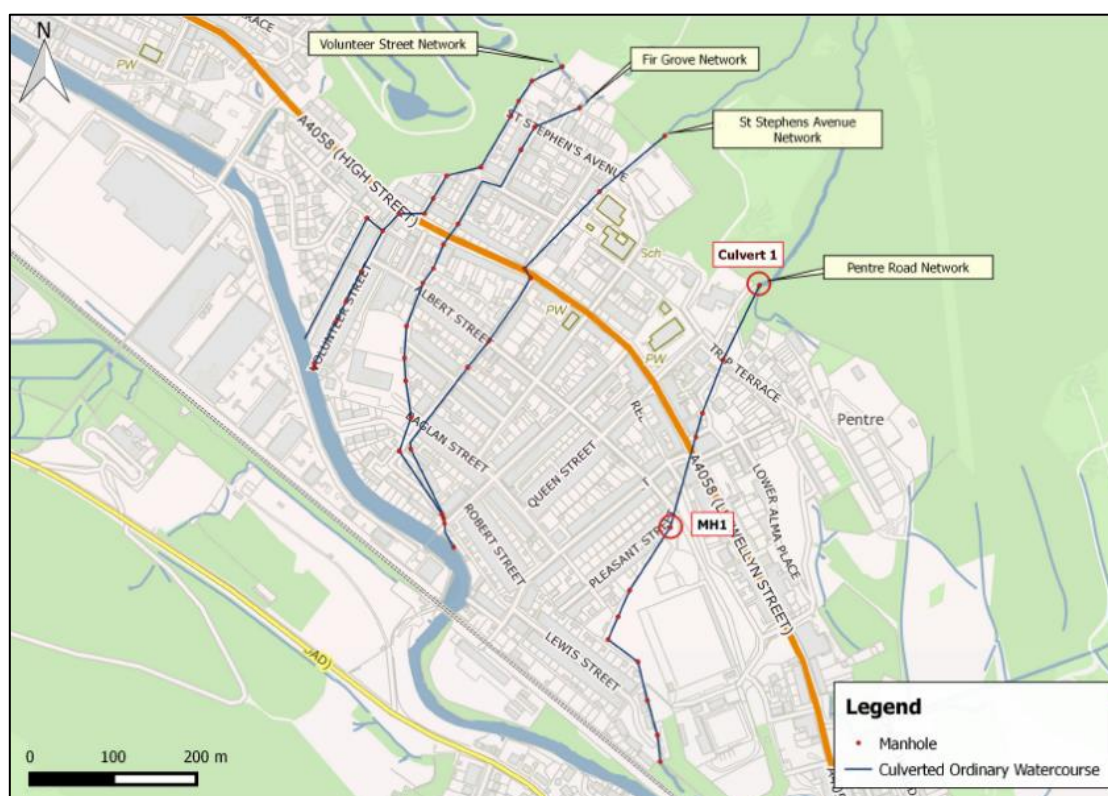
The ordinary watercourse structures as depicted within Figure 30, further referred to as Culvert 1 and MH1, have been assessed to identify the capacity of the network at the point of flooding. The summary of the assessment is depicted within Table 3.

Figure 30: Ordinary watercourse structures identified as flood sources during the 2020 flood events in Pentre

The second node associated to flooding several days following Storm Dennis was MH1 which is a manhole associated to the Nant Y Pentre ordinary watercourse network located within Pleasant Street Park (Figure 30). A review of the capacity of MH1 when free of blockage is identified as providing a SOP of Q25, which is below current design standards. As such the manhole would have been expected to surcharge during Storm Dennis with or without the identified full-bore blockage. It is likely that the initial blockage to the Pentre Road culvert inlet significantly reduced the volume of water entering the network and consequently reduced the likelihood of surcharge at MH1 during the initial flood event.

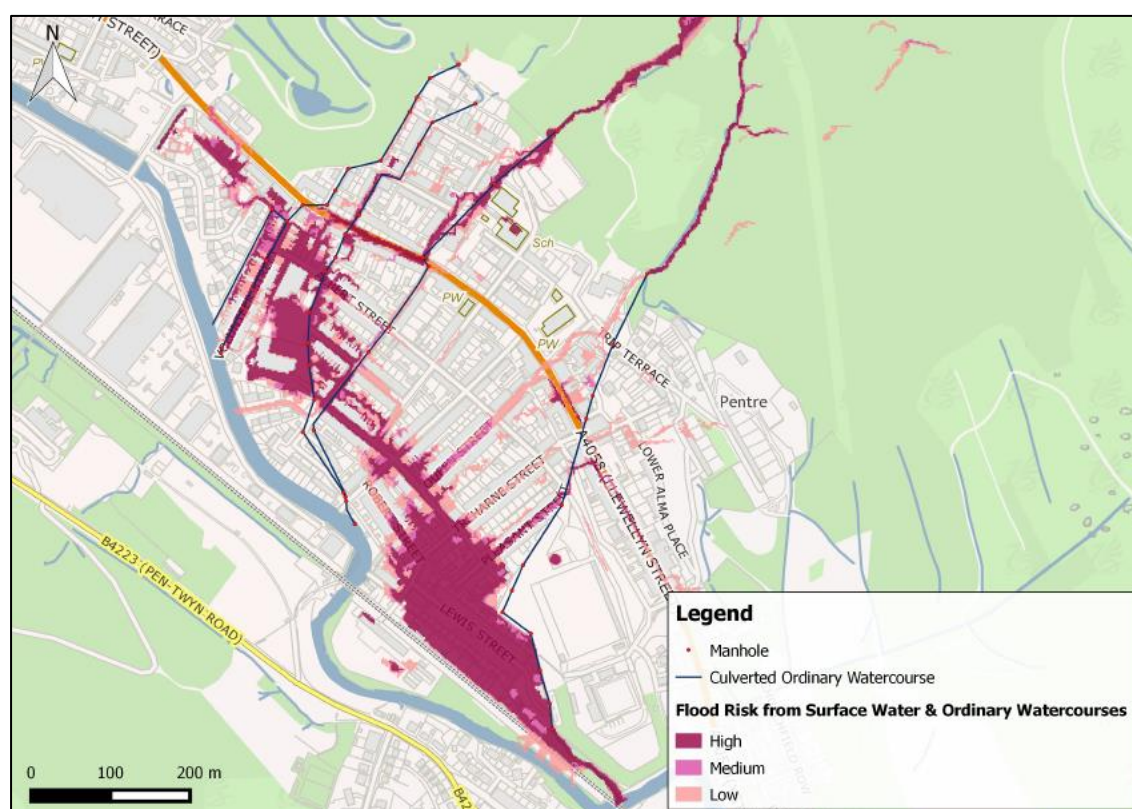
To assess the likely impacts of surface water flooding within the community of Pentre, the National Flood Maps produced by NRW and published in October 2020, have been used i.e. 'Flood Risk Assessment Wales' (FRAW). The outputs of the FRAW mapping is depicted within Figure 32.

Figure 32: Natural Resources Wales' Flood Risk Assessment Wales (FRAW) map for surface water and ordinary watercourse sources. Contains Natural Resources Wales information © Natural Resources Wales and database right. All rights reserved.

The extent of the high risk (Q30) flooding event, depicted within Figure 32, is comparable to the extent of flooding experienced during Storm Dennis and the June 17th flood event. This comparison provides evidence that surface water flooding has a significant impact on the community of Pentre, particularly towards the lower streets at the base of the catchment.
