**Flood and Water Management Act  
2010**

**Section 19 Flood Investigation  
Report**

**Storm Dennis –  
Flood Investigation Area RCT10**

**September 2021**

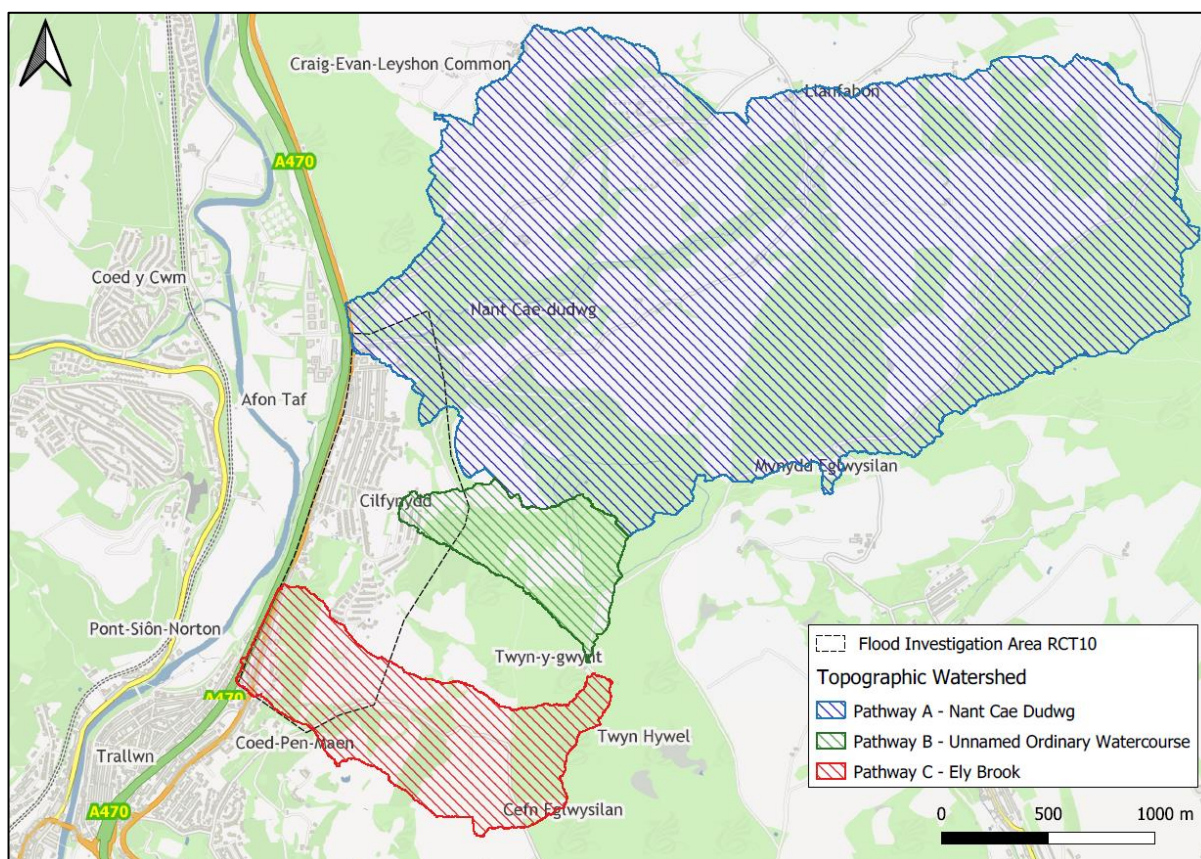
**Figure 3:** Rainfall Topographic Watersheds of the three primary watercourses flowing through investigation area RCT10

The principal sources of flooding, as depicted within Table 2, have been spatially represented within Figure 3, which depicts the topographic watershed of the three primary watercourses that drain towards the Cilfynydd urban area. The area of land that would expect to drain towards the three watercourses under investigation is shown in the hatched areas within Figure 3.

Residents of the affected properties in Cilfynydd reported the overtopping of the three watercourses flowing through the village, which resulted in flood water flowing overland towards the lower reaches of Cilfynydd and affecting several properties on its course. The primary flow paths that occurred during Storm Dennis have been identified as 'A' to the northeast (blue hatched area), 'B' on the eastern edge (green hatched area), and 'C' to the south (red hatched area) of investigation area RCT10 (Figure 3). These flow paths have been further described within their individual sections below.

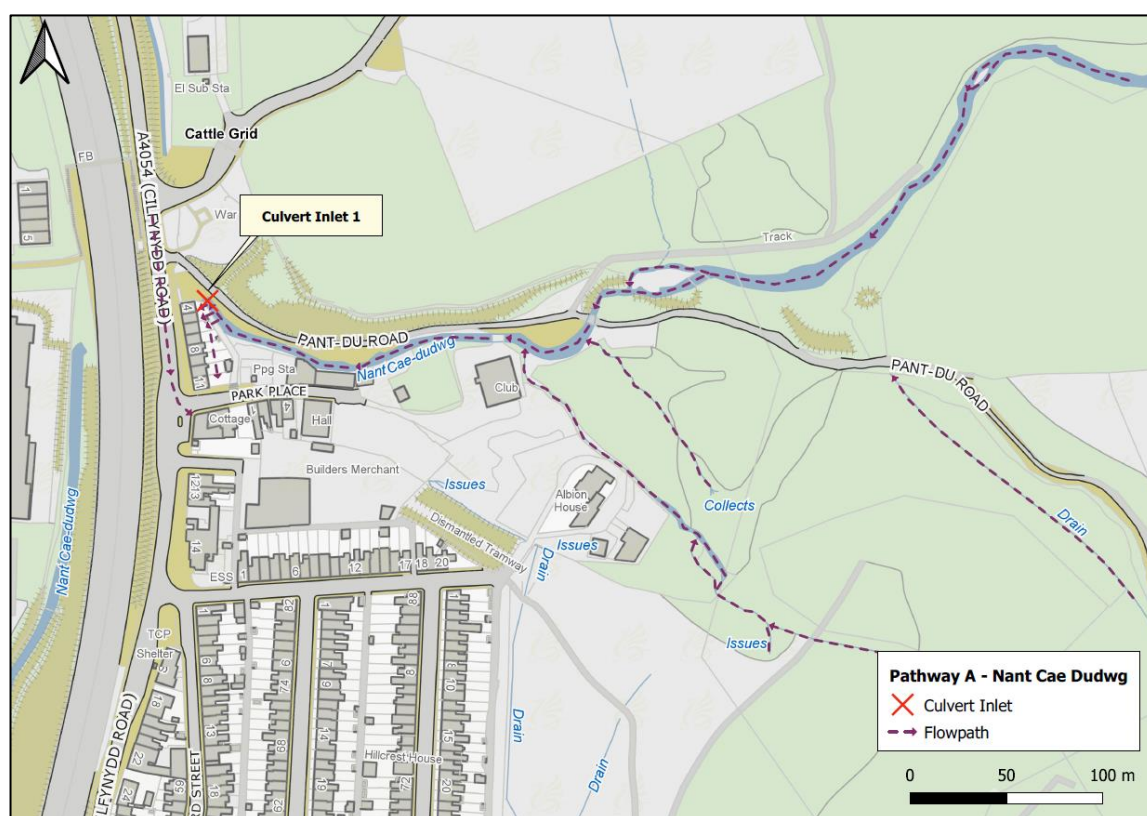
**Figure 4:** Map illustrating flow path A and the Nant Cae Dudwg culvert inlet, 'Culvert Inlet 1'

Several calls were received from residents at Cilfynydd Road on the 16<sup>th</sup> February 2020, to report that water from the Nant Cae Dudwg watercourse had overtopped the flood wall at the inlet (labelled 'Culvert Inlet 1' in Figure 4) and was threatening to enter the rear gardens of properties situated directly downstream of the culvert inlet. The inlet location is provided in Figure 4.

During the early hours of Sunday 16<sup>th</sup> February, the Nant Cae Dudwg ordinary watercourse overtopped the flood wall at the inlet, causing water to accumulate within the lane behind properties at Cilfynydd Road. The result of which saw riverine debris including silt and mud being deposited in the lane area. This resulted in blockages to the surface water drainage gullies in the lane, reducing the capacity of the drainage network to manage the excess water (Figure 5).

Based on data captured by the monitoring station, and accounts provided by residents, it is considered that the volume of water in the Nant Cae Dudwg watercourse exceeded the capacity of the inlet and headwall structures during the early hours of Sunday 16<sup>th</sup> February 2020. This resulted in the watercourse backing up the channel where the flood water overtopped the flood wall before ultimately entering the affected properties from the rear.

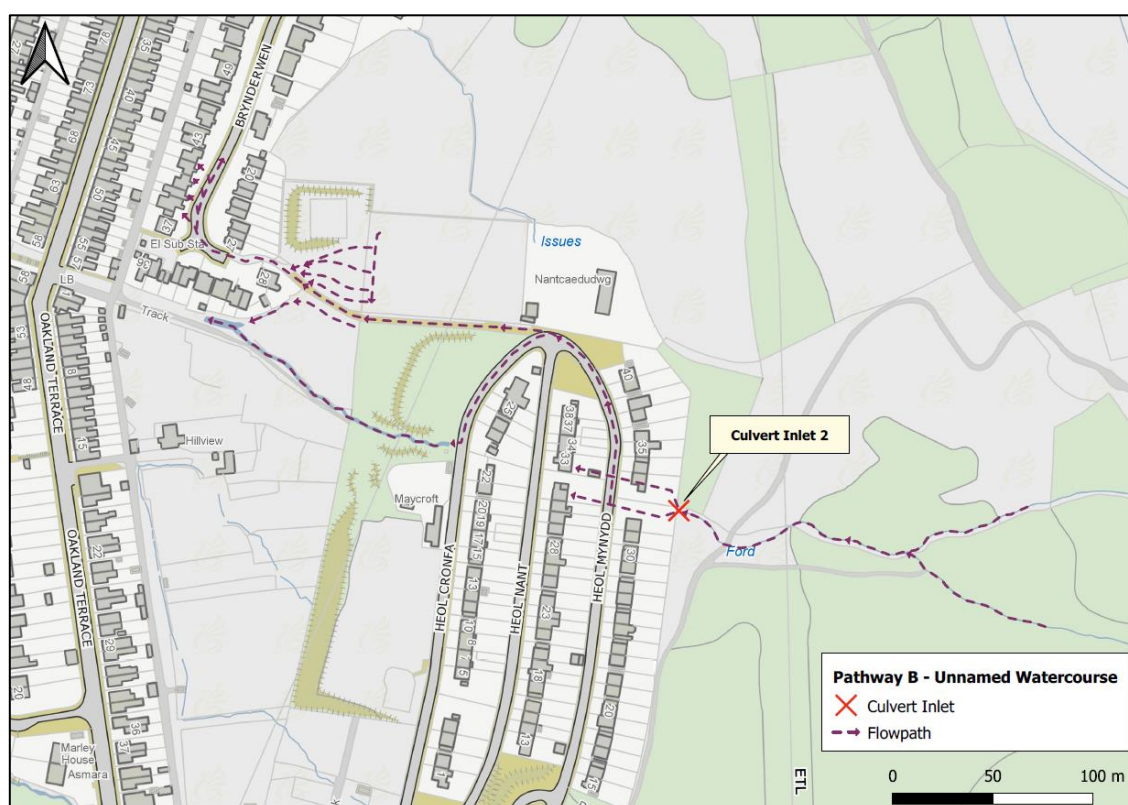
**Figure 8:** Map illustrating flow path B the culvert inlet of the unnamed watercourse, 'Culvert Inlet 2'

Pathway B, shown in Figure 3, shows where surface water flows from the east of Cilfynydd enter the town through an unnamed ordinary watercourse. The watercourse crosses the town via several culverts before discharging into the River Taff. Calls were received from residents at Heol Mynydd and Heol Nant to report that water from the unnamed watercourse to the rear of Heol Mynydd was overtopping near the inlet and beginning to flood properties. The inlet's location, labelled 'Culvert Inlet 2', is provided in Figure 8.

Post event inspections identified the inlet's debris screen as blocked with woody debris mobilised during the event, reducing the inlet's capacity to manage the flow and causing the inlet to surcharge and flood. According to residents, water was observed to have overtopped the garden walls to the rear of Heol Mynydd, flowing through the properties and out onto the street (Figure 9). Water then continued to flow downhill, flooding two properties on Heol Nant from the rear. As the water cascaded over the

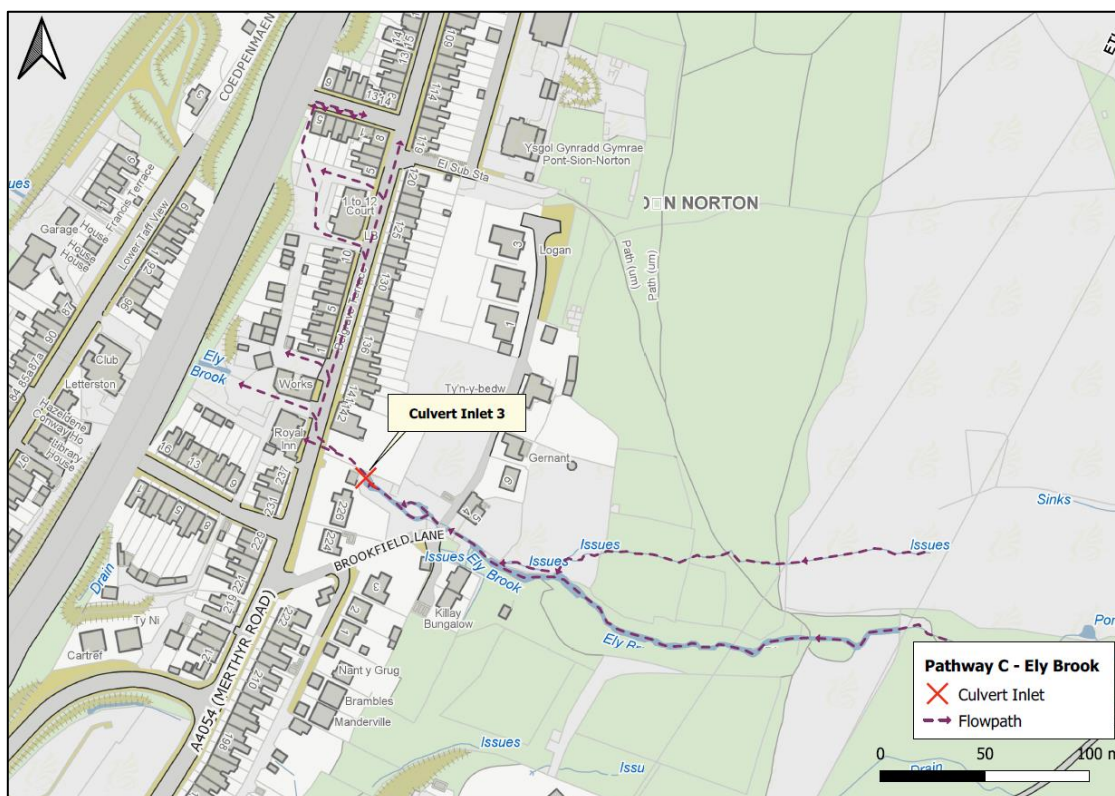
**Figure 13:** Map illustrating flow path C and the Ely Brook culvert inlet, 'Culvert Inlet 3'

Pathway C, shown in Figure 3, shows where surface water flows enter the investigation area from the southeast corner of the catchment. The surface water flows through the Ely Brook ordinary watercourse, passes through the southern catchment via several culverts, and ultimately discharges into the River Taff. On its course of flow, the Ely Brook culvert ('Culvert Inlet 3', Figure 13) surcharged at the inlet opposite the Royal Oak Inn and resulted in flooding to properties and the highway during the storm event. The inlet location is shown in Figure 13.

The evidence suggests the inlet became blocked with debris during the storm event which caused water to overflow from the culvert inlet and flow down the driveway of a residential property opposite the Royal Oak Inn, and onto Pontshonnorton Road. Post event inspections also identified a section of the tarmac driveway to have suffered from subterranean hydraulic pressure, i.e., the driveway appears to indicate that water from the culvert network erupted, through the tarmac and contributed to the flooding along Pontshonnorton Road (Figure 14).

of 'Culvert Inlet 3' (noted in Figure 13), alongside evidence of culvert failure (Figure 14), it is likely that the networks' hydraulic capacity was further reduced.

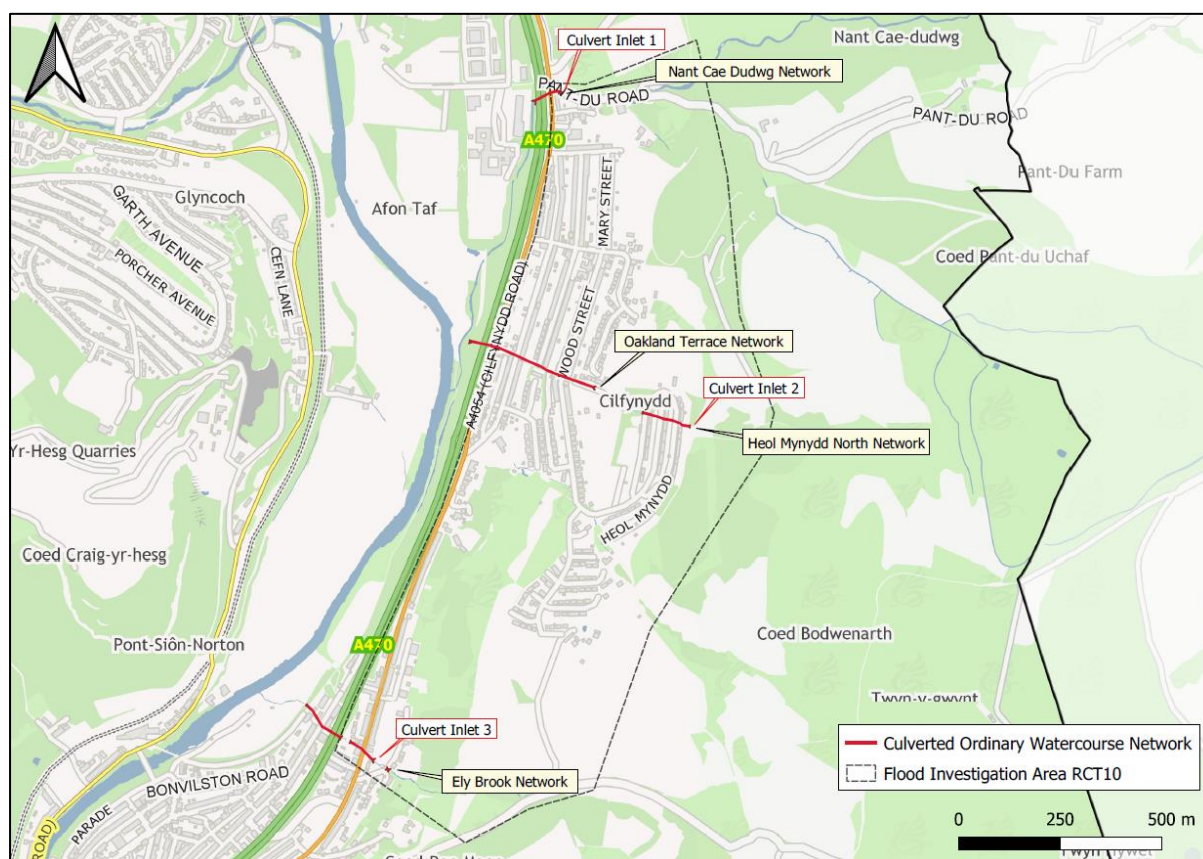
**Figure 15:** Surveyed culverted watercourse networks within flood investigation area RCT10

Several culvert inlets were inspected by RCT's Flood Risk Management team after the flood event to assess their condition and to determine whether they served as a contributing factor to the flooding in Cilfynydd. CCTV survey inspections of the culvert networks were also undertaken to ascertain both the operational condition of the network, and its structural integrity along sections of the network. Figure 15 outlines the four networks surveyed and highlights the culvert inlets known to have surcharged.

Culvert networks within the flood investigation area (Figure 15) were surveyed post event to ascertain the internal condition of the network, the results of which fed into a review of the hydraulic performance of the network to ascertain its current standard of protection using Causeway Flow modelling. The results of the culvert inlet capacity assessments are summarised in the Table below, along with a determination of whether flooding was observed during Storm Dennis.

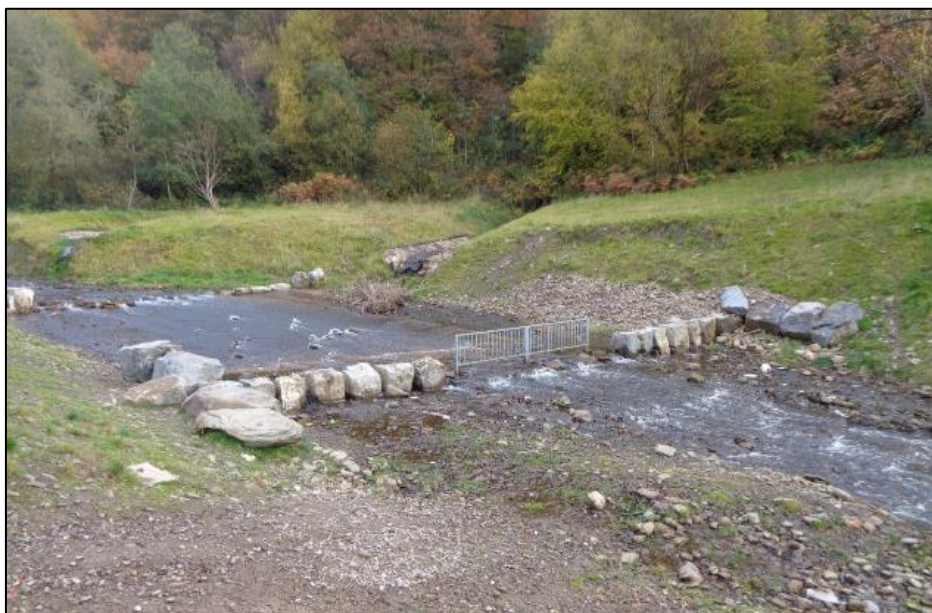
Figures 24 and 25 have been provided to illustrate the condition of the upper catchment debris screens operating debris free prior to Storm Dennis.

**Figure 24:** Initial upstream debris screen in the Nant Cae Dudwg watercourse captured prior to Storm Dennis

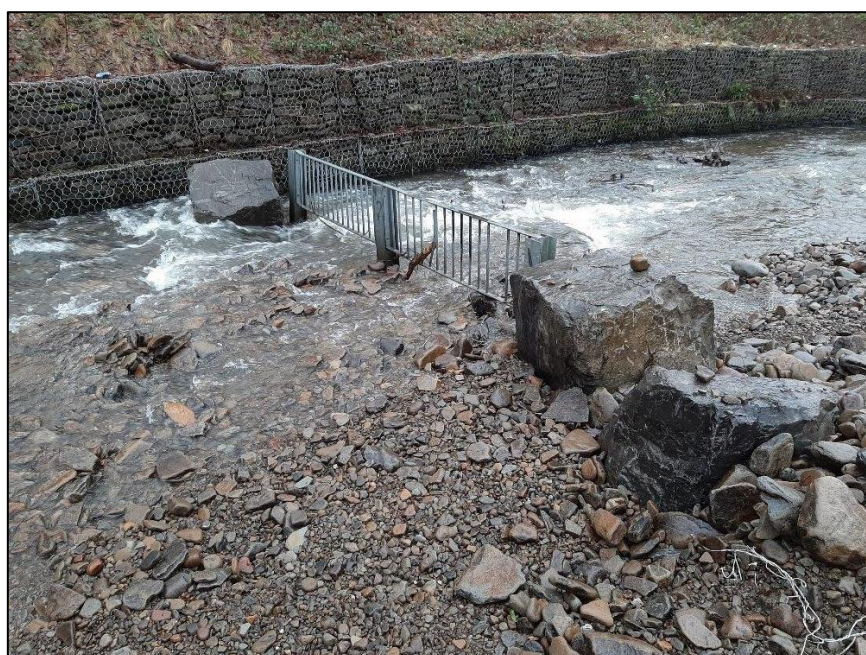
**Figure 25:** Second upstream debris screen in the Nant Cae Dudwg watercourse captured prior to Storm Dennis

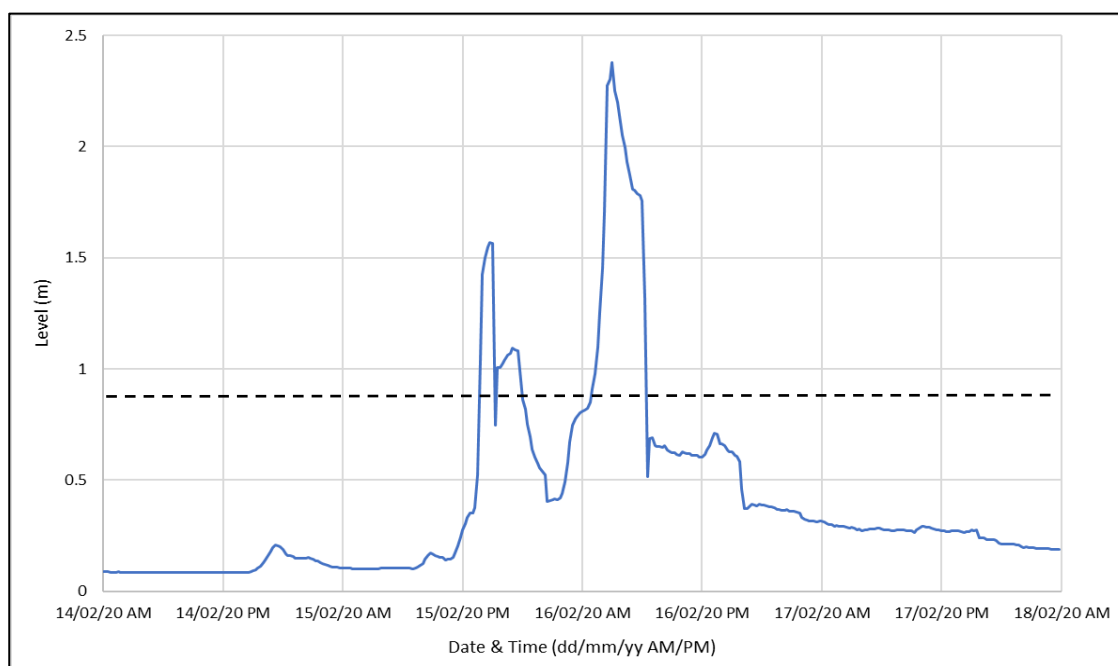
Based on data captured by RCT's Nant Cae Dudwg monitoring station, the storm resulted in two significant peaks in the level of flow within the Nant Cae Dudwg watercourse. Both peaks are illustrated in Figure 28. The initial peak triggered the alarm system at 13:45 on 15<sup>th</sup> February 2020 which resulted in a peak watercourse level of 1.567 meters at 14:45. During this hour the Nant Cae Dudwg rose suddenly by 528mm. The second and most prominent peak activated the alarm system at 01:00 on 16<sup>th</sup> February 2020 and caused a peak level of 2.37m at 03:00.

**Figure 28:** Water level in the Nant Cae Dudwg ordinary watercourse during the 14 – 18th February 2020 captured by RCT's monitoring station. Dashed line represents the alarm trigger threshold (0.9m)

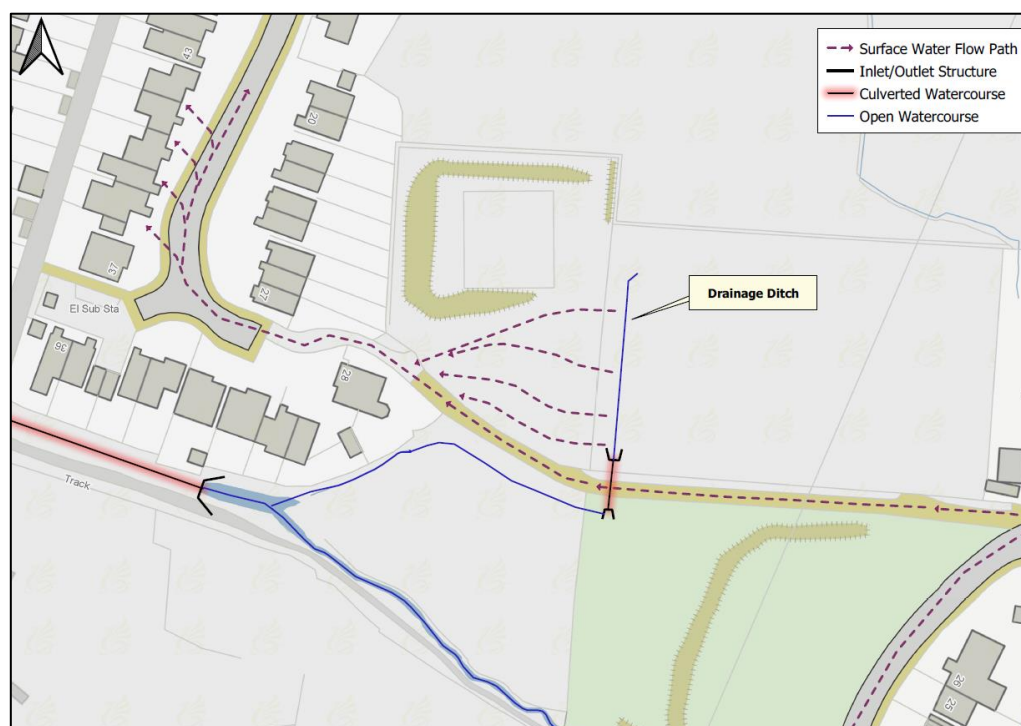
**Figure 33:** Location of the identified land drainage ditch and observed surface water flow paths during Storm Dennis

The inspection noted that the land drainage channel is culverted beneath the lane before outfalling into the adjacent stream that flows towards Oakland Terrace culvert network. Residents report that the inlet became blocked during the event, resulting in water overtopping the channel (Figure 32) and flowing towards the downstream field and onwards to impact properties at Brynderwen. The land drainage channel and observed flow paths have been illustrated in Figure 33.

Despite the land drainage channel being identified as a secondary source of flooding, the primary source of flooding to properties in this area originated from the surcharged culvert inlet to the rear of Heol Mynydd.
