# Flood and Water Management Act 2010

## Section 19 Flood Investigation Report

### Storm Dennis – Flood Investigation Area RCT27

November 2021

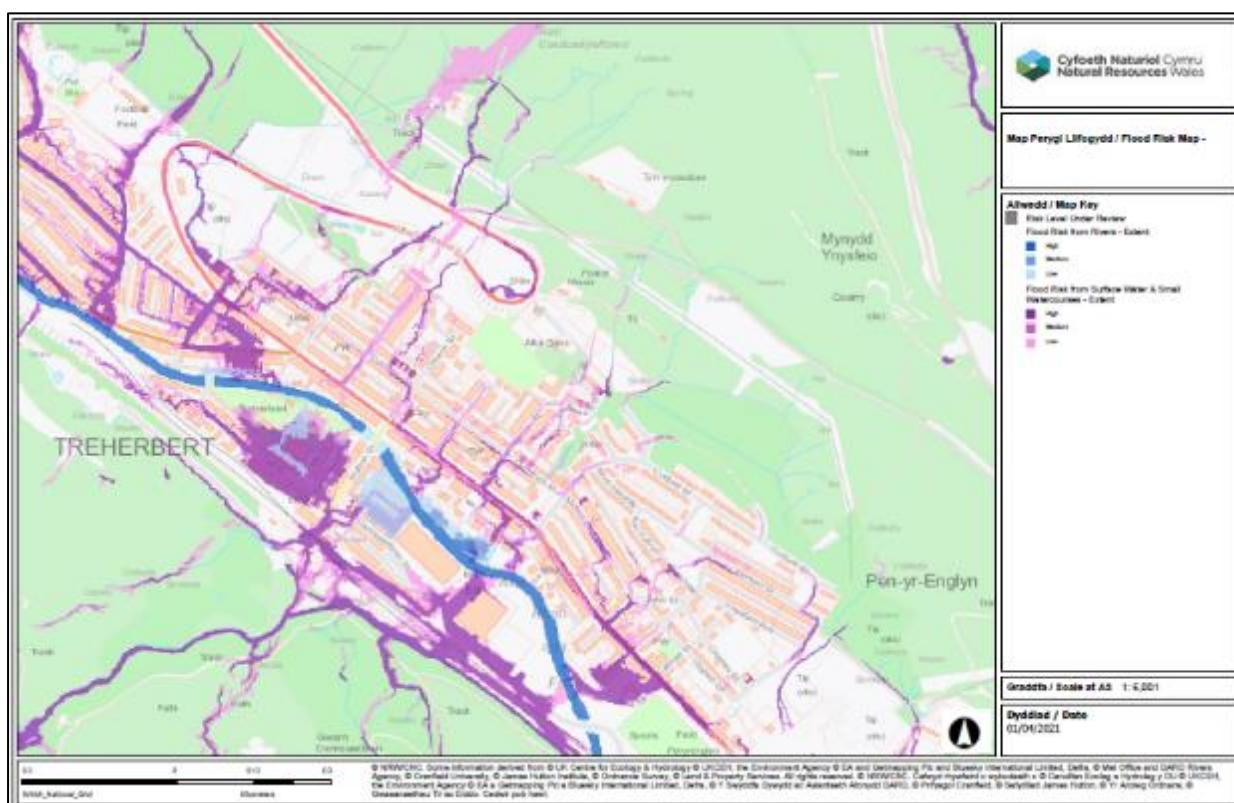
**Figure 2:** Natural Resources Wales’ Flood Risk Assessment Wales (FRAW) map for rivers and ordinary watercourse and surface water flood risk at investigation area RCT27. Contains Natural Resources Wales information © Natural Resources Wales and database right. All rights reserved.

The highest risk posed to people and properties according to the FRMP is broadly associated with culvert inlets located to the north of investigation area RCT27<sup>3</sup>. The risk of flooding from pluvial sources (surface water and ordinary watercourse) is illustrated within Natural Resources Wales’ Flood Risk Assessment Wales (FRAW) mapping (Figure 2). A low risk of flooding from the Main River is noted within the floodplains adjacent to the River Rhondda Fawr.

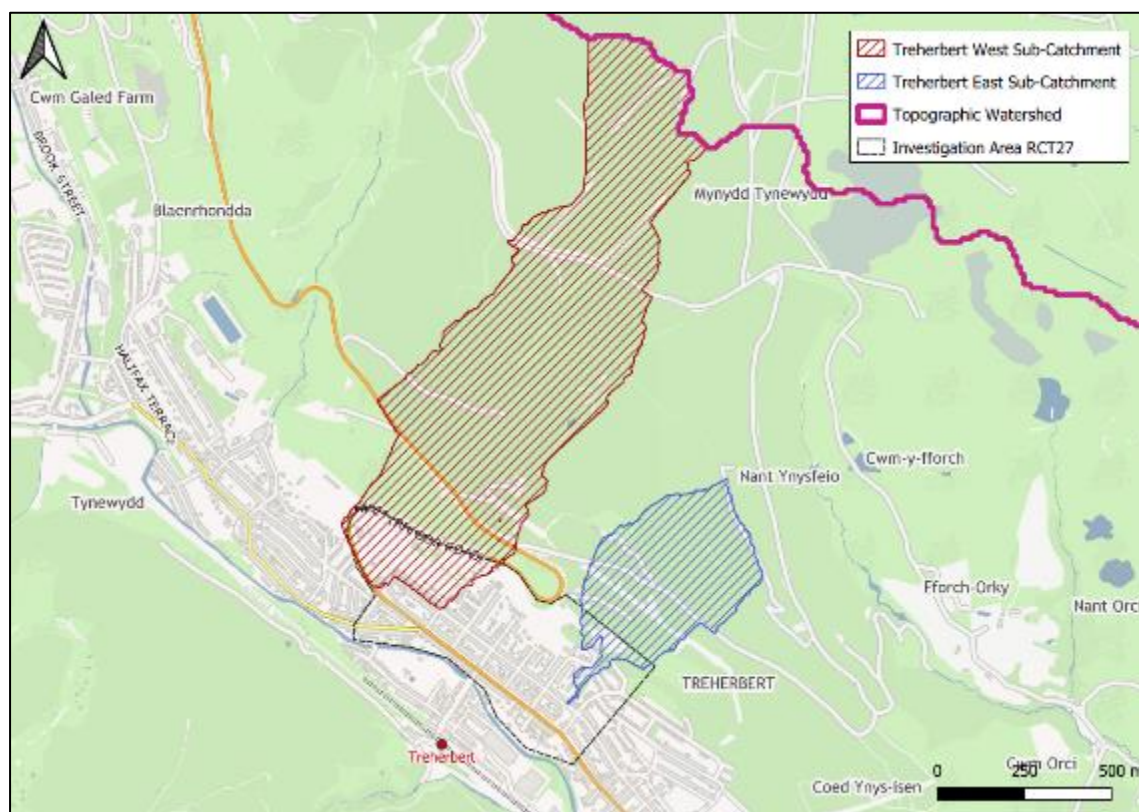
**Figure 3:** Rainfall Topographic Watershed and Sub-catchments above investigation area RCT27

Figure 3 depicts the topographic watershed of the Rhondda Fawr and Fach valleys (bold pink line), with rainfall to the south east of the watershed draining to the Rhondda Fawr catchment. The catchment above investigation area RCT27 can be sub-divided into further sub-catchments to illustrate the area of land that would expect to drain towards the investigation area (hatched areas in Figure 3). The flood incident at investigation area RCT27 will be further described in two parts: the incident at 'Treherbert West' sub-catchment (red hatched area, Figure 3) and the incident at 'Treherbert East' sub-catchment (blue hatched area, Figure 3).

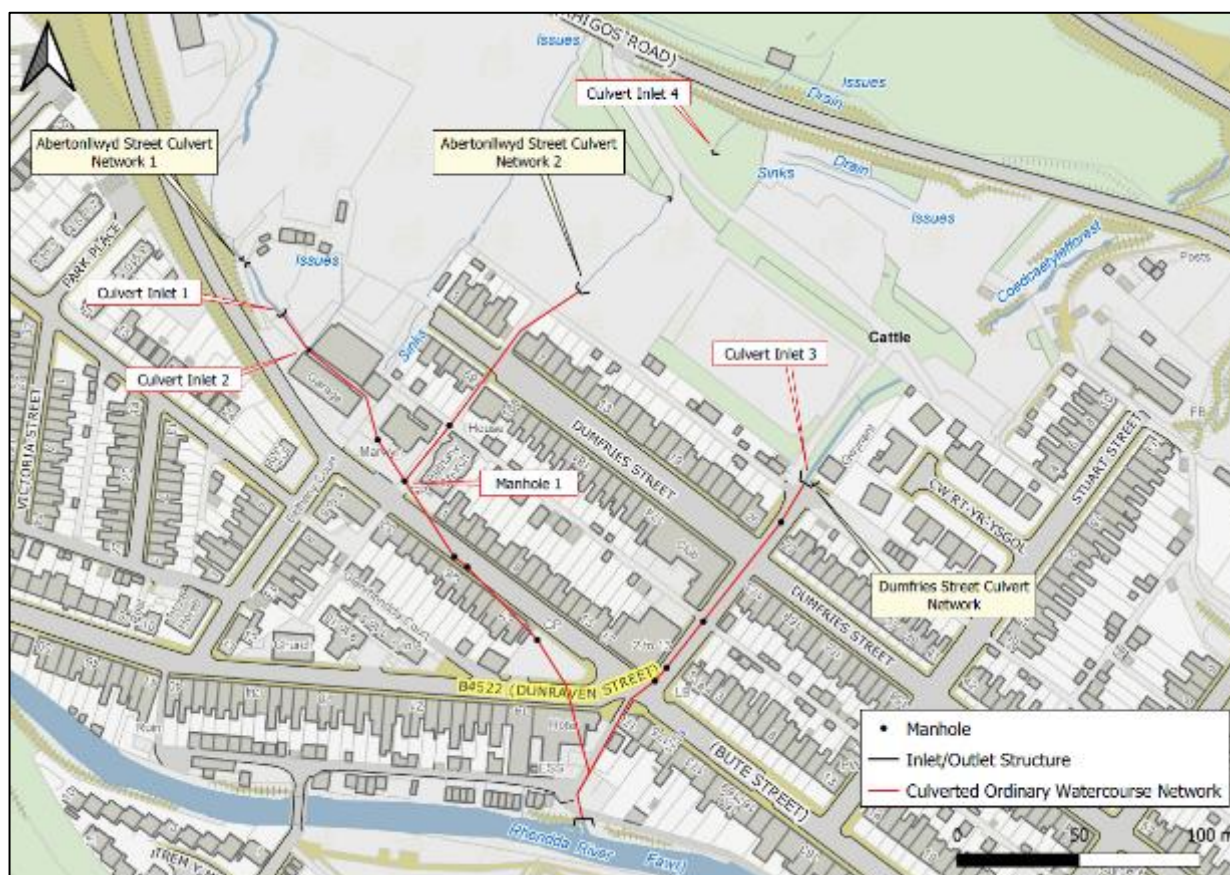
**Figure 11:** Surveyed culverted ordinary watercourse network within the 'Treherbert West' sub-catchment

Figure 11 outlines the three networks surveyed within the 'Treherbert West' sub-catchment and highlights the culvert inlets and manhole known to have surcharged.

According to on-site officers, several sections of open watercourse upstream of the 'Abertonllwyd Street Culvert Network 1' (Figure 11) had significant build-up of debris within the channels, indicating significant mobilisation of debris occurred during the storm event (depicted in Figure 20). The conveyance of sediment, silt and stone downstream is considered to have contributed to the surcharging of 'Culvert Inlet 1' and 'Culvert Inlet 2' during Storm Dennis. This debris is also considered to have entered the culvert network, contributing to the surcharge of 'Manhole 1' during the event.

The unnamed ordinary watercourses located above 'Abertonllwyd Street Culvert Network 2' (Figure 11) did not show evidence of significant debris mobilisation, however, it was apparent during post event inspections that significant overland flows had occurred along the hillside upon identifying evidence of flattened vegetation and saturated ground. The ordinary watercourse channel upstream of 'Culvert Inlet 4' (Figure 11), which surcharged during the storm event, was largely undefined and is considered to have contributed to the inlet becoming submerged, resulting in out-of-bank flows (Figure 8)

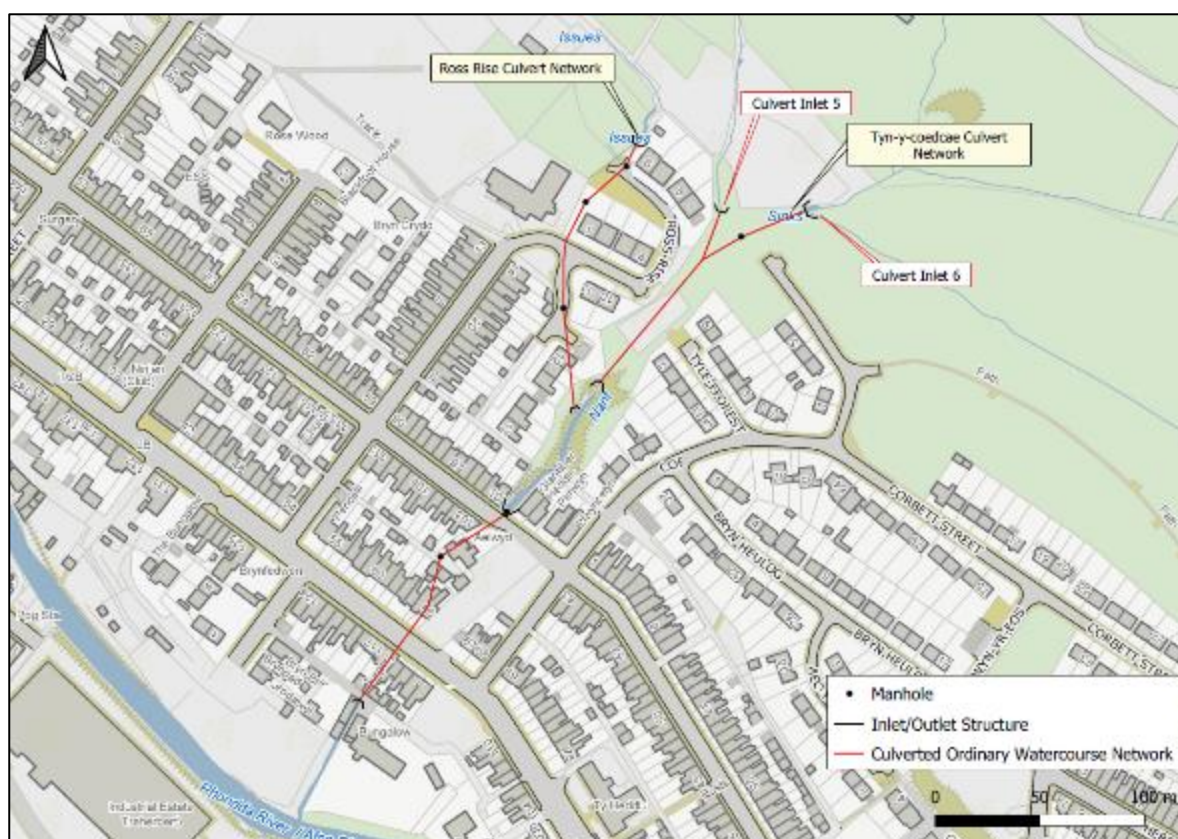
**Figure 17:** Surveyed culverted ordinary watercourses within the 'Treherbert East' sub-catchment

Figure 17 outlines both networks surveyed within the 'Treherbert East' sub-catchment and highlights the culvert inlets known to have surcharged.

The source of flooding to three properties at Ross Rise and Tyle Fforest was identified as originating from two surcharged culvert inlets located to the north of Tyn-y-coedcae, labelled 'Culvert Inlet 5 and 6' in Figure 17.

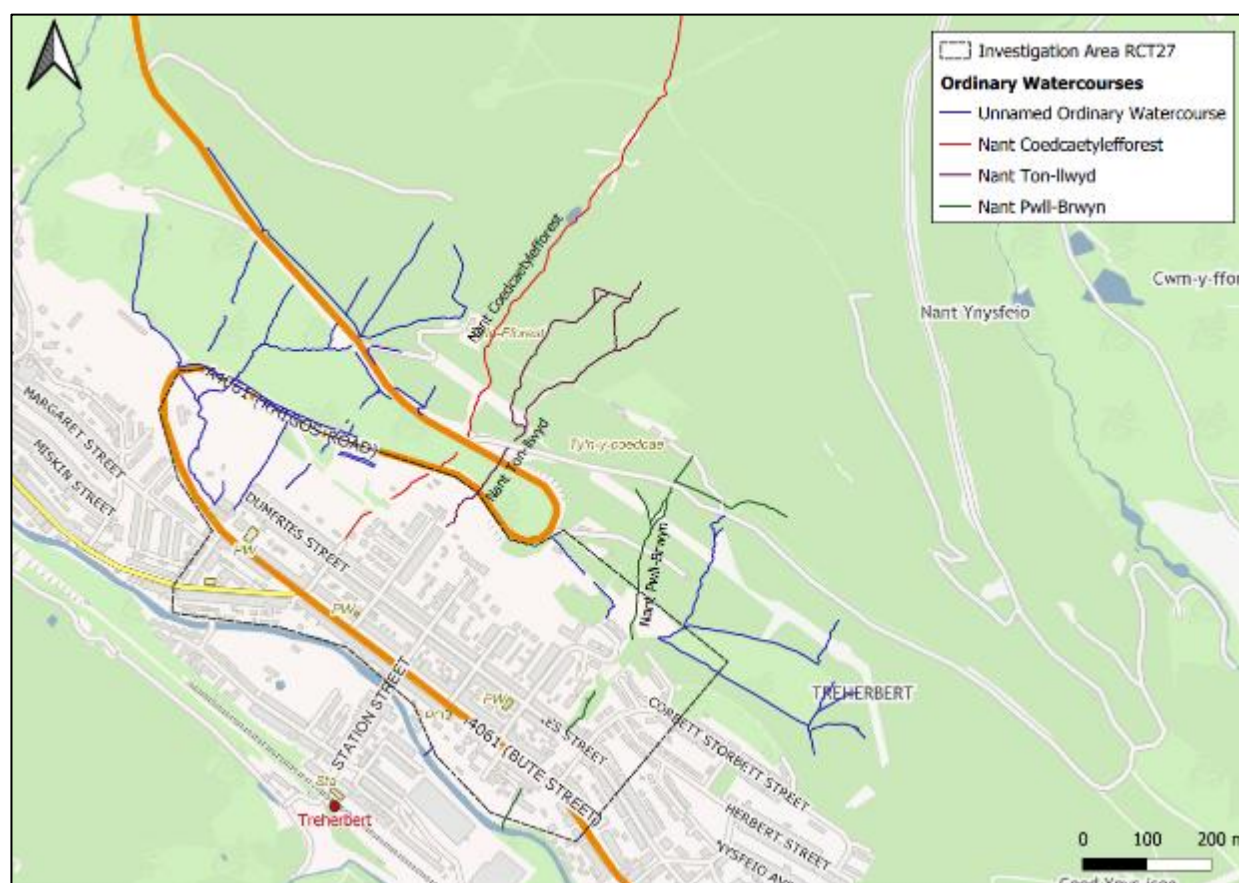
**Figure 19:** Map of Ordinary Watercourses which feed into investigation area RCT27

Several sections of natural ditches and open watercourses which drain the steep catchment above Treherbert are identified to flow through the investigation area, as illustrated in Figure 19. The most notable watercourses include the Nant Coedcaetylleforest, the Nant Ton-llwyd and Nant Pwll-brwyn.

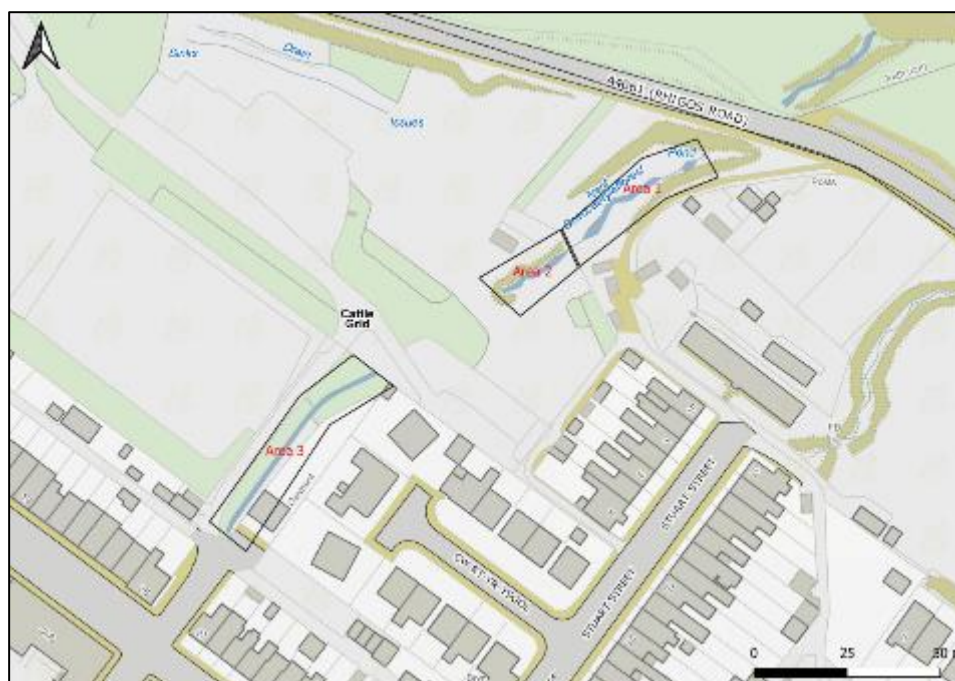
**Figure 21:** Nant Coedcaetylefforest ordinary watercourse inspection location plan

Following the surcharging of 'Culvert Inlet 3' (Figure 4) caused by debris blockage during Storm Dennis, the Nant Coedcaetylefforest ordinary watercourse was inspected by Flood Risk Management officers for signs of debris mobilisation. The watercourse was inspected at three areas, depicted in Figure 21.

The upstream sections of the Nant Coedcaetylefforest ordinary watercourse (Area 1, Figure 21) showed evidence of debris deposition within the man-made channel, along with significant accumulation of material across the upper debris screens and headwall structure. Figure 22 and 23 depicts the material, which consists of coarse stone, silt and woody debris, within the upper channel. This material is assumed to have been mobilised from the upper reaches above the A4061 (Rhigos Road) and carried downstream by the high flows during Storm Dennis.

Below the headwall structure, the channel and culvert inlet (Area 2, Figure 21) did not show evidence of debris conveyance or blockage to the inlet, as shown in Figure 24. It is considered that the upstream debris screens at Area 1 succeeded in minimising the volume of debris travelling downstream.

The channel immediately upstream of 'Culvert Inlet 3' (Area 3, Figure 21) is identified as man-made and therefore showed no signs of bank erosion. Upon an inspection of the surrounding area post Storm Dennis however, material on the banking area was evident (Figure 7). This material is not considered to have originated from Area 1.

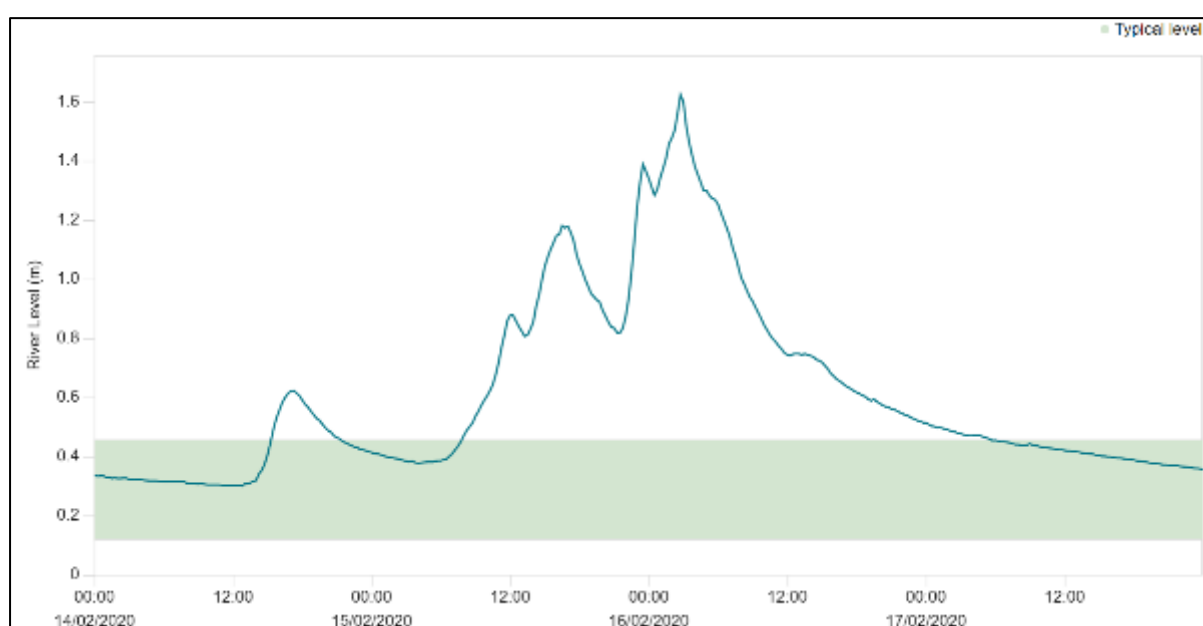
**Figure 25:** The Rhondda Fawr River levels at Tynewydd station between the 14<sup>th</sup> and 17<sup>th</sup> February 2020 (Natural Resources Wales)

The hydrograph in Figure 25 illustrates the rapid rise in levels of the River Rhondda Fawr in response to rainfall, captured at NRW's Tynewydd station. The River Rhondda Fawr at Tynewydd reached its highest peak ever recorded at 02:45 on 16<sup>th</sup> February 2020, reaching 1.62 meters.

The green bar displayed on the hydrograph shows the typical level of the River Rhondda Fawr at Tynewydd station, ranging between 0.1 and 0.5 meters. At its peak, the River Rhondda Fawr was over twice its average level, stressing the extreme and unprecedented levels that RCT's rivers rose to during the storm's peak intensity.
