**Section 19 Flood Investigation
Report**

**Storm Dennis –
Flood Investigation Area RCT12**

January 2022

Client	Director Frontline Services
Project	Flood and Water Management Act 2010, Section 19 Flood Investigation Report
Document Title	Storm Dennis – Flood Investigation Area RCT 12
Document Ref	FRM – S19 – 012
Project No	N/A

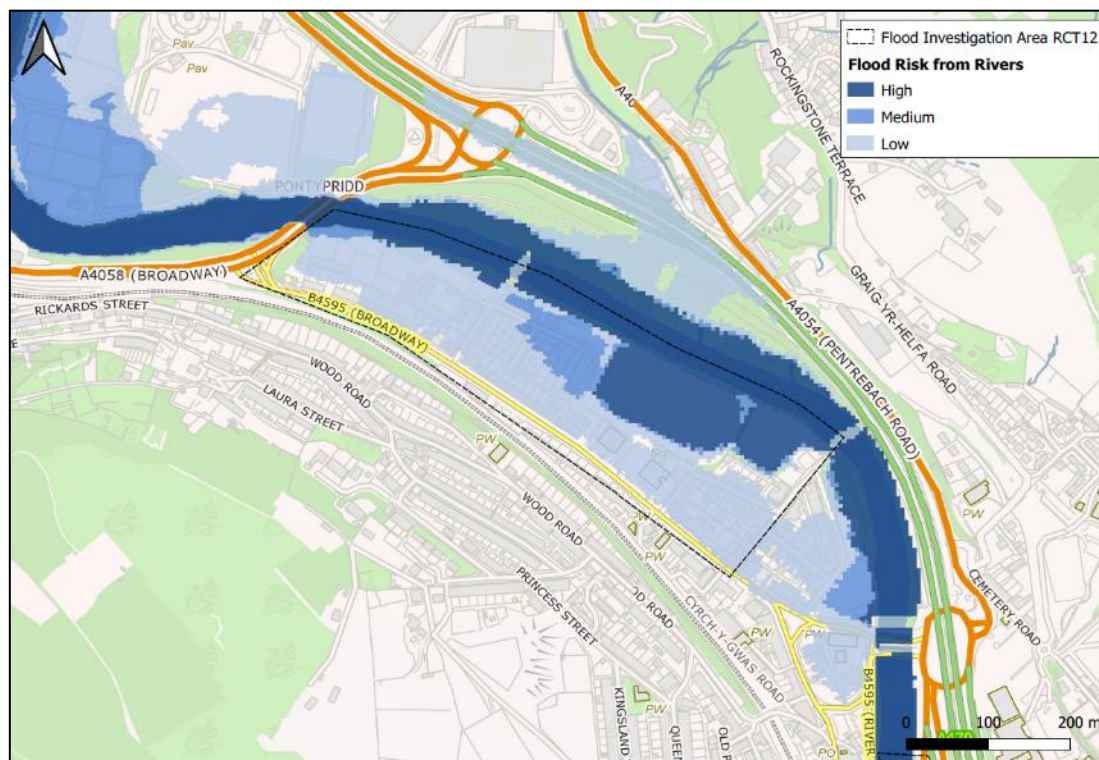
Figure 9: NRW's Flood Risk Assessment Wales (FRAW) map for River sources in RCT12. Contains Natural Resources Wales information © Natural Resources Wales and database right. All rights reserved.

The flooding that occurred within RCT12 during Storm Dennis is largely consistent with the modelled outputs of NRW's FRAW map (Figure 9), with the majority of the impacted areas within RCT12 falling within an area of medium and low risk of fluvial flooding.

Considering Storm Dennis has been estimated as a 1 in 200 annual probability (Q200) flood event, the area of flooding aligns with those depicted by the low main river flood risk extent (Figure 9).

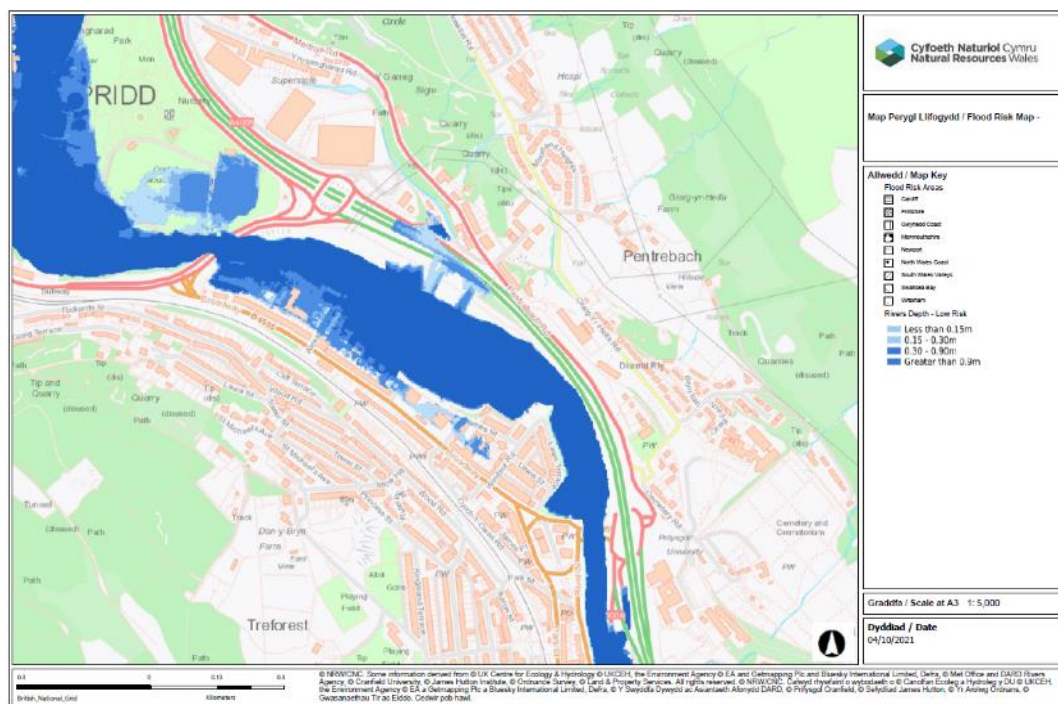
Figure 10: NRW’s National Hazard map for Low Risk River Flood Depth in RCT12. Contains Natural Resources Wales information © Natural Resources Wales and database right. All rights reserved.

Flooding up to 1.5 - 1.8 metres was observed across the worst affected streets at RCT12, including at Egypt, Niagara and Nile Streets. These observed flood depths also correlate well with NRW's Flood and Hazard map outputs for the low flood risk event (Figure 10).
