Section 19 Flood Investigation Report

Storm Dennis –
Flood Investigation Area RCT14

January 2022

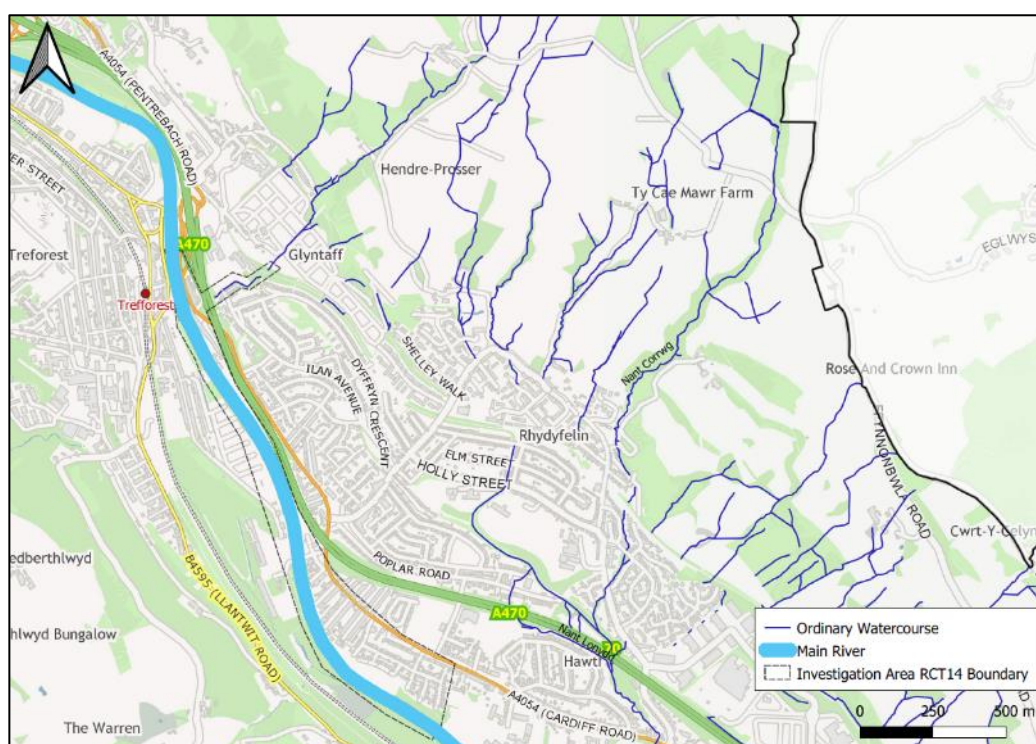
Figure 11: Map outlining main river and ordinary watercourse locations throughout RCT14 and the surrounding region.

Whilst there are several unnamed watercourses within the upper catchment of the investigation area, many of these watercourses convey into the Nant Corrwg and Nant Lonydd before discharging into the River Taf (highlighted in Figure 11). These watercourses and their tributaries fall outside of the investigation area.

There is no evidence to suggest that the ordinary watercourses outlined in Figure 11 contributed to the flooding experienced in RCT14 during Storm Dennis.

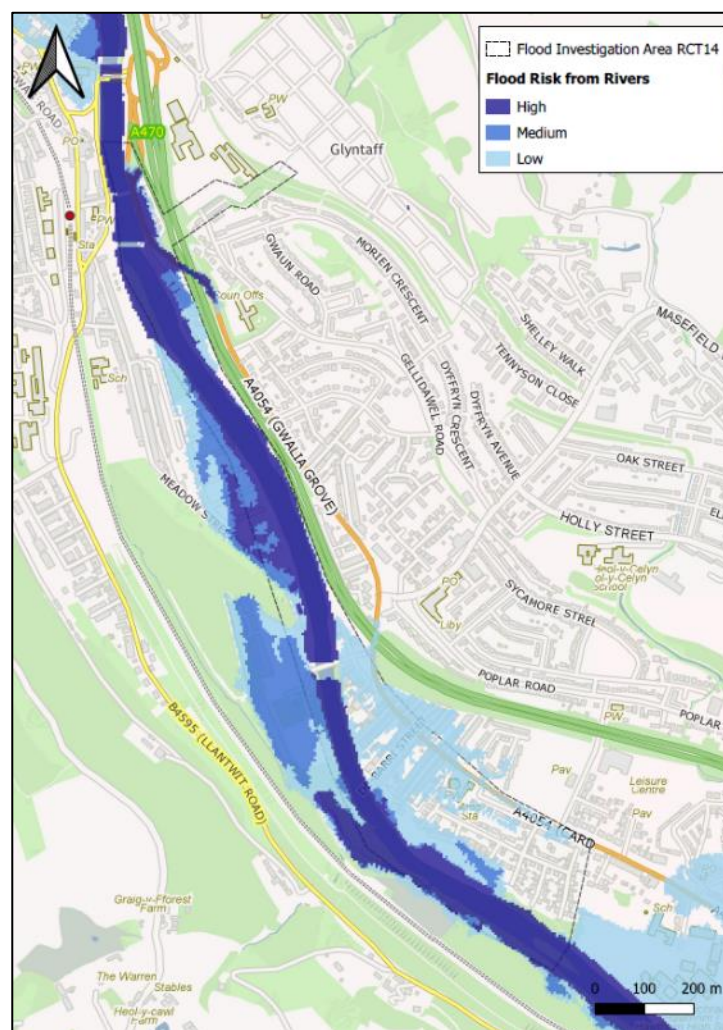
Figure 13: Natural Resources Wales' Flood Risk Assessment Wales (FRAW) map for River sources. Contains Natural Resources Wales information © Natural Resources Wales and database right. All rights reserved.

The flooding that occurred within RCT14 during Storm Dennis is largely consistent with the modelled outputs of NRW's FRAW map (Figure 13), with the majority of investigation area RCT14 identified at high and medium risk of fluvial flooding.

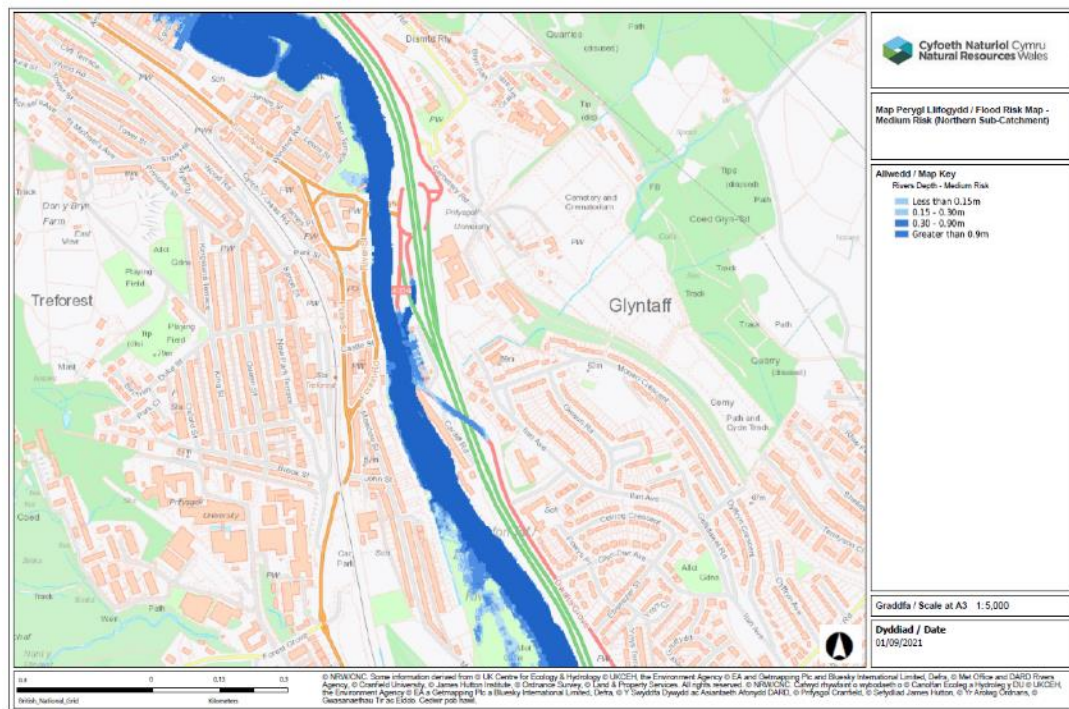
Figure 14: NRW's National Flood Hazard derived map for Medium Risk River Flood Depth in RCT14 Northern Sub-Catchment. Contains Natural Resources Wales information © Natural Resources Wales and database right. All rights reserved

Based on NRW's Flood Hazard maps, flooding to a depth greater than 0.9 metres is predicted along parts of Cardiff Road in the northern sub-catchment (Figure 14), as well as areas south of Nant-y-Dall Avenue in the southern catchment during a medium risk event (Figure 15). Flooding of this depth and greater was observed at these locations during Storm Dennis.

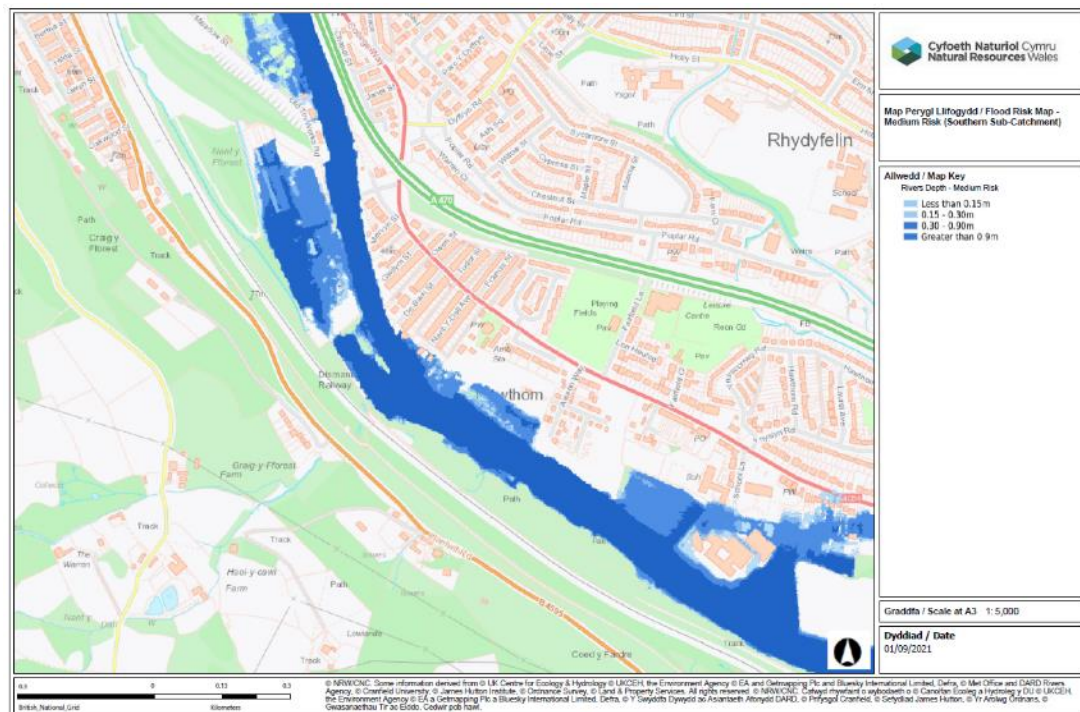
Figure 15: NRW's National Flood Hazard map for Medium Risk River Flood Depth in RCT14 Southern Sub-Catchment. Contains Natural Resources Wales information © Natural Resources Wales and database right. All rights reserved.

Figure 15 does not identify Alexon Way as an area of main river flood risk, further supporting the notion that fluvial flows did not reach the impacted property. Surface water flooding has been determined as the likely cause of internal flooding at this location.

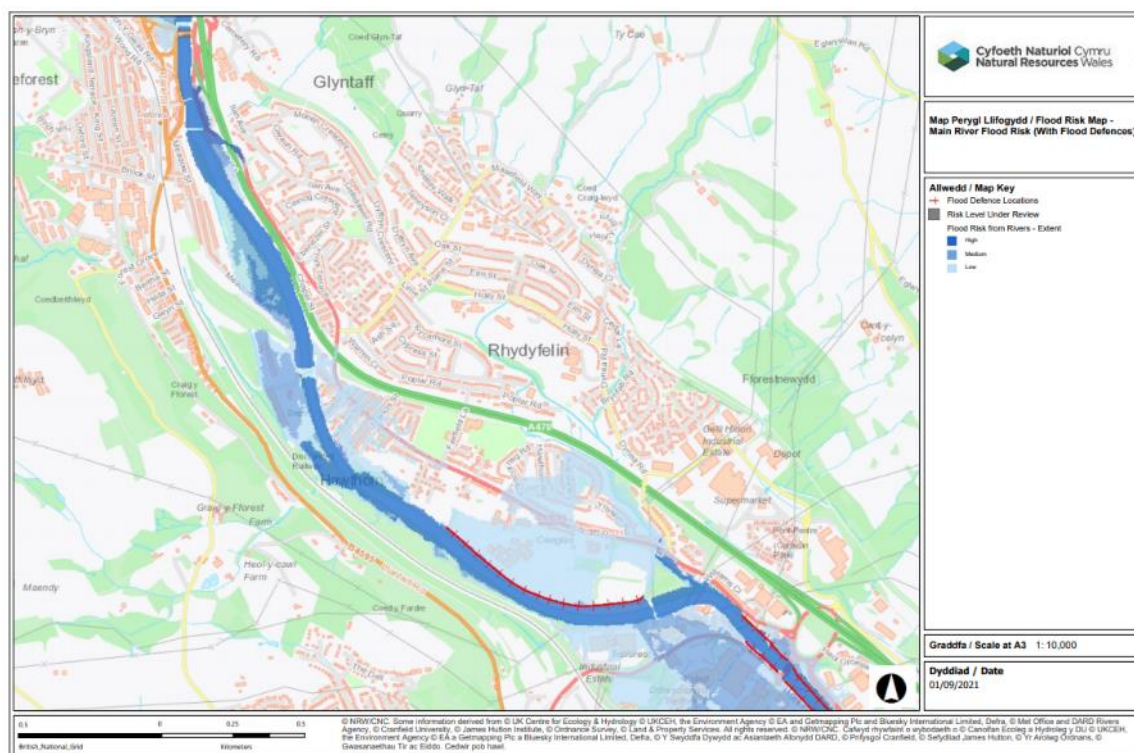
Figure 16: Natural Resources Wales' Flood Risk Assessment Wales (FRAW) map for River sources, including flood defence locations at investigation area RCT14. Contains Natural Resources Wales information © Natural Resources Wales and database right. All rights reserved.

There are no formally designated flood defences along the River Taf at investigation area RCT14, i.e., there are no flood defences operated or maintained by NRW. The closest flood defence, demarcated on Figure 16 by a bold red line, is immediately downstream of Alexon Way at the southern extent of the investigation area boundary.

Figure 16 illustrates the reduction in flood risk that derives from the presence of a flood defence structure, with the defended area of Hawthorn identified at low risk of main river flooding in comparison to areas of Glyn-taf and Rhydyfelin upstream that are identified at high and medium risk of fluvial flooding.

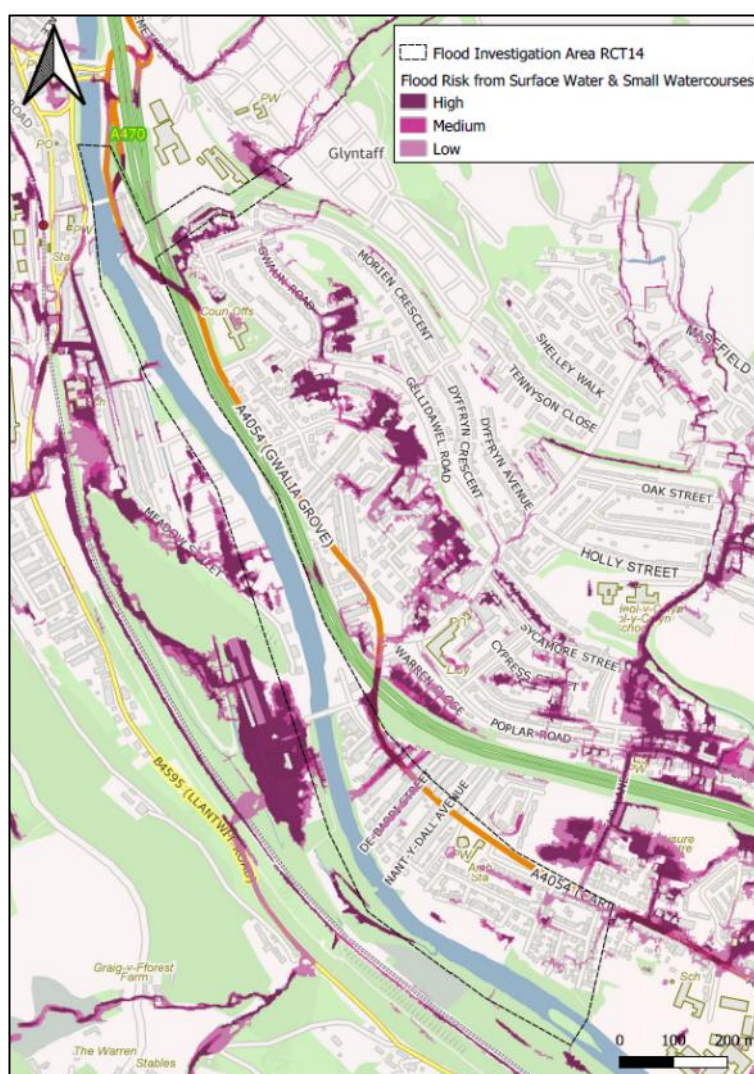
Figure 17: Natural Resources Wales' Flood Risk Assessment Wales (FRAW) map for Surface Water and Ordinary Watercourse flood sources. Contains Natural Resources Wales information © Natural Resources Wales and database right. All rights reserved.

The pathways for surface water runoff during the storm event were observed primarily along the highway network within RCT14. The exact flow routes have not been confirmed due to lack of anecdotal evidence, however, NRW's national surface water and ordinary watercourse flood maps (Figure 17) provide a reasonable indication of the pathways and areas most at risk of flooding from local sources.

With the exception of Owen Street, which is denoted as an area of medium surface water flood risk in Figure 17, the majority of high and medium surface water flood risk areas which experienced internal flooding were also flooded by the overtopping of the River Taf. This further reinforces the notion that surface water was a secondary influence on the flooding that occurred in RCT14, with areas that were solely impacted by surface water, such as Gwilym Street, primarily experiencing external flooding rather than internal flooding.
