Section 19 Flood Investigation Report

Storm Dennis –
Flood Investigation Area RCT01
(Hirwaun)

January 2022

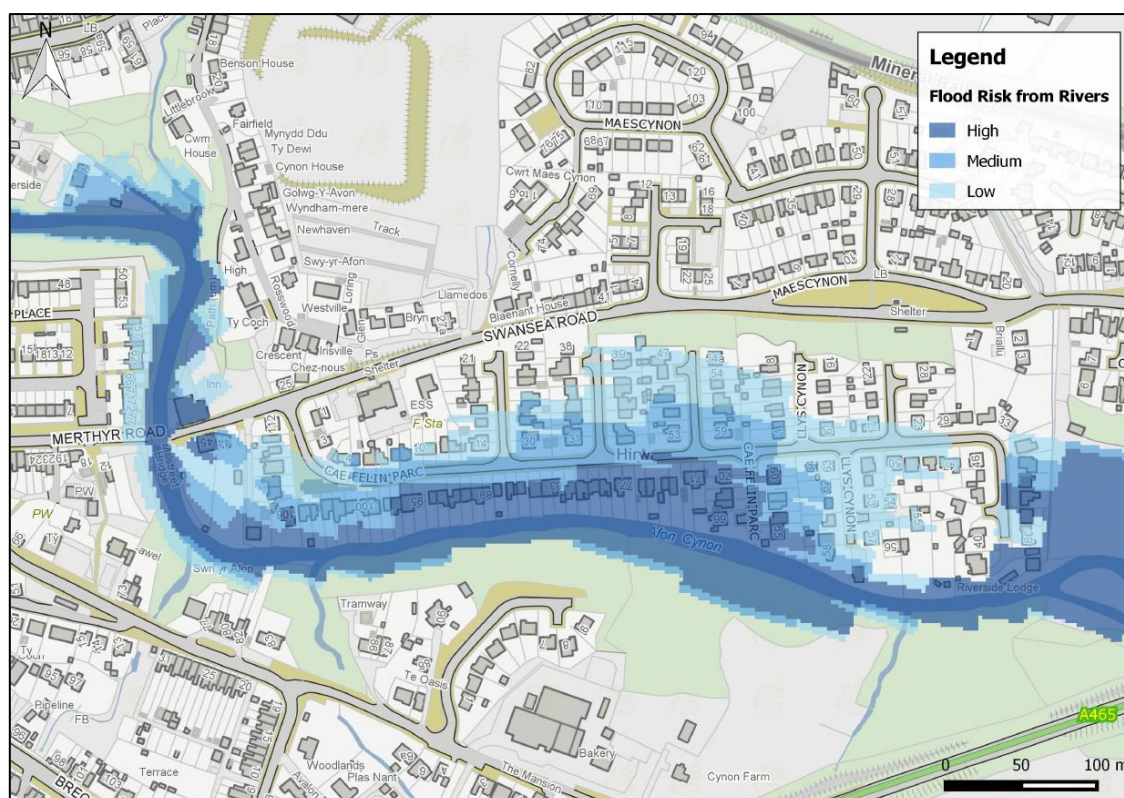
Figure 13: Natural Resources Wales' Flood Risk Assessment Wales (FRAW) map for River sources at RCT01. Contains Natural Resources Wales information © Natural Resources Wales and database right. All rights reserved.

Properties impacted by flooding at Cae Felin Parc are identified at high risk of fluvial flooding, as depicted within Figure 13, which is an extract from NRW's FRAW mapping exercise and depicts the main river flood extents for the 'Defended' scenario, i.e., with the presence of flood defence infrastructure. The darker shading identifies areas at higher risk of flooding (more frequent/less extreme rainfall events) and lighter shading showing the lower risk areas (less frequent/more extreme rainfall events).

Those properties directly adjacent to the River Cynon suffered the most severe impacts, with reported flood depths up to 1 metre in height observed at those properties falling in the high flood risk zone.

Based on evidence provided by the FRAW map and the lack of formal flood defences, properties at Cae Felin Parc are identified at high risk of flooding from the main river (Figure 13).

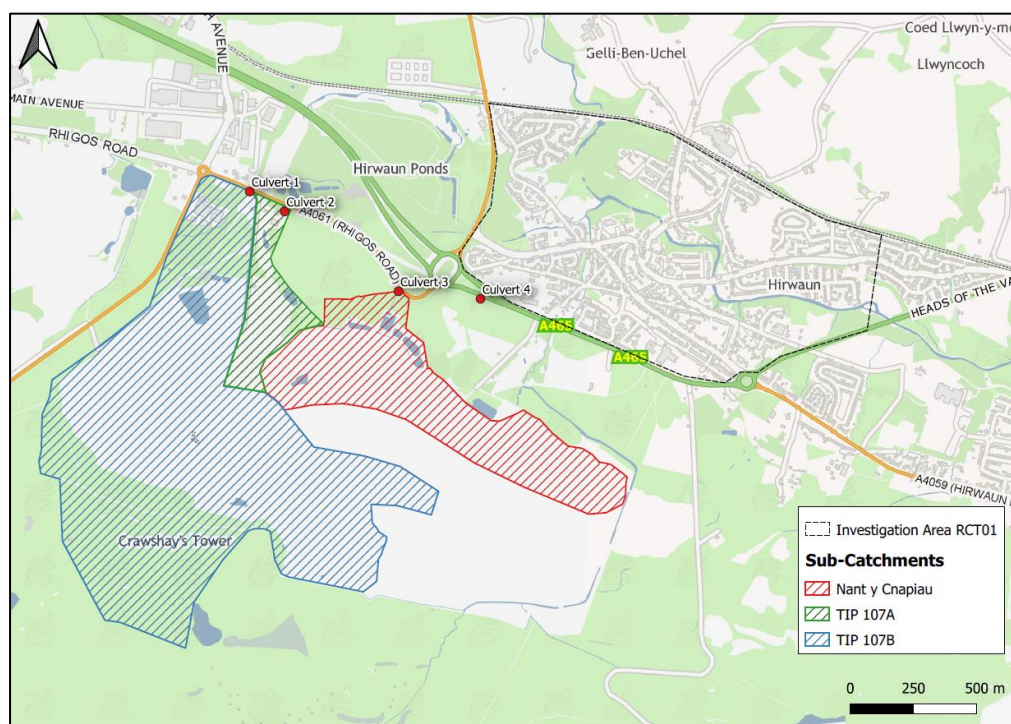
Figure 16: Tower Colliery sub-catchments and associated culvert inlets

At the time of the storm event however, the catchment areas were known to have not been arranged and re-profiled as post mining conditions stipulate. This means that the surface water and ordinary watercourse flows conveying down the sub-catchments towards 'Culverts 1, 2 & 3' (illustrated in Figure 16) were being exacerbated due to the arrangements of the catchment on site.

Culvert capacity assessments of the existing infrastructure (illustrated in Figure 16) based on post-mining discharge rates was undertaken as part of the Flood Risk Managements' team investigations. The results of which are summarised in Table 5.

- The Highway Authority intend to increase their resource capacity by establishing a dedicated 'Pluvial Drainage Team' to focus entirely on the refurbishment and maintenance of RCT's existing and enhanced highway drainage infrastructure.
- Upgrade works to 'Culvert 1' and 'Culvert 2', associated to the Tower Colliery sub-catchments (illustrated in Figure 16), to increase the SOP to Q100, are currently on the Highway Authority's development programme for construction in 2022/23. **(R3A)**
