Section 19 Flood Investigation Report

Storm Dennis –
Flood Investigation Area RCT16
(Upper Boat & Nantgarw)

January 2022

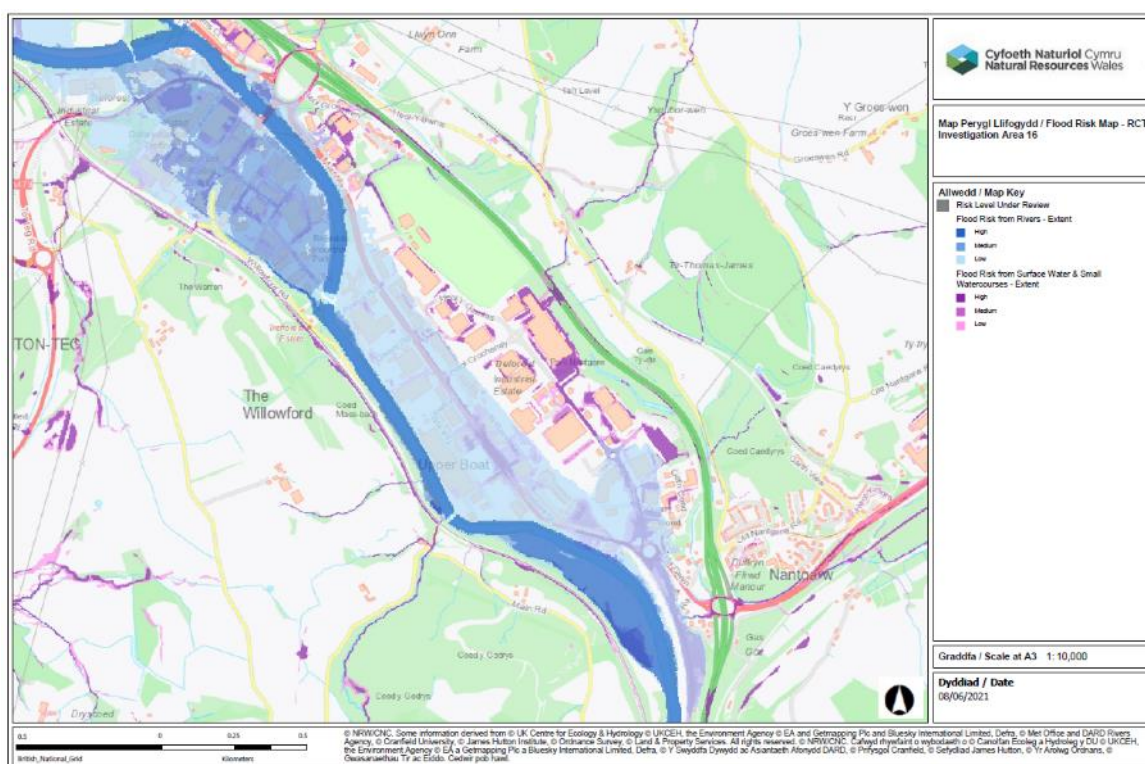
Figure 2: Natural Resources Wales' Flood Risk Assessment Water (FRAW) map for rivers and ordinary watercourse and surface water flood risk at investigation area RCT16. Contains Natural Resources Wales information © Natural Resources Wales and database right. All rights reserved.

NRW's Flood Risk Assessment Wales (FRAW) maps indicate that there are areas of low to high flood risk from both fluvial and surface water and ordinary watercourse sources within the investigation area. This is illustrated in Figure 2, which is an excerpt from the FRAW maps.

The highest risk posed to people and properties within RCT16 is associated with the River Taf, with a low risk of fluvial flooding observed across the eastern embankments and a medium to low risk of fluvial flooding present on the western floodplains at Treforest Industrial Estate.

Flood risk from surface water and ordinary watercourse sources is also noted across many parts of the investigation area, although not to the same degree and extent as main river flood risk. RCT's FRMP³ identifies areas of low to high surface water and ordinary watercourse flood risk within RCT16 associated with culvert inlets and potential bank breaches.

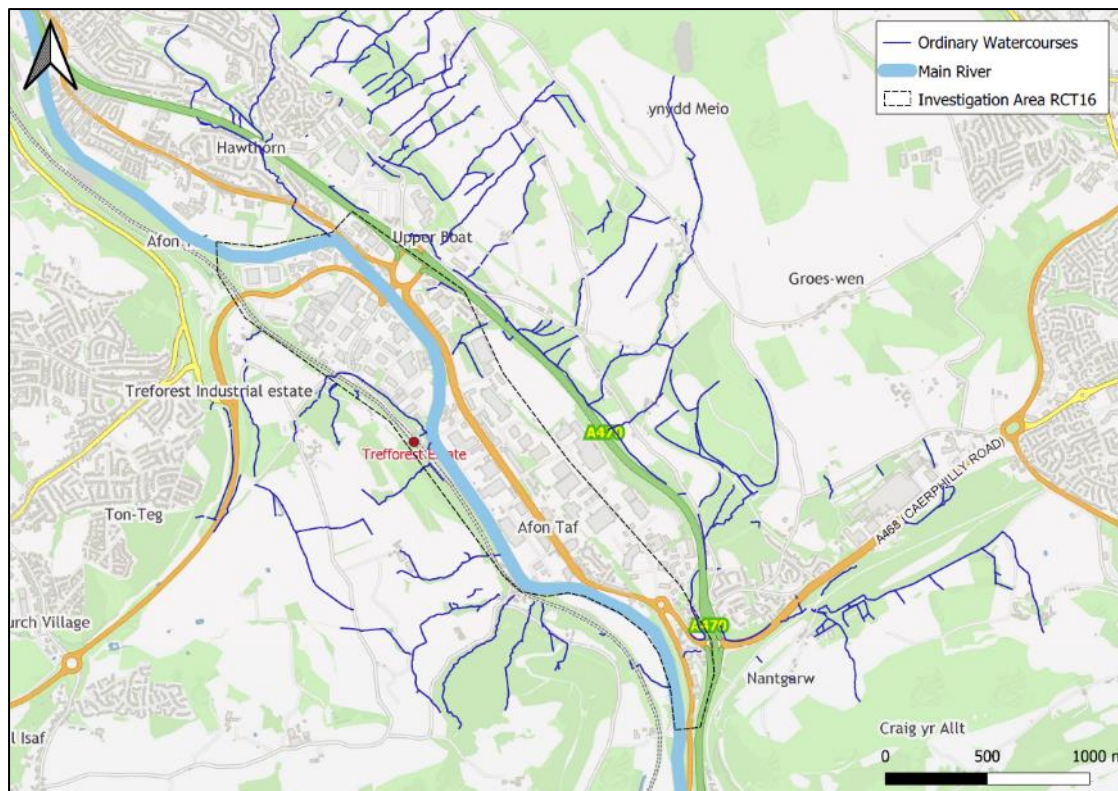
Figure 9: Map of ordinary watercourses that feed into investigation area RCT16

There are several named and unnamed ordinary watercourse that convey towards the River Taf through the investigation area (illustrated in Figure 9).

With the exception of the Nant Garw ordinary watercourse in the south of the investigation area, there is no evidence to suggest that the network of ordinary watercourses illustrated in Figure 8 contributed to the flooding experienced during Storm Dennis.

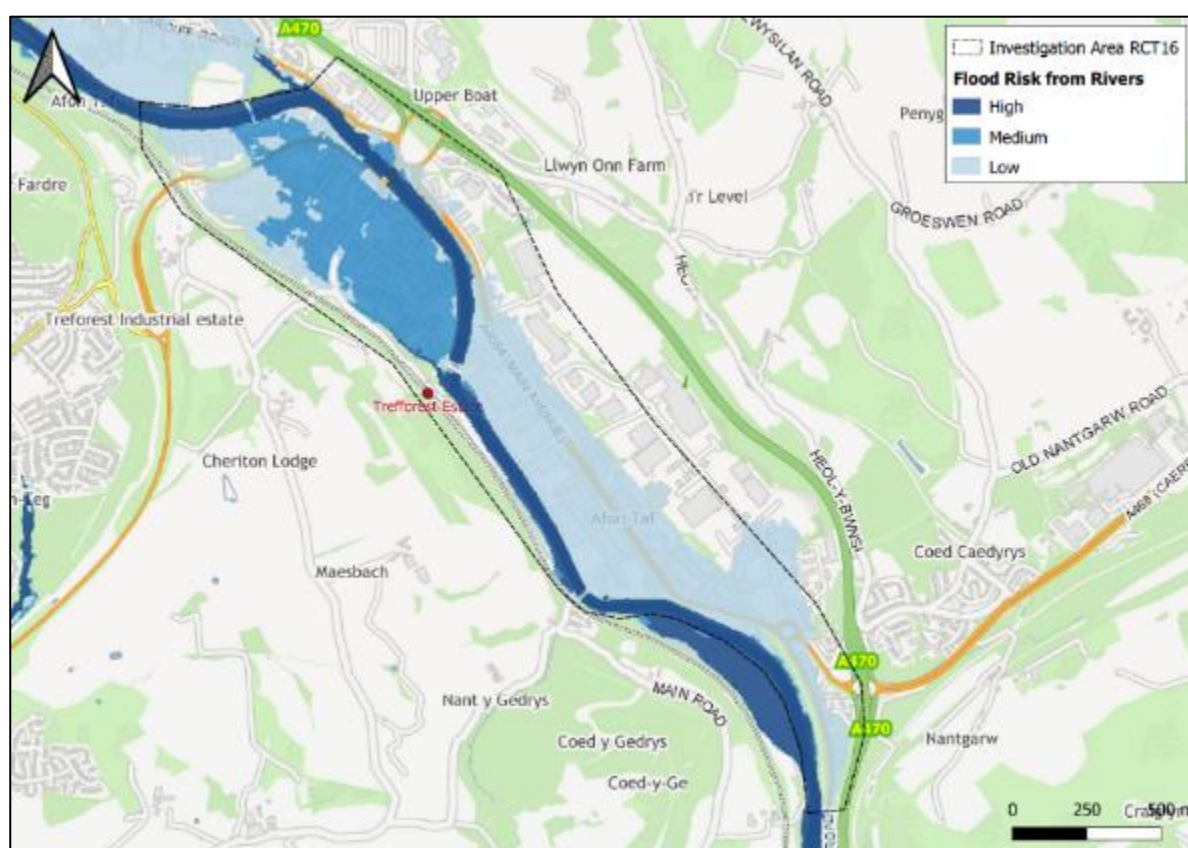
Figure 11: NRW's FRAW map for River sources at RCT16. Contains Natural Resources Wales information © Natural Resources Wales and database right. All rights reserved.

The flooding that occurred within RCT16 during Storm Dennis is largely consistent with the modelled outputs of NRW's FRAW map (Figure 11), with the majority of the

affected properties falling within an area of at least a low to medium main river flood risk.

A low risk of flooding means that an area has a chance of flooding of between 1 in 1000 (0.1%) and 1 in 100 (1%) each year; meanwhile, a medium risk of flooding signifies a yearly chance of flooding between 1 in 100 (1%) and 1 in 30 (3.3%). Considering Storm Dennis has been estimated as a 1 in 200 annual probability (Q200) flood event, the area of flooding during Storm Dennis aligns with those depicted by the low flood risk extents (Figure 11).

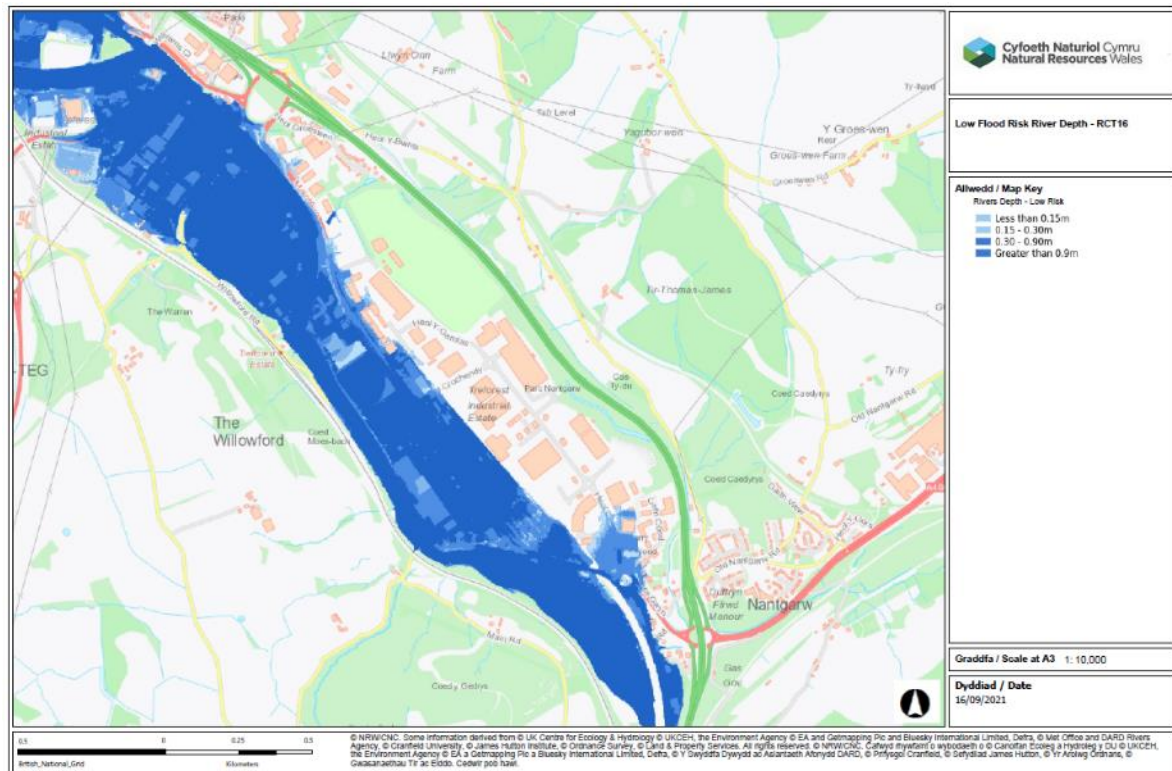
Figure 12: NRW's National Hazard map for Medium Risk River Flood Depth in RCT16. Contains Natural Resources Wales information © Natural Resources Wales and database right. All rights reserved.

NRW's Flood Hazard maps (Figures 12 and 13) illustrate the modelled flood depth predictions for a medium (Figure 12) and low (Figure 13) risk flood event.

The figures below highlight the substantial difference in predicted flood extents and impacts between a medium risk storm event and a low risk storm event, with the latter being more representative of the flooding that occurred during Storm Dennis, where flooding to a depth of greater than 0.9 metres was observed across most of RCT16.

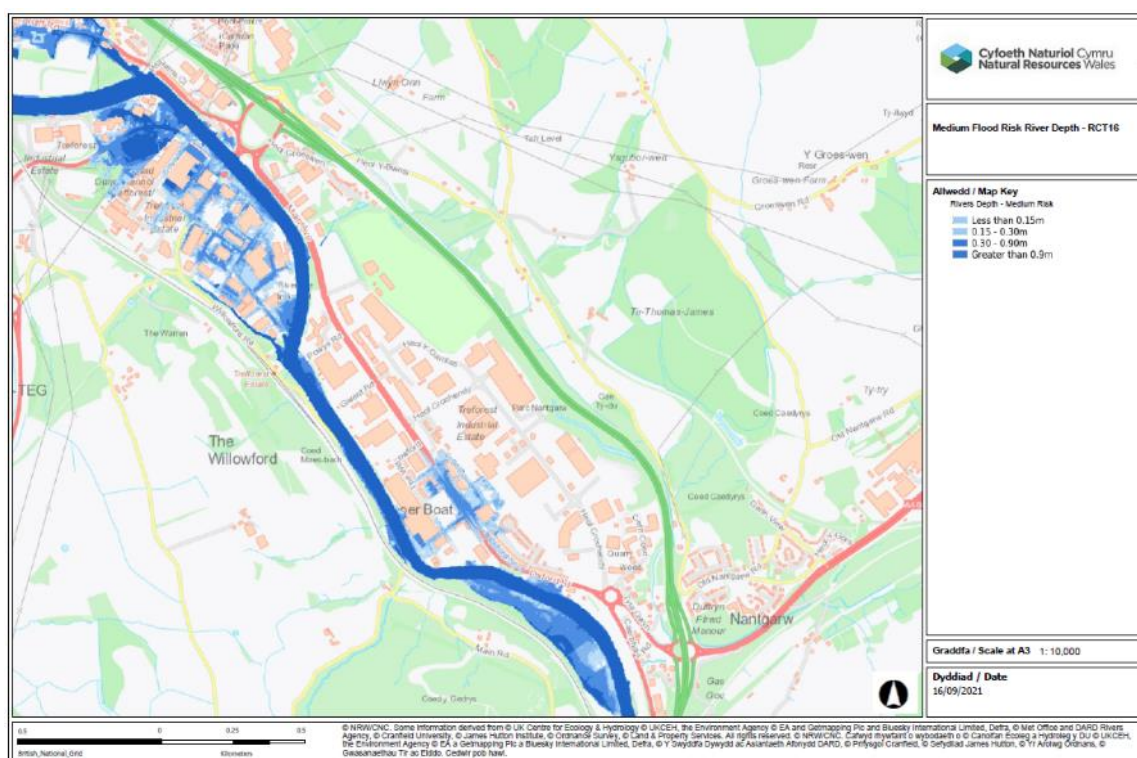
Figure 13: NRW’s National Hazard map for Low Risk River Flood Depth in RCT16. Contains Natural Resources Wales information © Natural Resources Wales and database right. All rights reserved.

Figure 13 also identifies a fluvial flow path from Oxford Street towards Cardiff Road, which supports the notion that main river flooding did not occur immediately adjacent to Cardiff Road in the south of the investigation area but was as a result of fluvial flows conveying southwards along the highway network.

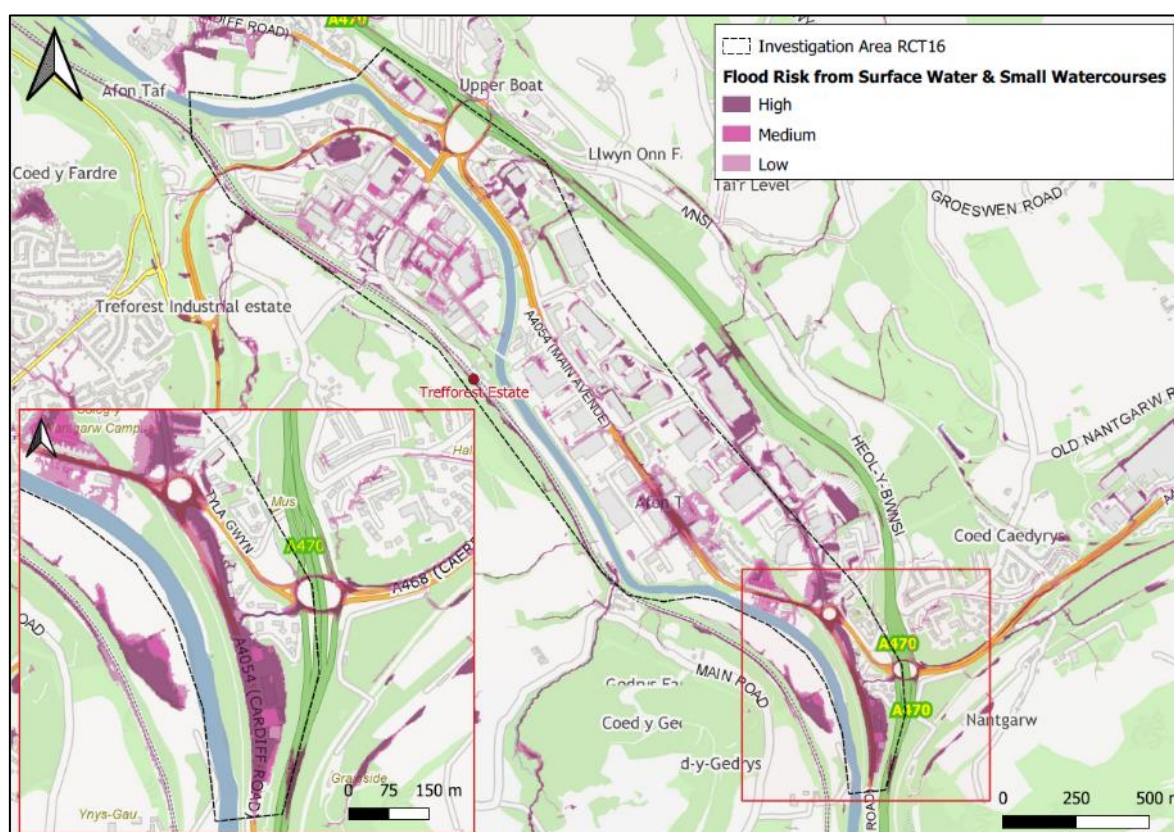
Figure 16: NRW's Flood Risk Assessment Wales (FRAW) map for Surface Water and Ordinary Watercourse flood sources at RCT16. Contains Natural Resources Wales information © Natural Resources Wales and database right. All rights reserved.

According to NRW, flood defence infrastructure throughout the Treforest Industrial Estate, including at Oxford Street and Rhyd-yr-Helyg, provides a standard of protection up to a 1 in 100 annual probability flood event (Q100) (black hatched area in Figure 16). Flood defence infrastructure at Upper Boat and William’s Place provide a reduced standard of protection of 1 in 20 annual probability (Q20) flood event.

The pathways for surface water runoff during the storm event were observed along the highway network within RCT16. The exact flow routes have not been confirmed due to lack of anecdotal evidence, however, NRW's national surface water and ordinary watercourse flood maps (Figure 16) provide a reasonable indication of the pathways and areas most at risk of flooding from local sources.

Notable areas where surface water flows are considered to have exacerbated the main river flooding include Williams Place, Cardiff Road, and parts of Rhyd-yr-Helyg and Oxford Street, where the FRAW map indicates a high to low risk of pluvial flooding (Figure 16). At Quarry Street, localised surface water flows generated by intense
