Former Scrap Yard

Former Chemical Manufacturing site

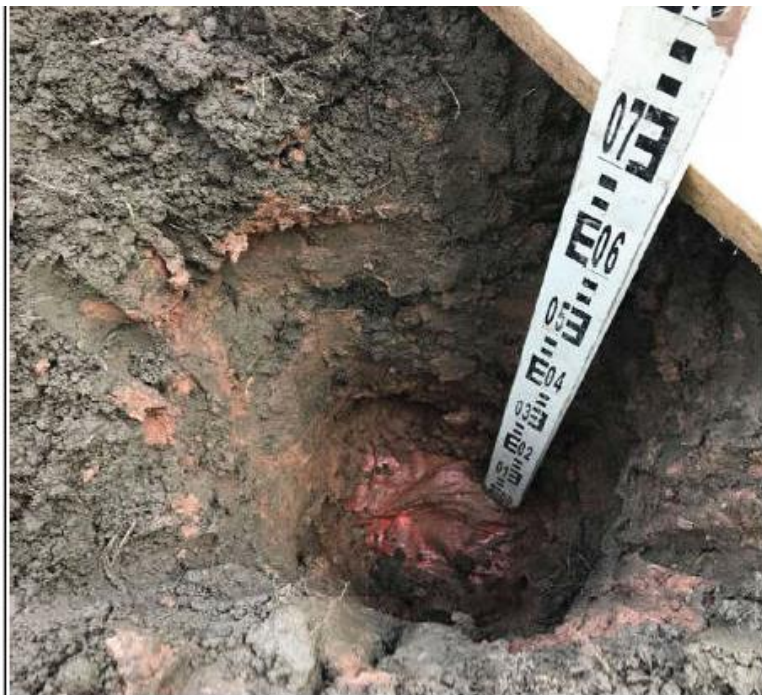
The photograph below shows the depth of clean cap cover being verified (approx. 600mm) within one of the gardens (last photograph).

Whilst the gross solvent/hydrocarbon contamination was dealt with through the process of excavation and removal of impacted soils, other possible contamination remained within the soils on site. This required the house developer to provide each house with a specialist gas membrane at foundation level and a clean cap of soils in the gardens placed above a marker geotextile.
